Mitigation Project Name UT to Mill Swamp Restoration Project
 DMS ID 95019
 River Basin White Oak
 Cataloging Unit 03030001

Subject: Task 11: Response Letter to DMS review comments regarding the Draft Year 5 Monitoring Report for the UT to Mill Swamp Restoration Project (#95019)
White Oak River Basin – CU#03030001, Onslow County, North Carolina
DEQ Contract No. 003992, Baker No. 124578

NCDMS Project ID Number – 95019, DEQ Contract No. 003992

Project Info: Credit Release Year: 5 of 7 (Sixth site measurement since construction)
Year of Data Collection: 2018
Year of Completed Construction: 2013
Submission Date: December 2019

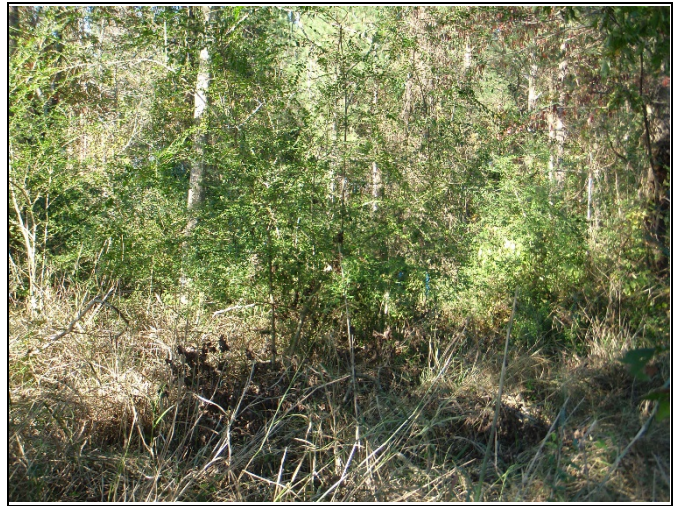
Invasive species areas of concern were observed and documented during Year 5 monitoring. One area of Chinese privet (*Ligustrum sinense*) re-sprouts totaling 0.53 acres was discovered along the left floodplain of the middle section of Reach UT1c. This area is identified as a Vegetation Problem Area (VPA) and will be treated in Monitoring Year 6. These resprouts overlap with a 0.55 acre area that had previously been treated for privet in February of 2018. The CCPV found in Appendix B shows the locations of each of these areas.

VPA (*Ligustrum sinense* resprouts) 10/30/18

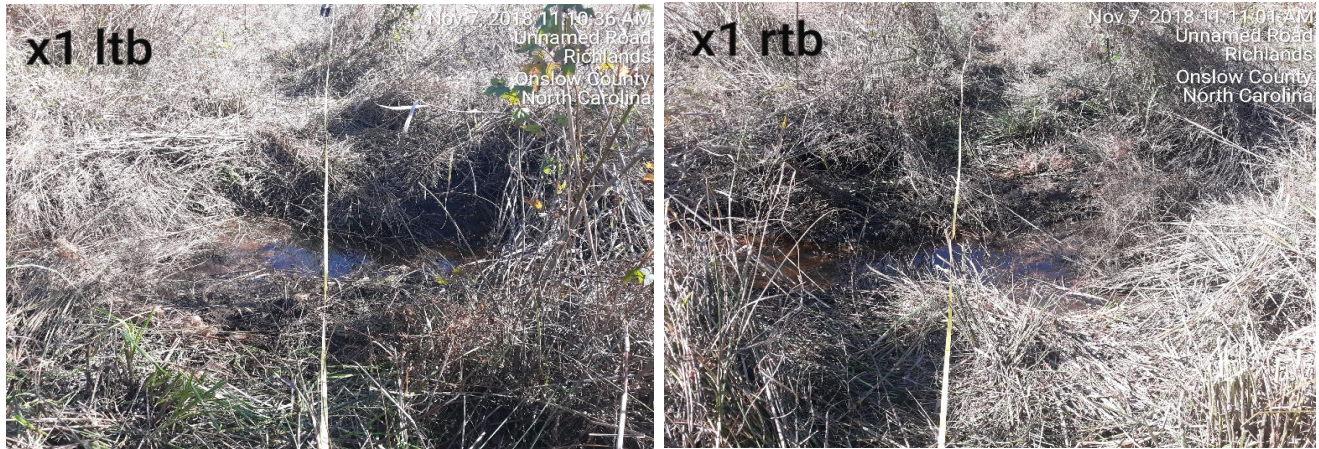
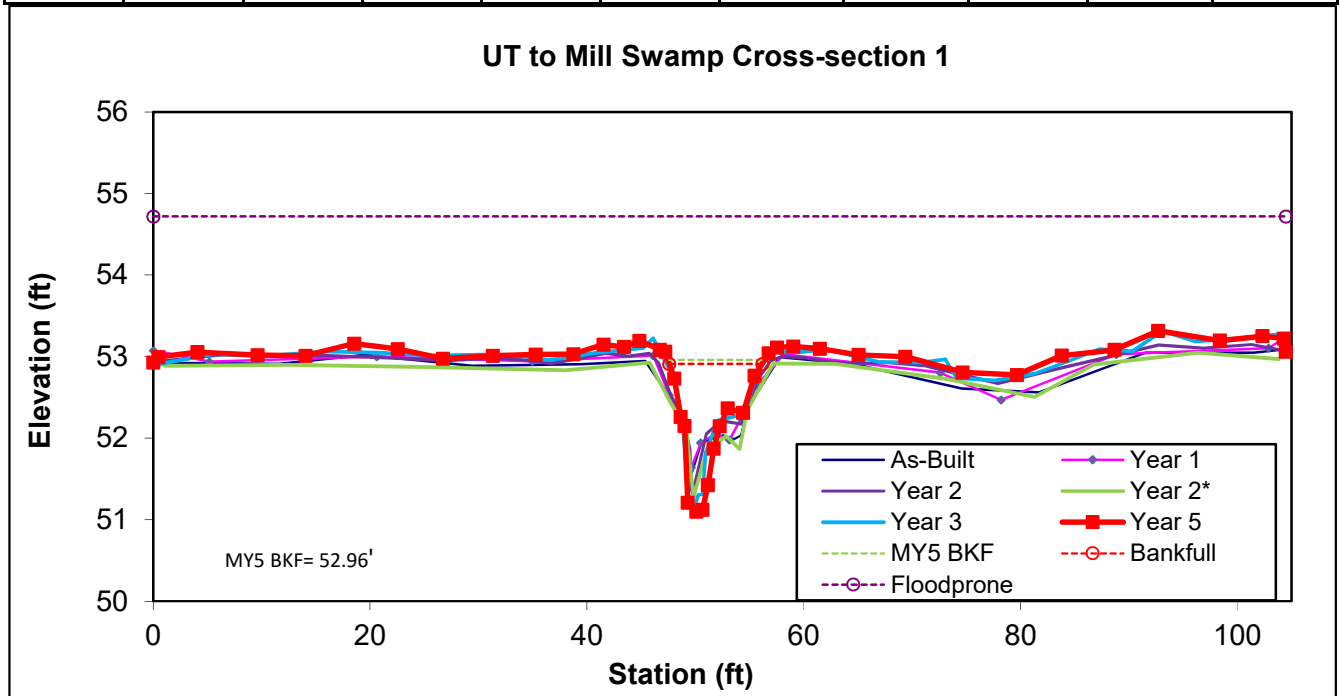
Permanent Cross-section 1
(Year 5 Data - Collected November 2018)

Feature	Stream Type	BKF Area	BKF Width	BKF Depth	Max BKF Depth	W/D	BH Ratio	ER	BKF Elev	TOB Elev
Riffle	E	7.0	8.5	0.8	1.8	10.3	1.0	12.3	52.91	53.04

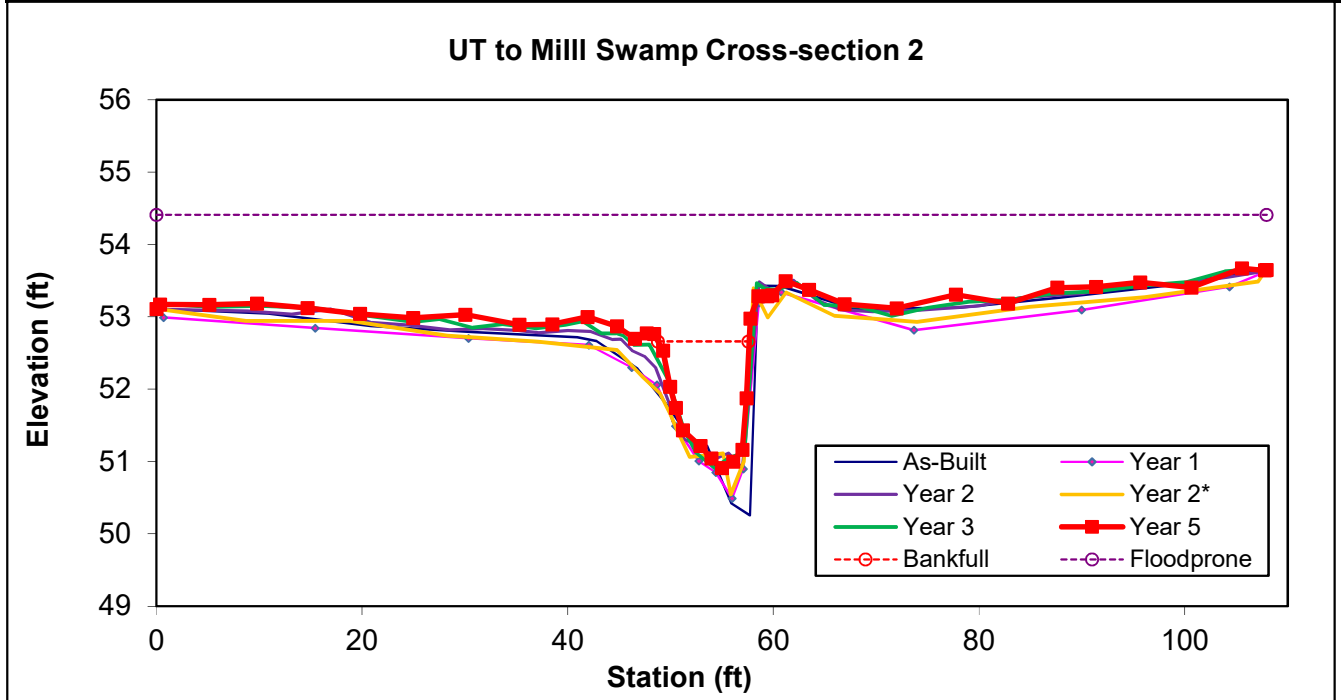
Permanent Cross-section 2

Feature	Stream Type	BKF Area	BKF Width	BKF Depth	Max BKF Depth	W/D	BH Ratio	ER	BKF Elev	TOB Elev
Pool	-	10.9	8.9	1.2	1.7	7.2	-	-	52.66	52.76

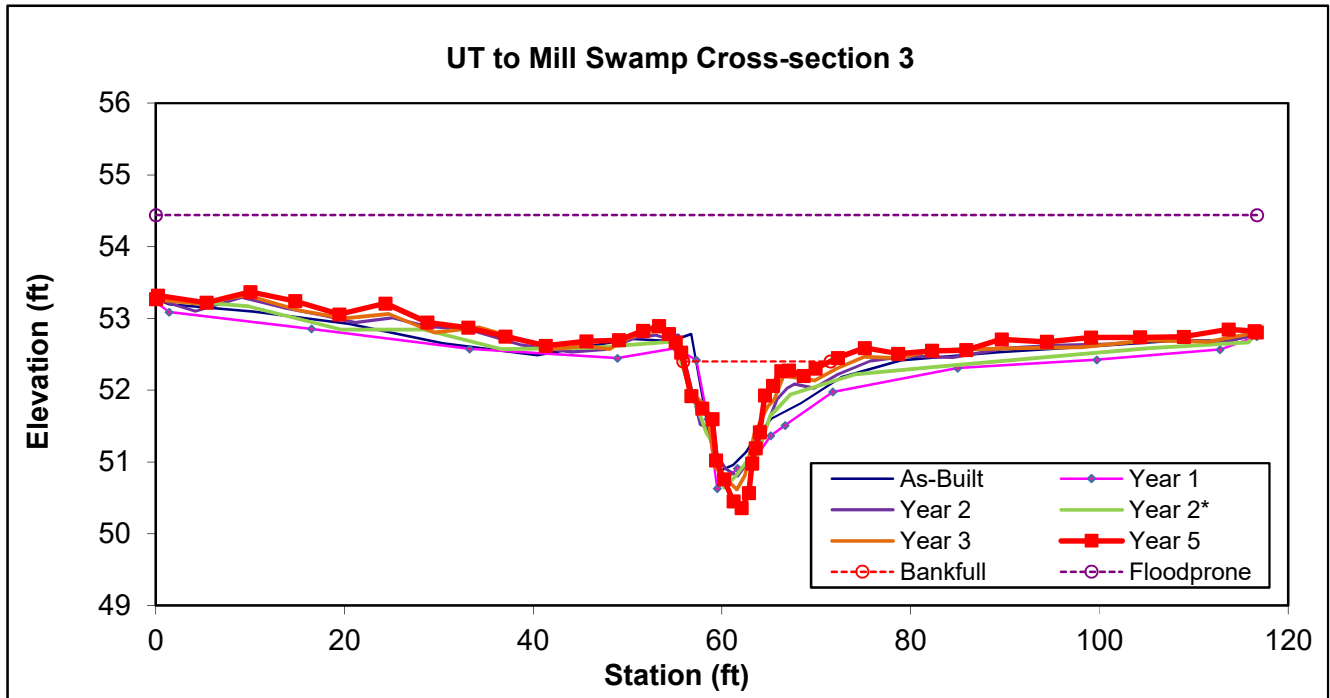
Permanent Cross-section 3

Feature	Stream Type	BKF Area	BKF Width	BKF Depth	Max BKF Depth	W/D	BH Ratio	ER	BKF Elev	TOB Elev
Pool	-	11.4	15.6	0.7	2.0	21.2	-	-	52.40	52.27

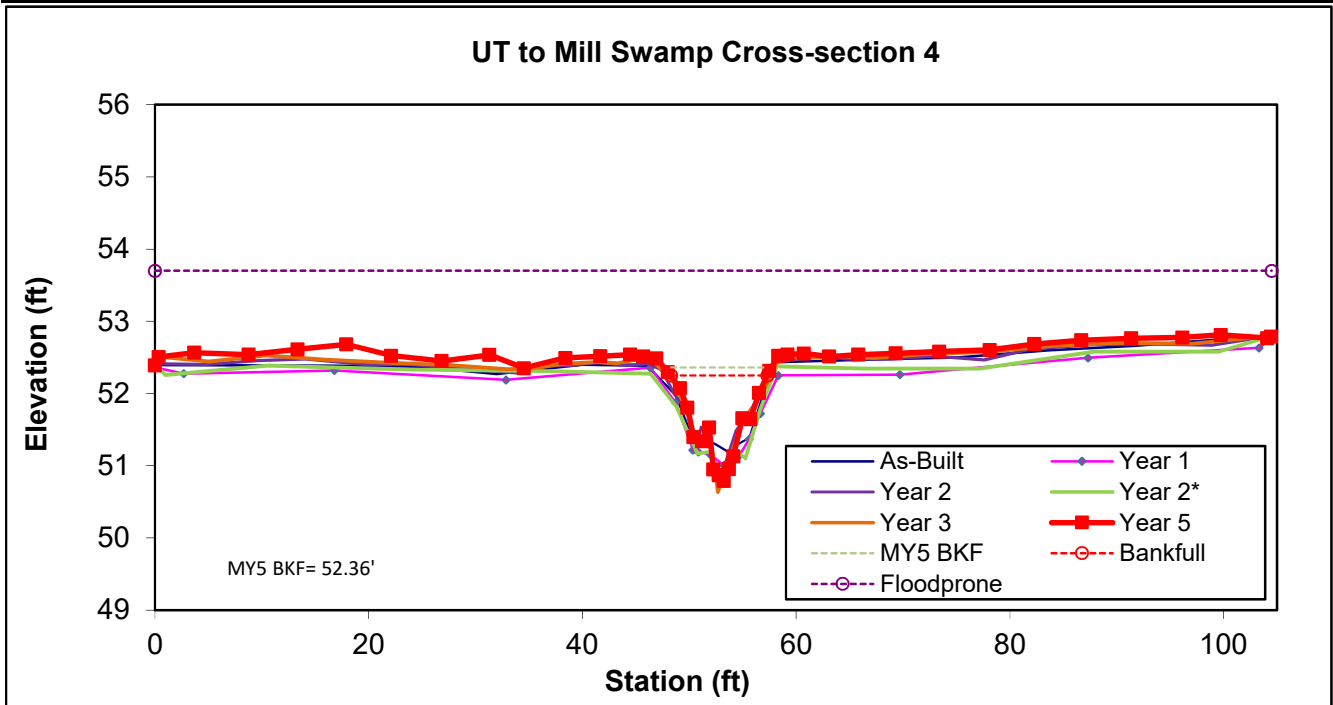
Permanent Cross-section 4

Feature	Stream Type	BKF Area	BKF Width	BKF Depth	Max BKF Depth	W/D	BH Ratio	ER	BKF Elev	TOB Elev
Riffle	C	6.4	9.0	0.7	1.5	12.7	1.1	11.6	52.25	52.49

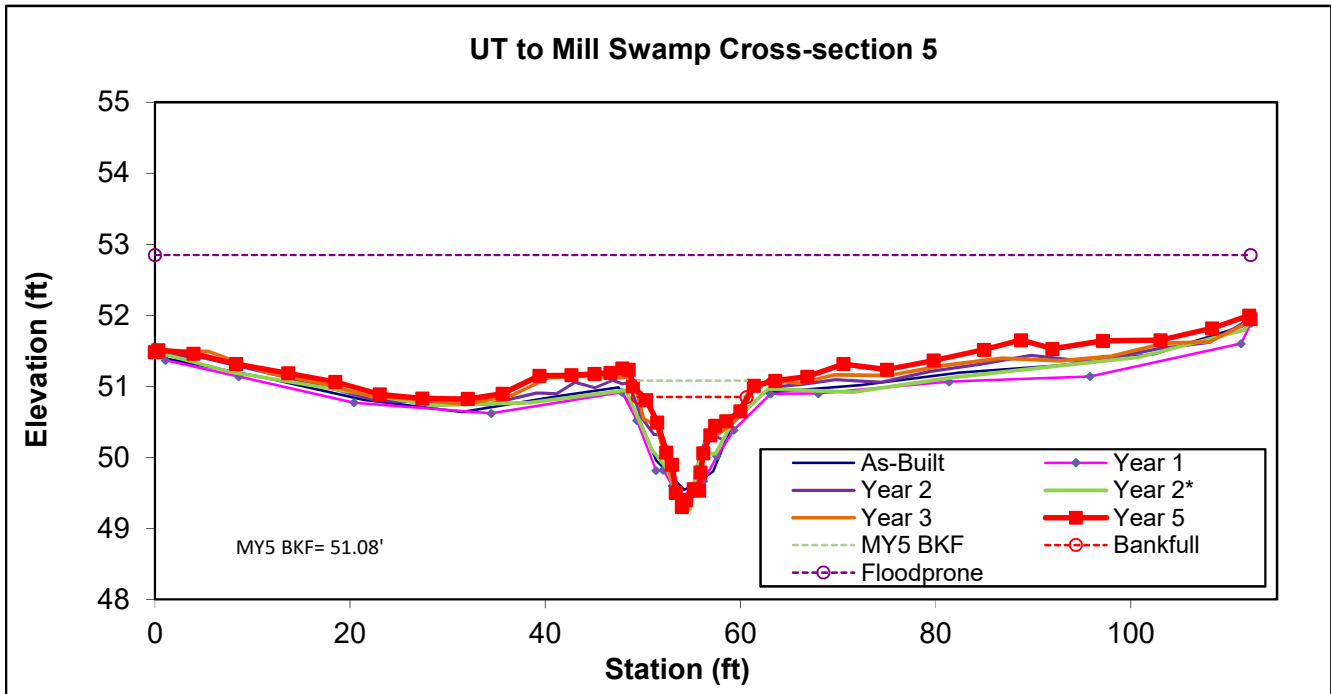
Permanent Cross-section 5

Feature	Stream Type	BKF Area	BKF Width	BKF Depth	Max BKF Depth	W/D	BH Ratio	ER	BKF Elev	TOB Elev
Riffle	C	7.1	10.7	0.7	1.5	16.2	1.0	10.5	50.85	50.45

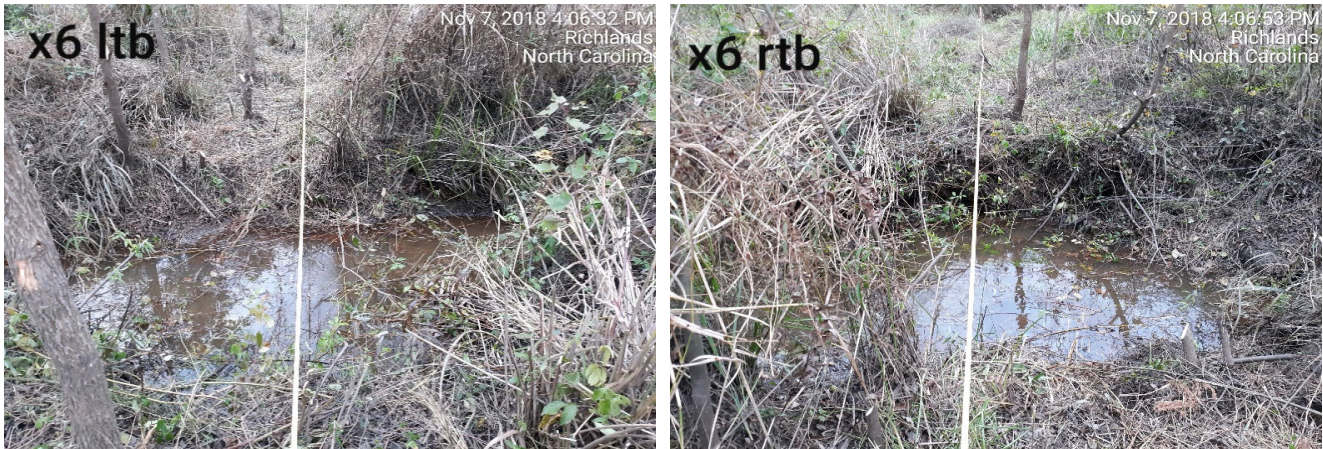
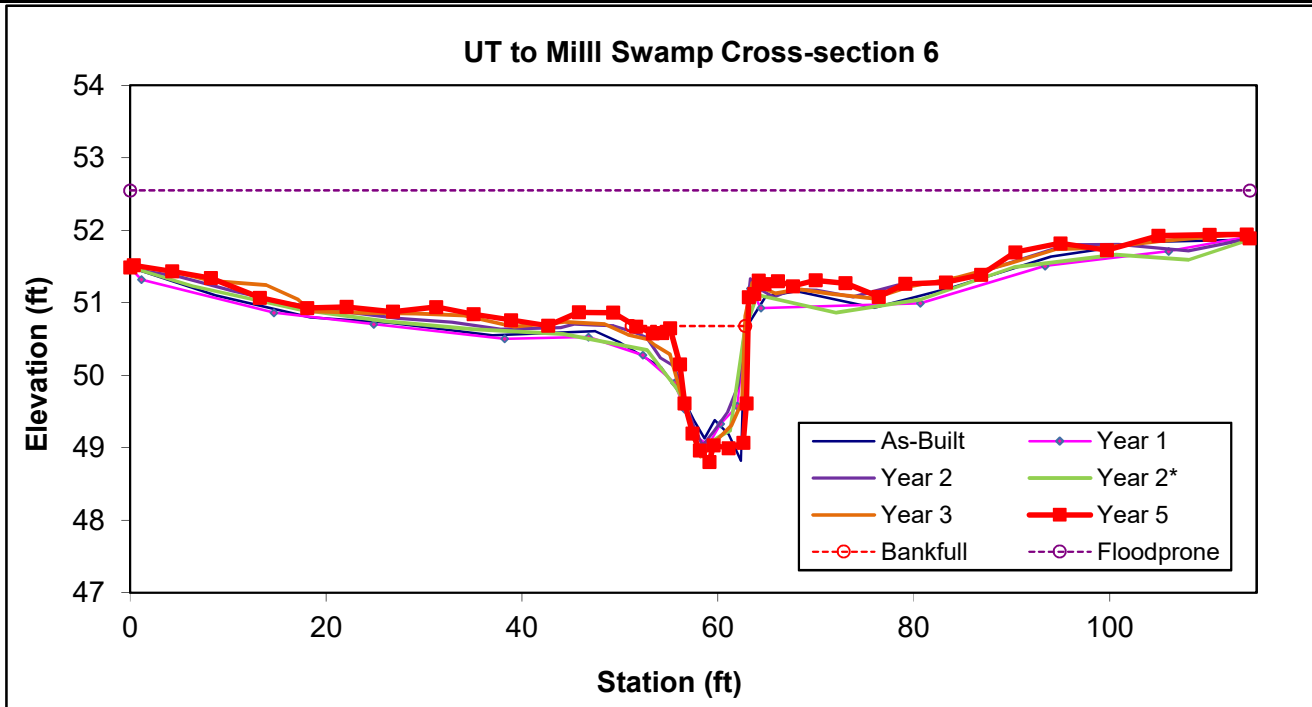
Permanent Cross-section 6

Feature	Stream Type	BKF Area	BKF Width	BKF Depth	Max BKF Depth	W/D	BH Ratio	ER	BKF Elev	TOB Elev
Pool	-	11.2	11.5	1.0	1.9	11.8	-	-	50.68	50.65

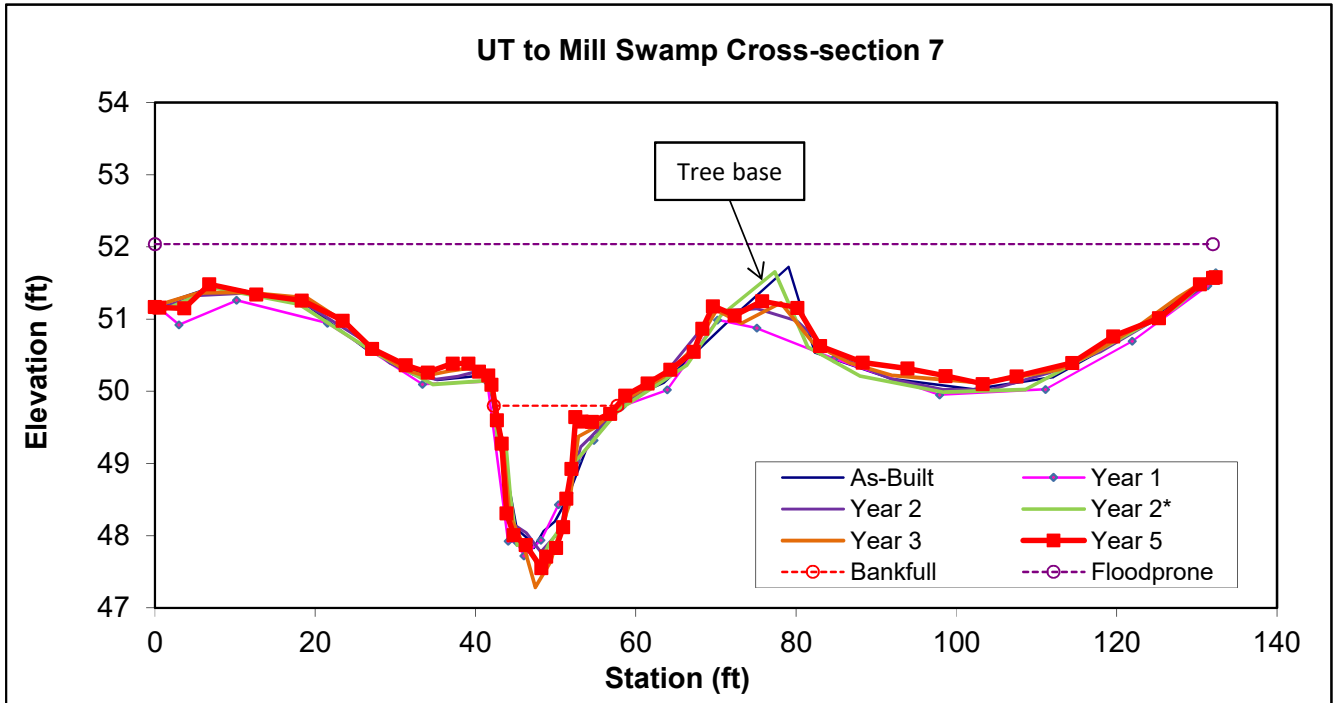
Permanent Cross-section 7

Feature	Stream Type	BKF Area	BKF Width	BKF Depth	Max BKF Depth	W/D	BH Ratio	ER	BKF Elev	TOB Elev
Pool	-	17.0	15.2	1.1	2.2	13.6	-	-	49.80	49.65

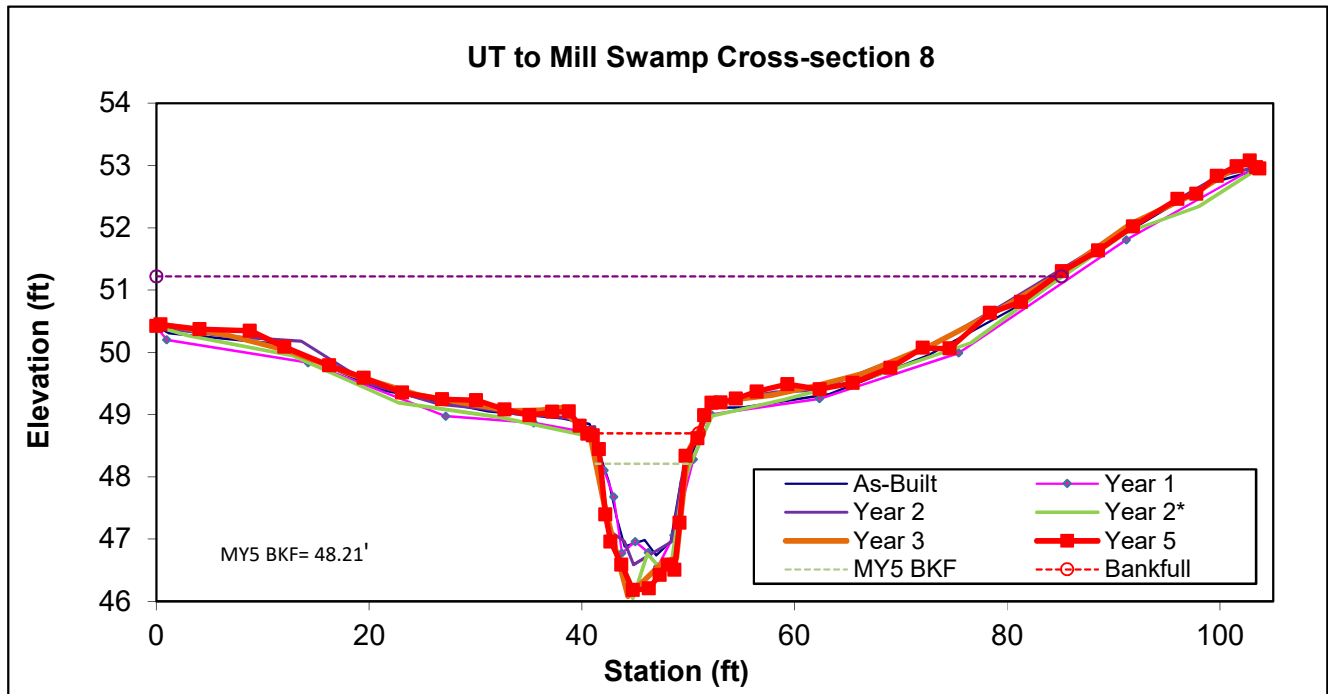
Permanent Cross-section 8

Feature	Stream Type	BKF Area	BKF Width	BKF Depth	Max BKF Depth	W/D	BH Ratio	ER	BKF Elev	TOB Elev
Riffle	E	16.6	10.5	1.6	2.5	6.7	1.2	8.0	48.70	48.66

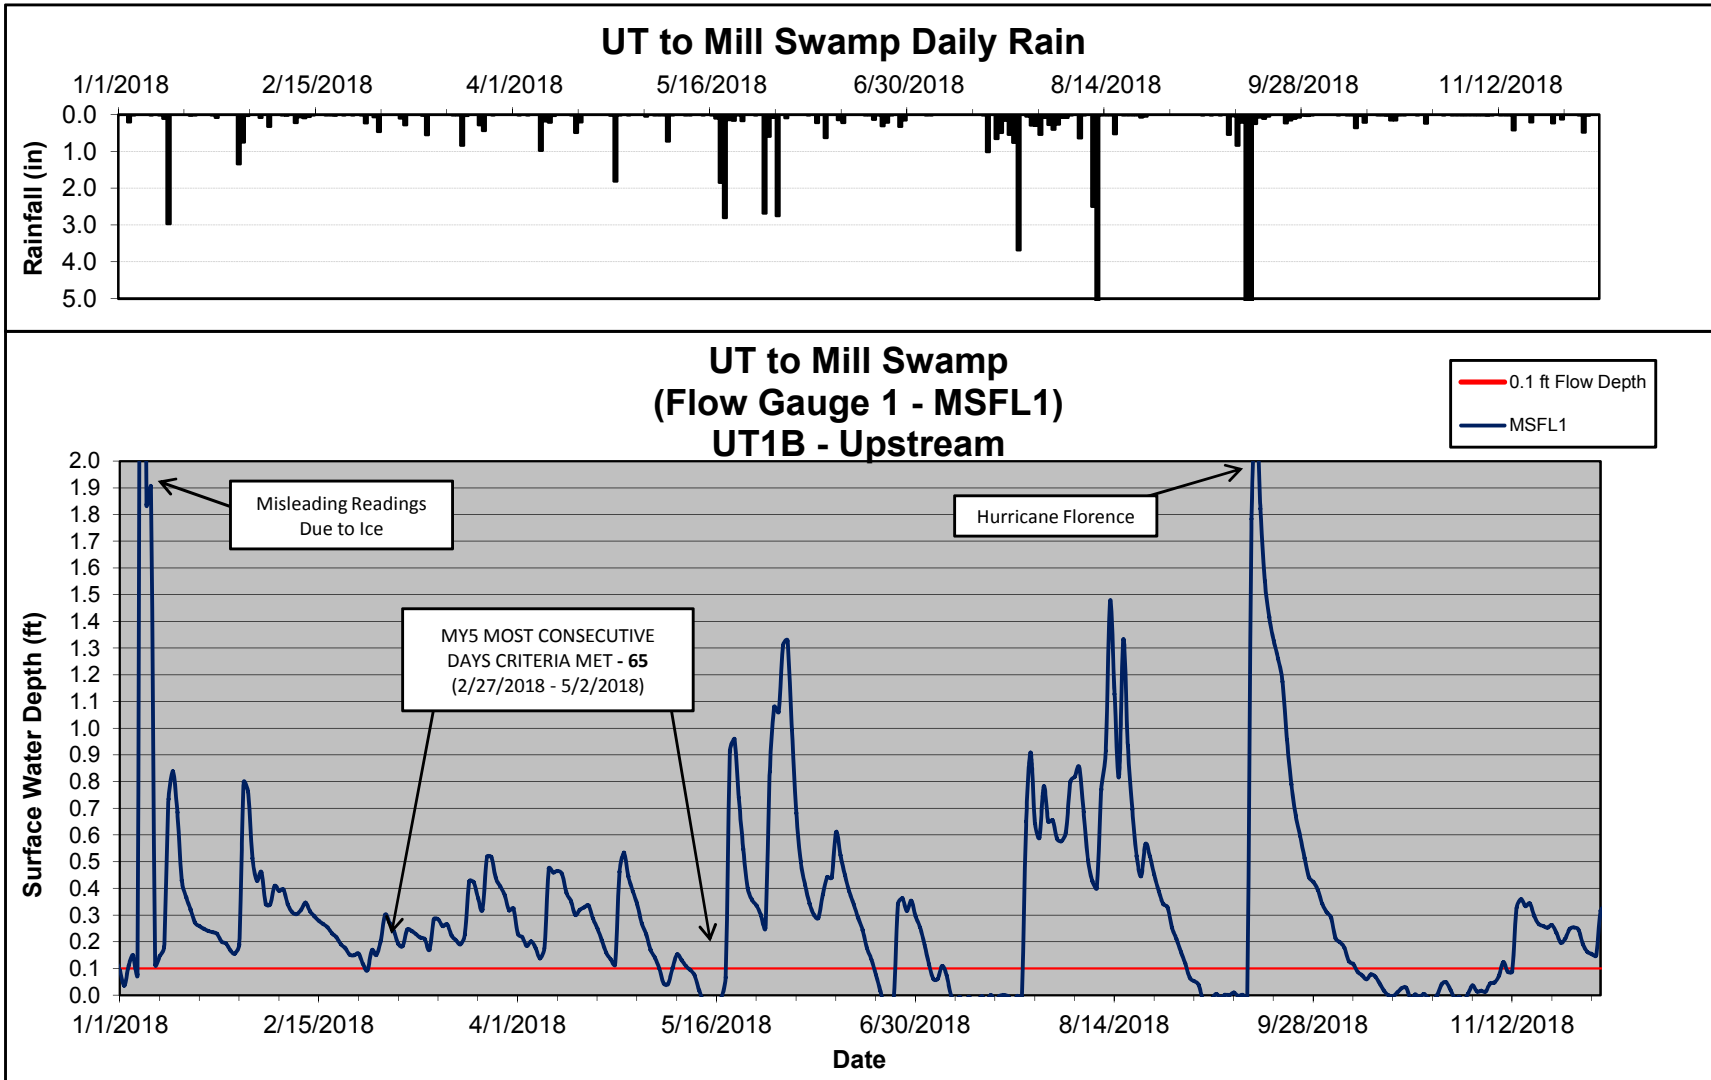
Figure 5. Flow Gauge Graph

Year 5 flow monitoring on Reach UT1b demonstrated that flow gauge MSFL1 (on upper UT1b) met the stated success criteria of 30 days or more of consecutive flow through upper UT1b with 65 days of consecutive flow and 247 days of total cumulative flow. The gauge demonstrated similar patterns relative to rainfall events observed in the vicinity of the Site. Flow gauge MSFL2 (on lower UT1b) unexpectedly and permanently failed during the winter of 2017/2018. It will not be replaced as it had already met the required project success criteria

* Surface water flow is estimated to have occurred when the pressure transducer reading is equal to or above 0.1 feet in depth.
