UT to Mill Swamp Restoration Project Seventh Monitoring Measurement Sixth Year of Credit Release - Final

Onslow County, North Carolina

DMS Project ID Number – 95019, DEQ Contract No. 003992

Report Prepared and Submitted by Michael Baker Engineering, Inc.

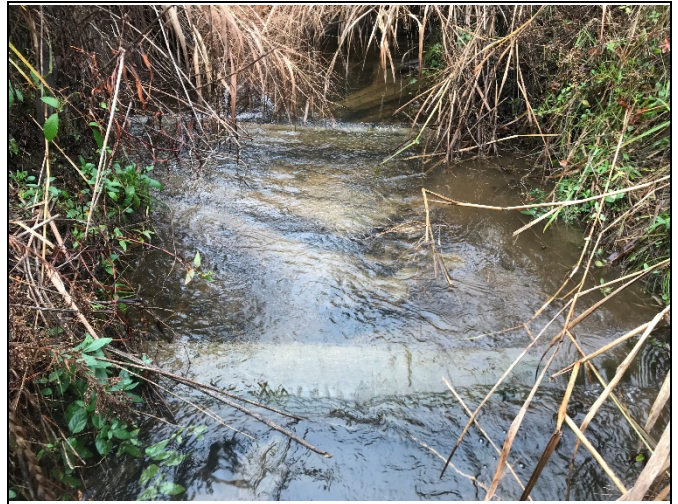
Photo Point 2 – Log Jam

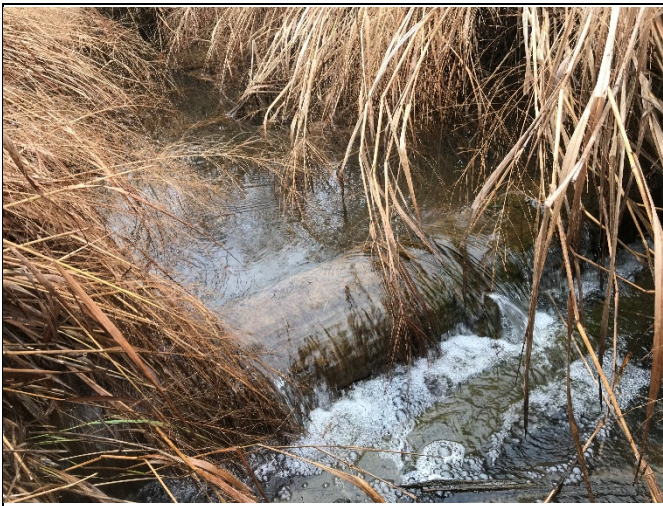
Photo Point 3 – Log Weir/Log Jam

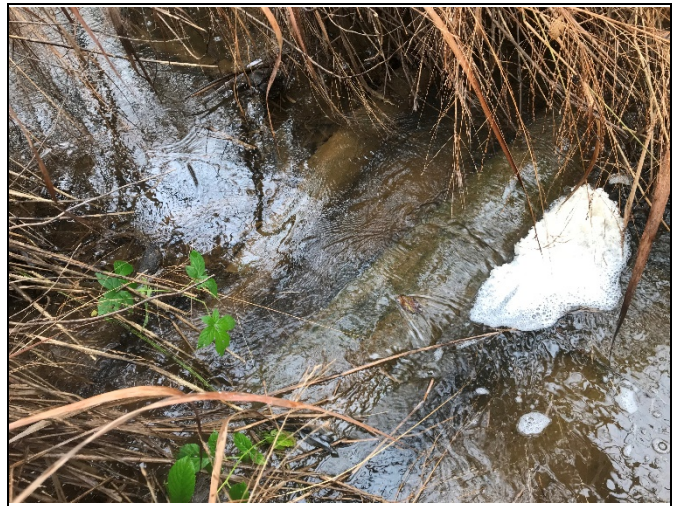
Photo Point 4 – Log Jam

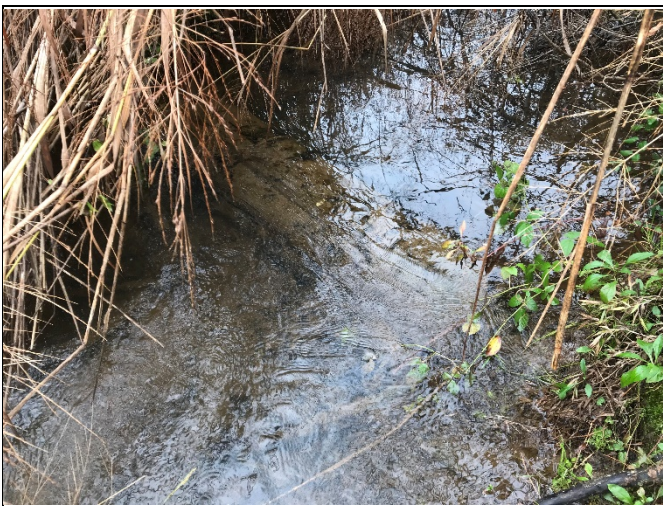
Photo Point 5 – Log Jam

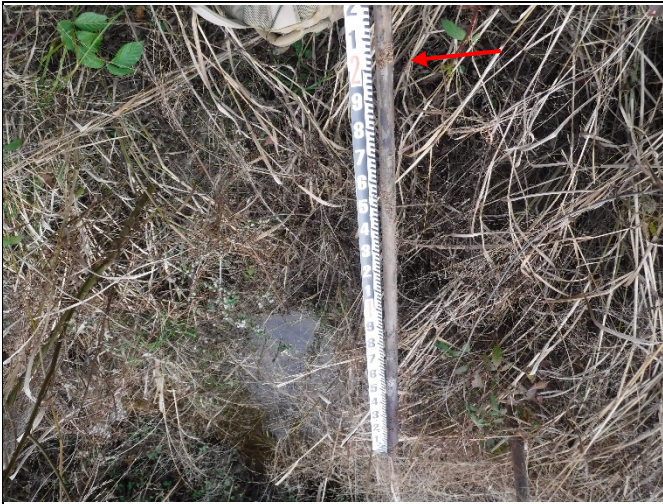
The Site was also found to have had at least one above-bankfull event based on the crest gauge reading (and confirmed with flow gauge data) during Year 6 monitoring. The recorded event was measured to be 2.10 feet above bankfull and was associated with a significant storm on 9/5/19.

Crest gauge reading: 2.10 ft from 9/5/19 storm event

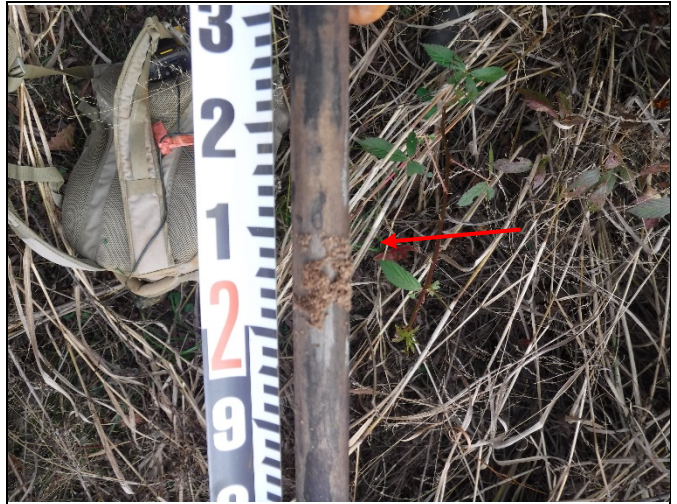
Close-up of crest gauge reading: 2.10 ft from 9/5/19 storm event

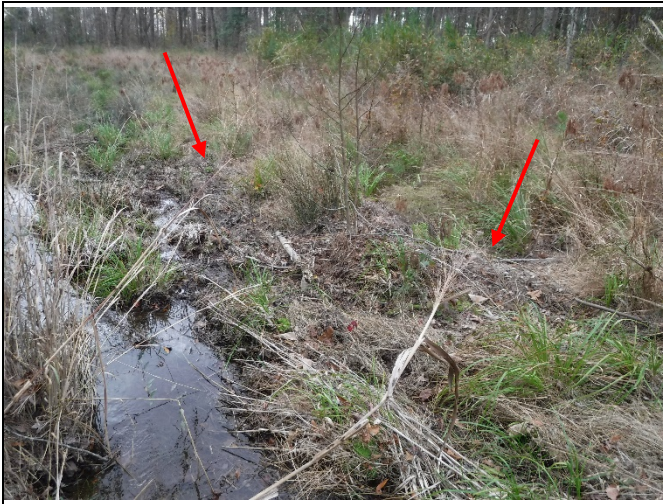
Debris and wrack lines in the floodplain from overbank event on UT-1a (photo from 12/6/19)

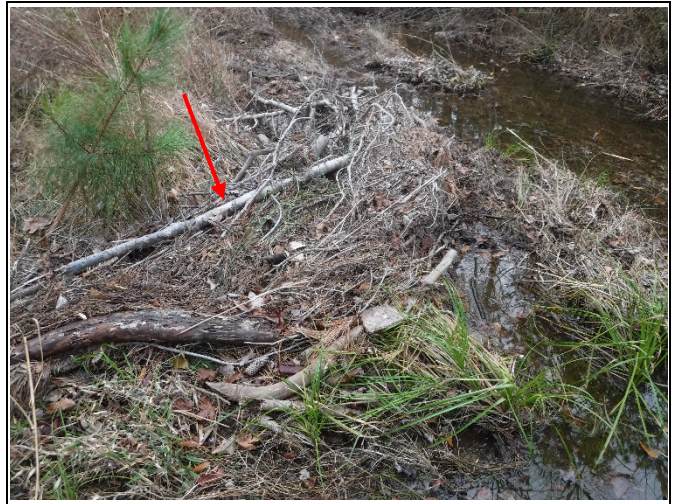
Debris and wrack lines in the floodplain from overbank event on UT-1b (photo from 12/6/19)

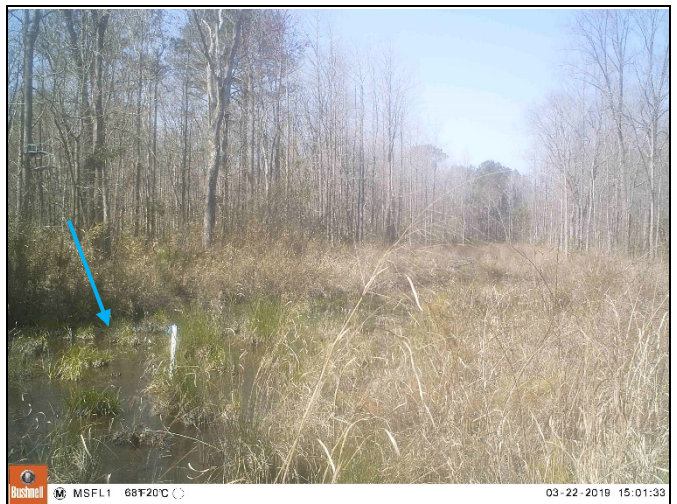
Flow Camera #1 on 3/22/19 (flow in channel)

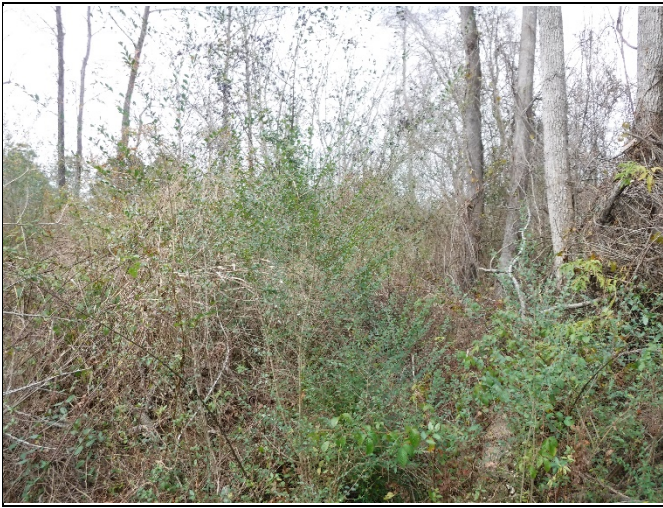
Invasive species areas of concern were observed and documented during Year 6 monitoring. Two areas of scattered Chinese privet (*Ligustrum sinense*) re-sprouts totaling 0.96 acres were discovered in portions of the floodplain along both banks of the middle and lower sections of Reach UT1c. They are identified as a Vegetation Problem Area (VPA) in Table 6b and will be treated as soon as temperatures are appropriate for spraying. Much of the VPA area on the left bank had previously been treated for privet in March of 2019. The

VPA (*Ligustrum sinense* resprouts) 12/6/19

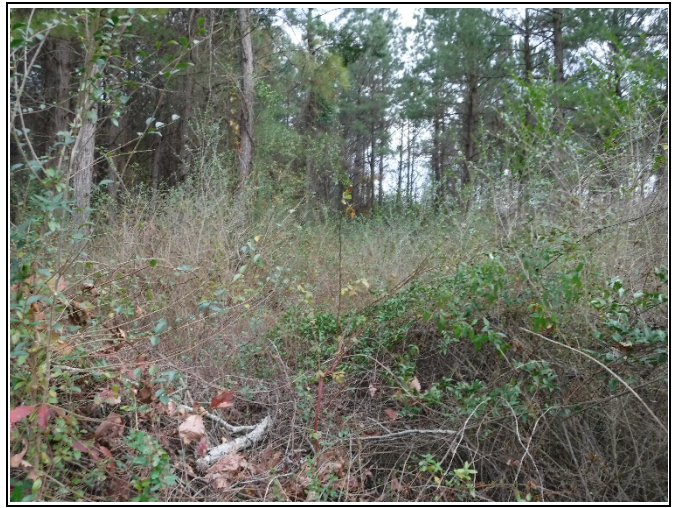
VPA (*Ligustrum sinense* resprouts) 12/6/19

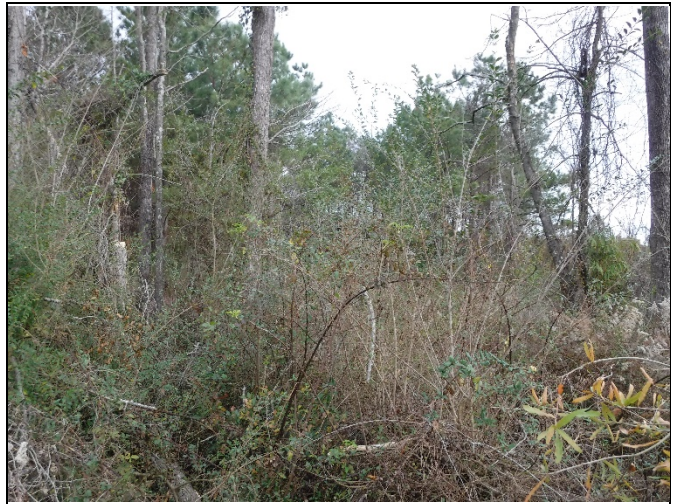
VPA (*Ligustrum sinense* resprouts) 12/6/19
