UT to Mill Swamp Restoration Project Eighth Monitoring Measurement Seventh Year of Credit Release - Final

Onslow County, North Carolina

NCDMS Project ID Number – 95019, DEQ Contract No. 003992

Report Prepared and Submitted by Michael Baker Engineering, Inc.

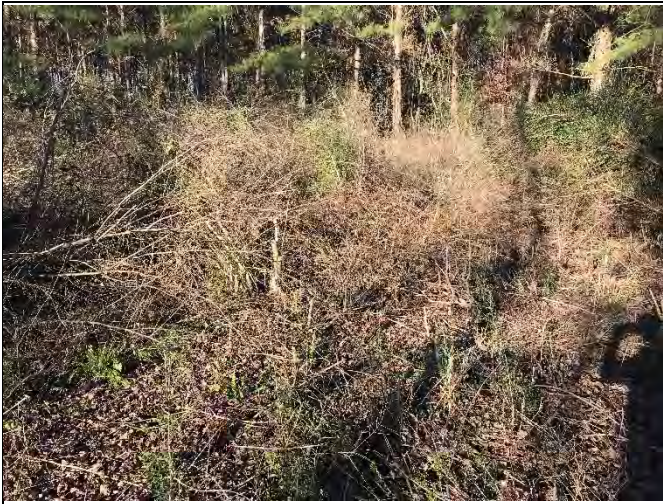
Two areas of invasive Chinese privet (*Ligustrum sinense*) totaling 0.96 acres that had previously been identified as a Vegetation Problem Area (VPA) in the Year 6 report were treated in September of 2020. However, additional resprouts were again observed and documented during Year 7 monitoring. Scattered privet resprouts totaling 0.87 acres were observed in two areas along the left and right floodplain of the middle and lower sections of Reach UT1c. These invasives are identified as a Vegetation Problem Area (VPA) and will be treated in the spring of 2021, prior to Site closeout evaluations. These resprout areas overlap significantly with the previously treated areas. The CCPV found in Appendix B shows the locations of each of these areas.

Privet treated (photo from Dec. 2020), note some resprouts already found within the treated area

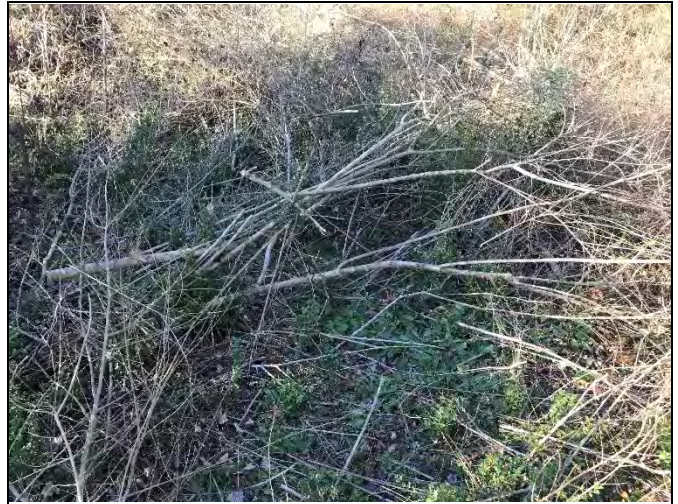
Privet treated (photo from Dec. 2020), note some resprouts already found within the treated area

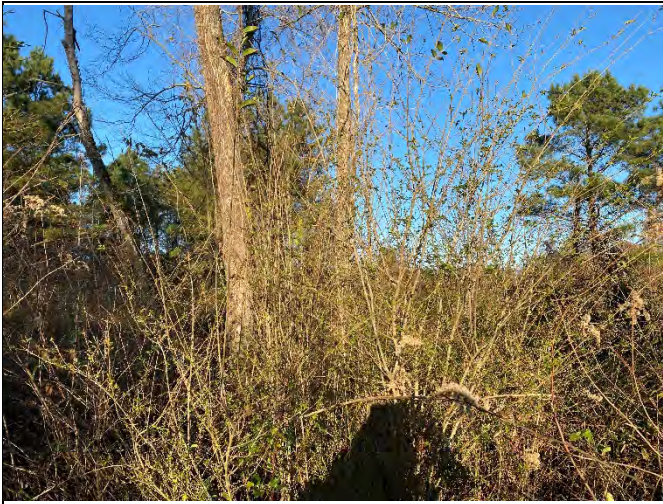
Privet resprouts observed (Dec. 2020)

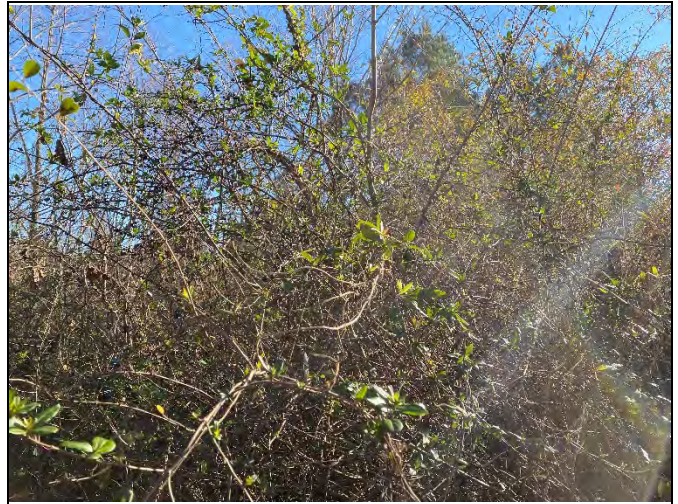
Privet resprouts observed (Dec. 2020)

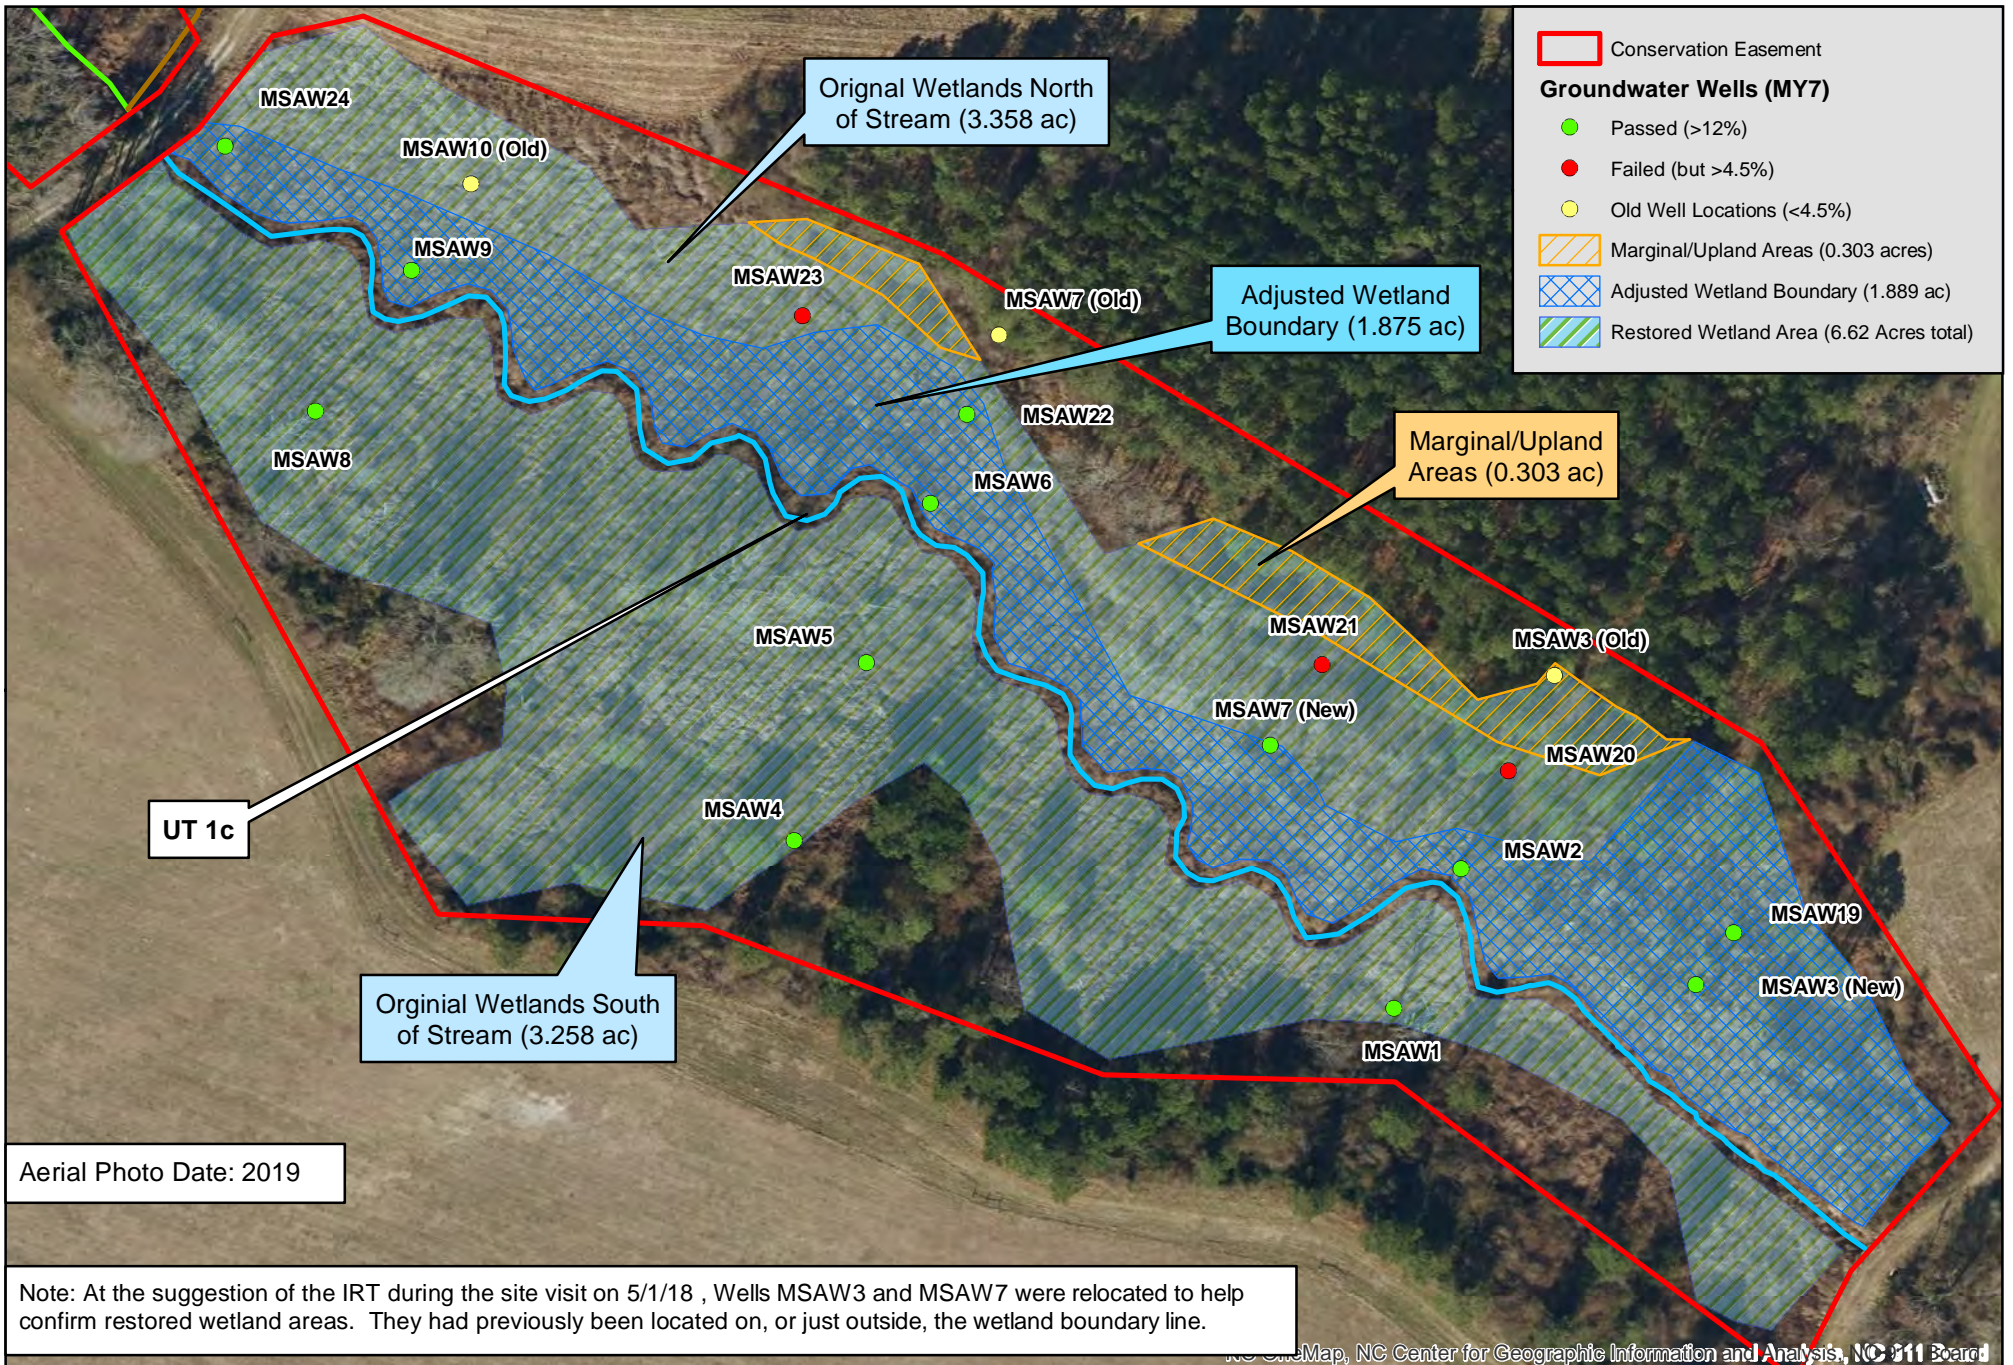
Figure 1
Wetland Restoration
Boundary Adjustment
UT to Mill Swamp Site

During the course of the assessment, a relatively clear visual boundary was apparent running roughly mid-way through the wetland. The inner portion of the boundary was characterized primarily by the presence of very shallow standing water and/or soil saturation to the surface (despite not having rained since getting < 0.25" 5 days prior). It also contained notably wetter vegetation (more rushes, sedges, mosses, wet ferns, etc), had water-stained leaves commonly present, and had other scattered indicators of hydrology such as crayfish burrows and trim lines on tree trunks. The adjacent outer area still appeared to be a wetland (i.e. it still appeared to meet all three jurisdictional parameters) but was nevertheless visually distinct from the clearly wetter inner area. Of note, strong hydric soils were found throughout the restored wetland and so the boundary adjustment focused on the presence of the other factors discussed above.

As previously noted, the historic well data in the more marginal areas that were removed in the boundary adjustment provide further evidence to support the new boundary. The wells located within the removed areas met the hydrologic criteria for jurisdiction in most years but did not meet the restoration success criteria of 12%.

Note: At the suggestion of the IRT during the site visit on 5/1/18, Wells MSAW3 and MSAW7 were relocated to help confirm restored wetland areas. They had previously been located on, or just outside, the wetland boundary line.
