***BASELINE MONITORING DOCUMENT &
AS-BUILT BASELINE REPORT***

UT TO NEUSE RIVER (BIG DITCH)

Wayne County, North Carolina

EEP Project # 92682

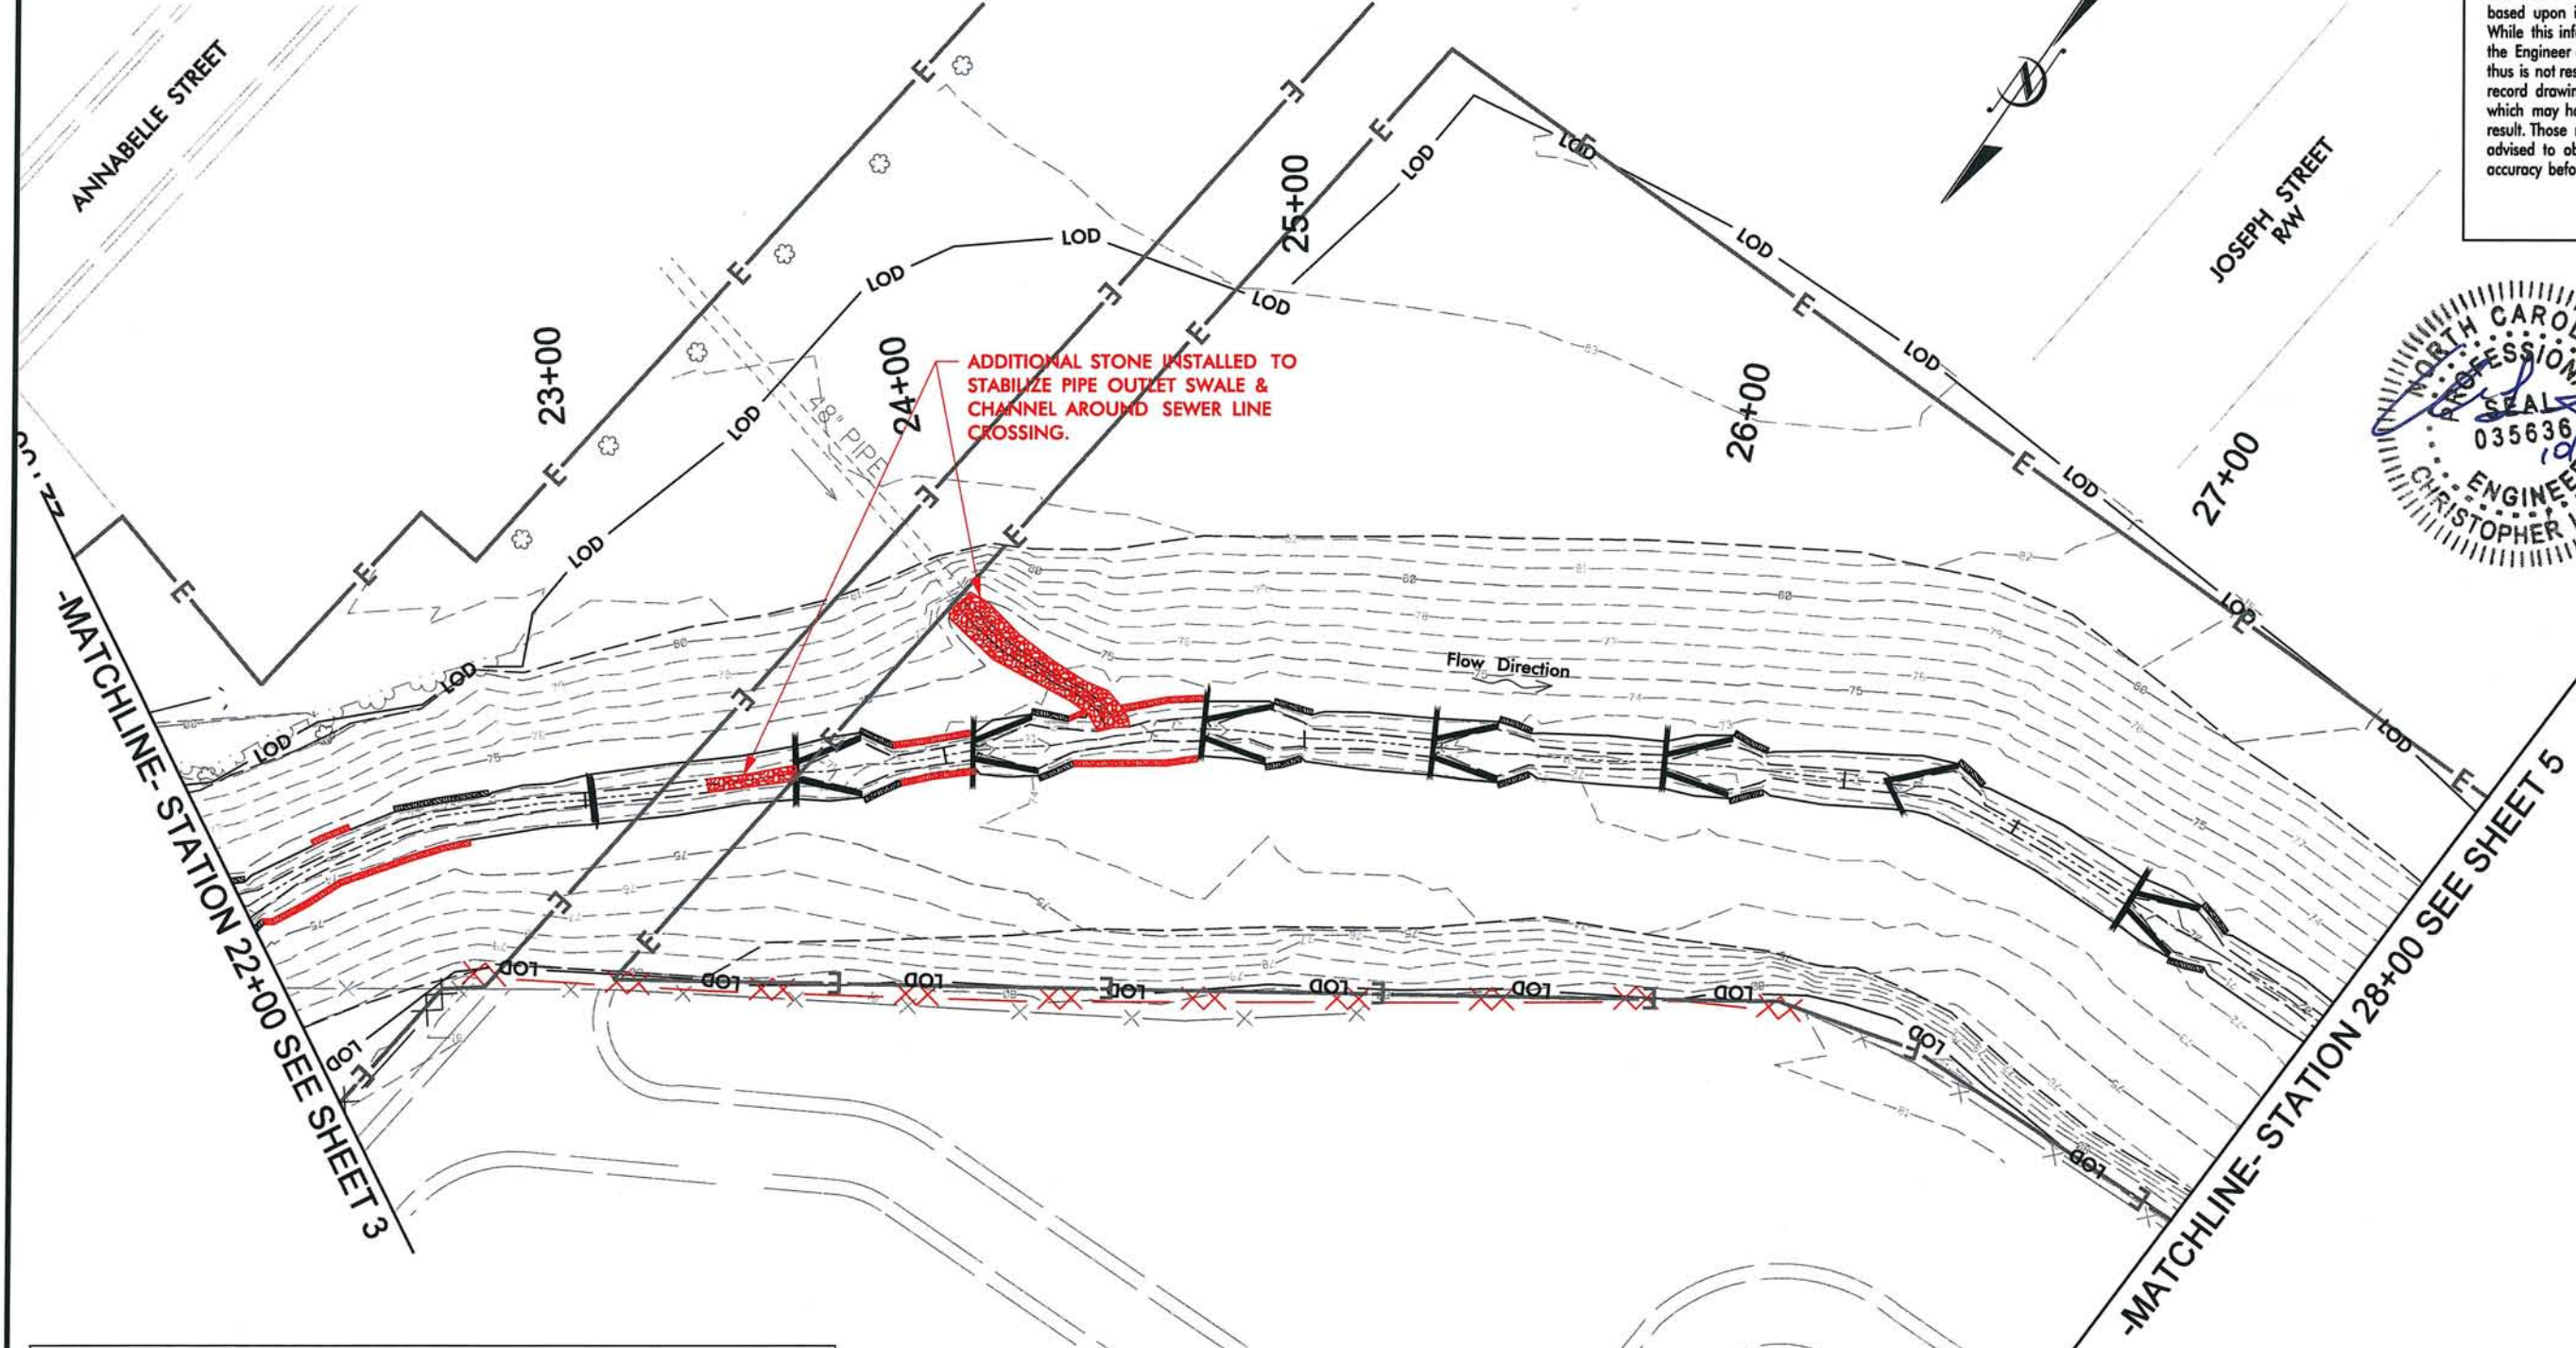
ADDITIONAL STONE INSTALLED TO STABILIZE PIPE OUTLET SWALE & CHANNEL AROUND SEWER LINE CROSSING.
