YEAR 1 MONITORING REPORT

UT TO NEUSE RIVER (BIG DITCH) STREAM RESTORATION SITE

Wayne County, North Carolina

EEP Project No.: 92682

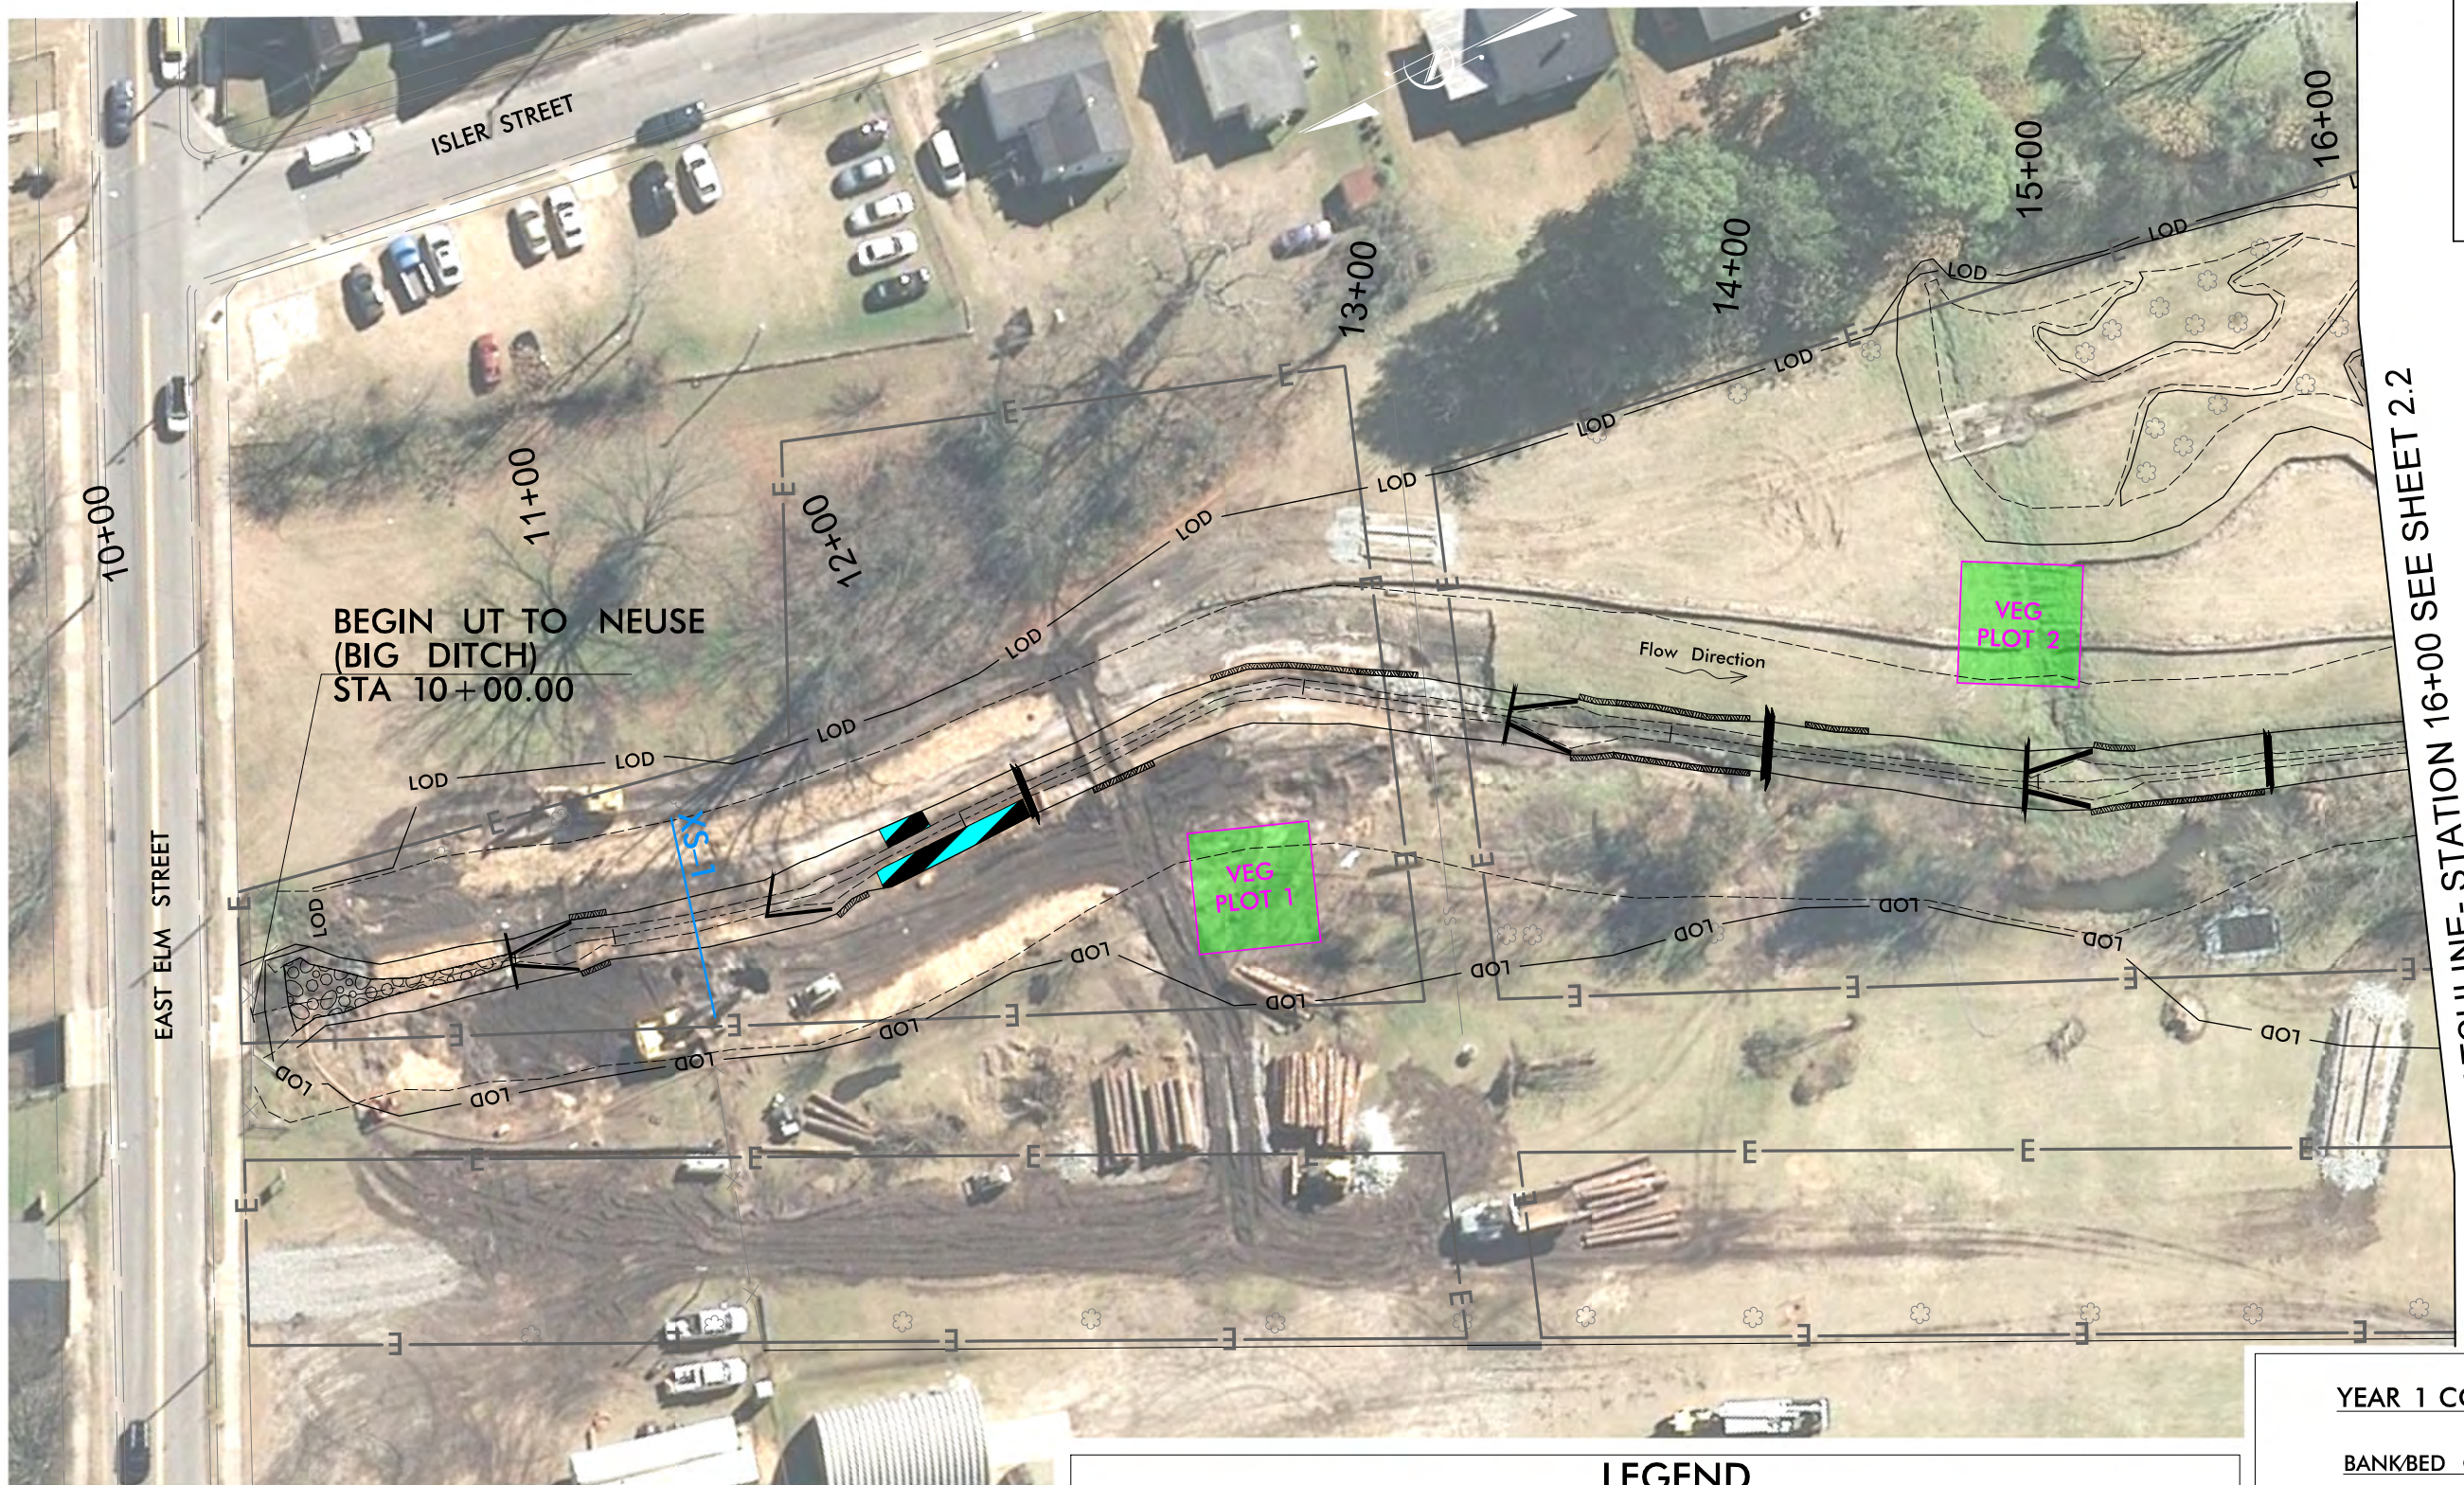
FIGURE 2.1

YEAR 1 CONDITIONS	
	MINOR EROSION
	CRITERIA MET
	CRITERIA UNMET

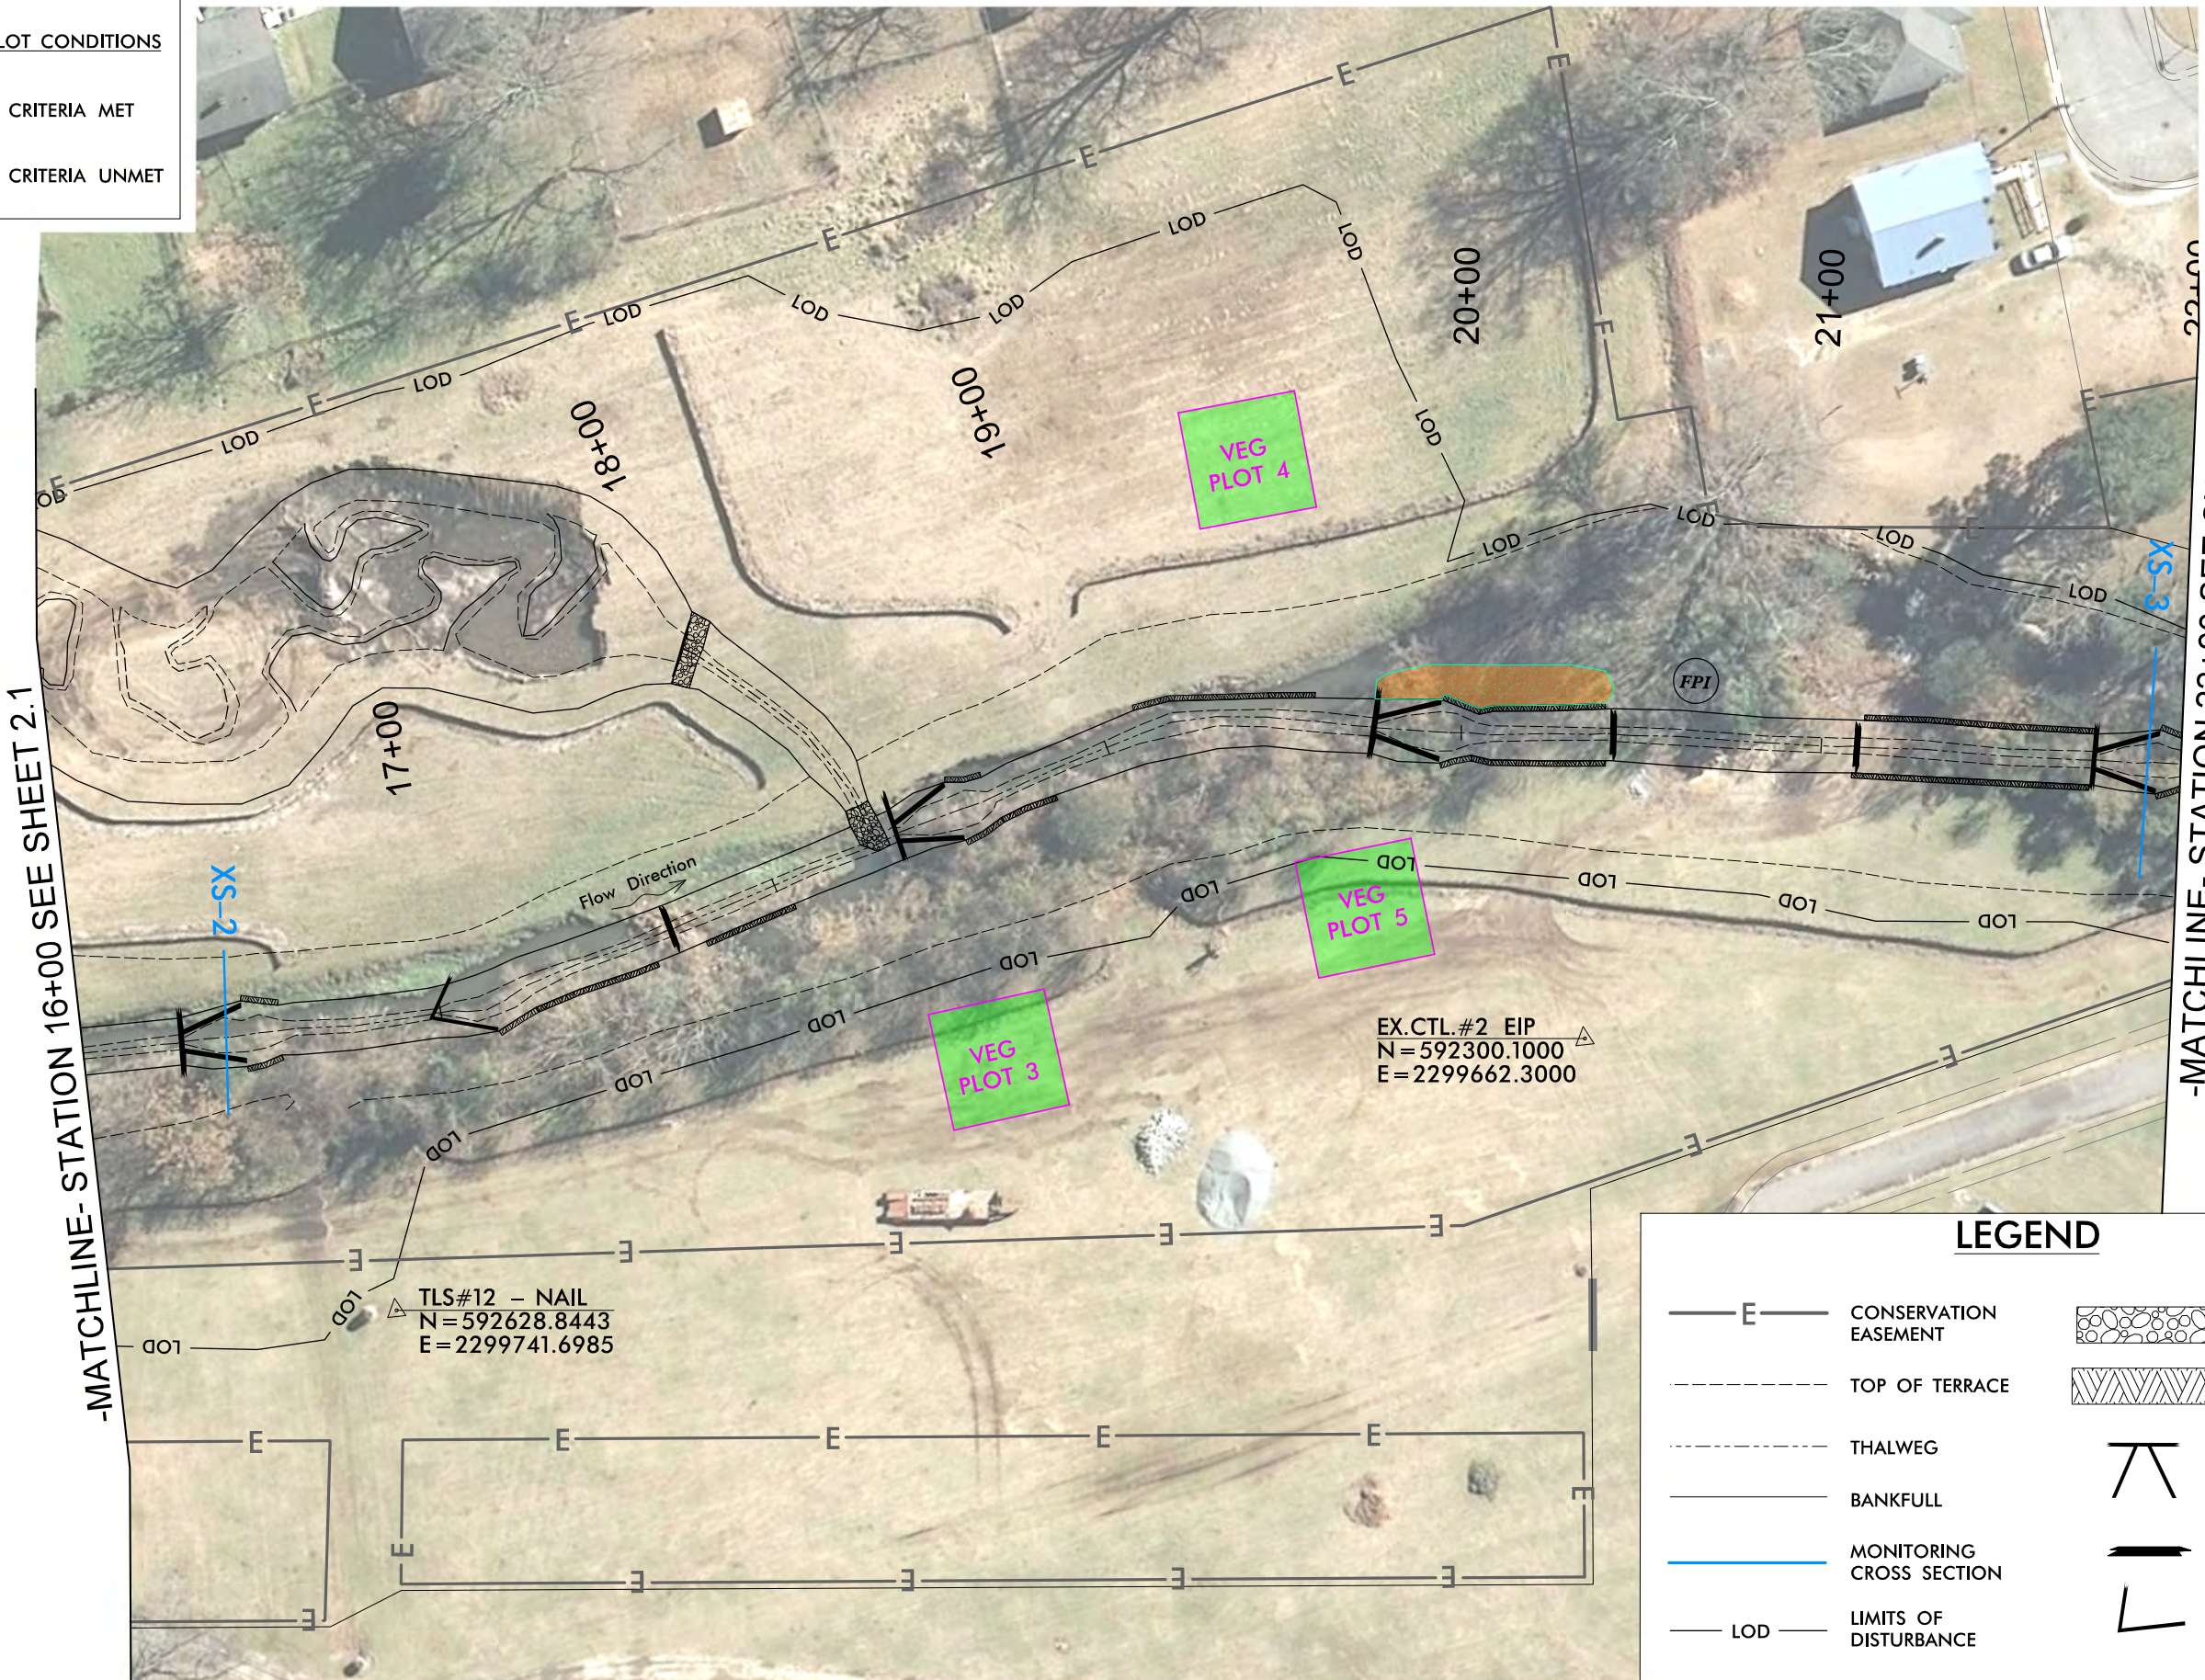
FIGURE
2.2

YEAR 1 CONDITIONS

VEGETATION PROBLEM AREAS

THIN GRASS

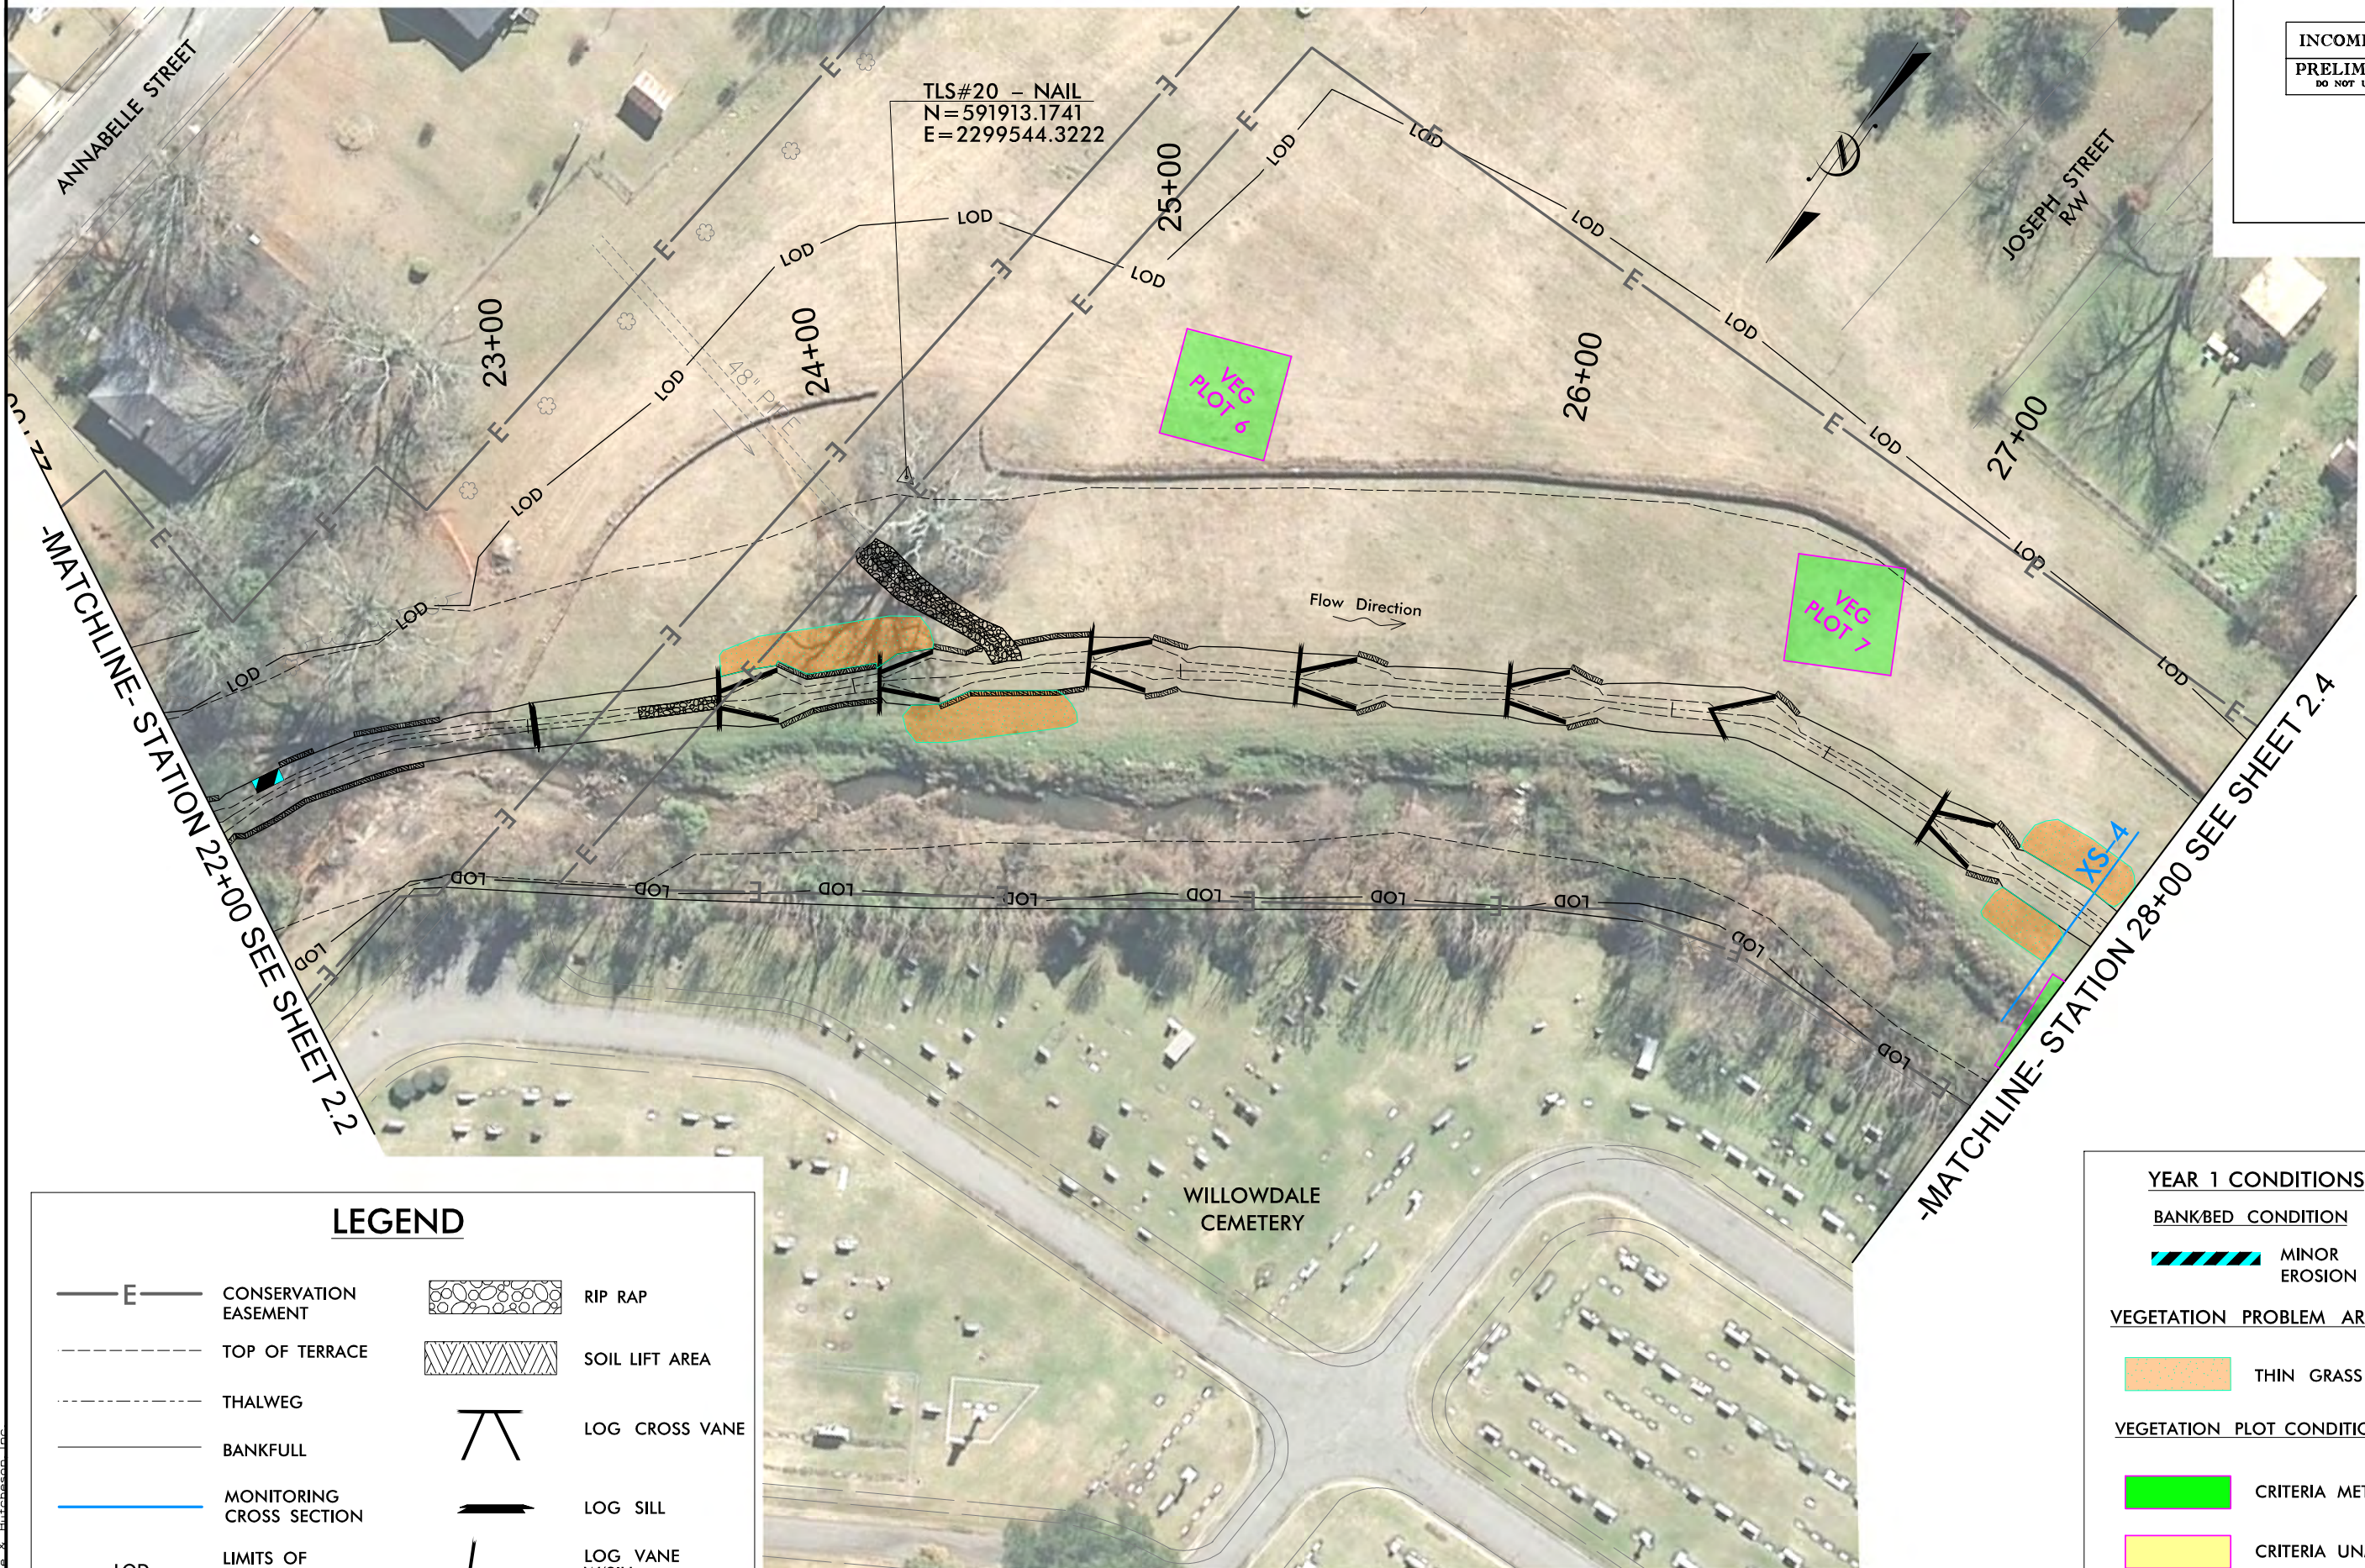
FIGURE 2.3

YEAR 1 CONDITIONS

BANKBED CONDITION

- MINOR EROSION

VEGETATION PROBLEM AREAS

- THIN GRASS

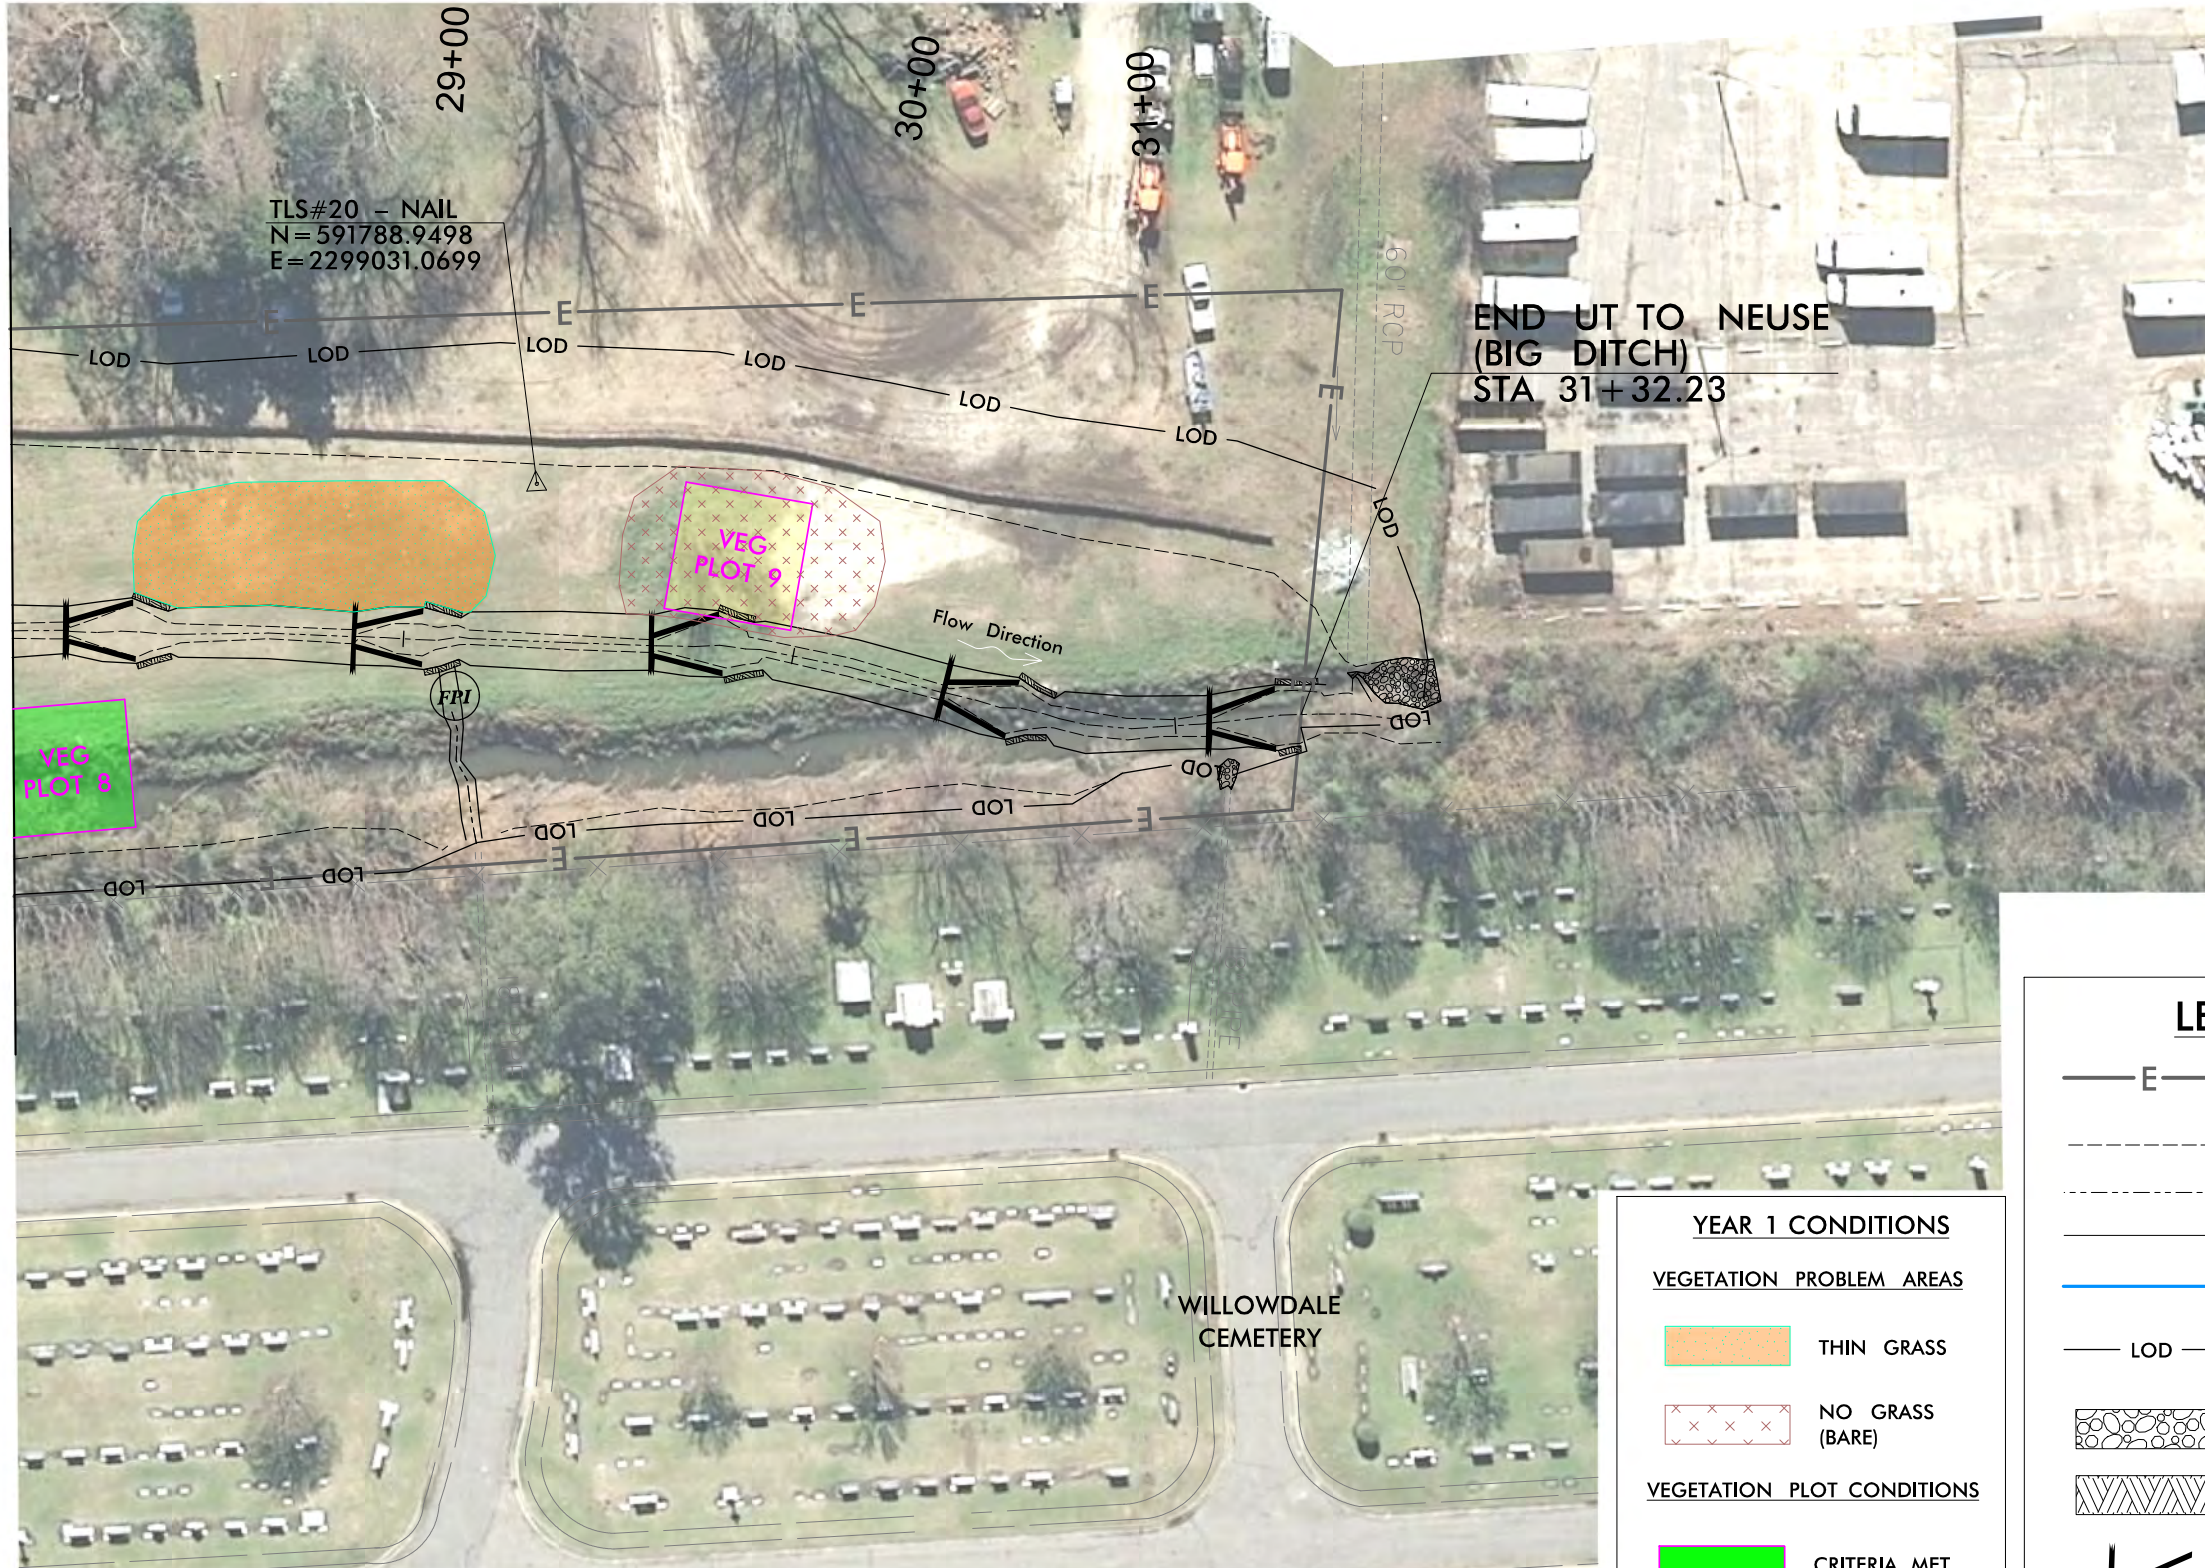
DATE: 10-29-14
CCPV
YEAR 1
FIGURE
2.4

The area in and surrounding Plot 9 is completely bare. Erosion in this area is resulting in exposed roots of the planted stems and hindering the maturation of Plot 9. Additional seeding or planting is recommended to stabilize the soil in this area and prevent further erosion. Ground cover is limited along several areas of the terrace slopes. The sparsely vegetated areas total 0.18 ac and are depicted in the CCPV (Figures 2.1-2.4). Minimal erosion was observed in these areas and rooted plants surrounding the areas of limited ground cover should help stabilize the side slopes as they mature. Areas with sparse or no vegetative cover will be watched closely throughout the next monitoring year. There are no areas of concern for invasive populations at this time.

YEAR 1 CONDITIONS	
VEGETATION PROBLEM AREAS	
	THIN GRASS
	NO GRASS (BARE)
VEGETATION PLOT CONDITIONS	
	CRITERIA MET
	CRITERIA UNMET

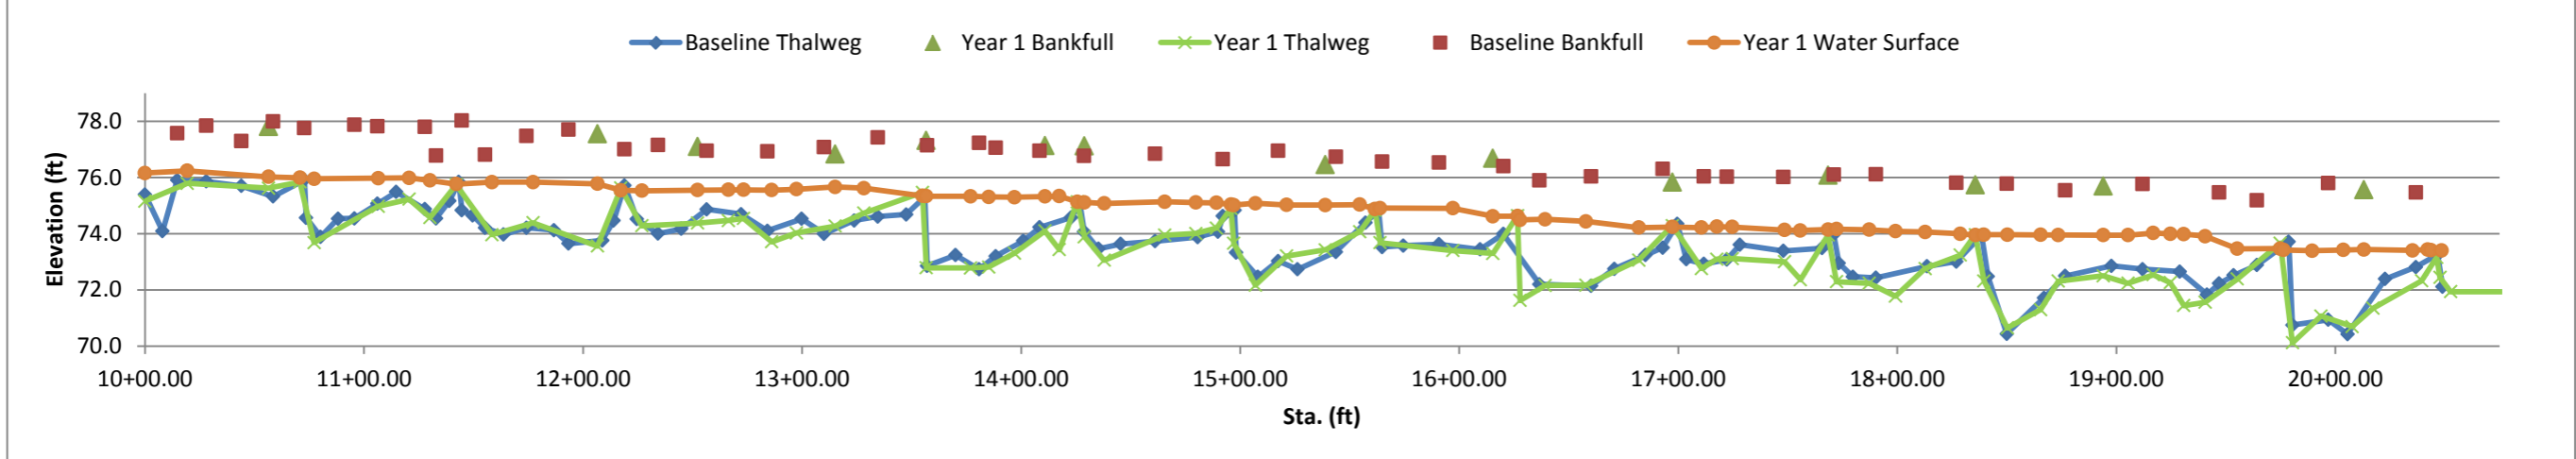
Figure 5.1 UT Neuse - Longitudinal Profile

After the first year of monitoring the UT to Neuse River appears to be stable and functioning as intended. There are no significant changes to the stream profile. Minor scouring of pools was observed but this type of fluctuation is to be expected in a dynamic sand bed system. Most of the changes are observed downstream of station 24+00. In the coming monitoring years we expect the profile to continue to fluctuate and some pools will fill in while others will scour out. Overall, there are very few changes and the profile is considered to be stable.

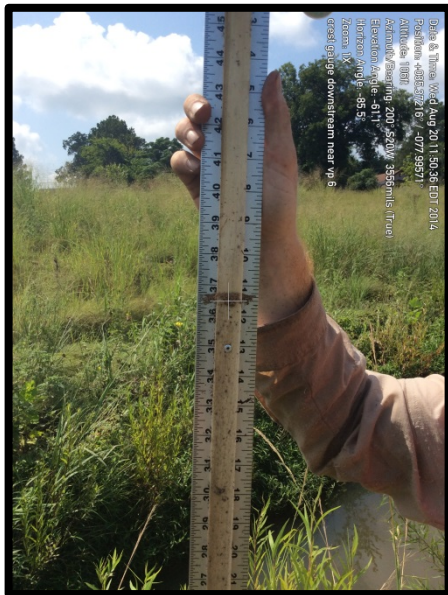
Figure 6.1 Crest Gauge 8/20/2014

The site has experienced at least two bankfull flows throughout the first year of monitoring. Crest gauge installed on-site was inspected on April 28, 2014 and on August 20, 2014. The crest gauge indicated that a bankfull event occurred at least twice during the year (Table 13). Additional overbank evidence includes debris and detritus lines, vegetation bent in the downstream direction, and exposed roots within the floodplain and on the terrace slopes.
