# ***YEAR 3 MONITORING REPORT***

## **UT TO NEUSE RIVER (BIG DITCH) STREAM RESTORATION SITE**

Wayne County, North Carolina

DMS Project No.: 92682

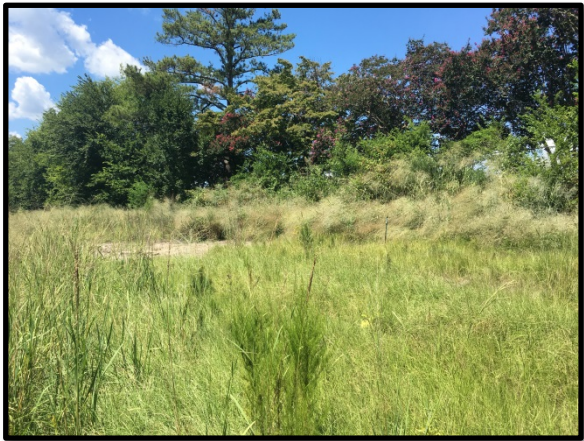
Plots 8 and 9 are in close proximity to large bare spots and are also subject to frequent overbank flows. Despite previously noted exposed roots and stunted growth, stems in Plots 8 and 9 have resprouted over the course of the monitoring year and both plots meet success criteria when including natural stems.

**3.7 Vegetation Plot 8**

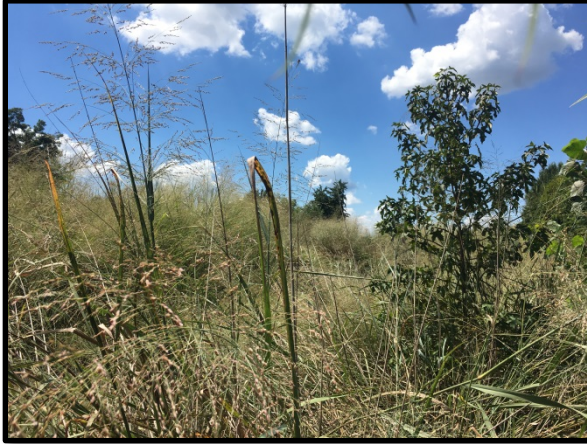
**3.8 Vegetation Plot 9**

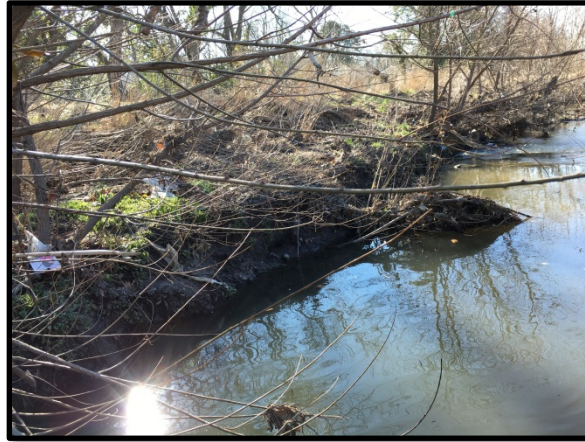
**3.9 Minor Erosion Station 12+00**

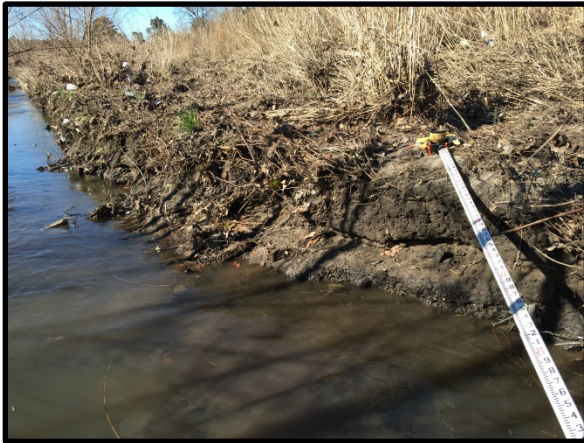
**3.10 Moderate Erosion Station**

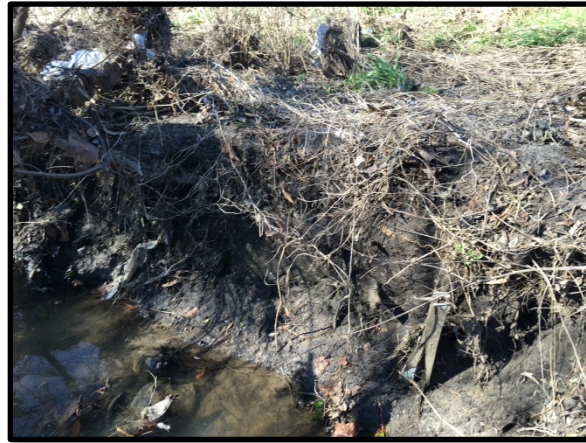
**3.11 Moderate Erosion Station 14+50**

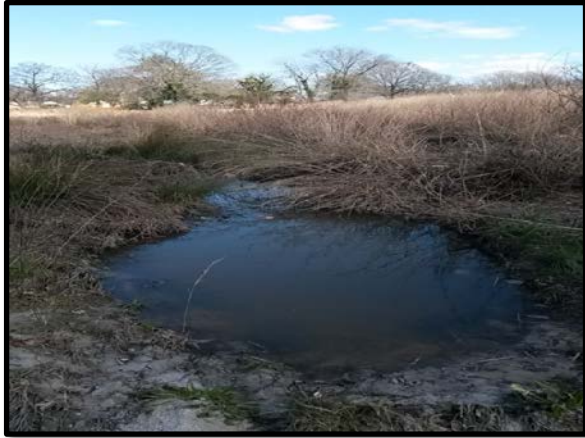
**3.12 Gully Station 24+75**

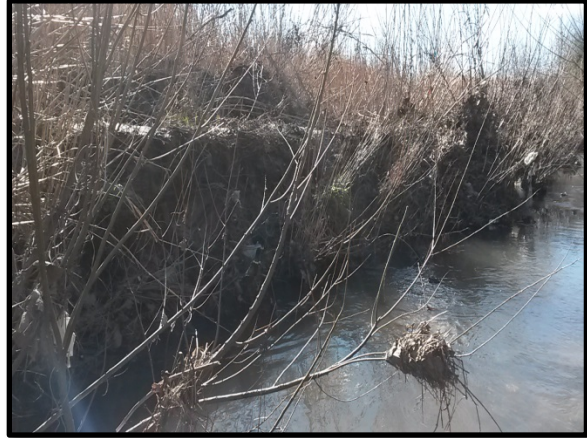
**3.13 Moderate Erosion Station 30+00**

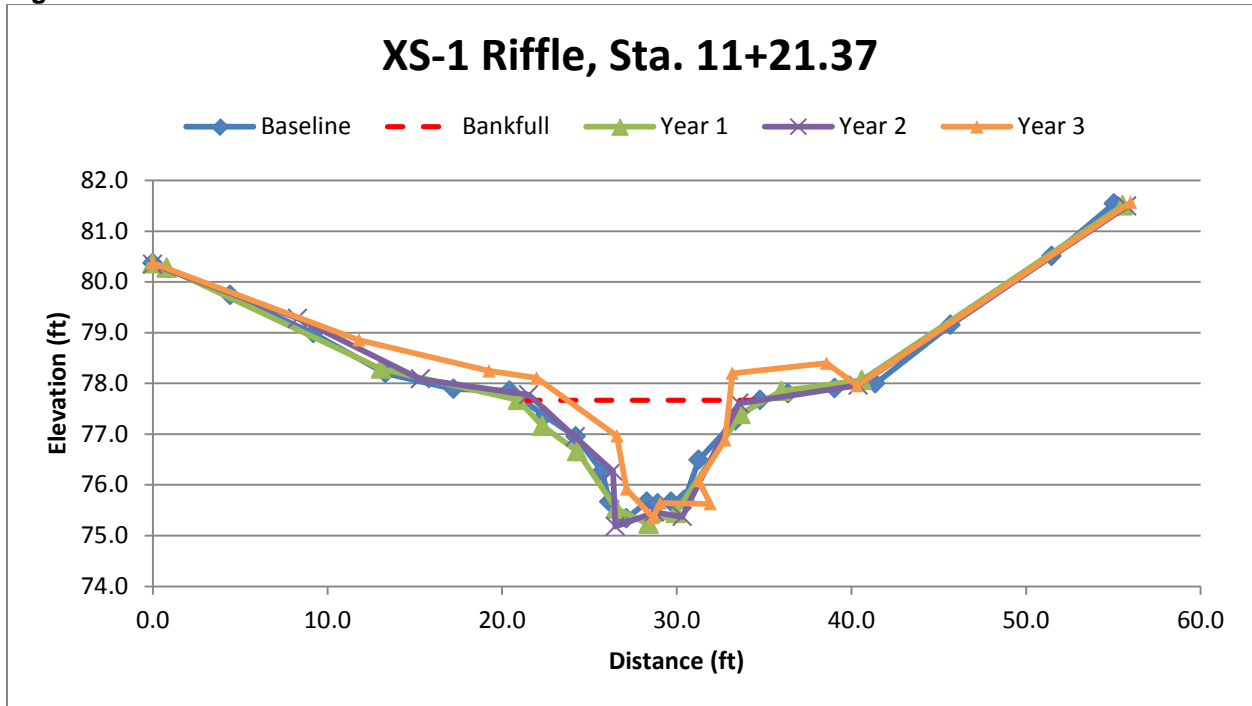
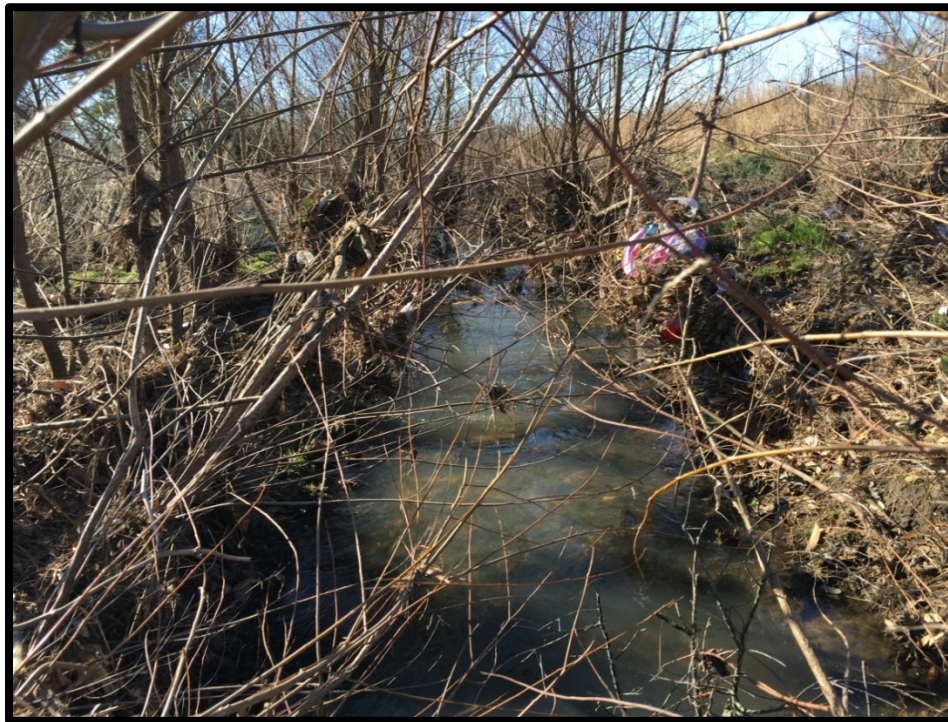
Figure 4.0

Overbank sediment deposition is occurring from approximately station 10+00 – 19+50. Additionally, Cross Section 1 is demonstrating a narrowing channel due to sediment deposition along the banks. At Cross Section 4 the channel bed is scouring and sediment is being deposited on the floodplain. Width/Depth ratio remains consistent with Year 2 monitoring data.

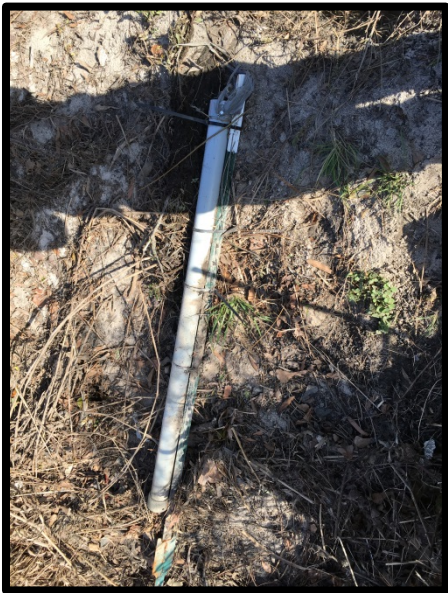
The site has experienced at least four bankfull flows through the first two years of monitoring. The crest gauge installed on-site was inspected on February 26, 2016 and was found in need of repair due to high flows. The crest gauge was reinstalled on

**Figure 6.5 Damaged Crest Gauge 2/26/2016**

3/30/2016. Bankfull event records can be seen in Table 13. Additional overbank evidence includes debris and detritus lines, vegetation bent in the downstream direction, and exposed roots within the floodplain and on terrace slopes.
