YEAR 4 MONITORING REPORT

UT TO NEUSE RIVER (BIG DITCH) STREAM RESTORATION SITE

Wayne County, North Carolina

DMS Project No.: 92682

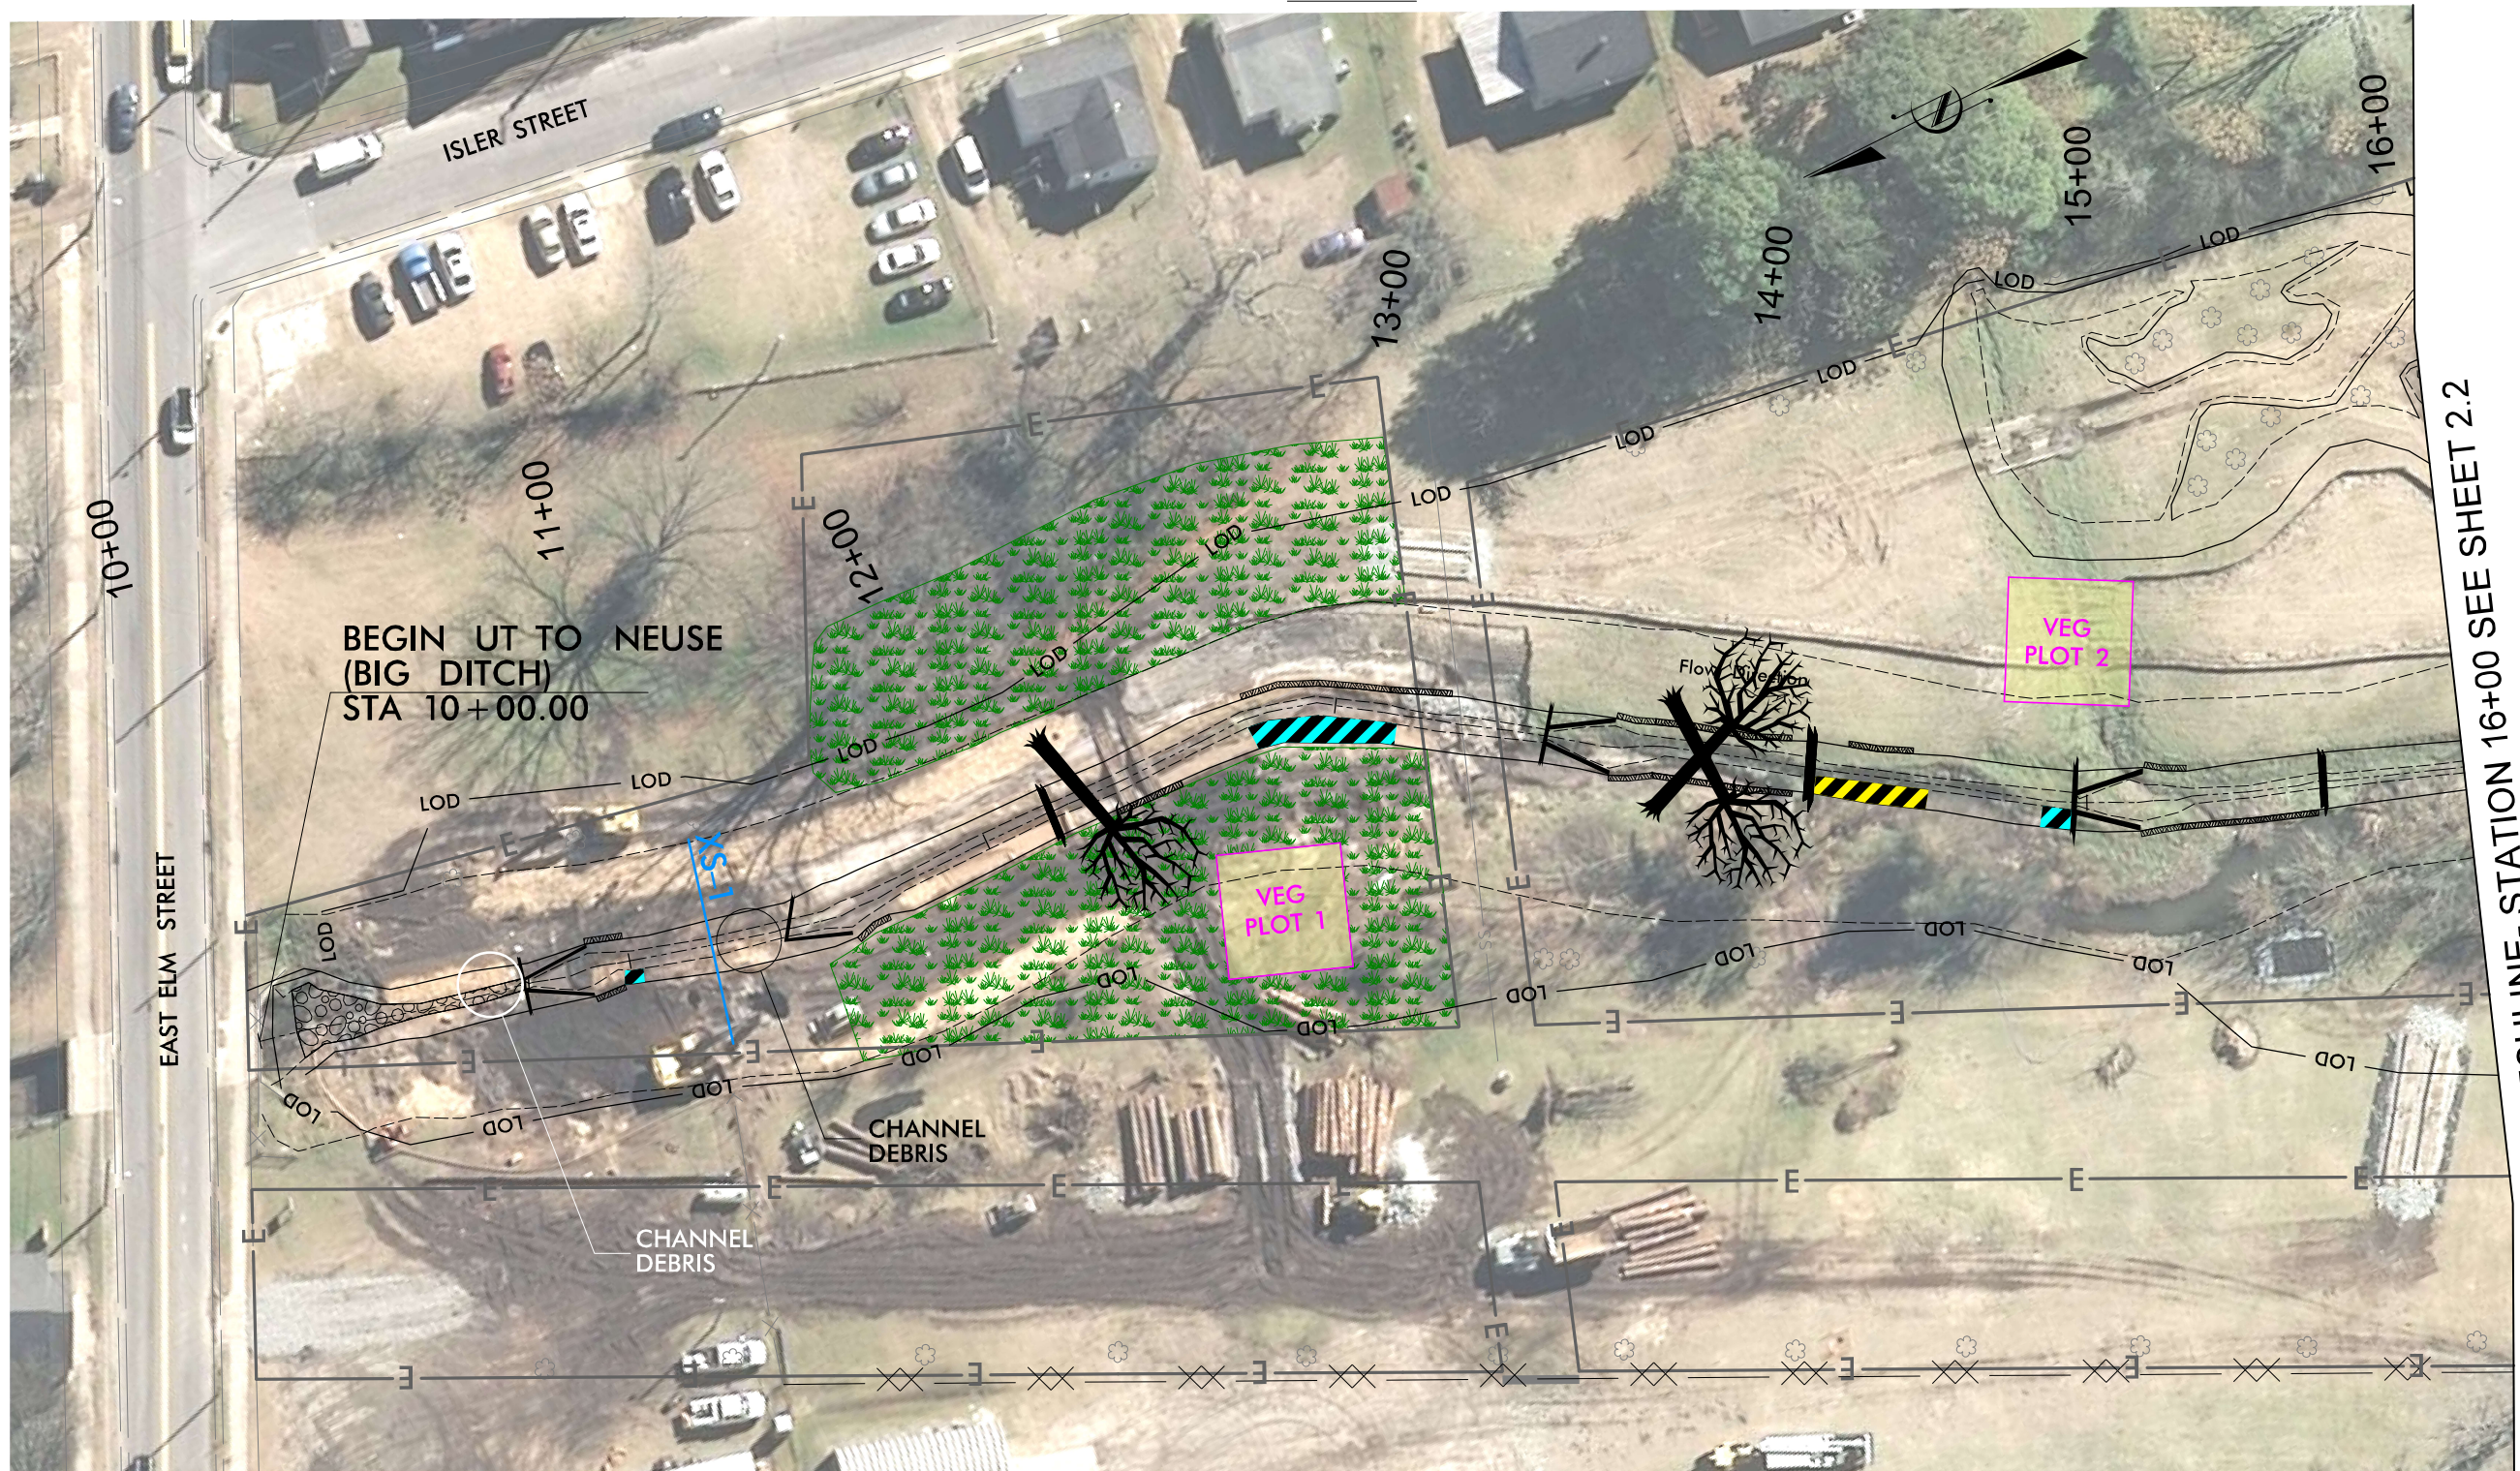
FIGURE
2.1

Channel deposition is occurring between station 11+60 – 12+11, however, the deposition is isolated to a pool and was likely caused by Hurricane Matthew. HDR|ICA expects that the deposition will flush out over time.

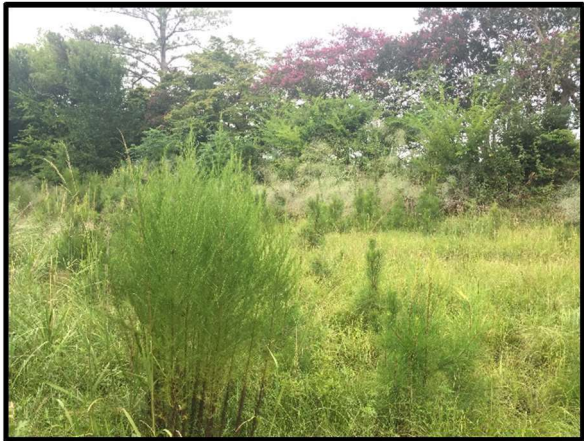
3.7 Vegetation Plot 8

Plots 8 and 9 remain bare near the downstream extent of the site. Despite previously noted exposed roots and stunted growth, stems in Plots 8 and 9 have resprouted over the course of the monitoring year and both plots meet success criteria when including natural recruits.

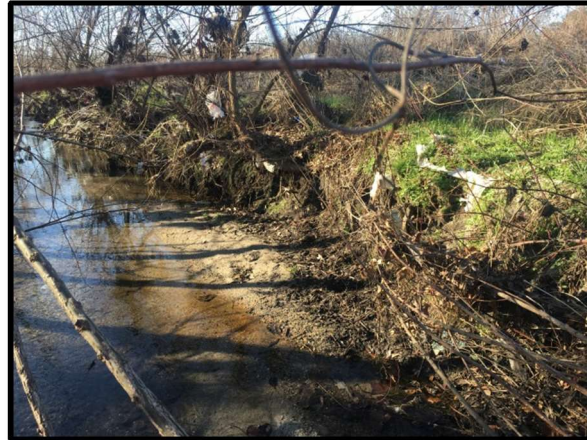
3.9 Minor Erosion Station 11+00

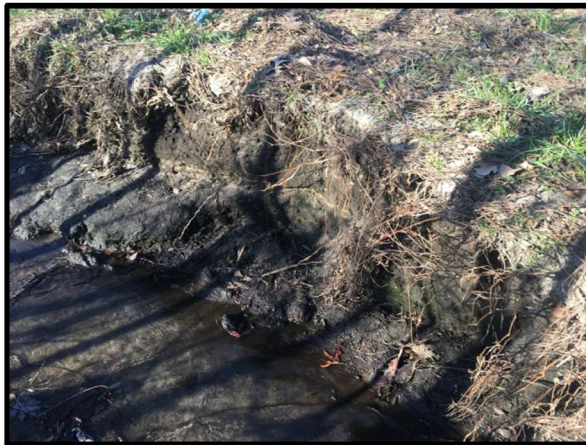
3.10 Moderate Erosion Station 13+00

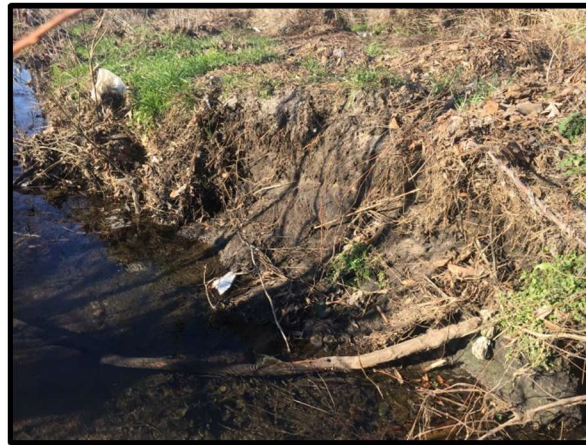
3.11 Moderate Erosion Station 14+50

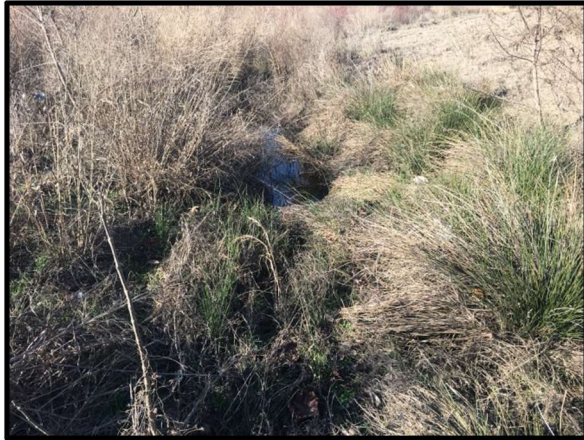
3.12 Gully Station 26+25

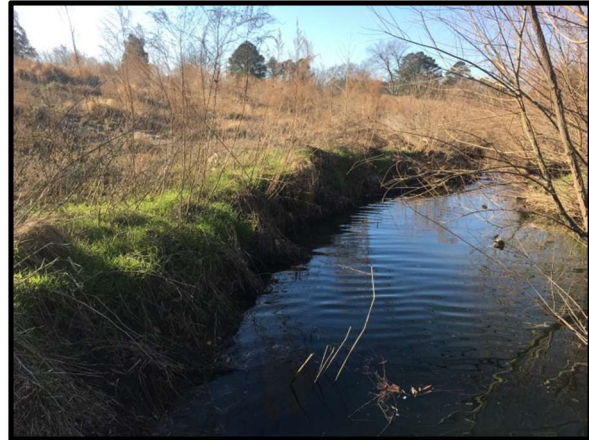
3.13 Minor Erosion Station 23+00

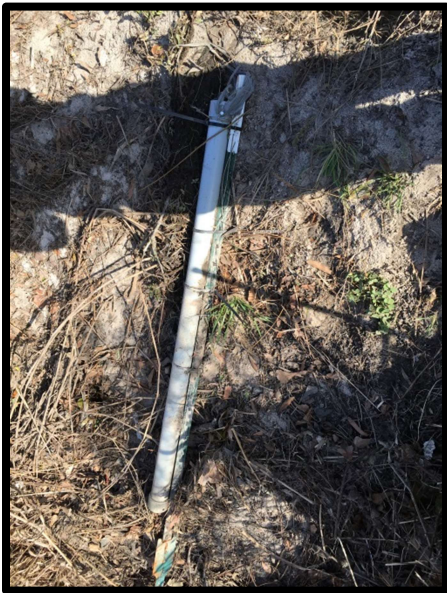
**Figure 6.5 Damaged Crest Gauge
2/26/2016**
