YEAR 5 MONITORING REPORT

UT TO NEUSE RIVER (BIG DITCH) STREAM RESTORATION SITE

Wayne County, North Carolina

DMS Project No.: 92682

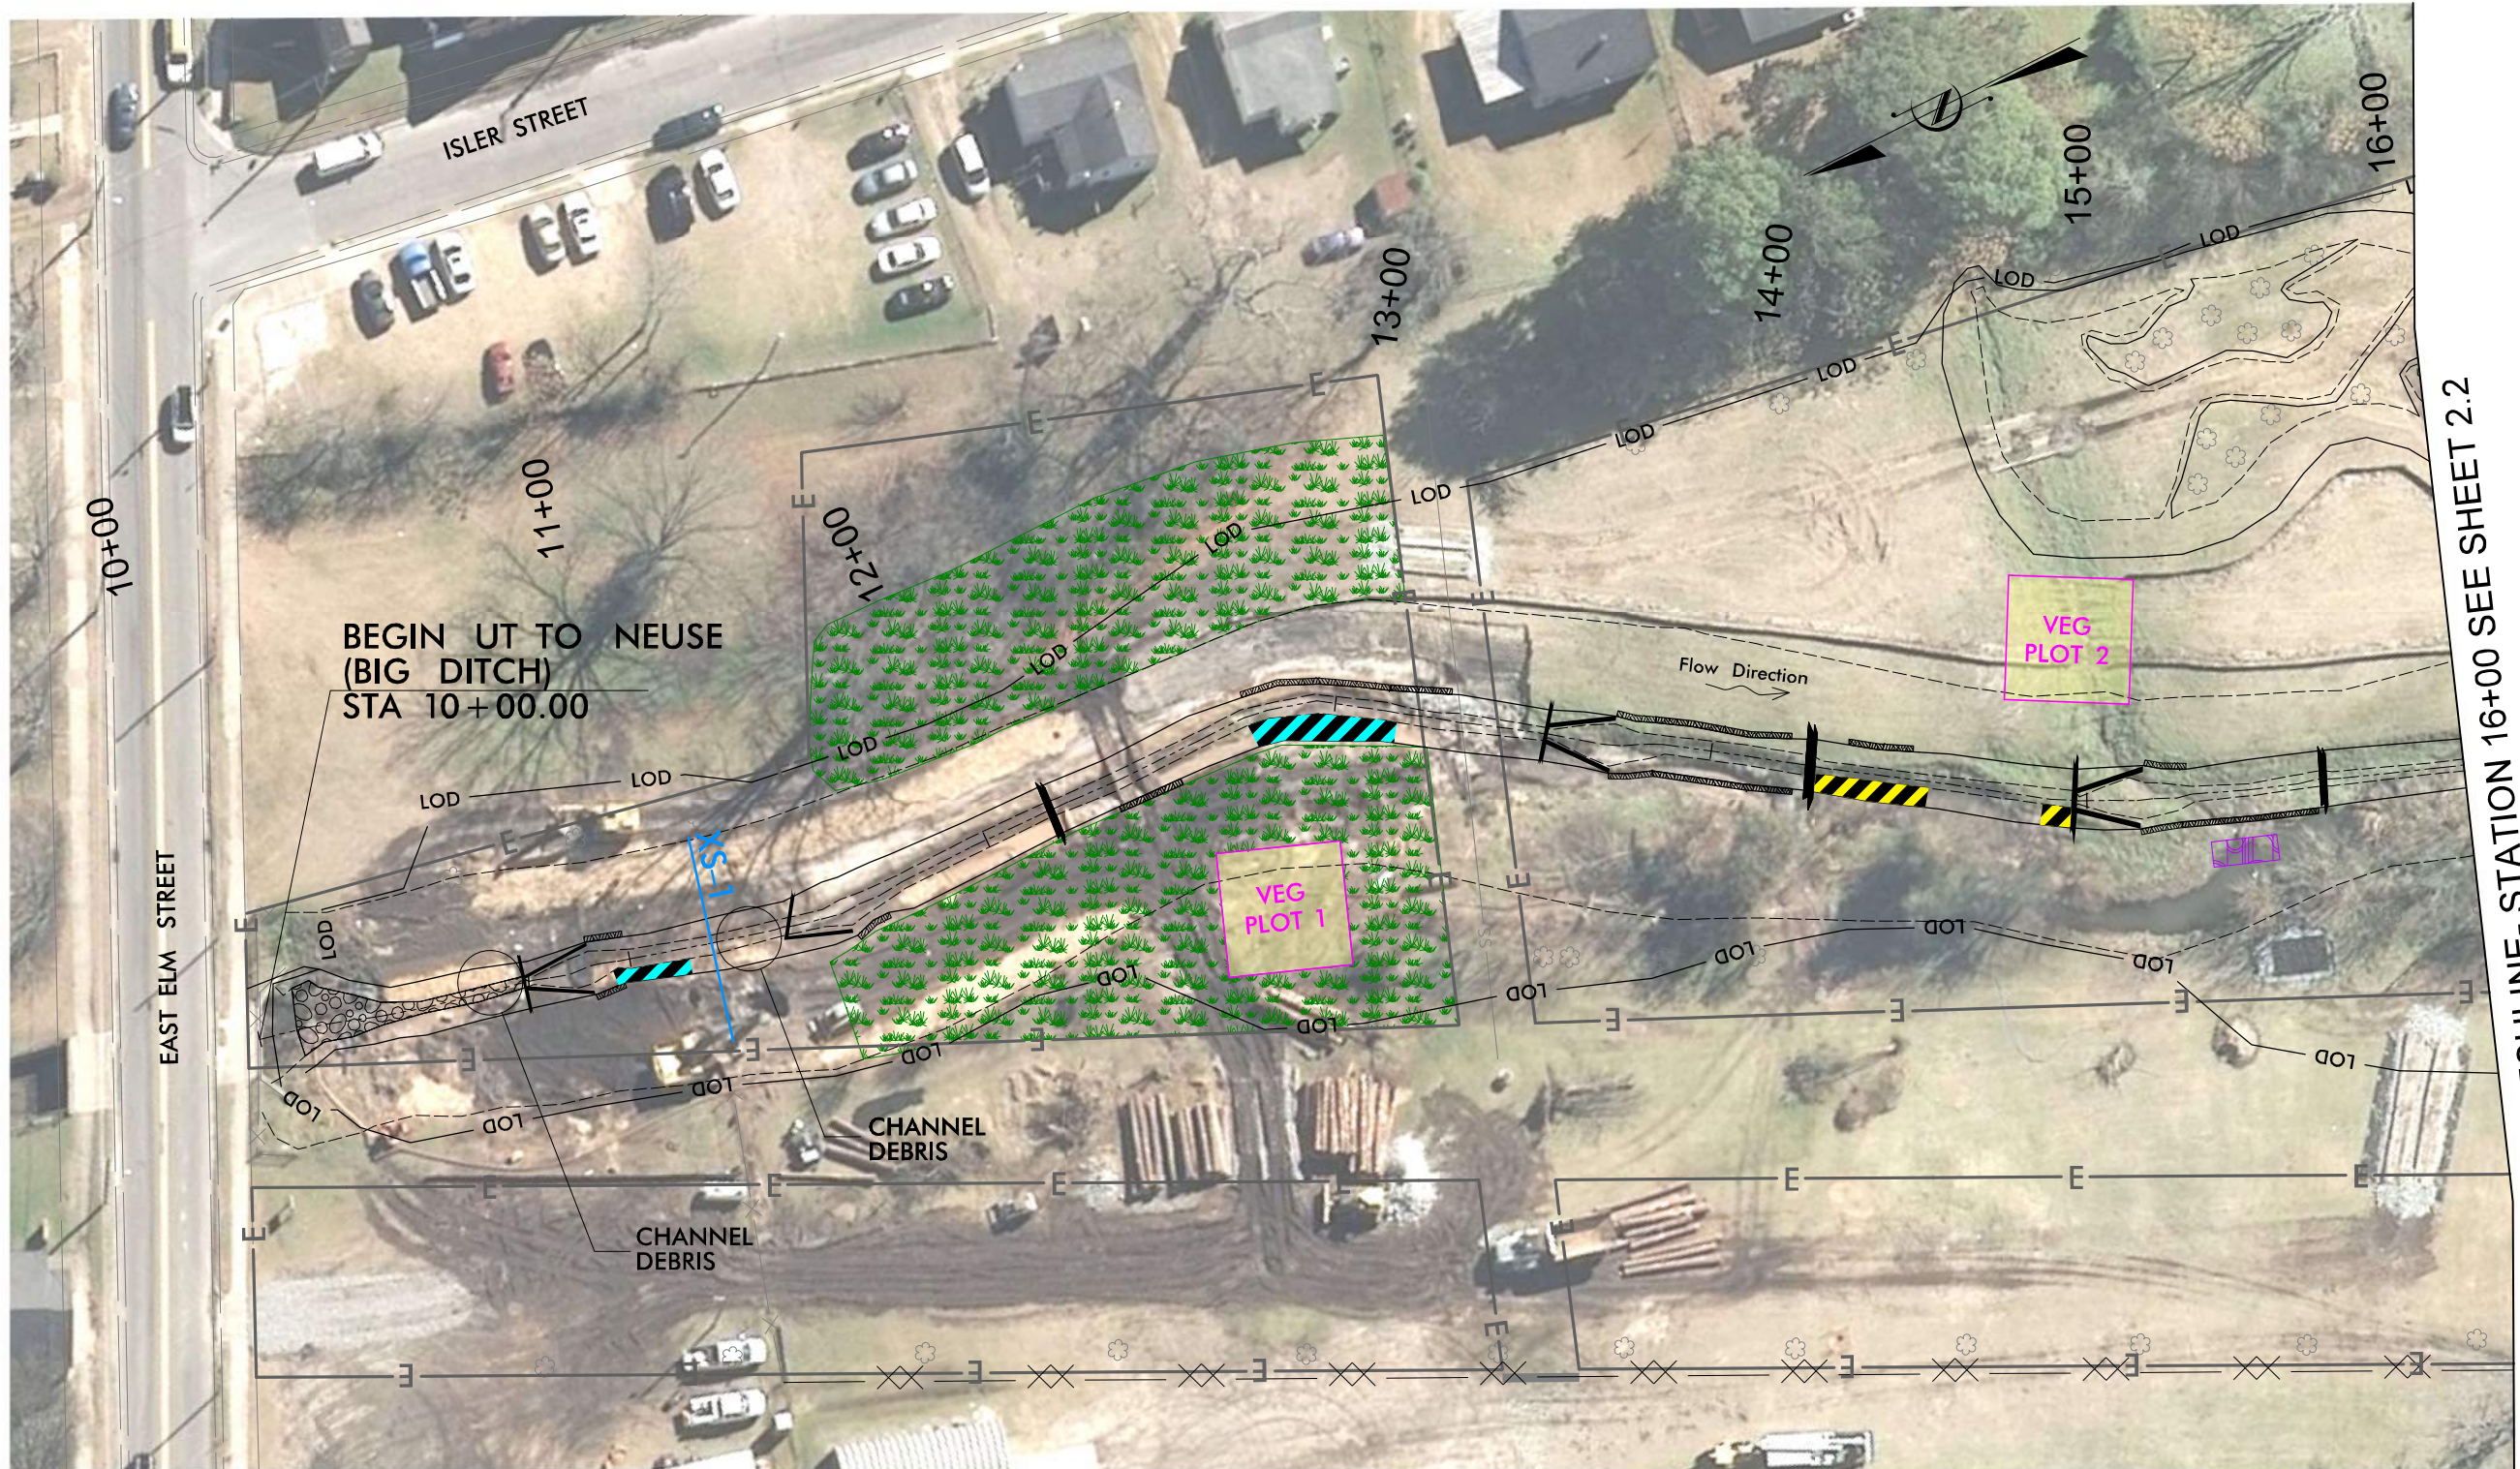
FIGURE 2.1

a. CCPV Figure 2.1 shows two fallen trees across the channel but there is no discussion in the report narrative regarding these trees or any impacts current or potential they might have on the projects. Clarify if they are causing or could potentially cause problems for this project.

b. In addition, during an October 10, 2018 site visit by DMS staff, it did not appear that these trees were laying across the channel. Either revise the figure showing the correct position of these trees or provide photos showing them across the channel.

The fallen trees have been removed from the CCPV.

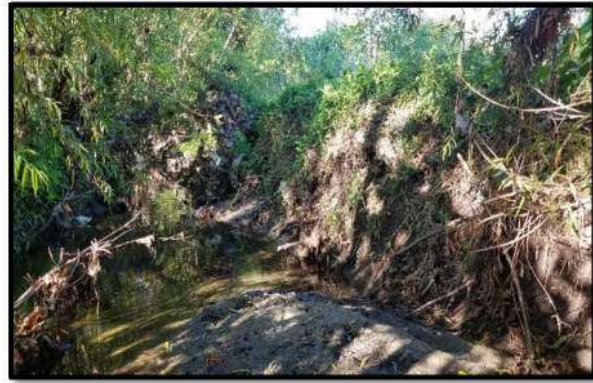
3.9 Minor Erosion Station 11+00

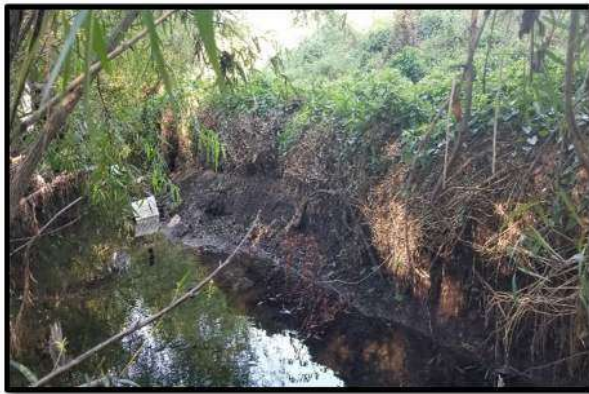
3.10 Minor Erosion Station 13+00

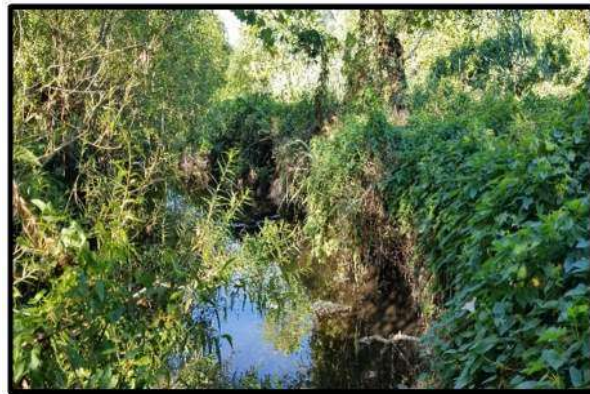
3.11 Moderate Erosion Station 14+00

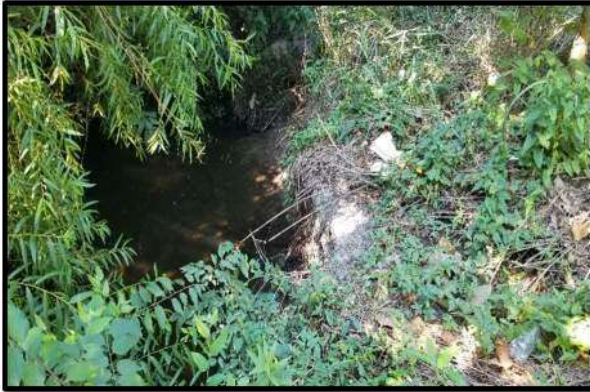
3.12 Moderate Erosion Station 20+60

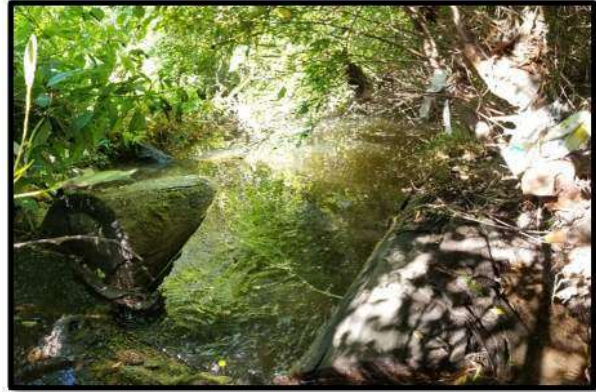
The left arm of the log cross vane at STA 24+08 has become dislodged at the downstream side and collapsed into the pool. The upstream side of the arm remains secured to the head of the structure and water is still flowing over the sill and right arm as designed. Bank erosion is isolated to the left side of the scour pool and behind the left arm. The structure does not appear to be causing any adverse effects downstream at this time.

**3.13 Left arm of Log Cross Vane
at Station 24+08**

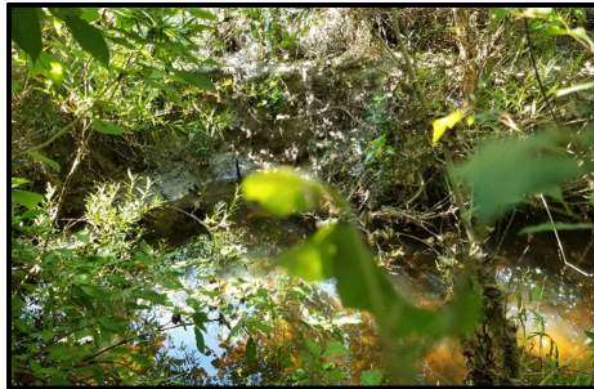
3.14 Moderate Erosion Station 29+25

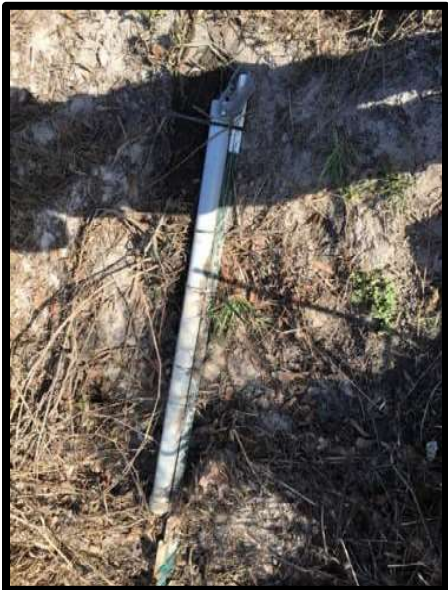
Figure 6.5 Damaged Crest Gauge 2/26/2016
