# TRIBUTARY TO REEDY FORK CREEK STREAM RESTORATION

CONTRACT # D06028-A

## ANNUAL MONITORING REPORT (YEAR 4 OF 5)

FEBRUARY 2012

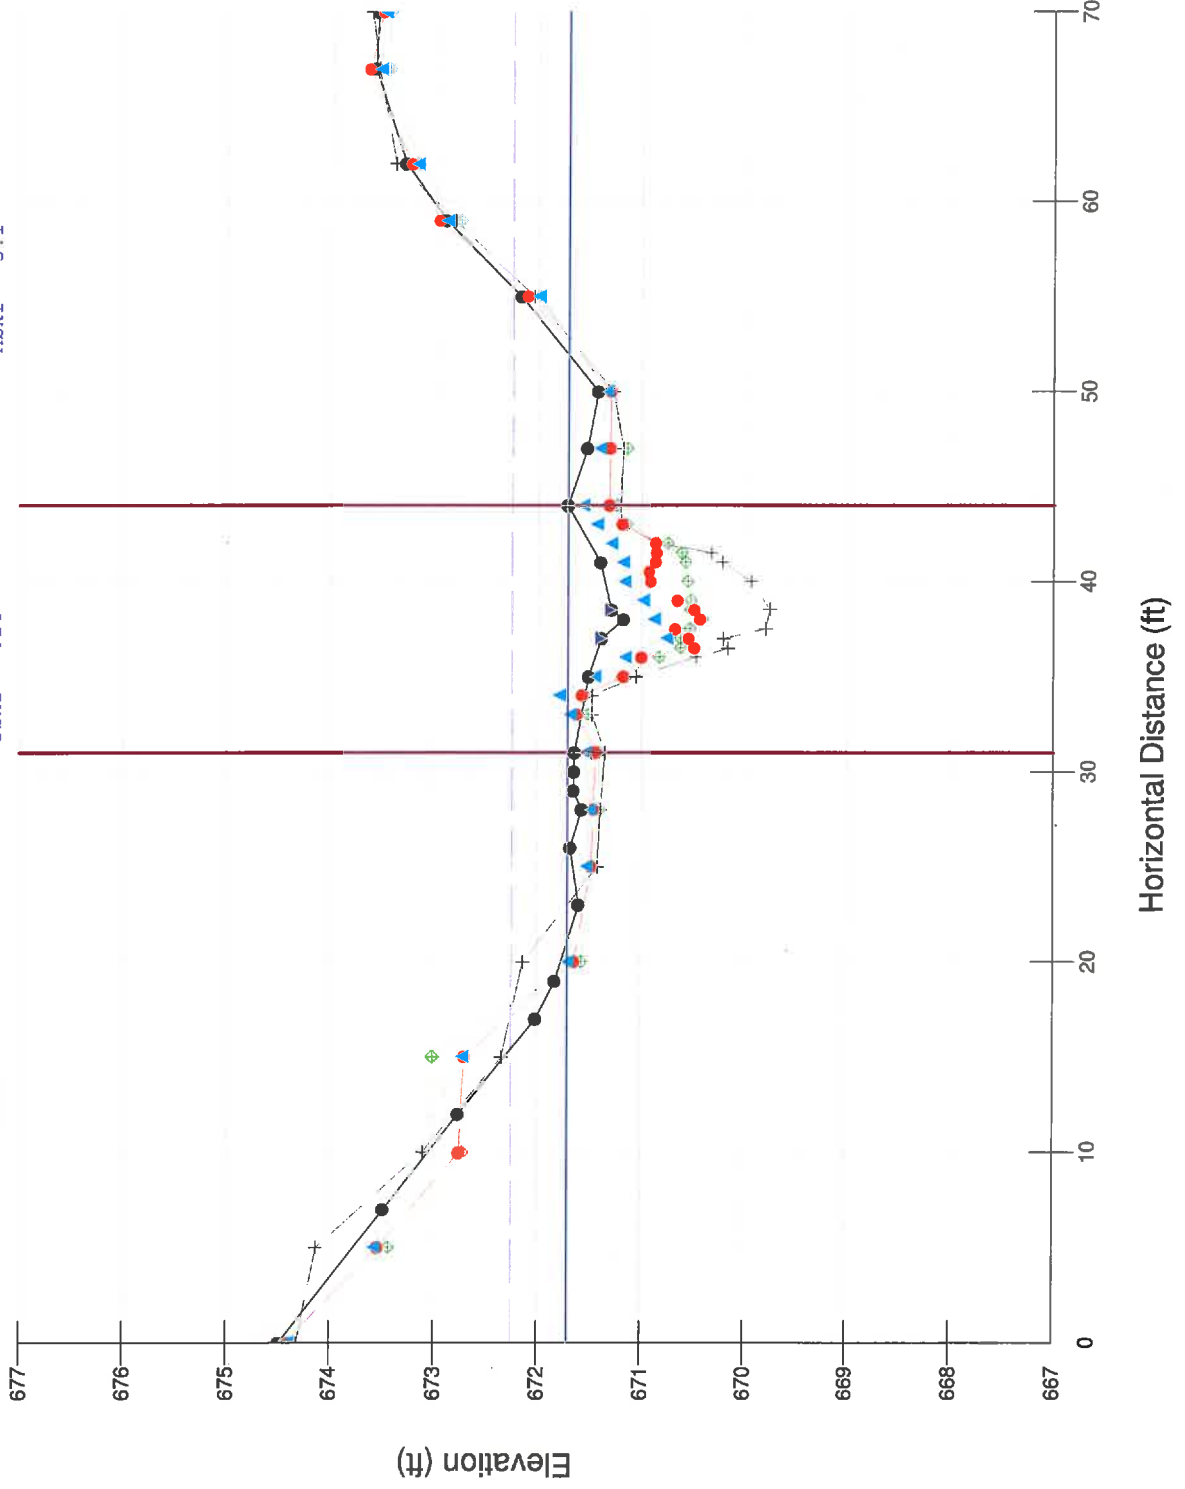
RIVERMORPH CROSS SECTION SUMMARY

River Name: (Year 4) Reedy Fork Creek  
 Reach Name: R2-4b  
 Cross Section Name: (Year 4) Cross Section 1 - Riffle (R2-4b)  
 Survey Date: 12/06/2011

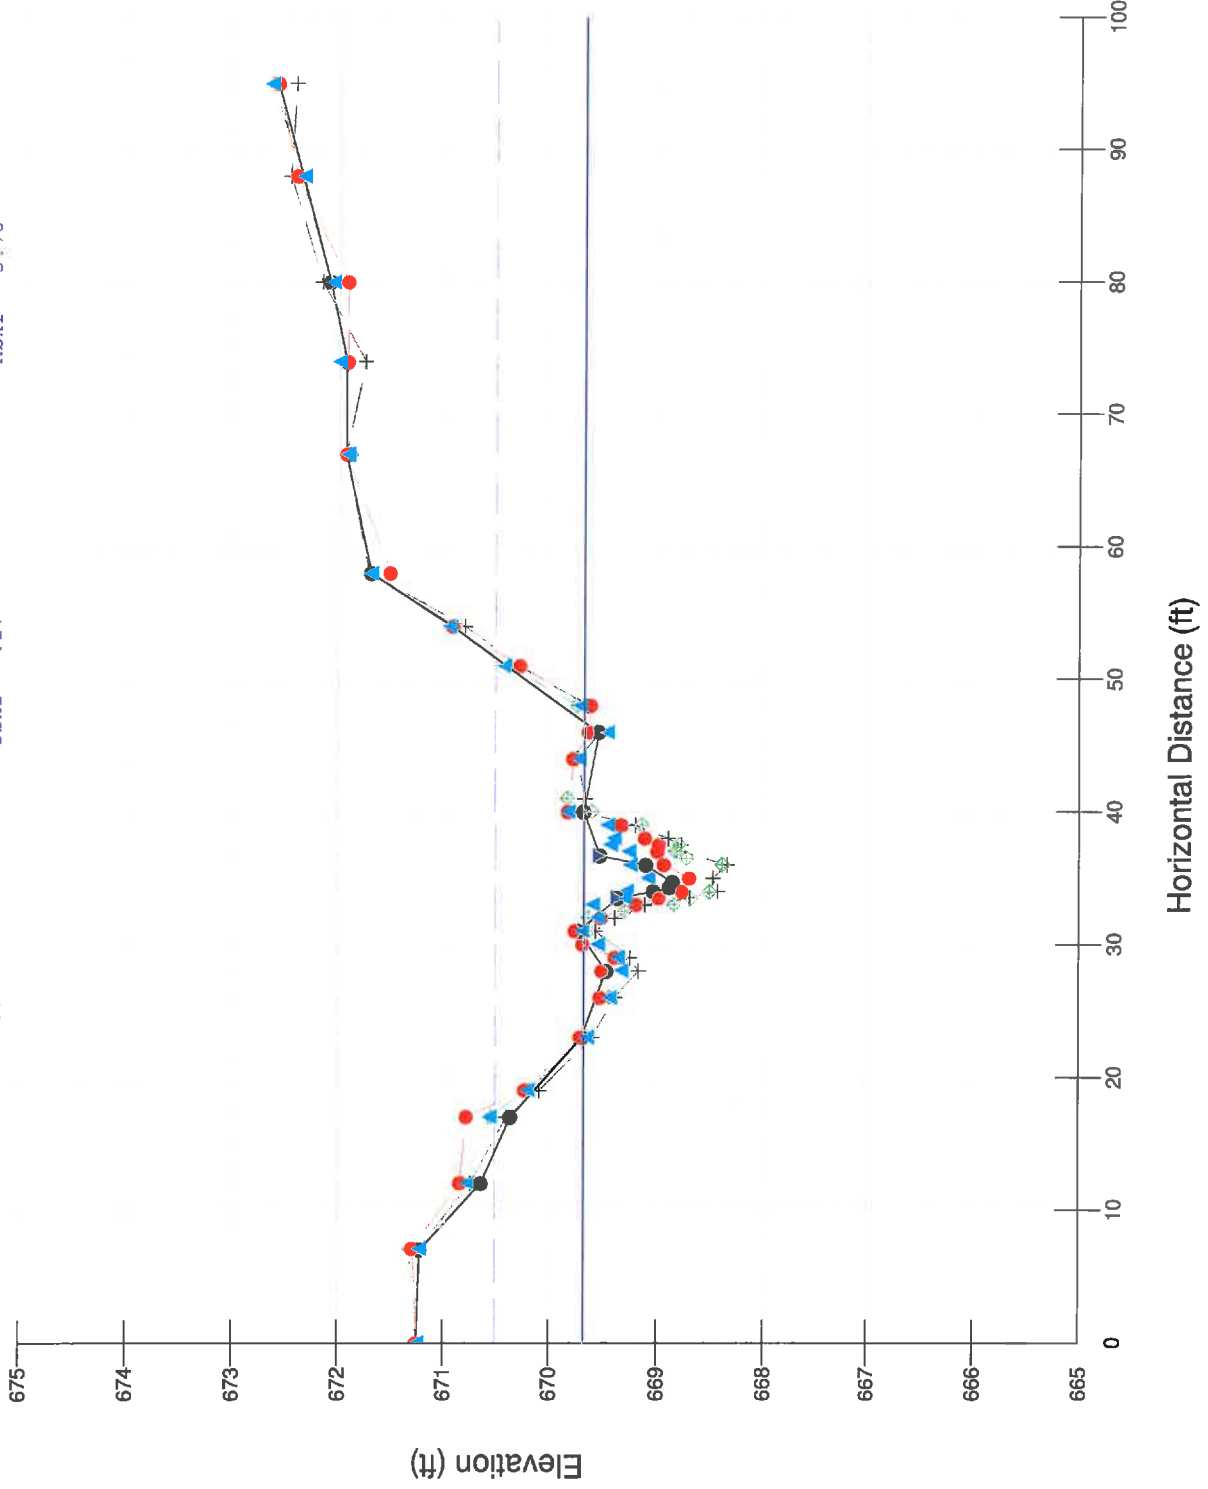
# (Year 4) Cross Section 2 - Riffle (R2-4c)

River Name: (Year 4) Reedy Fork Creek  
 Reach Name: R2-4c  
 Cross Section Name: (Year 4) Cross Section 2 - Riffle (R2-4c)  
 Survey Date: 09/26/2011

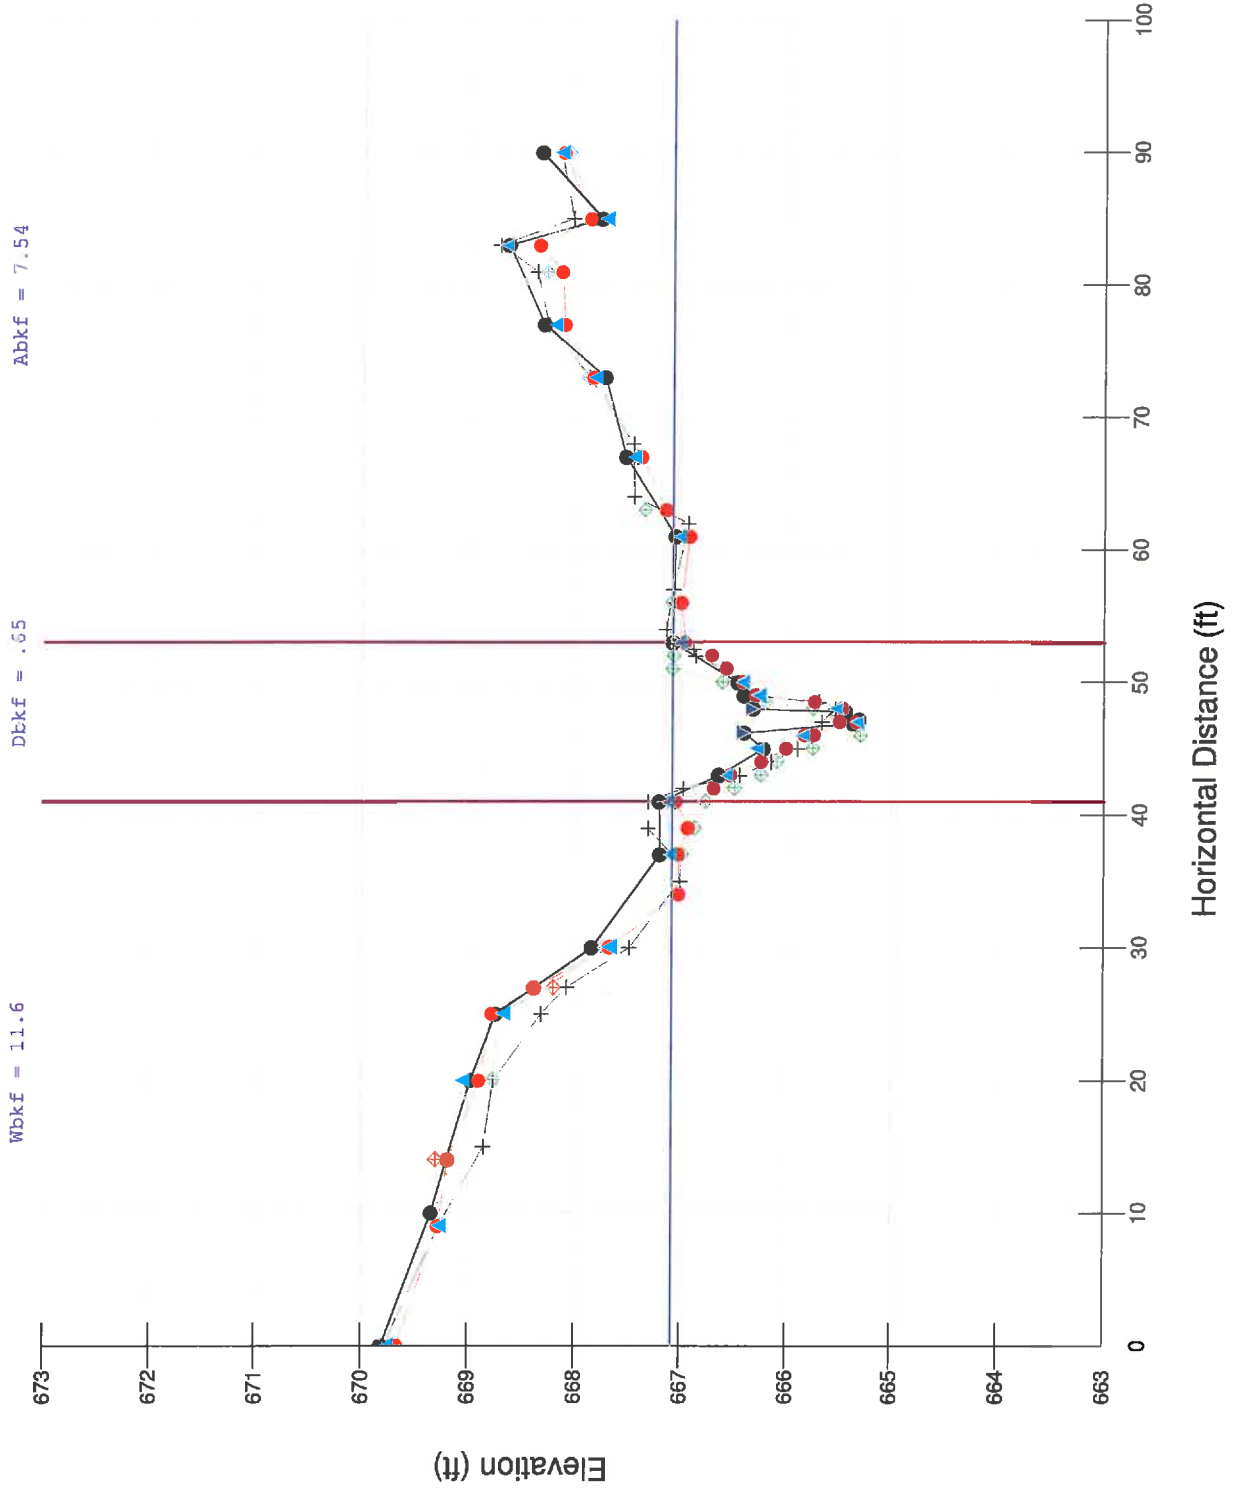
# (Year 4) Cross Section 3 - Pool (R2-3)

-----  
 River Name: (Year 4) Reedy Fork Creek  
 Reach Name: R2-3  
 Cross Section Name: (Year 4) Cross Section 3 - Pool (R2-3)  
 Survey Date: 09/26/2011  
 -----

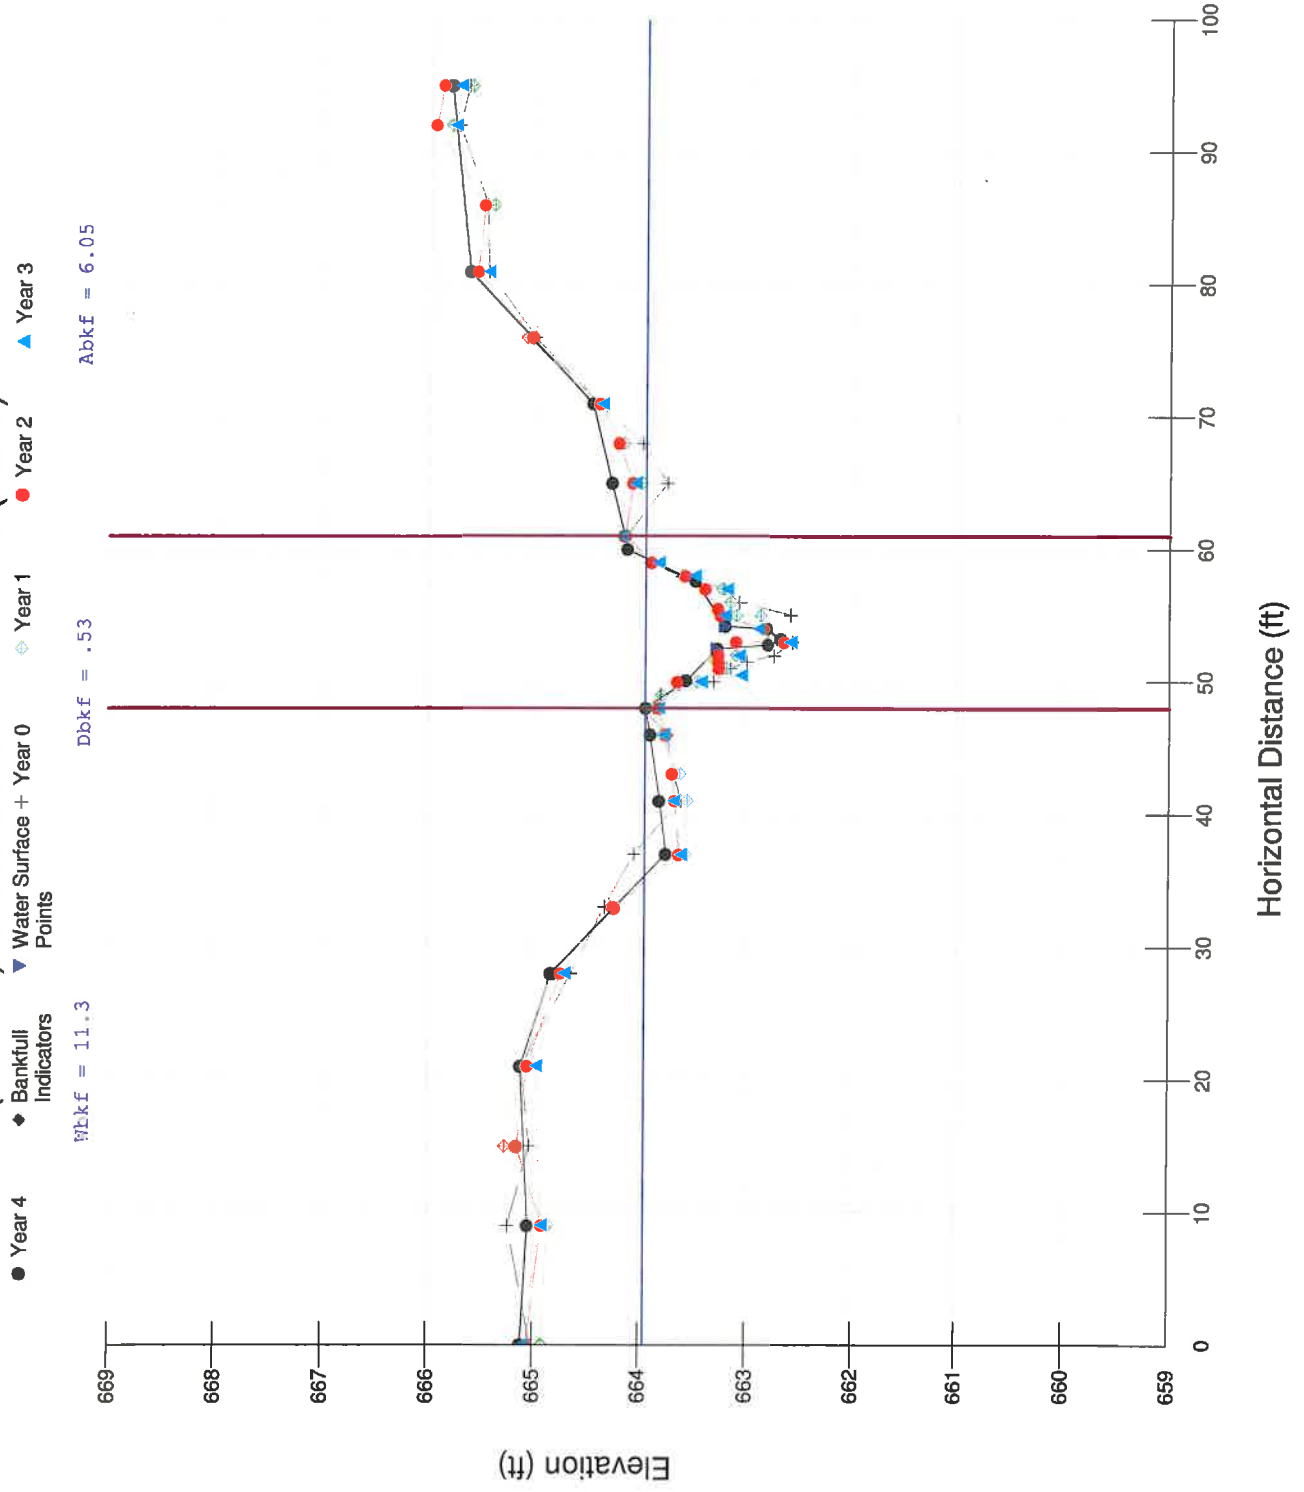
# (Year 4) Cross Section 4 - Rifle (R2-3)

-----  
 River Name: (Year 4) Reedy Fork Creek  
 Reach Name: R2-3  
 Cross Section Name: (Year 4) Cross Section 4 - Riffle (R2-3)  
 Survey Date: 09/26/2011  
 -----

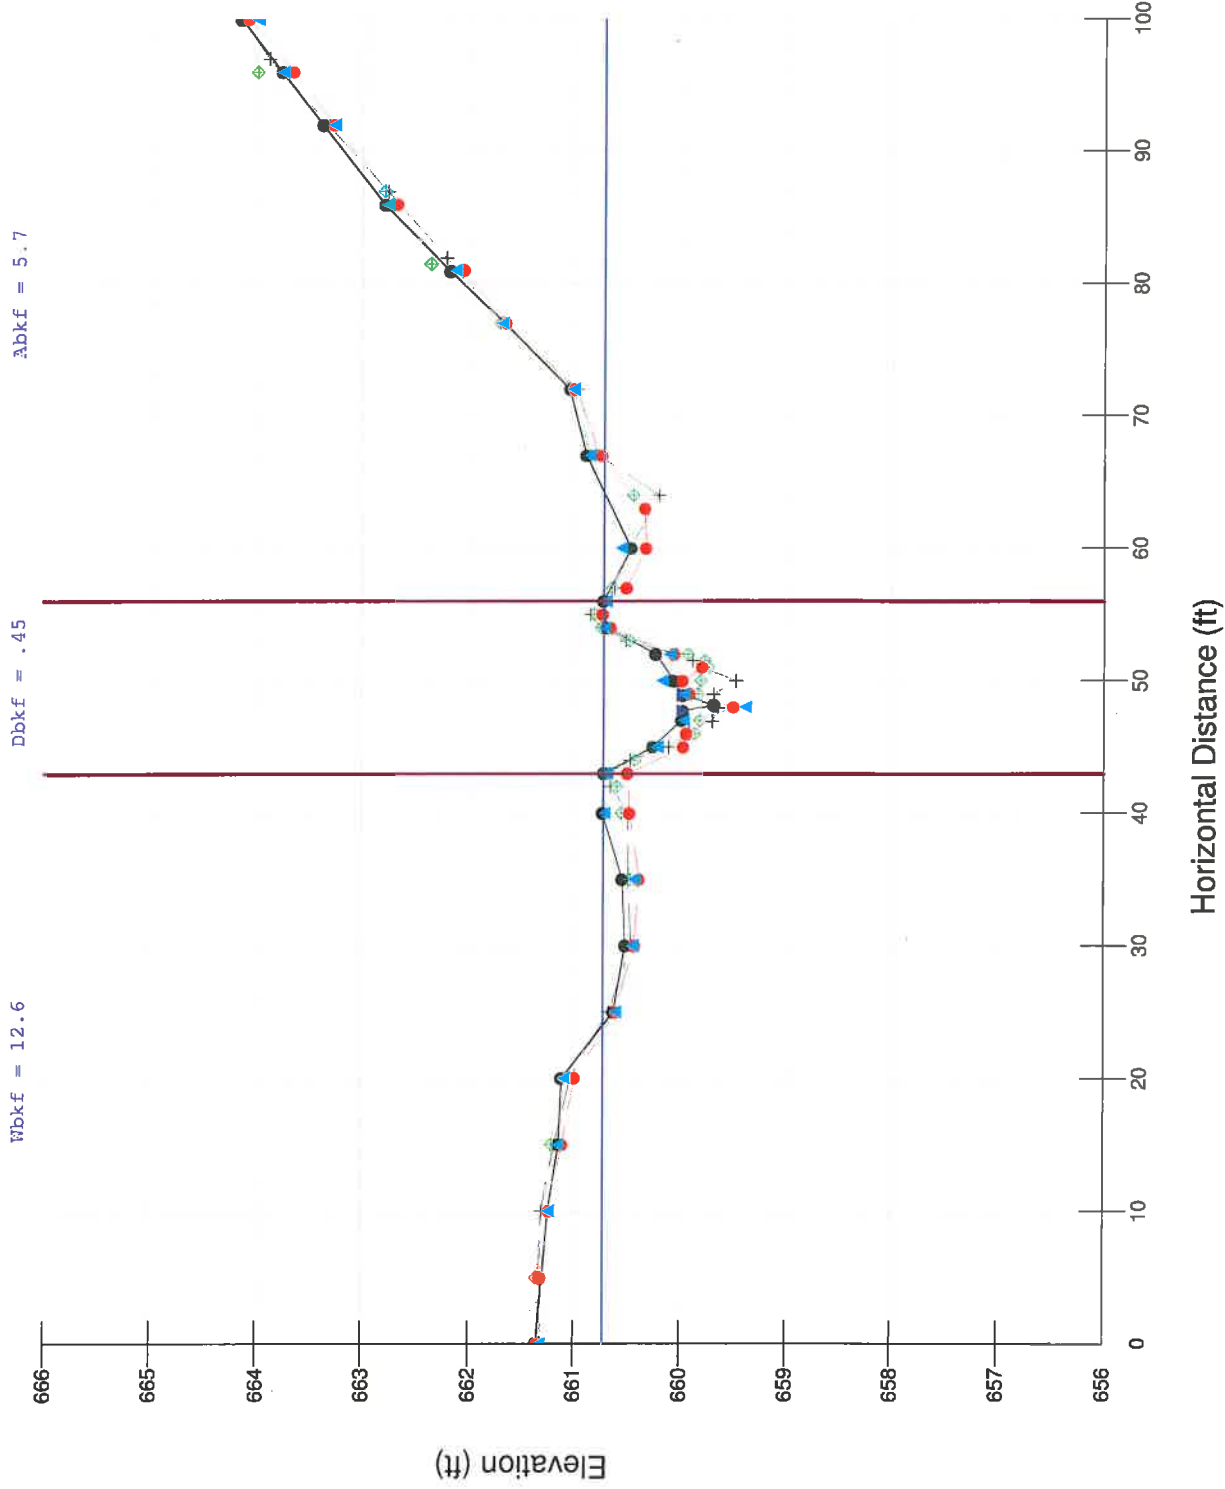
# (Year 4) Cross Section 5 - Rifle (R2-3)

River Name: (Year 4) Reedy Fork Creek  
 Reach Name: R2-3  
 Cross Section Name: (Year 4) Cross Section 5 - Riffle (R2-3)  
 Survey Date: 09/26/2011

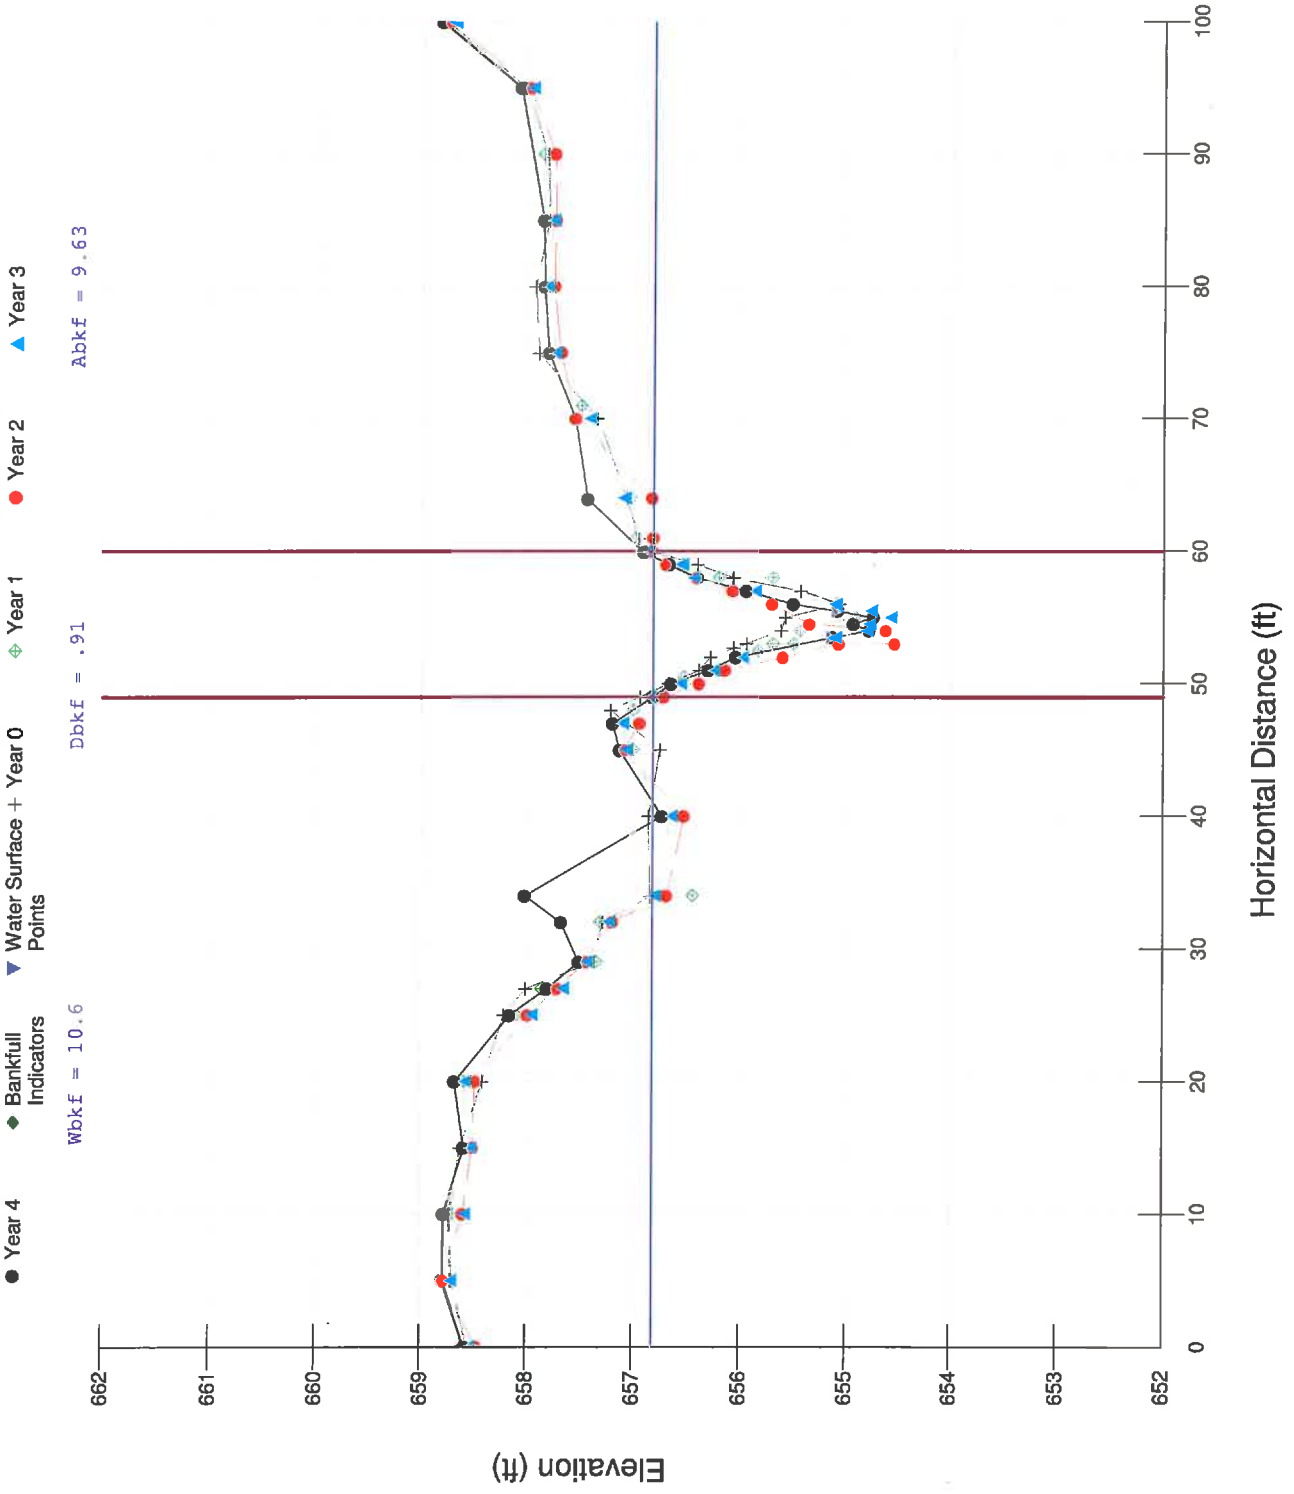
# (Year 4) Cross Section 6 - Pool (R2-3)

River Name: (Year 4) Reedy Fork Creek  
 Reach Name: R2-3  
 Cross Section Name: (Year 4) Cross Section 6 - Pool (R2-3)  
 Survey Date: 09/26/2011

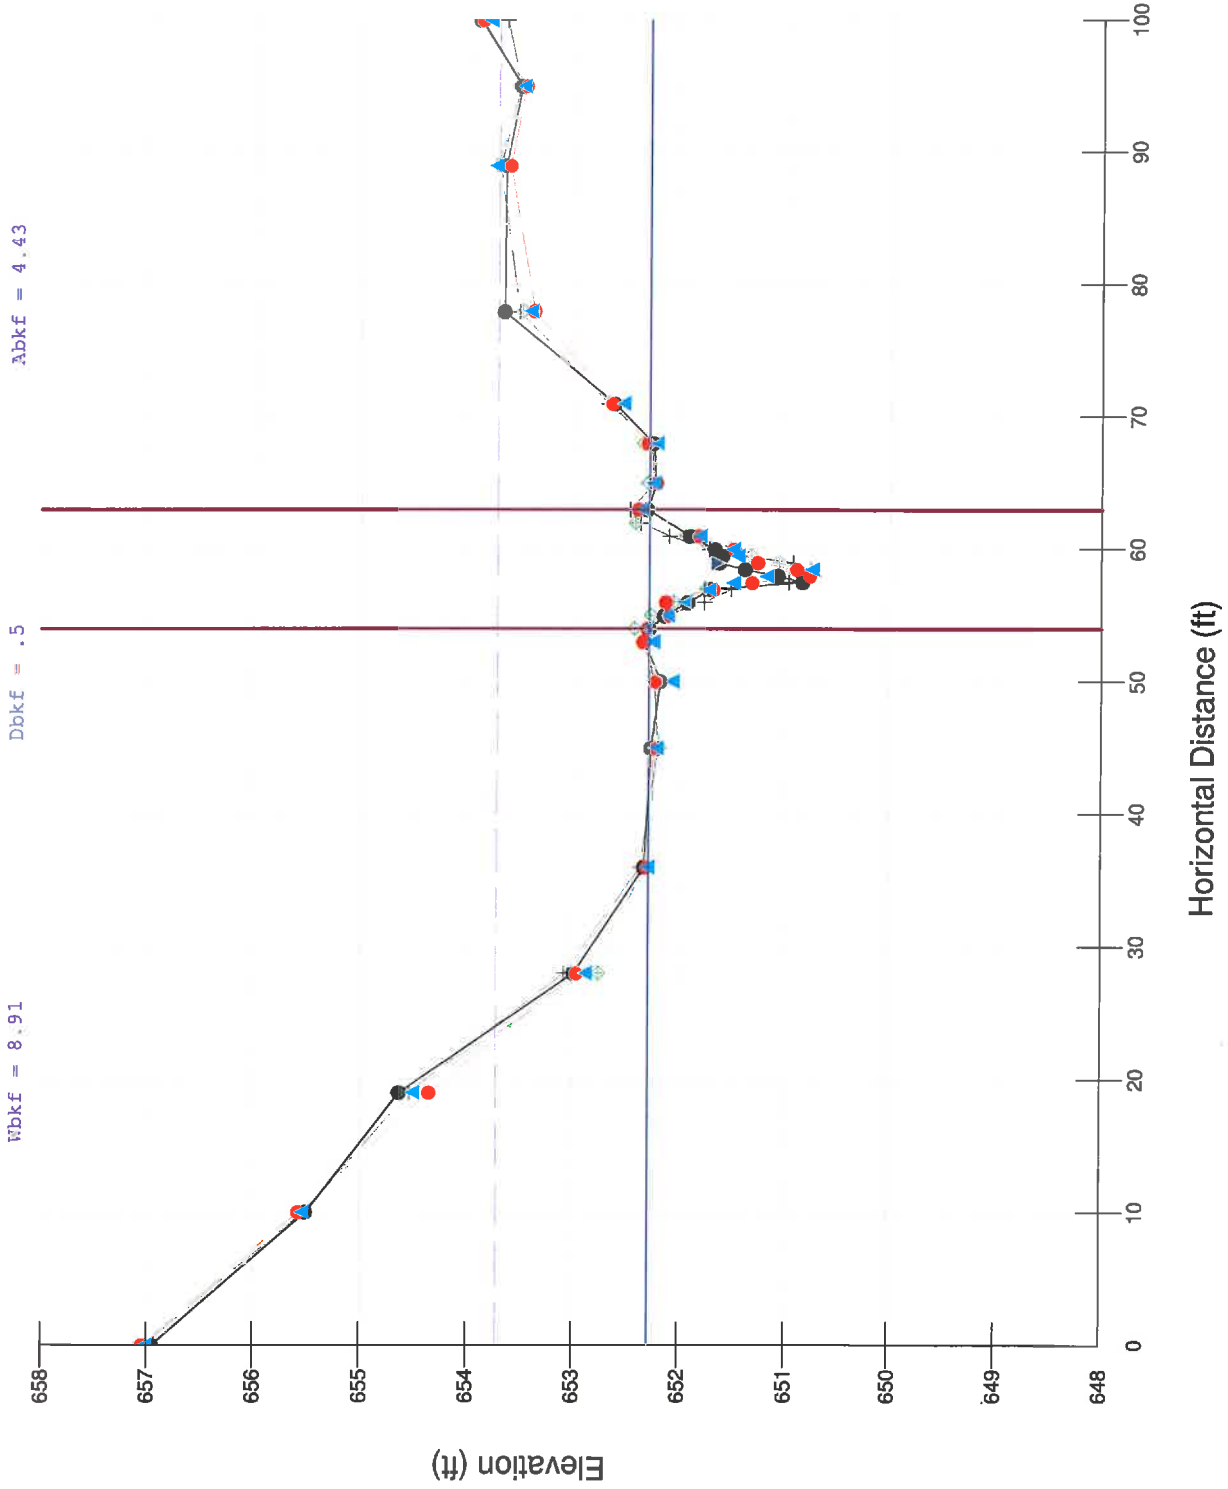
# (Year 4) Cross Section 7 - Pool (R1)

River Name: (Year 4) Reedy Fork Creek  
 Reach Name: R1  
 Cross Section Name: (Year 4) Cross Section 7 - Pool (R1)  
 Survey Date: 09/26/2011
