# ***YEAR 1 MONITORING REPORT***

## **UT ROCKY RIVER – HARRIS ROAD MIDDLE**

EEP IMS No. 92383, Contract No. 004346

Submitted: January 3, 2013

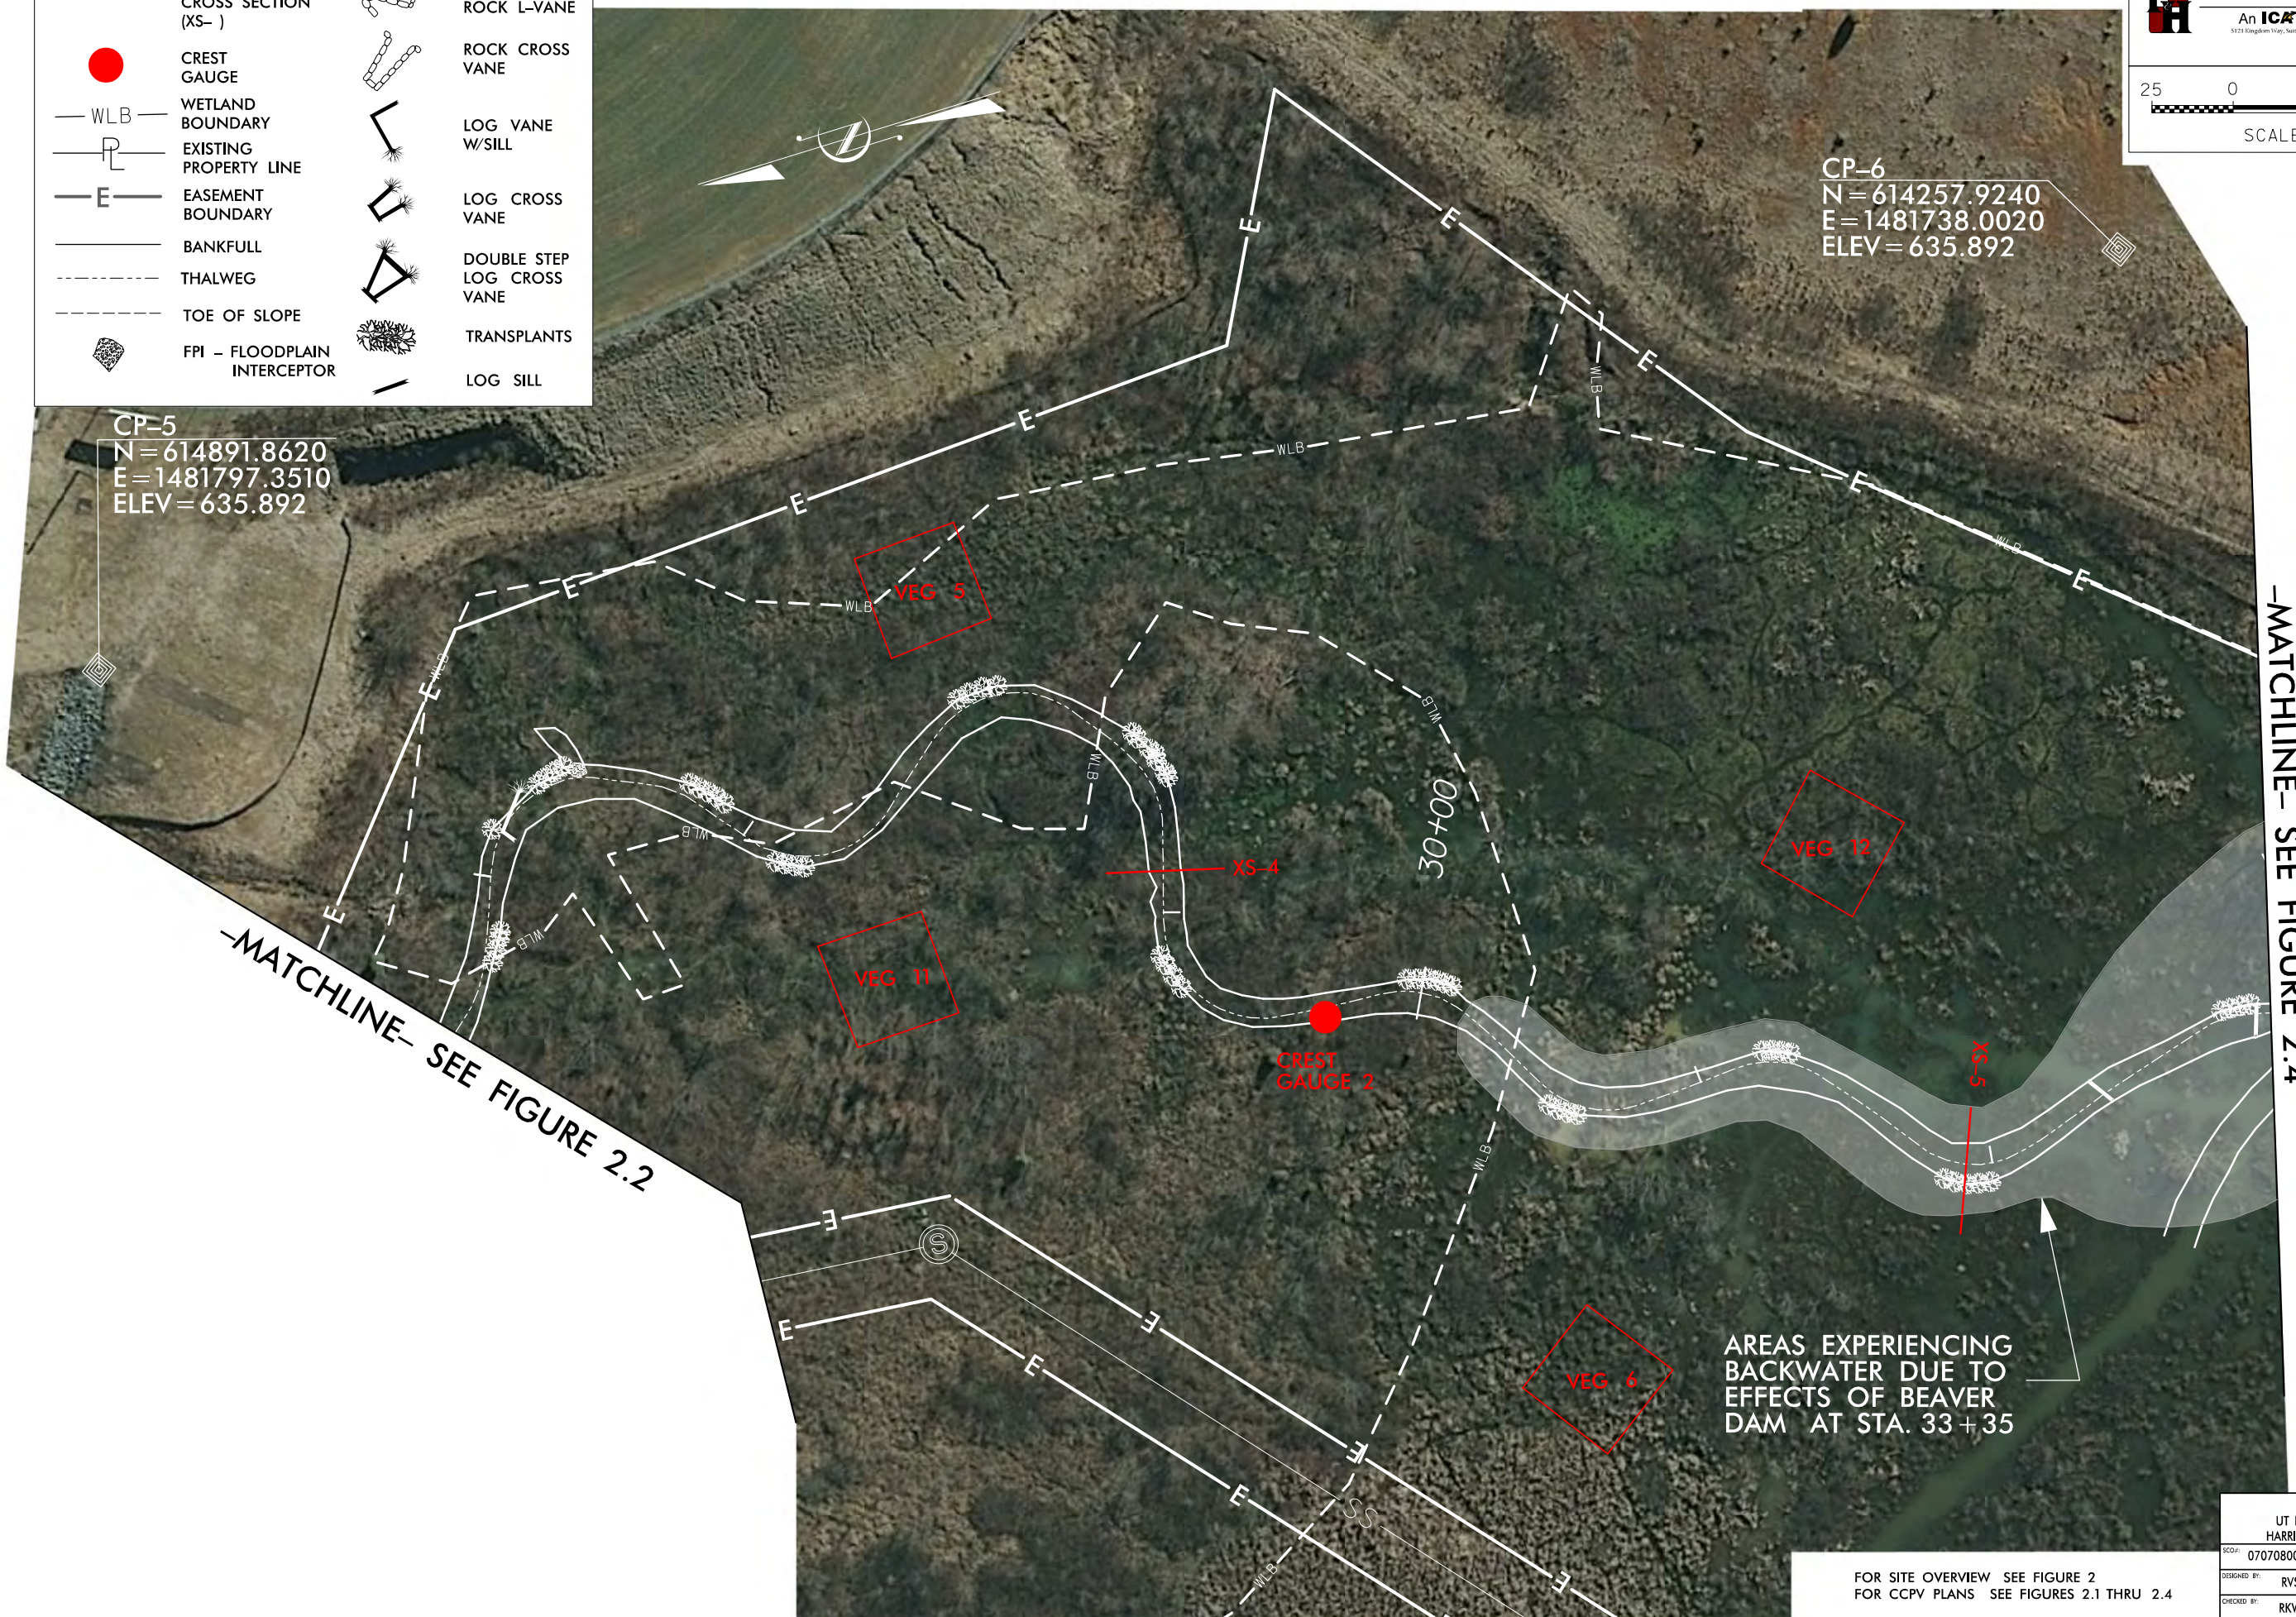
AREAS EXPERIENCING BACKWATER DUE TO EFFECTS OF BEAVER DAM AT STA. 33+35

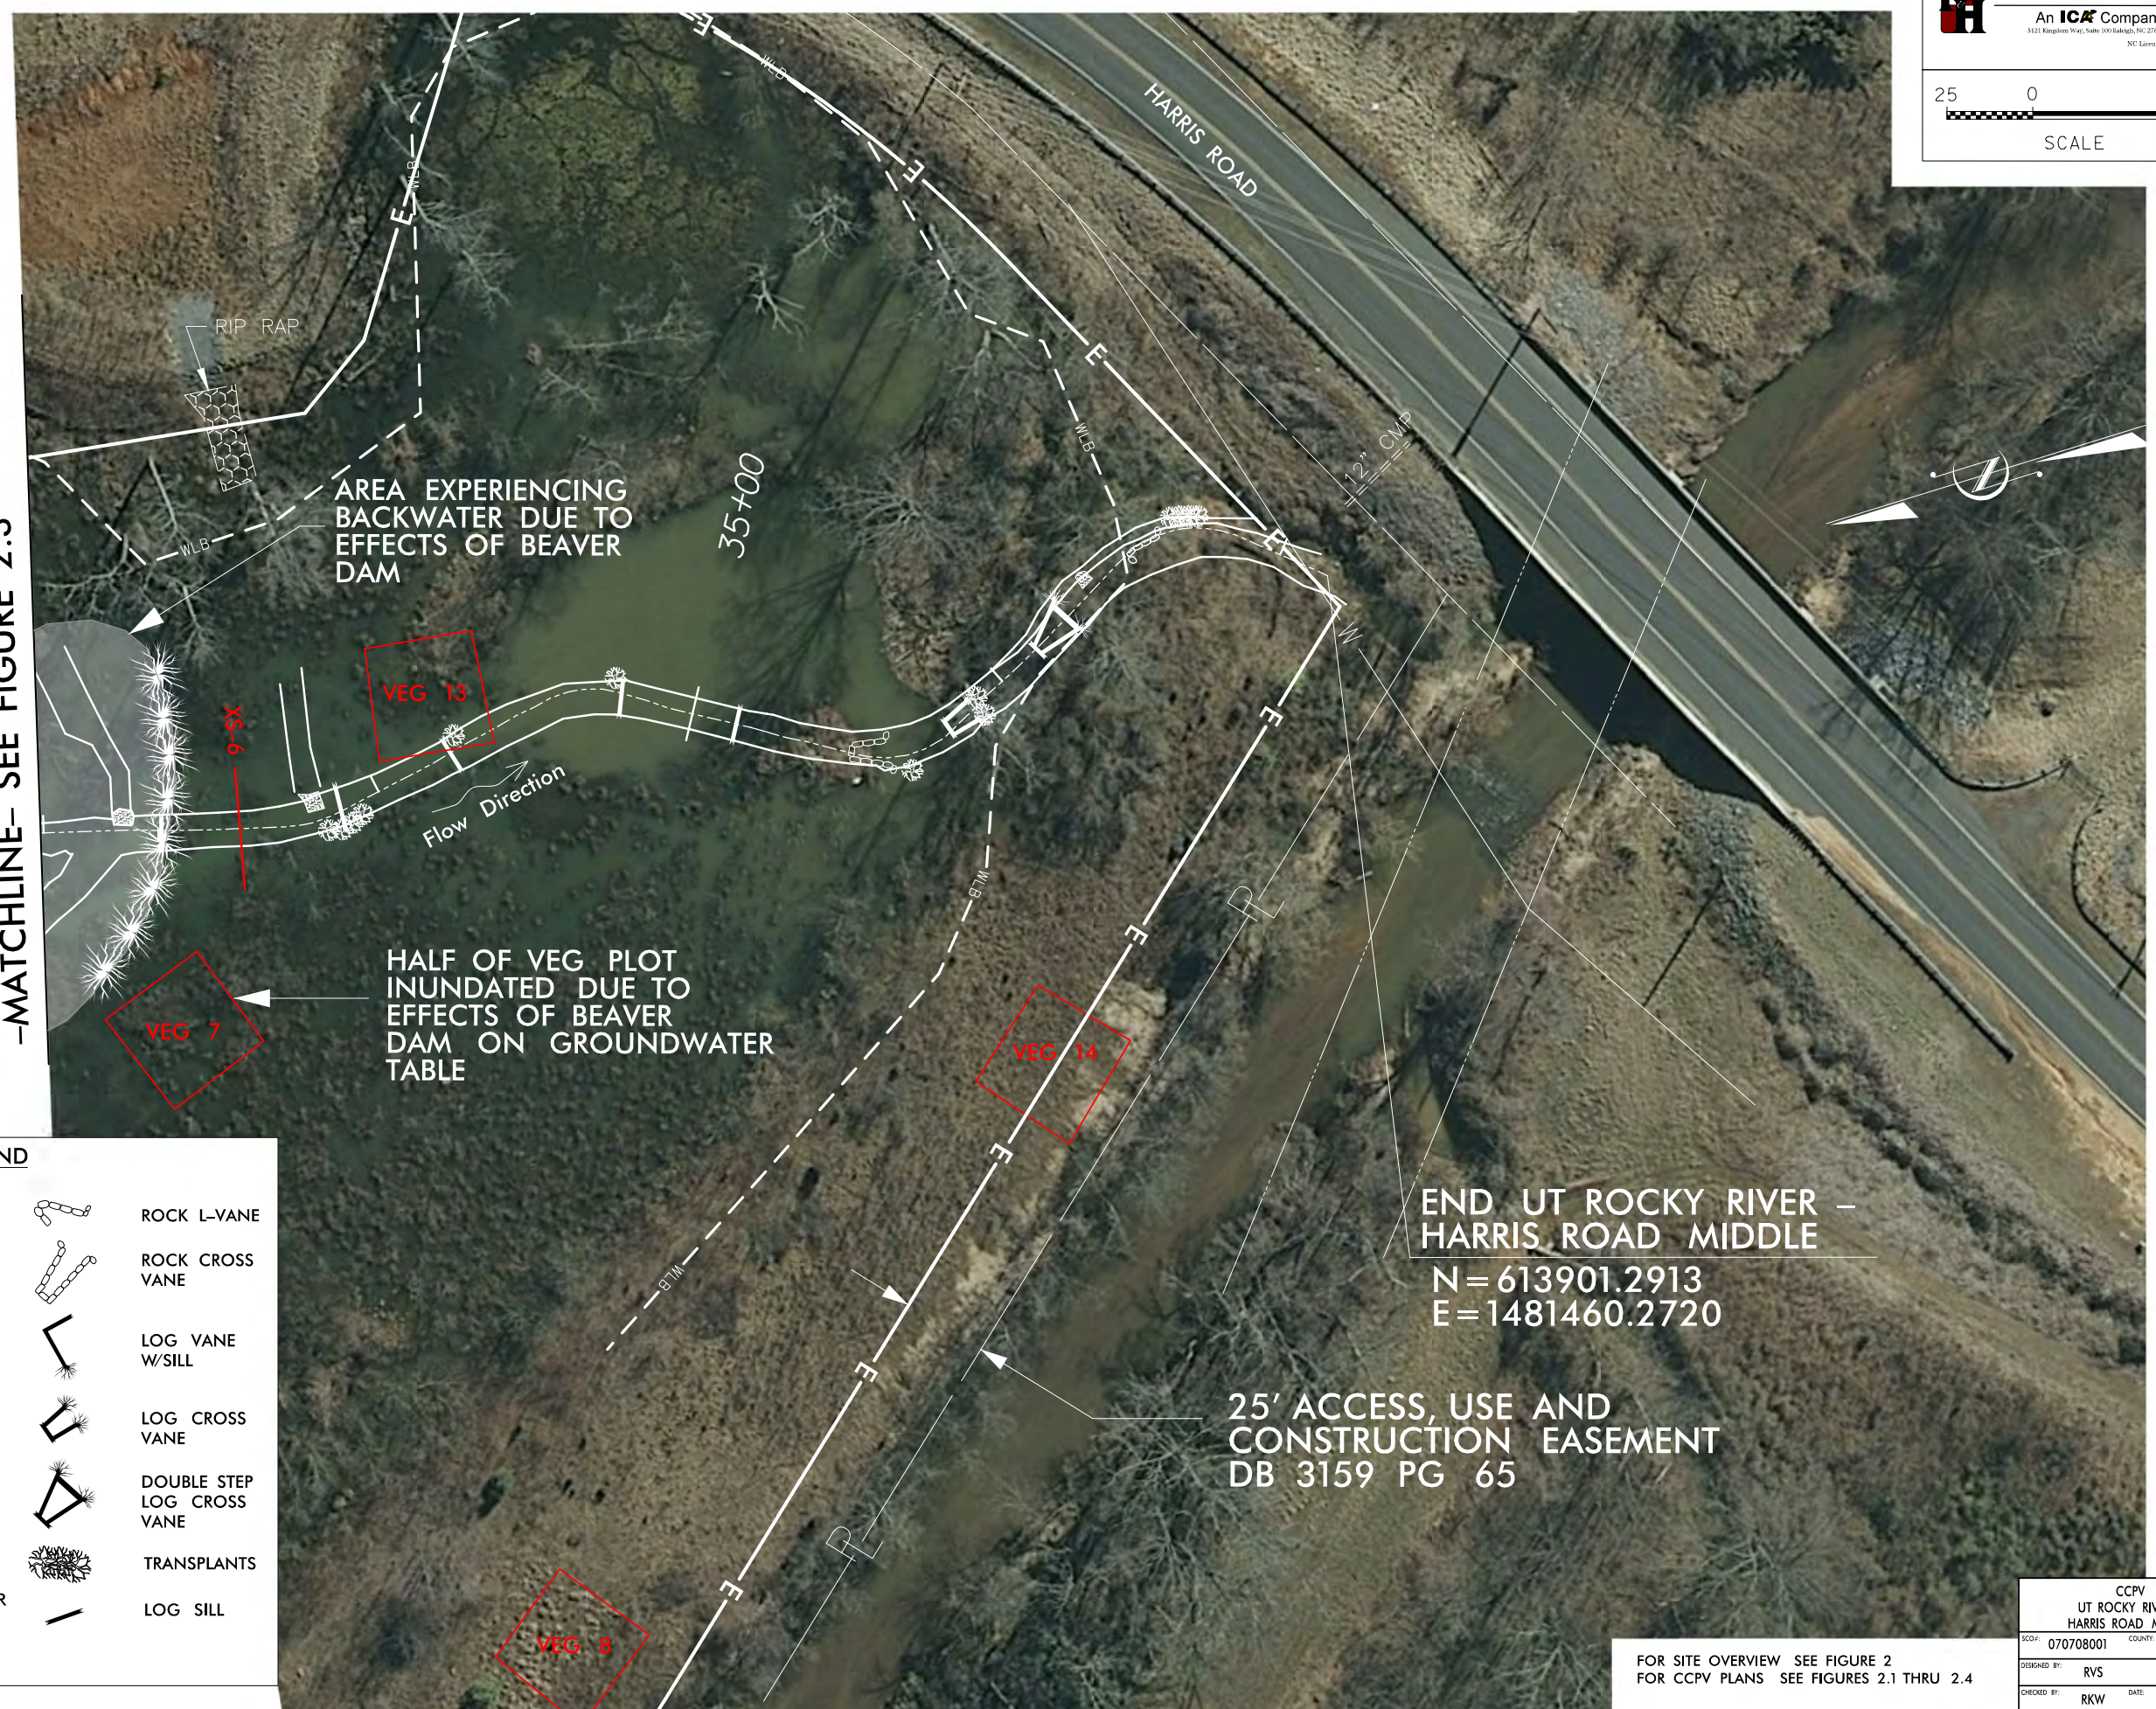
AREA EXPERIENCING BACKWATER DUE TO EFFECTS OF BEAVER DAM

HALF OF VEG PLOT INUNDATED DUE TO EFFECTS OF BEAVER DAM ON GROUNDWATER TABLE

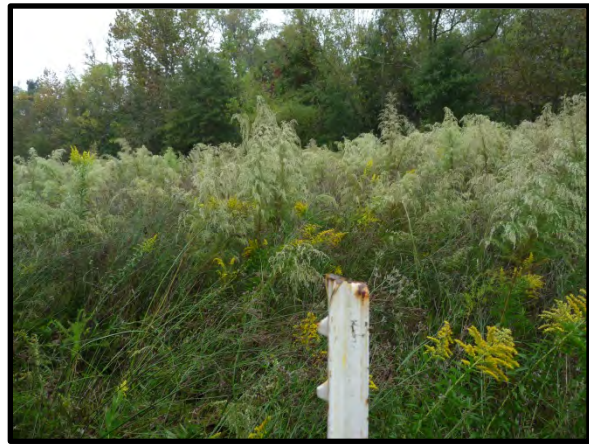
**3.8 Vegetation Plot 8**

Plot 8 is located on a terrace slope along the southern boundary of the Site. This area appears to be drier than other areas at the Site, which may be contributing to the poor survival of planted stems in Plot 8. Approximately half of Plot 10 is also located along a terrace side slope and appears somewhat drier than other areas. Additional plantings are not recommended at this time because natural recruitment of character tree species is anticipated over the course of the monitoring period and the areas exhibiting poor survivability are relatively small.

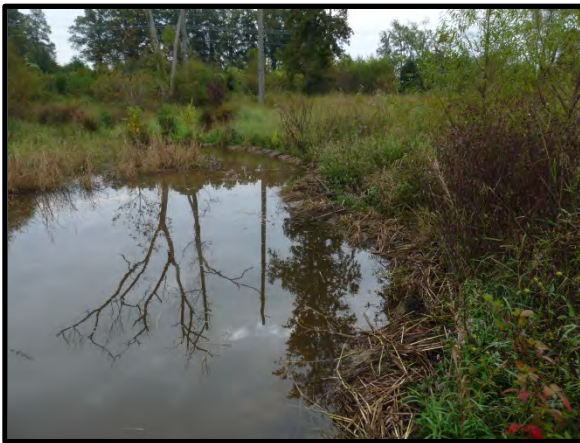
A beaver dam was observed near station 33+30. Backwater from the beaver dam was observed as far upstream as station 30+00. The beaver dam has not had a significant impact on the stability of the stream, and it will be removed prior to Year 2 Monitoring surveys. As noted in Section 1.3, EEP has been informed of the Beaver dam and they have contracted APHIS to trap beaver, remove the dam, and conduct monthly inspections to prevent re-colonization through the monitoring period.

**3.15 Beaver dam near station 33+50**

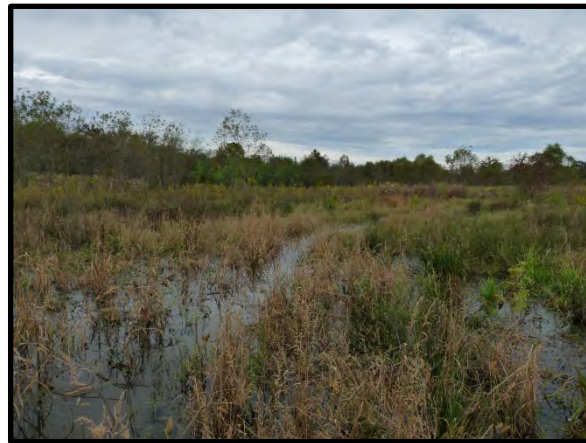
**3.16 Backwater from beaver dam**

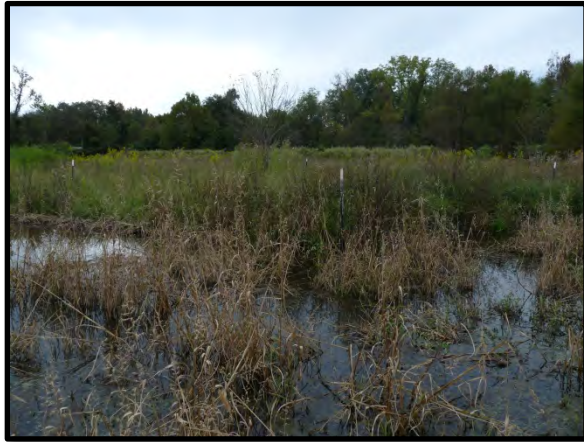
**3.17 Looking at beaver dam in floodplain  
at VP7**

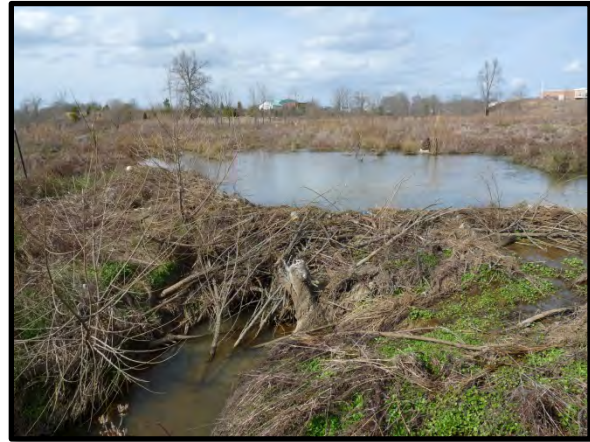
**3.18 Looking upstream at Beaver Dam**

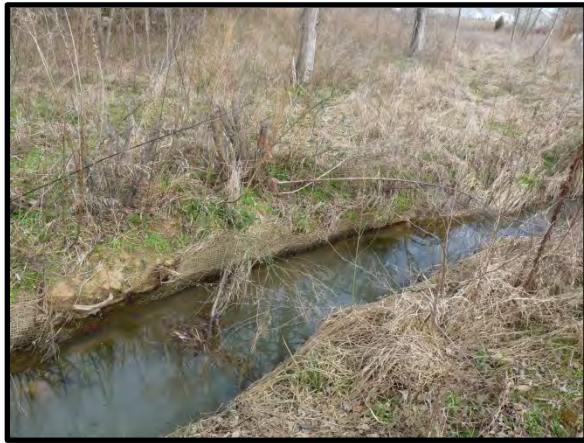
Approximately 40 feet of the right bank near station 14+50 has eroded to create a vertical bank; however, woody vegetation is well established in this area, due to live stake plantings and transplants located along the streambank. Woody vegetation should aid in stabilizing this section of streambank, therefore no repairs are recommended at this time.

**3.19 Eroded right bank near 14+50**

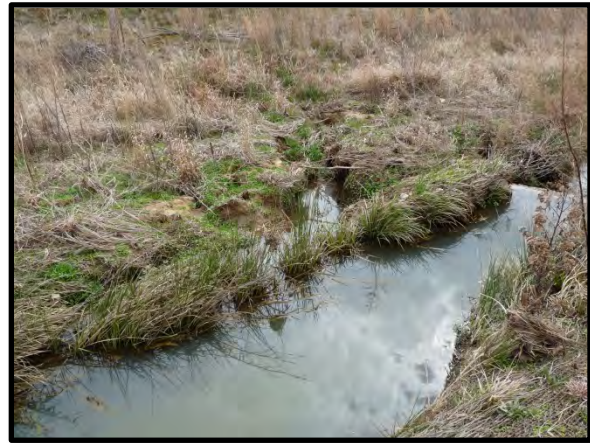
Approximately 20 feet of the left bank near station 20+90 has scoured allowing higher flows to migrate into the floodplain. The erosion occurs just upstream of a log sill, but the stream has not fully migrated around the log sill at this time. Woody and herbaceous vegetation in the floodplain is slowing the progression of erosion. This area will be watched closely and if the stream continues to migrate around the log sill corrective actions will be recommended to repair the area.

**3.20 Eroded left bank near 20+90**

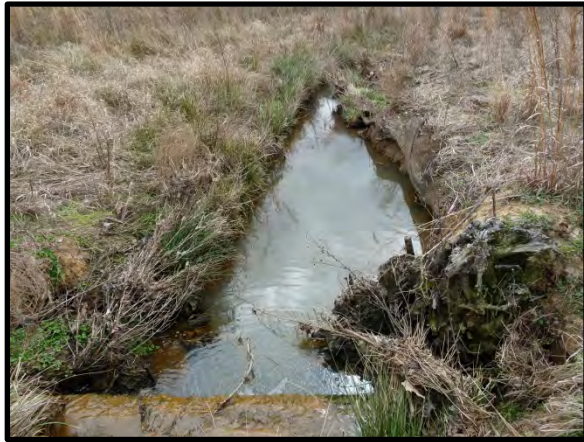
Immediately downstream of the log sill near station 20+90, the right bank has scoured for approximately 15 feet. A rootwad was placed in this bank to stabilize the log sill and it appears

that the erosion has occurred along the trunk of the rootwad. Due to the relatively small size of this eroded area and the stability of the bank behind the rootwad, corrective actions are not recommended at this time.

**3.21 Eroded bank downstream of log sill  
near 20+90**

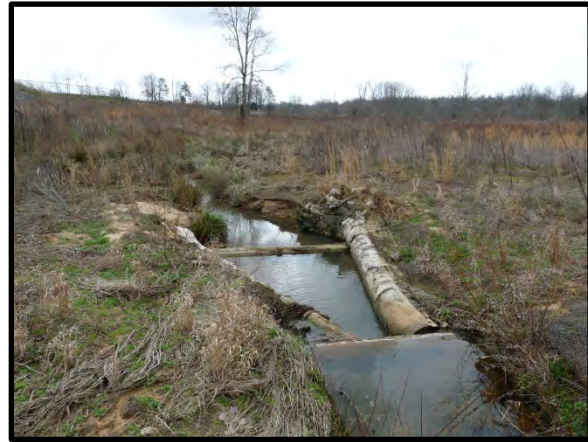
Two structures are experiencing piping as noted in Table 5. The structures are two double step log cross vanes located at stations 20+50 and 22+30. The header logs are functioning as intended and holding grade but water is piping through the second step header and footer log on each structure. Since the header logs and vane arms are functioning as intended, corrective actions are not recommended at this time.

**3.22 Double step log cross vane, notice  
water piping under second log step**
