# ***YEAR 2 MONITORING REPORT***

## **UT ROCKY RIVER – HARRIS ROAD MIDDLE**

EEP IMS No. 92383, Contract No. 004346

Submitted: November 6, 2013

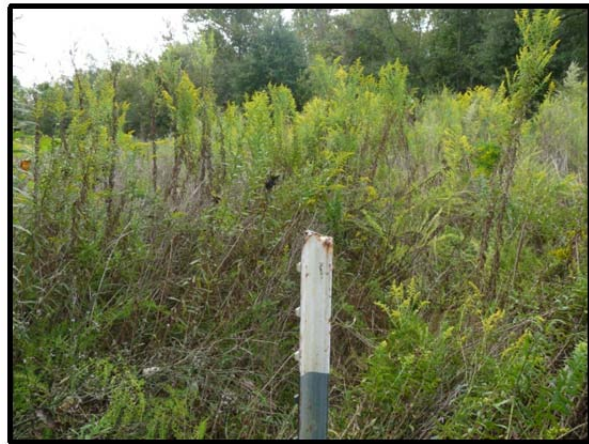
**3.8 Vegetation Plot 8**

Plot 8 is located on a terrace slope along the southern boundary of the Site. This area appears to be drier than other areas at the Site, which may be contributing to the poor survival of planted stems in Plot 8. Approximately half of Plot 10 is also located along a terrace side slope and appears somewhat drier than other areas. Encroachment has occurred within Plot 10. It appears mowers have entered the easement/plot and taken out a vegetation plot stake. Additional plantings are not recommended at this time because natural recruitment of character tree species is anticipated over the course of the monitoring period and the areas exhibiting poor survivability are relatively small.

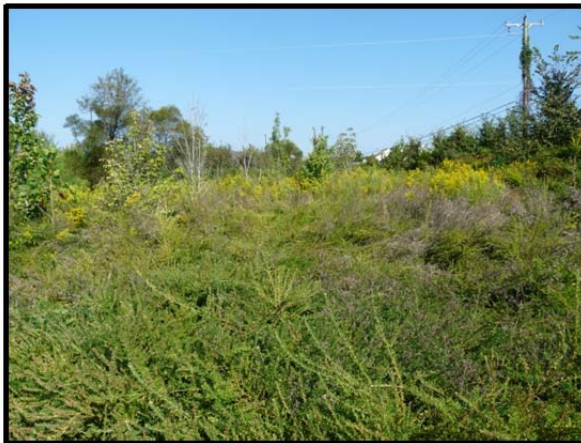
A small cluster of *Sericea lespedeza* (*Lespedeza cuneata*) was observed within Plot 9. Plot 9 is located near Moss Farm Street and a sewer easement that crosses UT Rocky River at the beginning of the project making this area susceptible to encroachment of invasive species. Plot 9 is currently not exceeding success criteria goals with 283 planted stems per acre surviving after Year 2; however, the stem count is 567 with natural recruits. EEP does not typically treat *lespedeza* during invasive species treatments; however, if the population continues to have a detrimental effect on the plot and surrounding area in monitoring Year 3, EEP will reassess.

**3.15 Lespedeza population near  
Vegetation Plot 9**

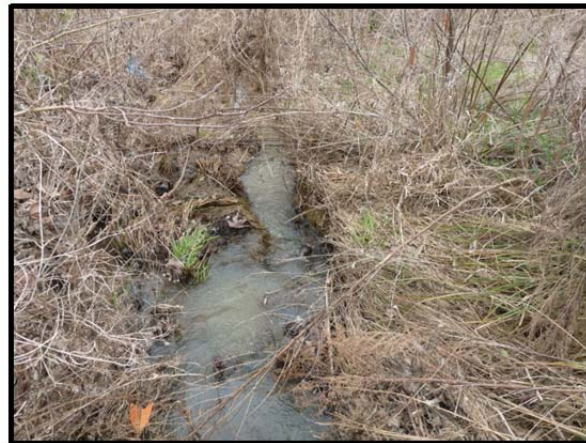
Table 5, Visual Stream Morphology Stability Assessment, details 97 percent of the stream bed as stable, performing as intended for Year 2 Monitoring. One minor headcut was noted at station 14+20 (Figure 3.16). Nine areas along the bank are experiencing erosion and are depicted on the Current Conditions Plan View (CCPV) located in Appendix B. Photos of each problem area are also included in Appendix B.

**3.16 Small headcut at Station 14+20  
facing downstream**

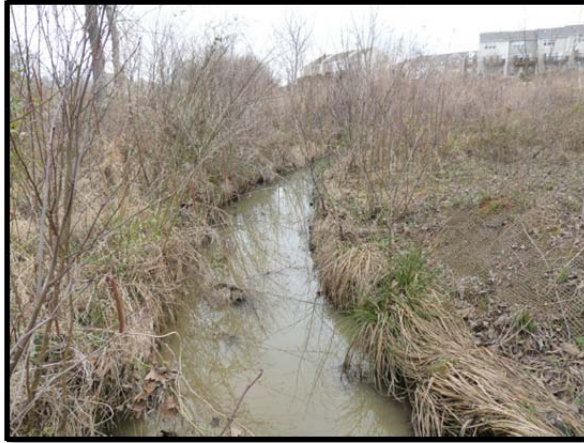
Approximately 40 feet of the right bank near station 14+50 has stabilized since the vertical bank was observed during Year 1 Monitoring. The right bank at station 14+90 has little to no vegetation (Figure 3.17).

**3.17 Minor bank erosion at Station 15+00 facing downstream**

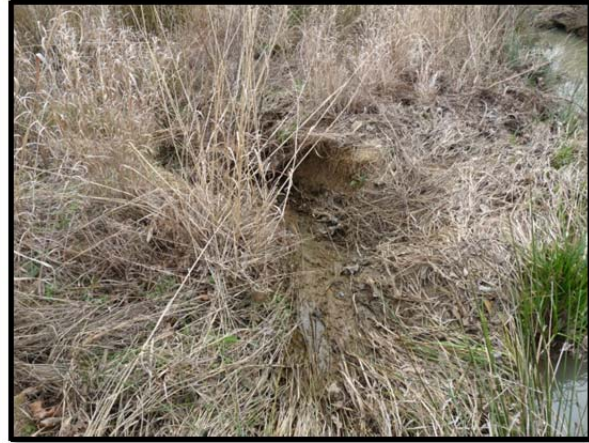
Approximately 20 feet of the left bank near station 20+90 has scoured allowing higher flows to migrate into the floodplain (Figure 3.18). The erosion occurs just upstream of a log sill, but the stream has not fully migrated around the log sill at this time. Woody and herbaceous vegetation in the floodplain is slowing the progression of erosion. This area will be watched closely and if the stream continues to migrate around the log sill corrective actions will be recommended to repair the area. The log sill at 20+90 appears to be piping at low flow but is still holding grade. Immediately downstream of the log sill near station 20+90, the right bank has scoured for approximately 15 feet (Figure 3.19). A rootwad was placed in this bank to stabilize the log sill

**3.18 Minor bank erosion at Station 20+90 facing left bank**

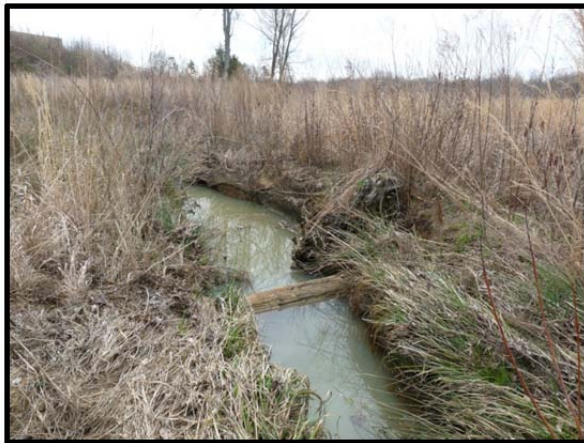
and it appears that the erosion has occurred along the trunk of the rootwad. Due to the relatively small size of this eroded area and the stability of the bank behind the rootwad, corrective actions are not recommended at this time.

**3.19 Erosion and piping at Station 20+90 facing downstream**

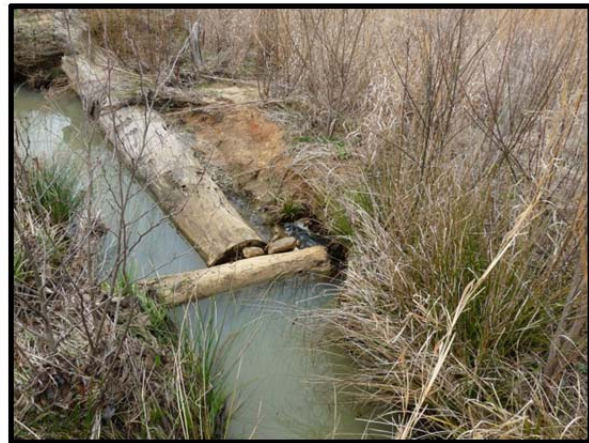
The double step log cross vane at 22+30 has eroded on the right bank of the structure and is piping around the side of the header log (Figure 3.20). Corrective actions are not recommended at this time.

**3.20 Piping of structure at Station 22+30 facing downstream**

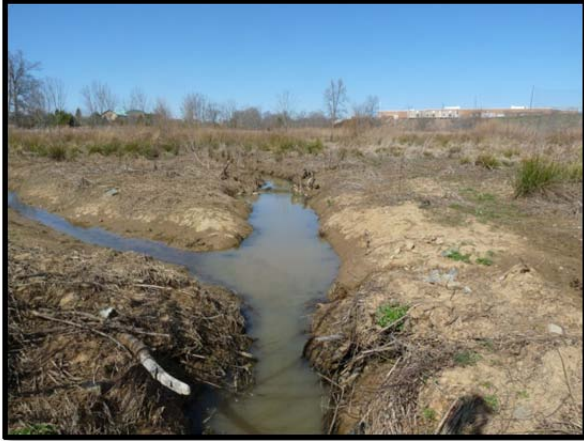
The beaver dam observed near station 33+30 during Year 1 monitoring was removed during January and February of 2013. Backwater from the beaver dam was observed as far upstream as station 30+00. The beaver dam has not had a significant impact on the stability of the stream (Figure 3.21). EEP had previously contracted APHIS to conduct monthly inspections to prevent re-colonization through the monitoring period. Due to the lack of recent activity and cost, APHIS site inspections for beaver activity are now quarterly on the site.

**3.21 Beaver damage Station 33+30  
facing upstream**

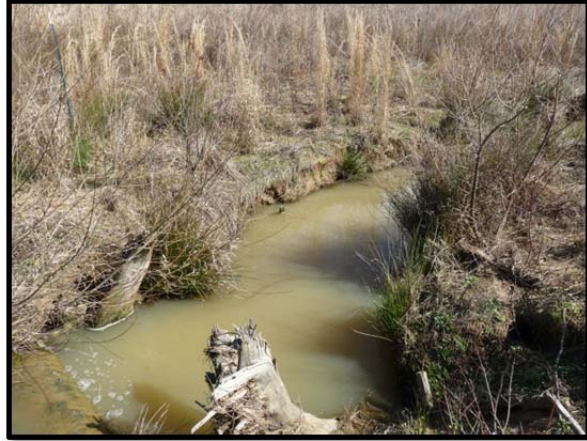
**3.22 Moderate bank erosion  
at Station 34+25 facing downstream**

Minor bank erosion has occurred at station 34+25 near vegetation plot 13 (Figure 3.22). Major bank erosion has been noted around the meander bend at station 35+80 upstream of the log cross vane's right arm (Figure 3.24). This area will be watched closely. EEP plans to plant additional live stakes in these areas during the upcoming dormant season.

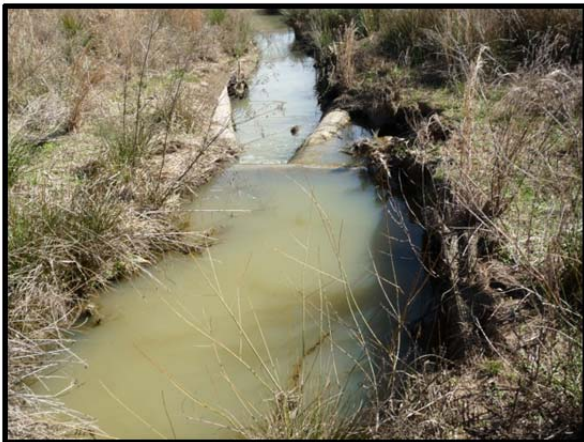
**3.23 Eroded bank Station 35+80  
facing downstream**
