YEAR 3 MONITORING REPORT

UT ROCKY RIVER – HARRIS ROAD MIDDLE

Cabarrus County, North Carolina

EEP IMS No. 92383, Contract No. 004346

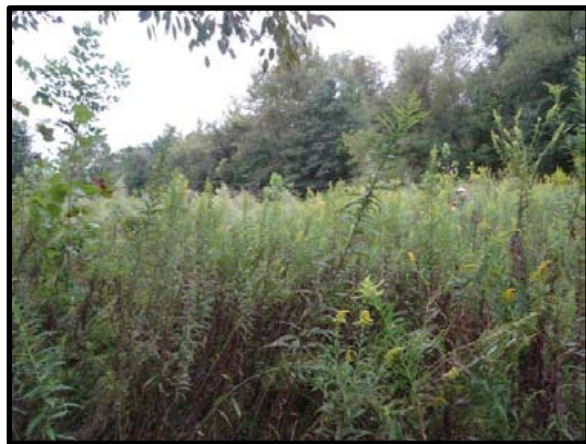
3.8 Vegetation Plot 8

In previous monitoring years Plots 8 and 10 were noted as being drier than other plots, potentially leading to their lack of success. The plots remain drier than the rest of the site, and continue to fall short of success criteria when counting planted stems alone. However, as expected, both plots exceed 360 stems per acre when including natural recruits. Additional planting is not recommended due to continued development of natural recruit tree species. Previous encroachment occurring within Plot 10 appears to have ceased.

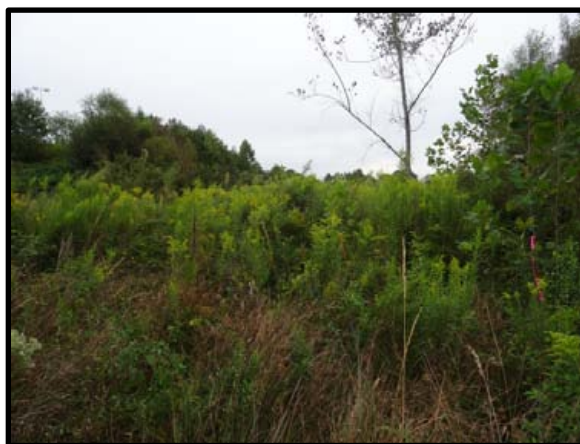
3.10 Vegetation Plot 10

Blackberry (*Rubus argutus*) is very dense throughout the site and in specific areas is beginning to choke out planted species. Plot 12 is overrun with blackberry growing up to 8 feet tall. Additionally, Plot 10 has dense blackberry that is contributing to the planted species not meeting success criteria. The plot has an average stem density of 283 stems per acre and several planted stems have gone missing since the first year of monitoring. While blackberry is affecting the growth of planted species, natural recruits are surviving well in these plots as both plots have greater than ten natural stems.

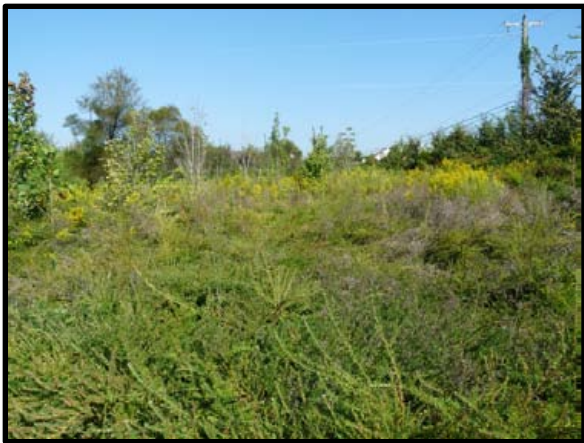
The cluster of serica lespedeza (*Lespedeza cuneata*) observed in Monitoring Year 2 is still present and has expanded in coverage. The cluster is in the vicinity of Plot 9, which is located near Moss Farm Street. A sewer line easement makes the area susceptible to invasive plant species encroachment. While the invasive plant species remain, Plot 9 has improved over the previous monitoring year. The plot is now exceeding success criteria with an average stem density of 364 stems per acre without natural recruits. Invasive plant species should be watched closely in the coming years; however, no action is necessary at this time as affected plots have improved.

3.16 Lespedeza cluster near Plot 9

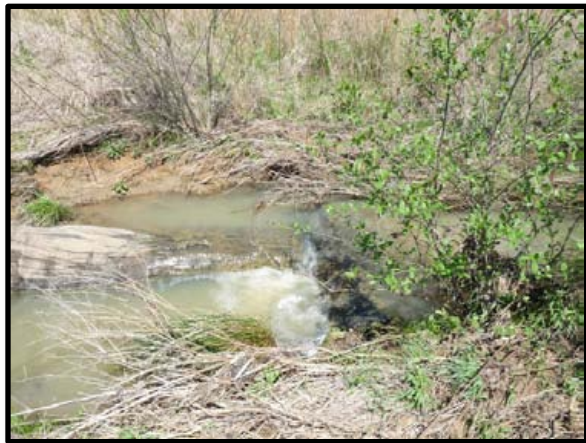
3.17 Major erosion near 22+50

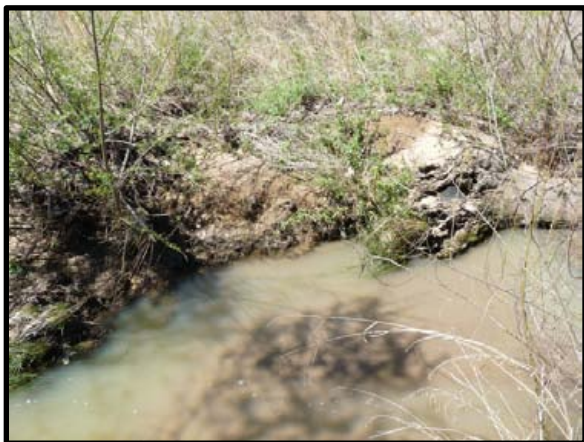
The log cross vane below STA 35+00 failed before Year 2 Monitoring. The structure was not able to be surveyed during Year 3 surveys due to back water from Rocky River. If damages are not contained in the upcoming monitoring year repairs may be necessary.

3.18 Major erosion below 35+00

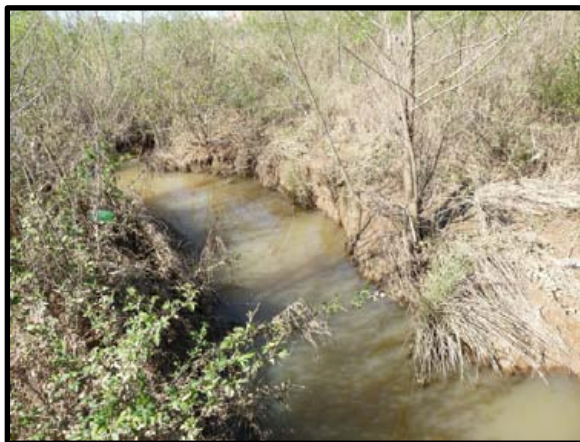
3.19 Moderate erosion above 35+00

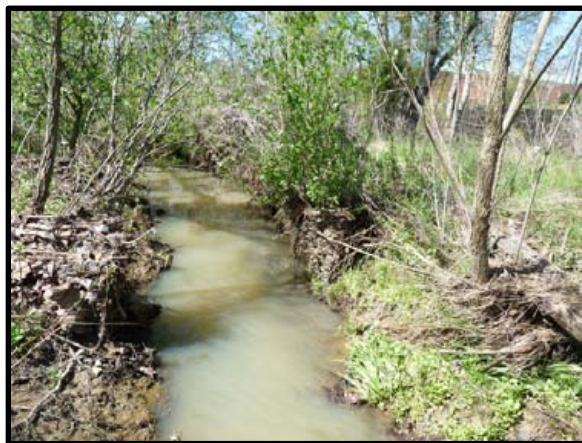
3.20 Minor erosion at 15+00

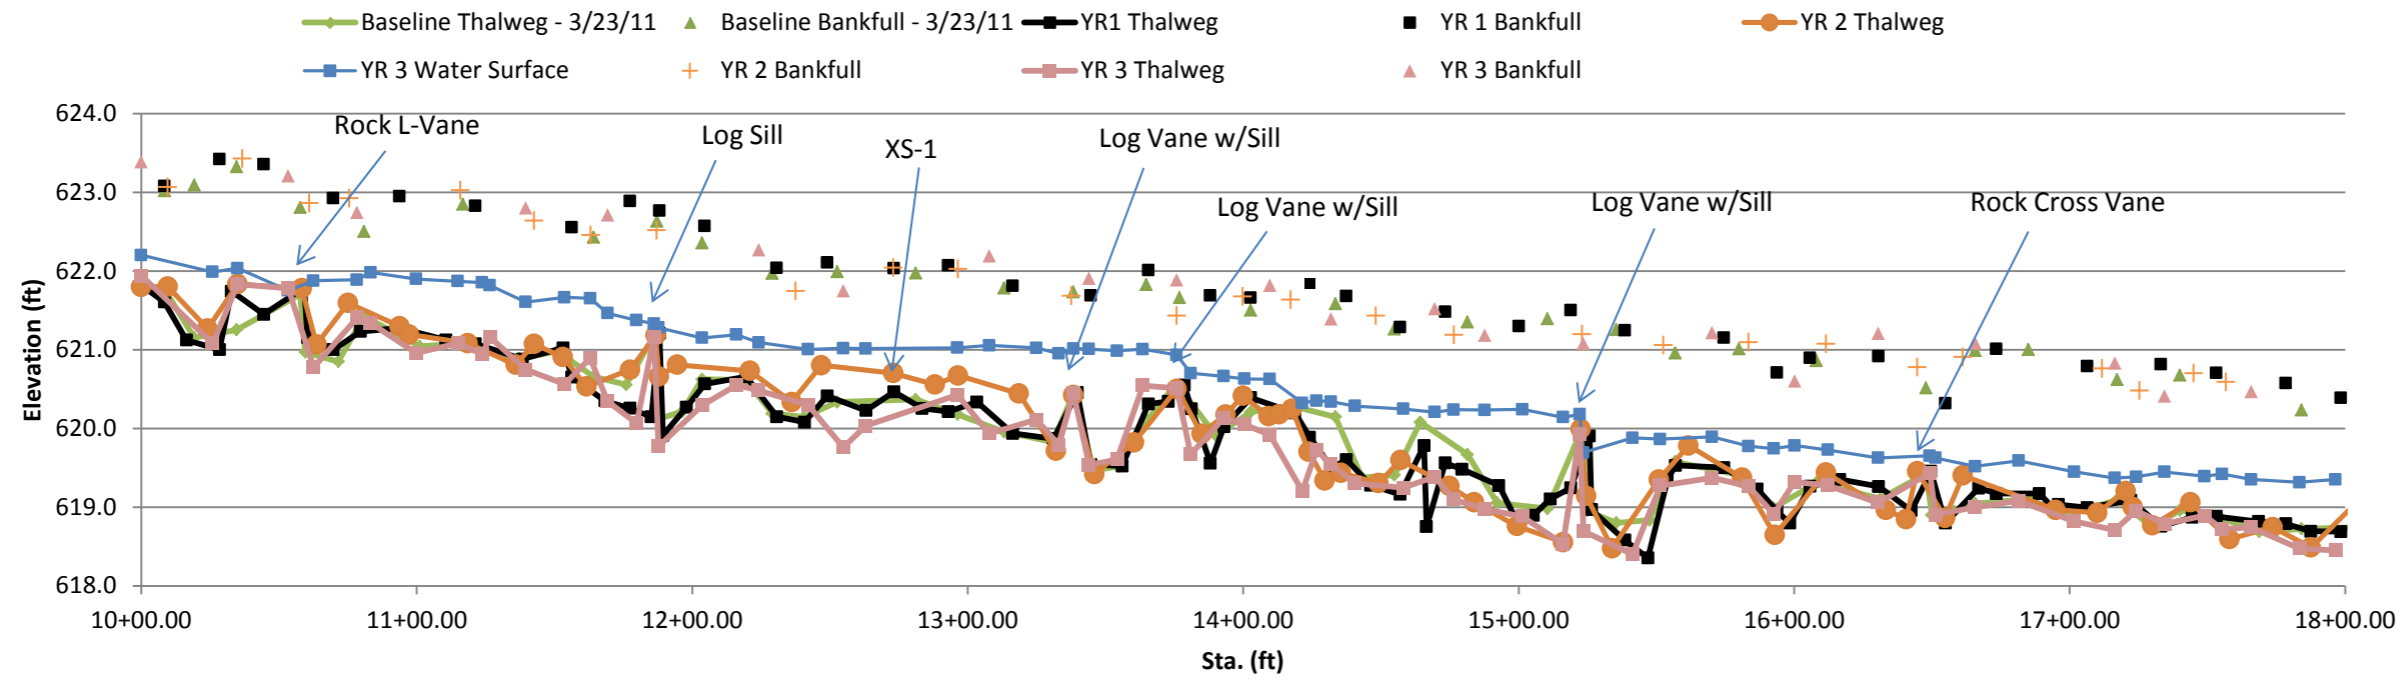
Figure 5.1 UT Rocky River - Longitudinal Profile

Table 5, Visual Stream Morphology Stability Assessment, details 99 percent of the stream bed as stable, performing as intended for Year 3 Monitoring. The minor headcut observed in Year 2 Monitoring is still present (Figure 5.1). Additionally, six segments of stream bank are scoured/eroding. These segments account for two percent of total stream bank. All of the segments experiencing minor/moderate erosion have woody vegetation along the areas of concern which should prevent erosion from accelerating. Two segments are experiencing mass wasting totaling 34 feet or 0.6 percent of stream bank. Neither segment has woody vegetation growing along the mass wasting bank, and because of this erosion will likely remain active without vegetative stabilization in the winter months.

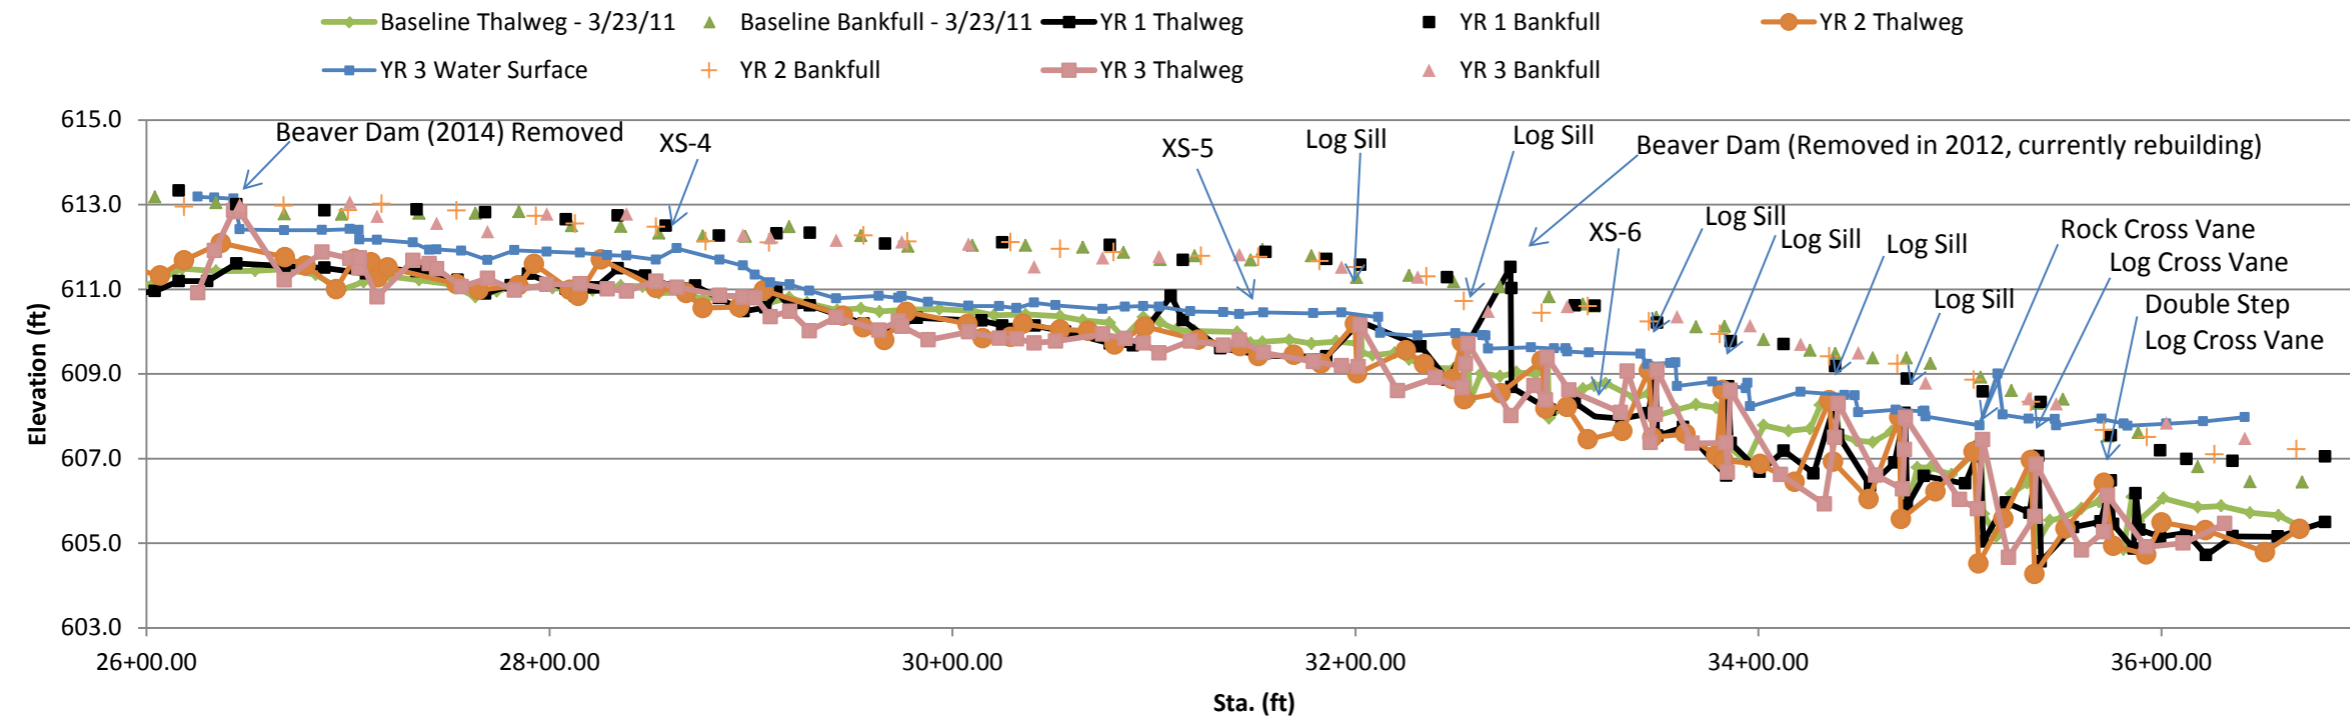
Figure 5.3 UT Rocky River - Longitudinal Profile

UT Rocky River appears to be stable and functioning as designed. The area affected by the beaver dam removed in 2012 is recovering and does not show significant changes from Year 2 Monitoring. However, it appears that the beaver were attempting to rebuild the dam at this location during vegetation surveys in September 2014. Another beaver dam was observed at station 26+46 and is reflected in the longitudinal profile (Figure 5.3). The beaver dam was removed in summer 2014.
