YEAR 5 MONITORING REPORT

UT ROCKY RIVER – HARRIS ROAD MIDDLE

Cabarrus County, North Carolina

DMS IMS No. 92383, Contract No. 004346

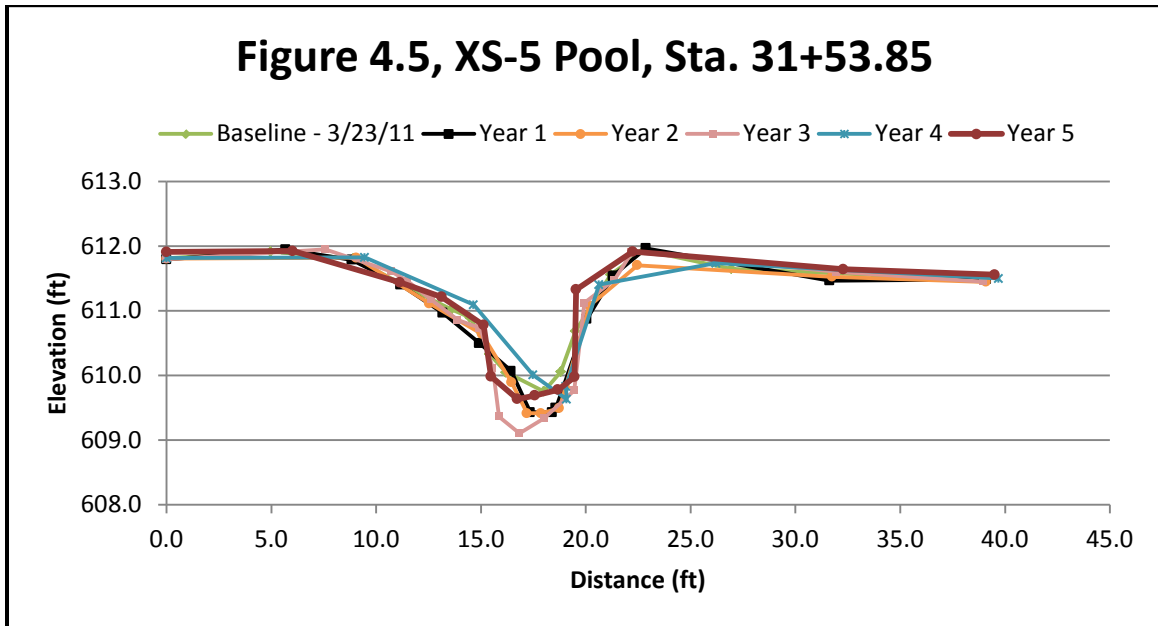
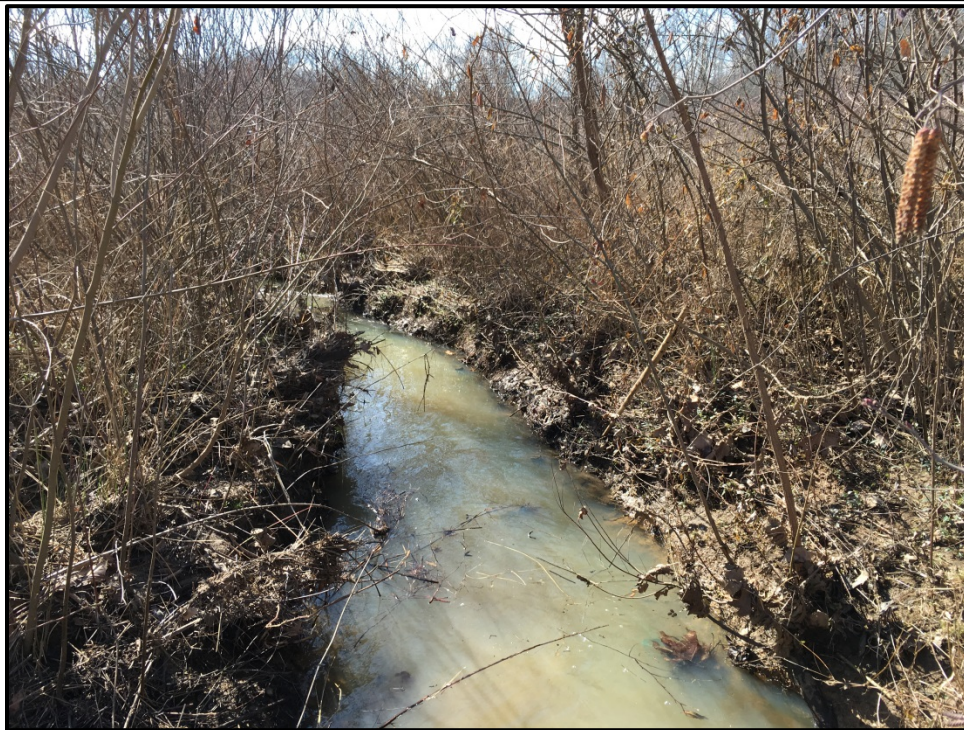
**Figure 4.6, XS-6 Pool (formerly Riffle), Sta.
33+18.49**

Overall cross section data shows that while cross section dimensions have fluctuated over the course of the monitoring period, channel geometry remains similar to baseline dimensions. Throughout the course of monitoring the channel is moving from a C to an E type channel as the stream has become slightly more entrenched.
