UT to Rocky River (Smith Tract) Stream and Buffer Restoration, Enhancement, and Preservation

Chatham County, North Carolina

Final Monitoring Report

(Year 1 of 5)

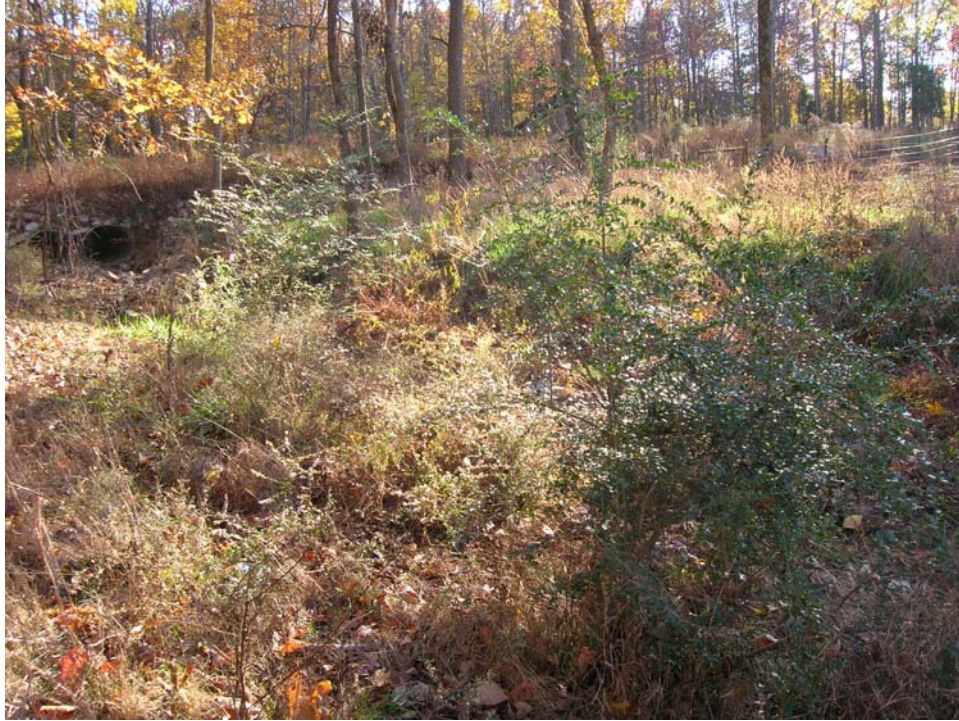
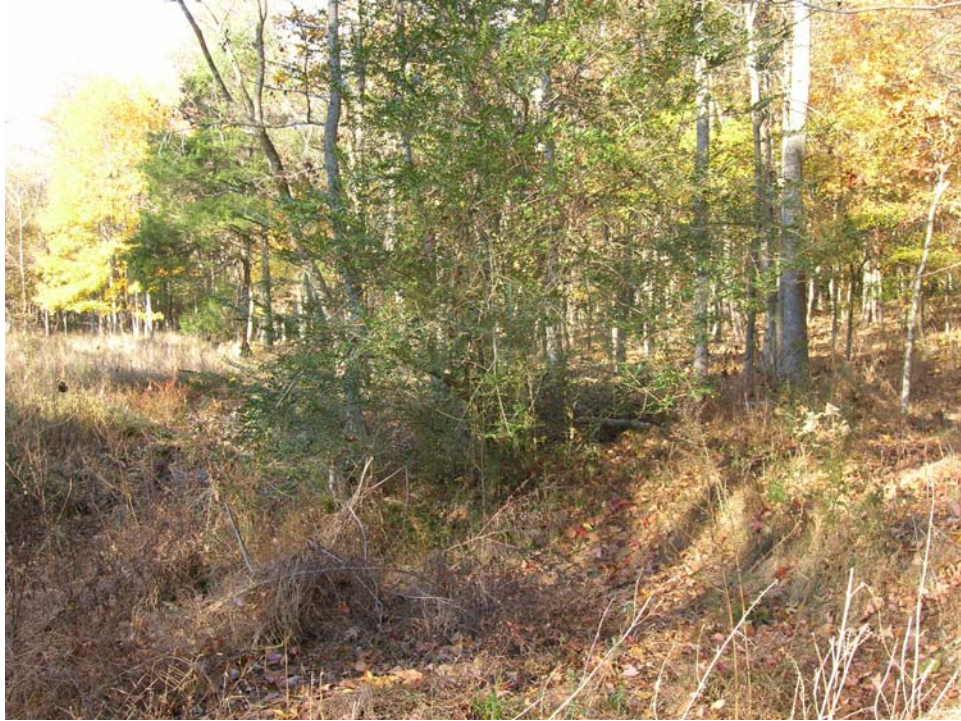
Photos 1 and 2: Site 1 - Small population of privet in floodplain, bank, and bench (about 20 stems). All appear to be less than 2 years old.

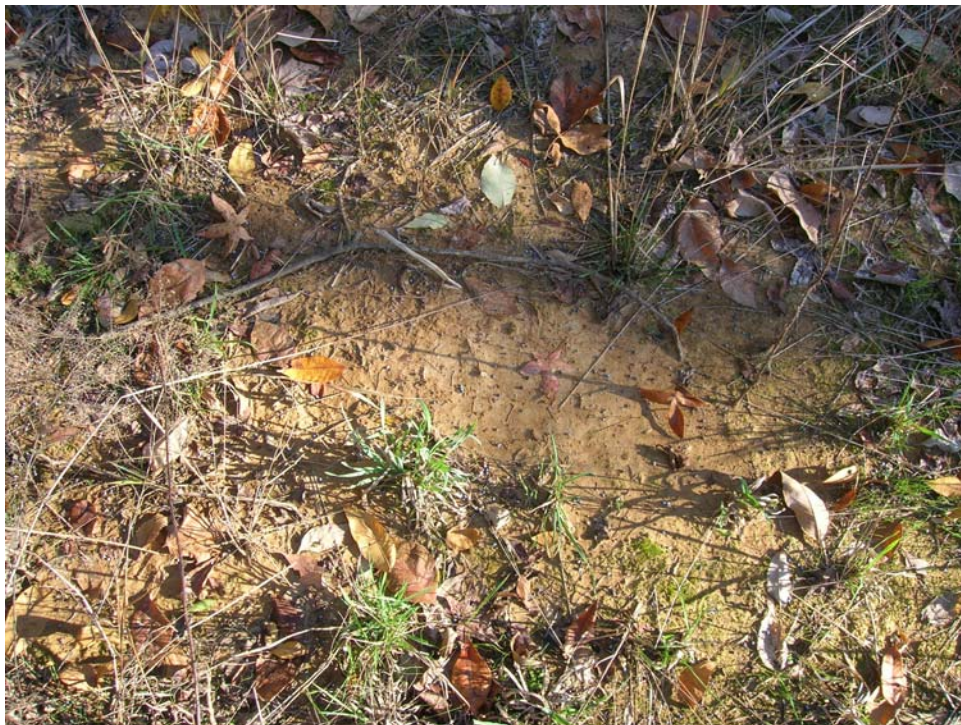
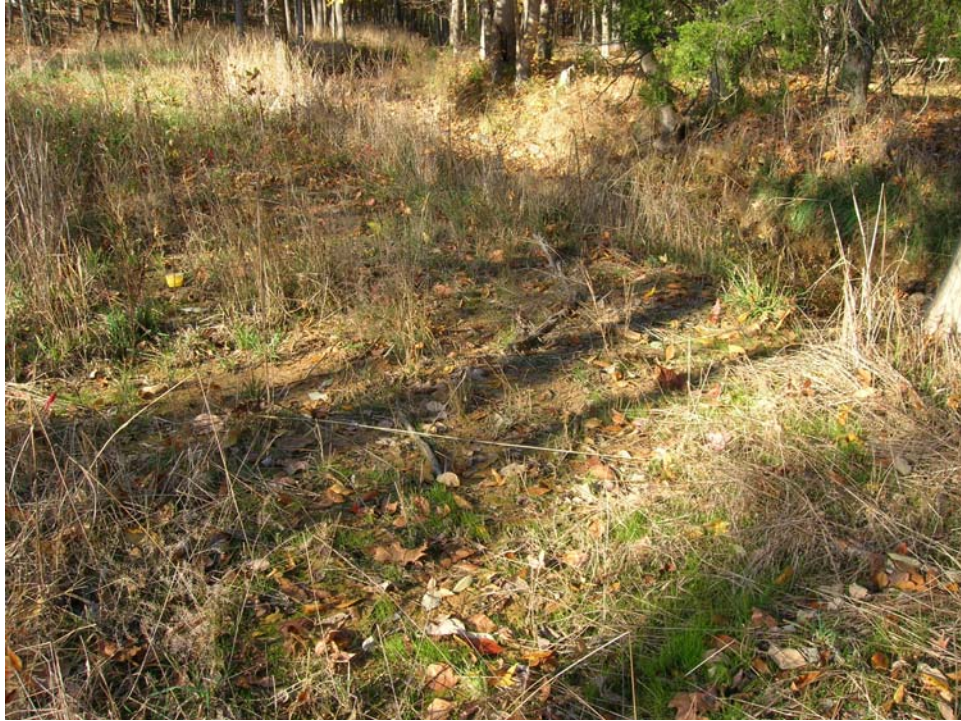
Photos 3 and 4: Site 2 - Bare floodplain, 30-80% soil exposure in 3 x 10 meter area

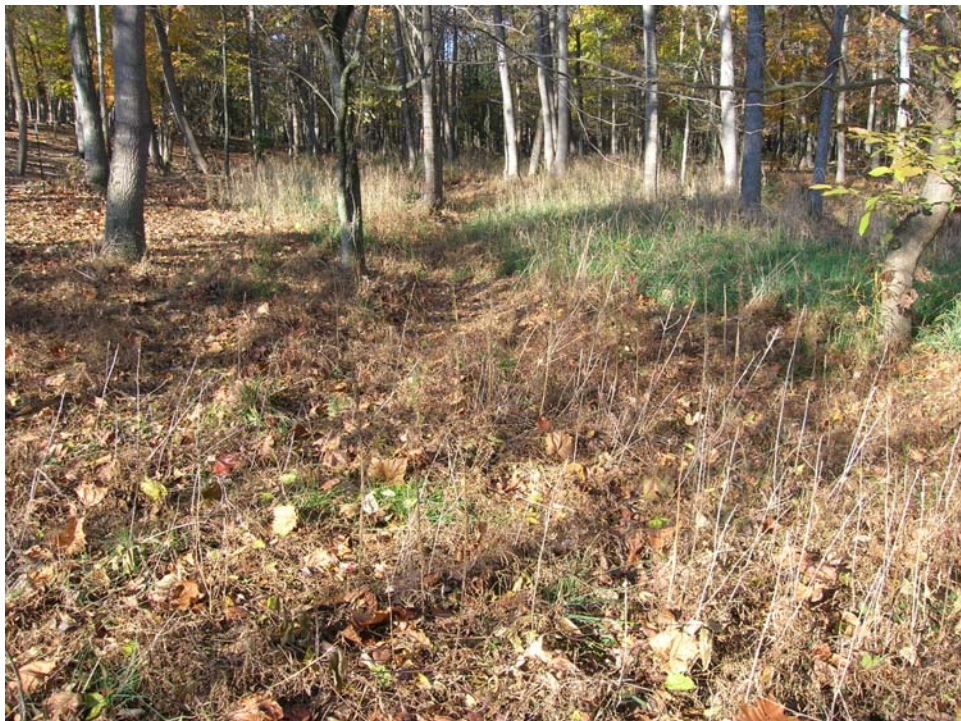
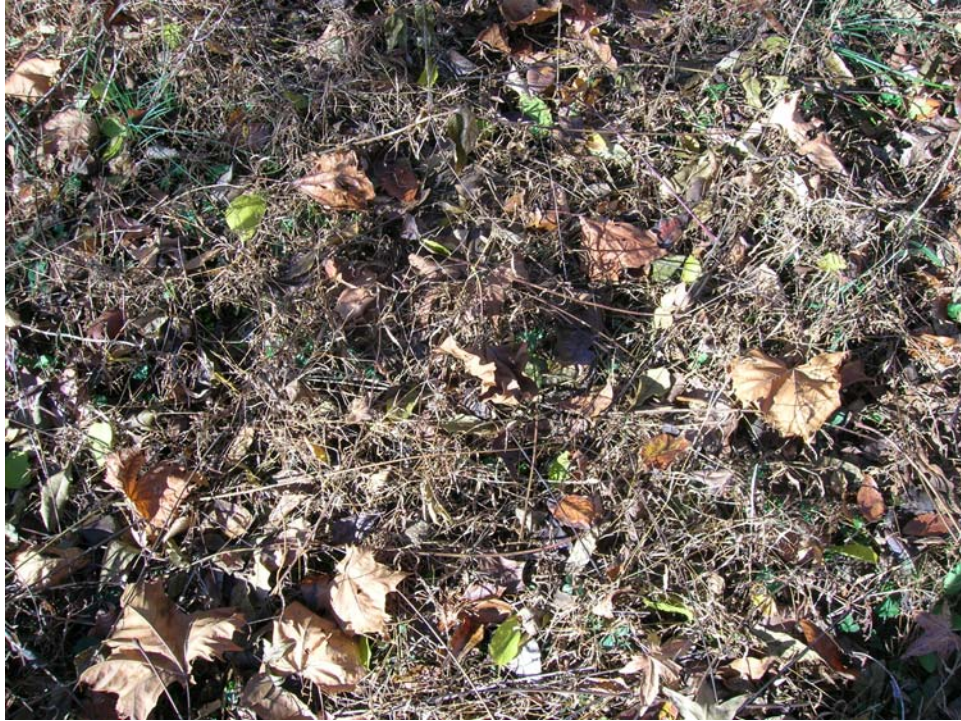
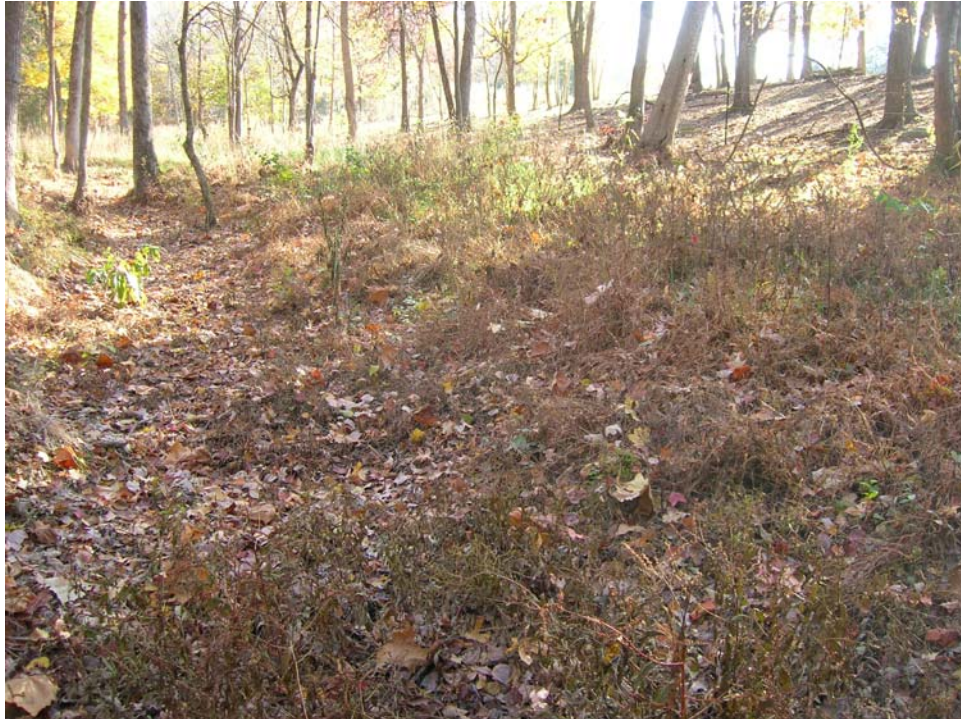
Photo 5-7: Site 3 - *Microstegium* invasion (50-90% coverage) in floodplain depression along side slope and in adjacent floodplain

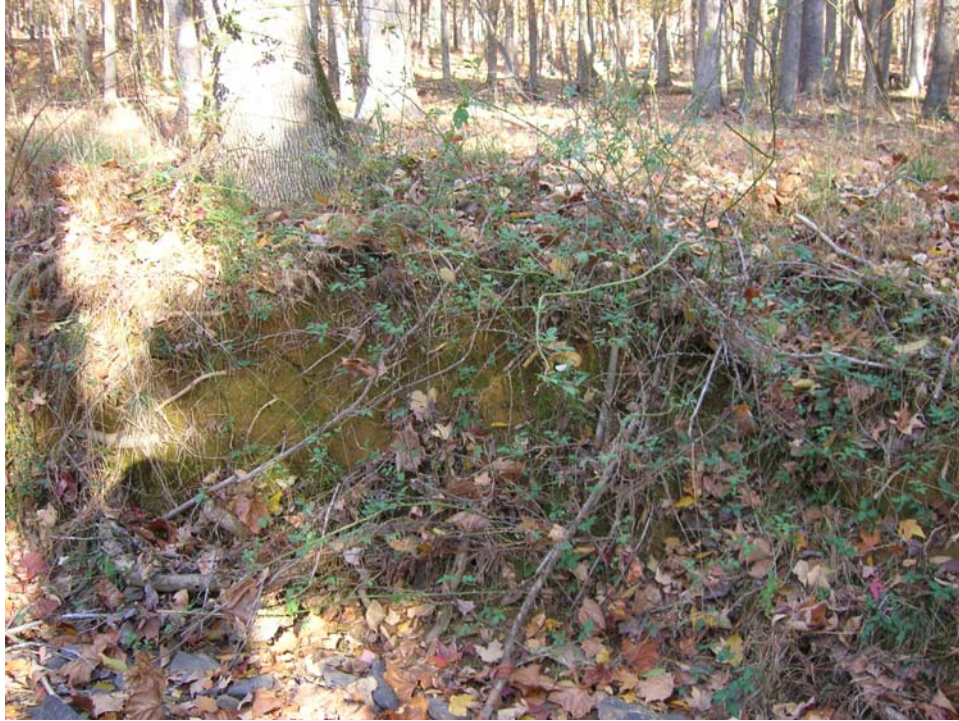
Photo 8

Photo 8: Site 4 - Bare bank and outbreak of *Rosa multiflora* on bank.

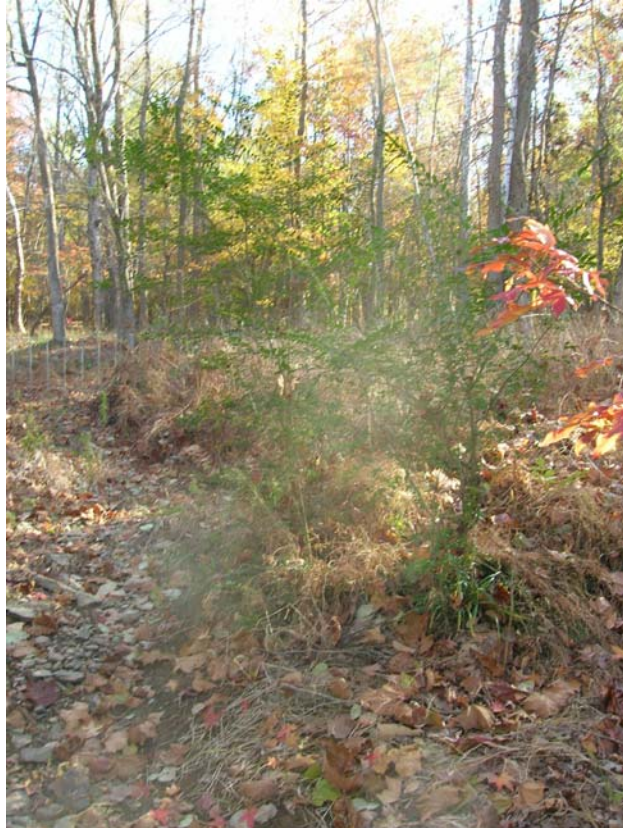
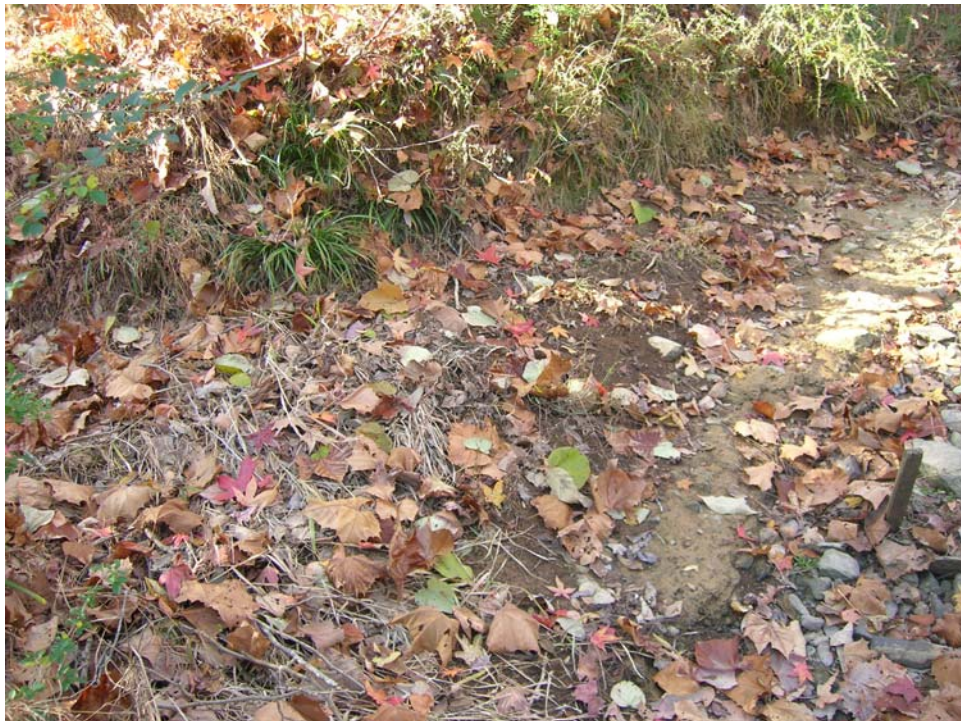
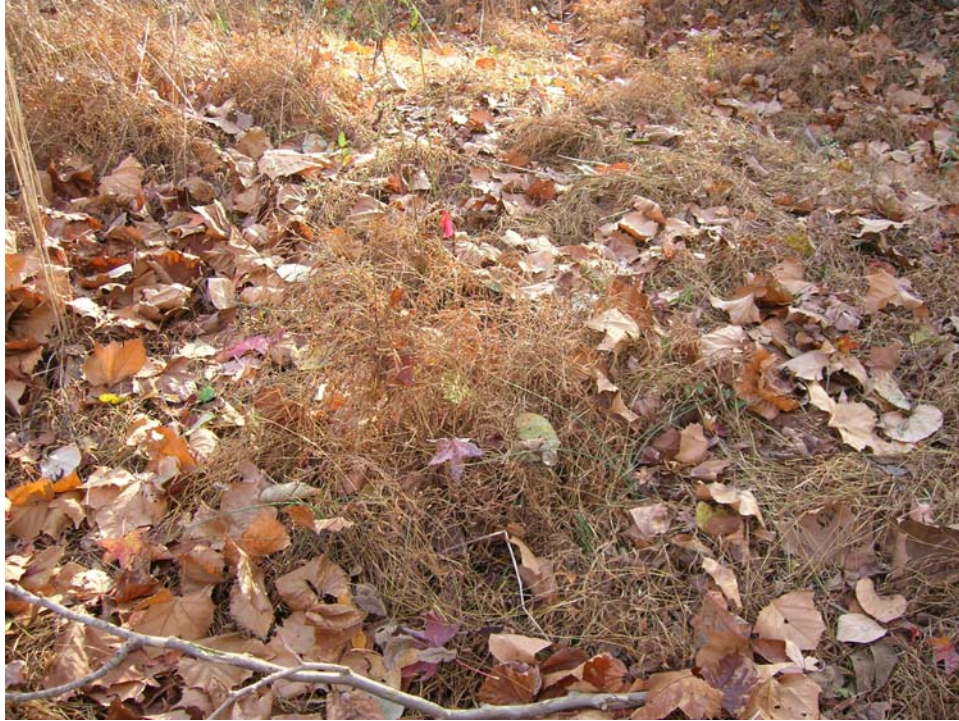
Photo 9-11: Site 5 - Privet outbreak on top of bank (about 15 stems). All appear to be 2 to 3 years old. Microstegium sp. (70-100% coverage) on entire left descending floodplain. Bare bench on left descending side.

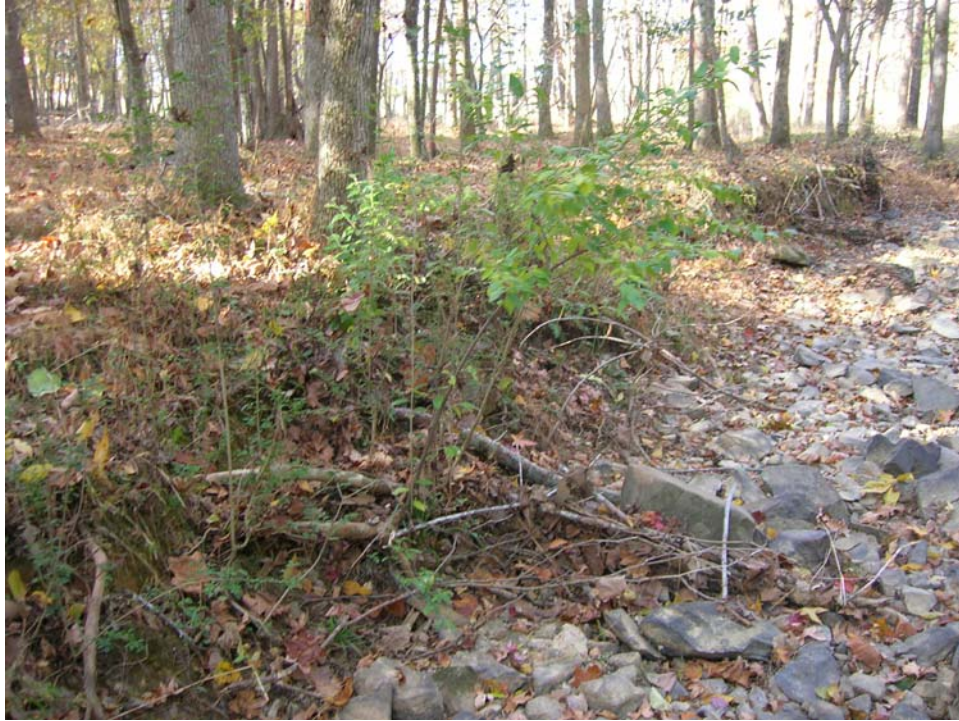
Photo 12

Photo 12: Site 6 - Small outbreak of privet (5-10 stems) and a few blackberry stems on banks and top of banks

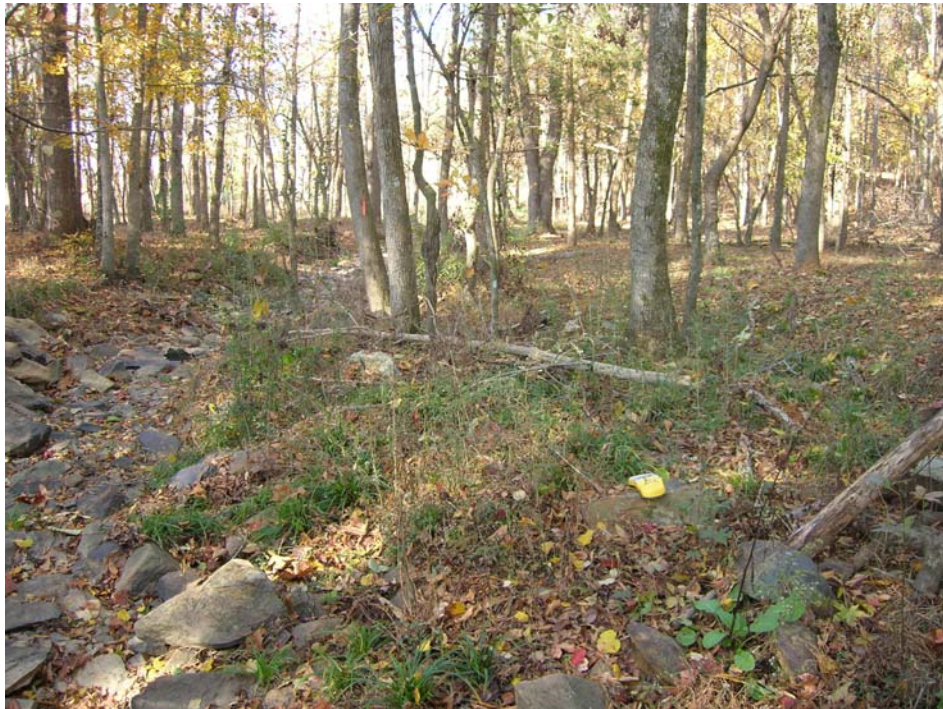
Photo 13

Photo 13: Site 7 - Privet outbreak (about 30 stems) on banks and large bench. All appear to be between one and two years old.

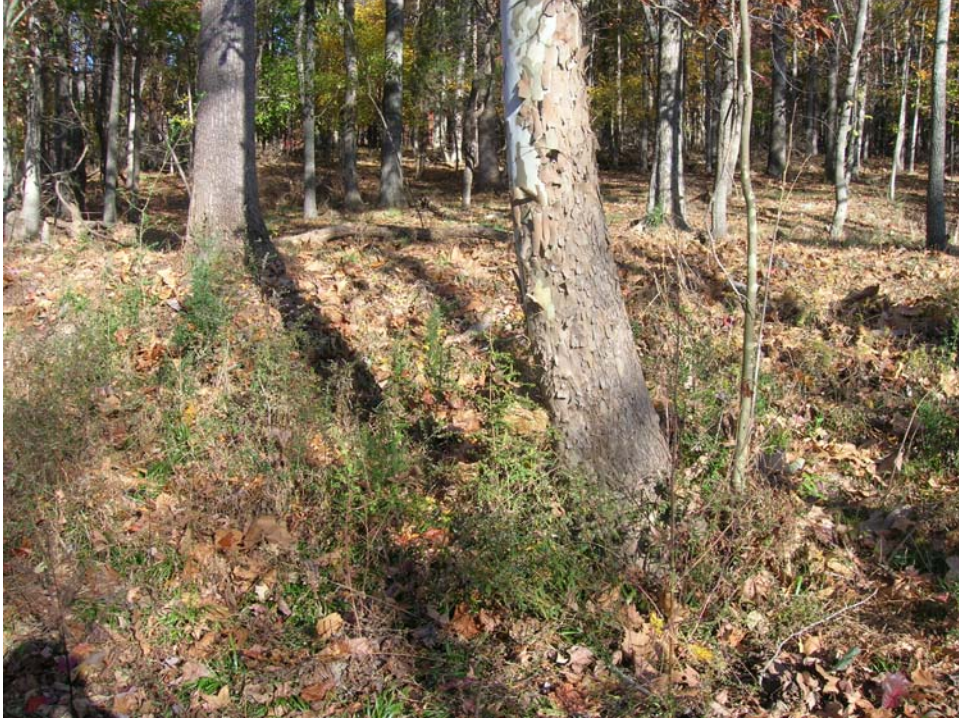
Photo 14

Photo 14: Site 8 – Privet outbreak (around 20 stems) on bench and banks. All appear to be between one and two years old.

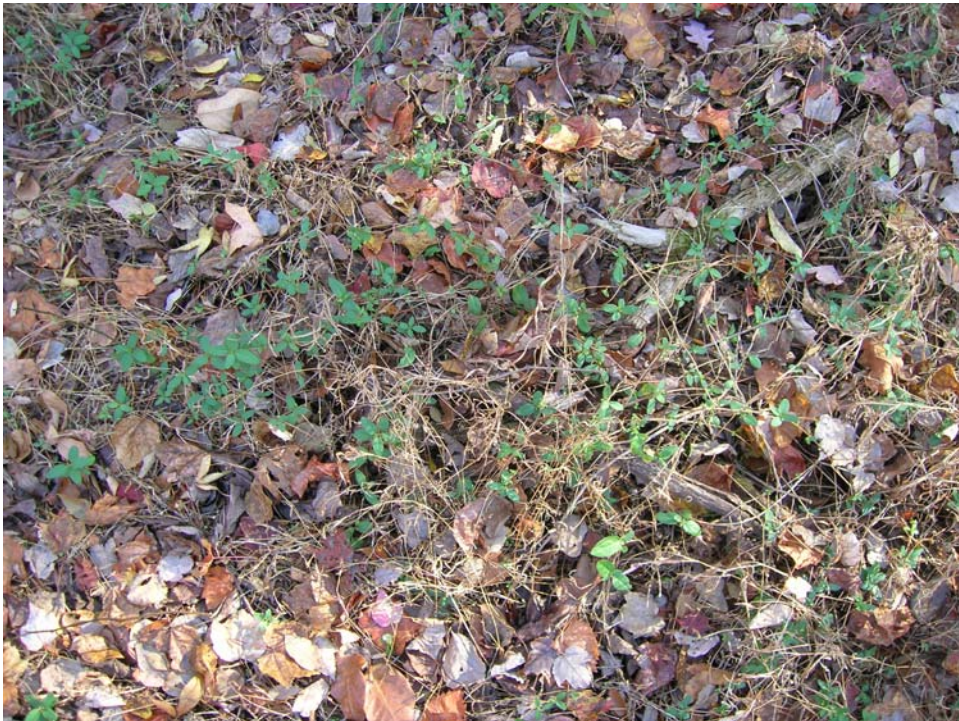
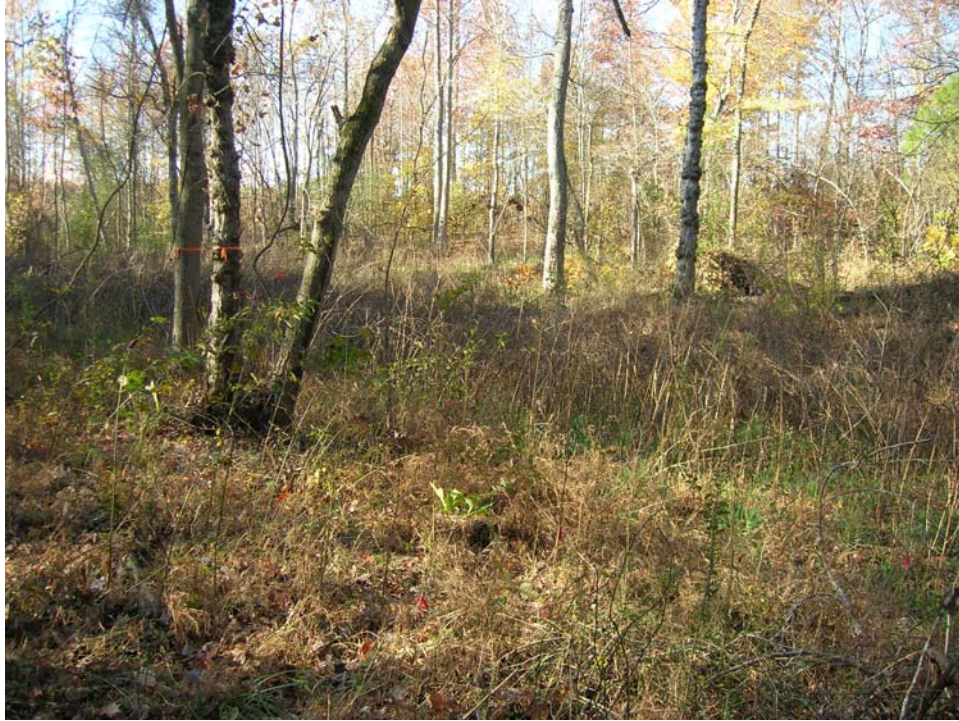
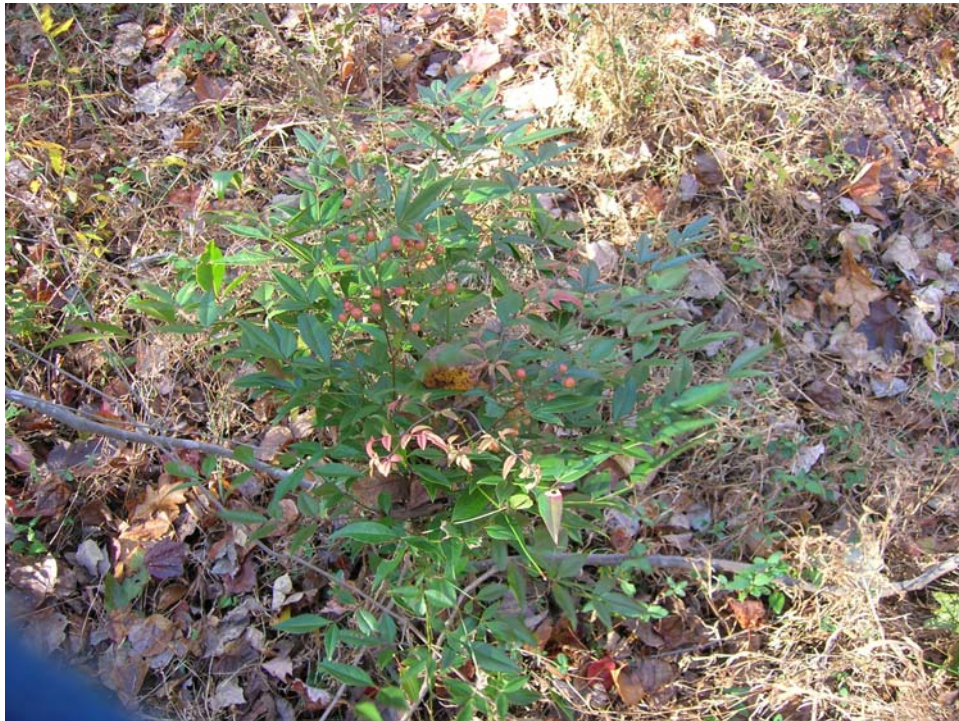
Photos 15-17: Site 9 – Significant outbreak of blackberry (about 15 stems) and privet (about 20 stems) in floodplain. All appear to be less than one year old. Japanese honeysuckle is the dominant herbaceous plant. Microstegium is dominant as well. One Japanese lantern as well.

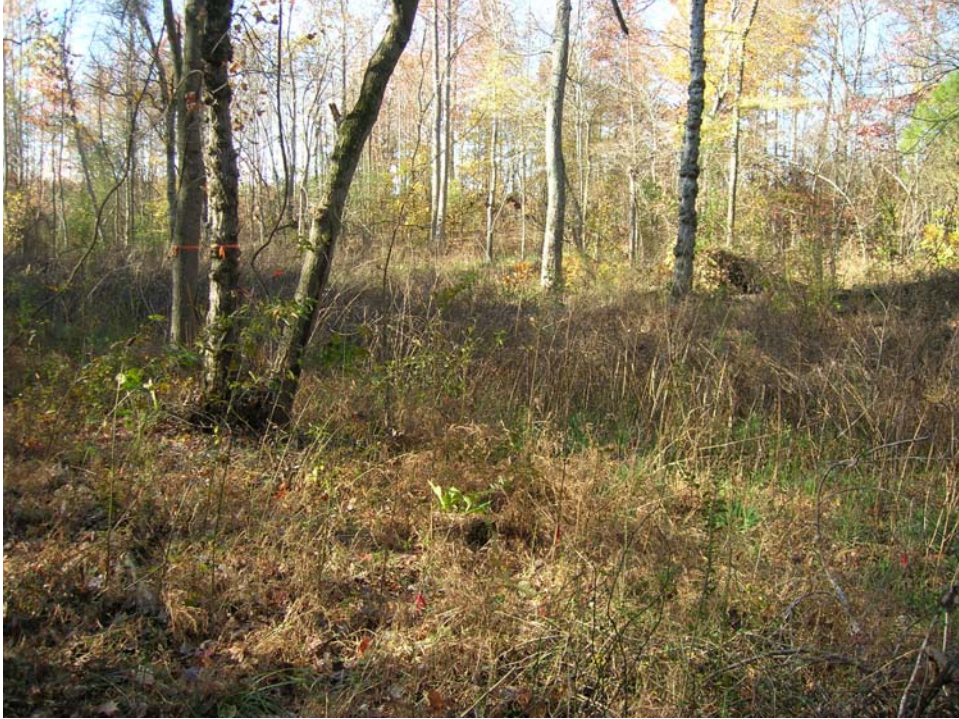
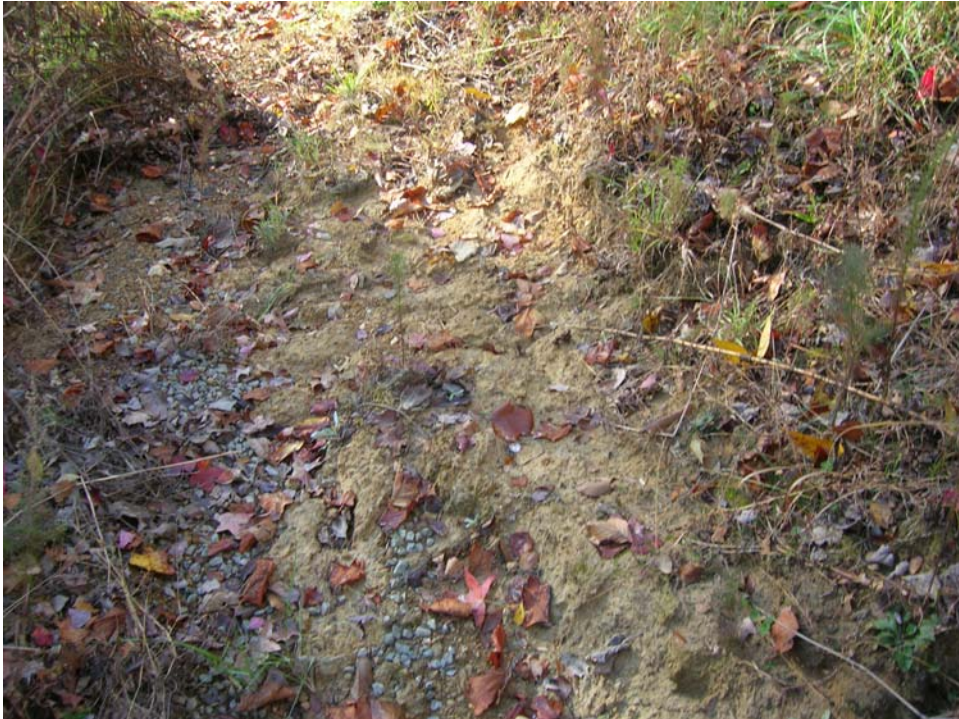
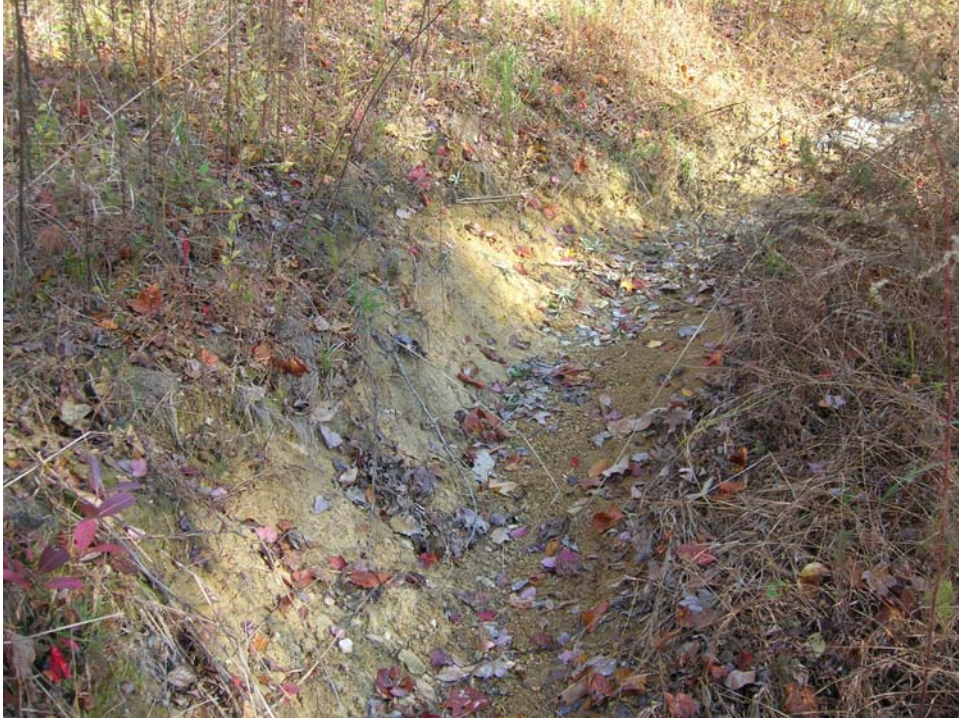
The most significant needs for vegetation repair are on the exposed and eroding banks of Reach 2 (Sites 10a -10d), most likely caused by loss of erosion control fabric and support vegetation prior to plant establishment and growth in early 2007. Of less concern, but as a potential erosion risk, Site 11 is a fairly large area of exposed soil that should be reseeded to prevent: 1) soil loss during flooding events and 2) development of exotics and weedy vegetation. The abundance of autumn olive and Chinese privet is relatively low and does not yet present a threat to planted, volunteer, or pre-existing native vegetation. It may be expected, however, that these species will increase in abundance over time from on and off site seed and vegetative sources. There is a small amount of Fescue growing in the channel of Reach 2. This originated from an upstream seed source.

Photos 18-20: Sites 10a-f – Bare bank and bench at several sites along reach.

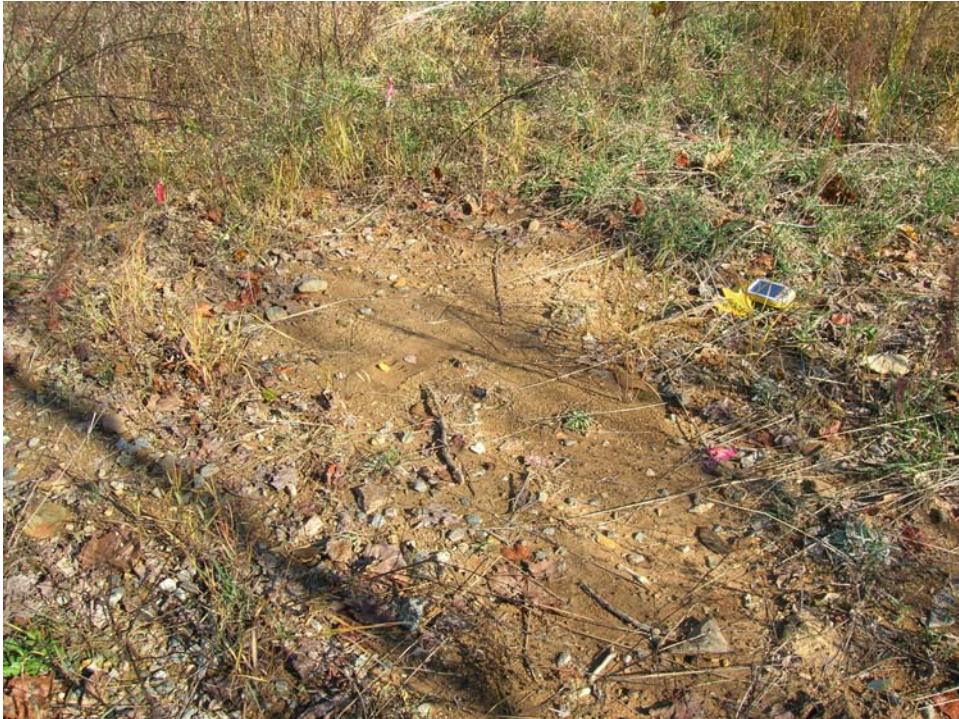
Photo 21

Photo 21: Site 11 – Bare floodplain (about 25 m²) with between 20-100% soil exposure.

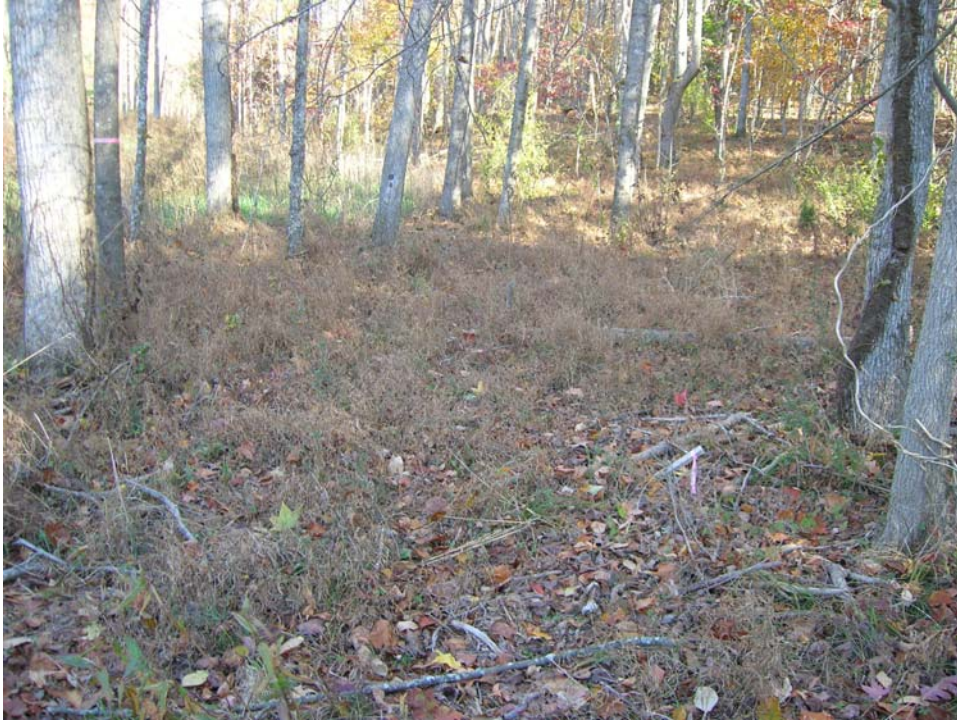
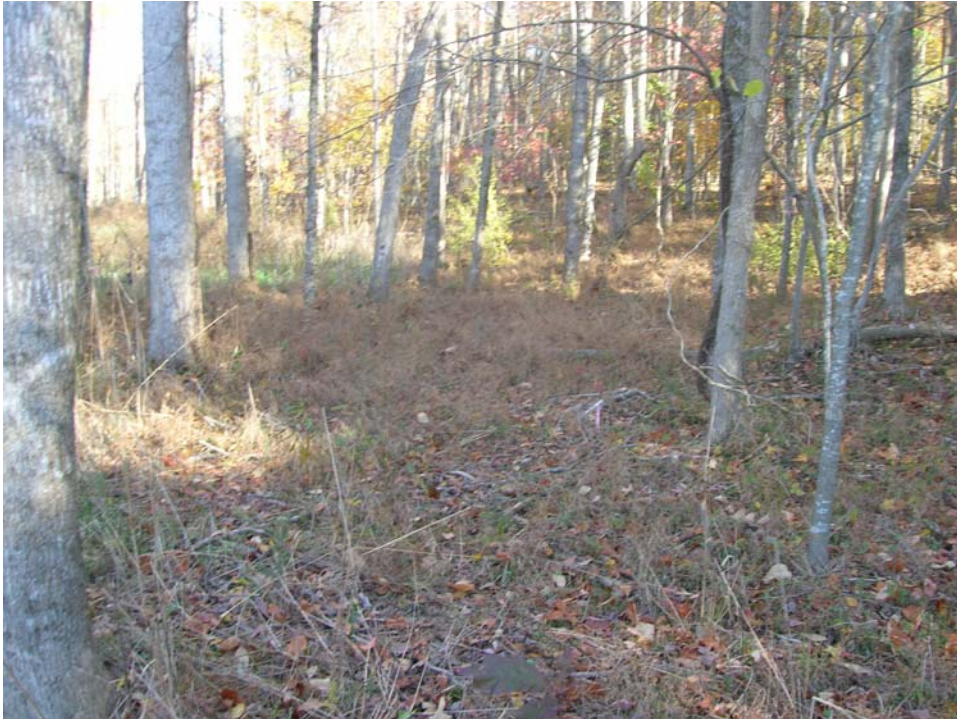
Photos 22-23: Site 12 – Floodplain area (3 meter by 15 metr) that was not planted but has dense *Microstegium* cover (approx. 80%). Also, Blackberry and privet are present (about 30 stems). Additionally, there are three stems of autumn olive (1-3 years old) present.

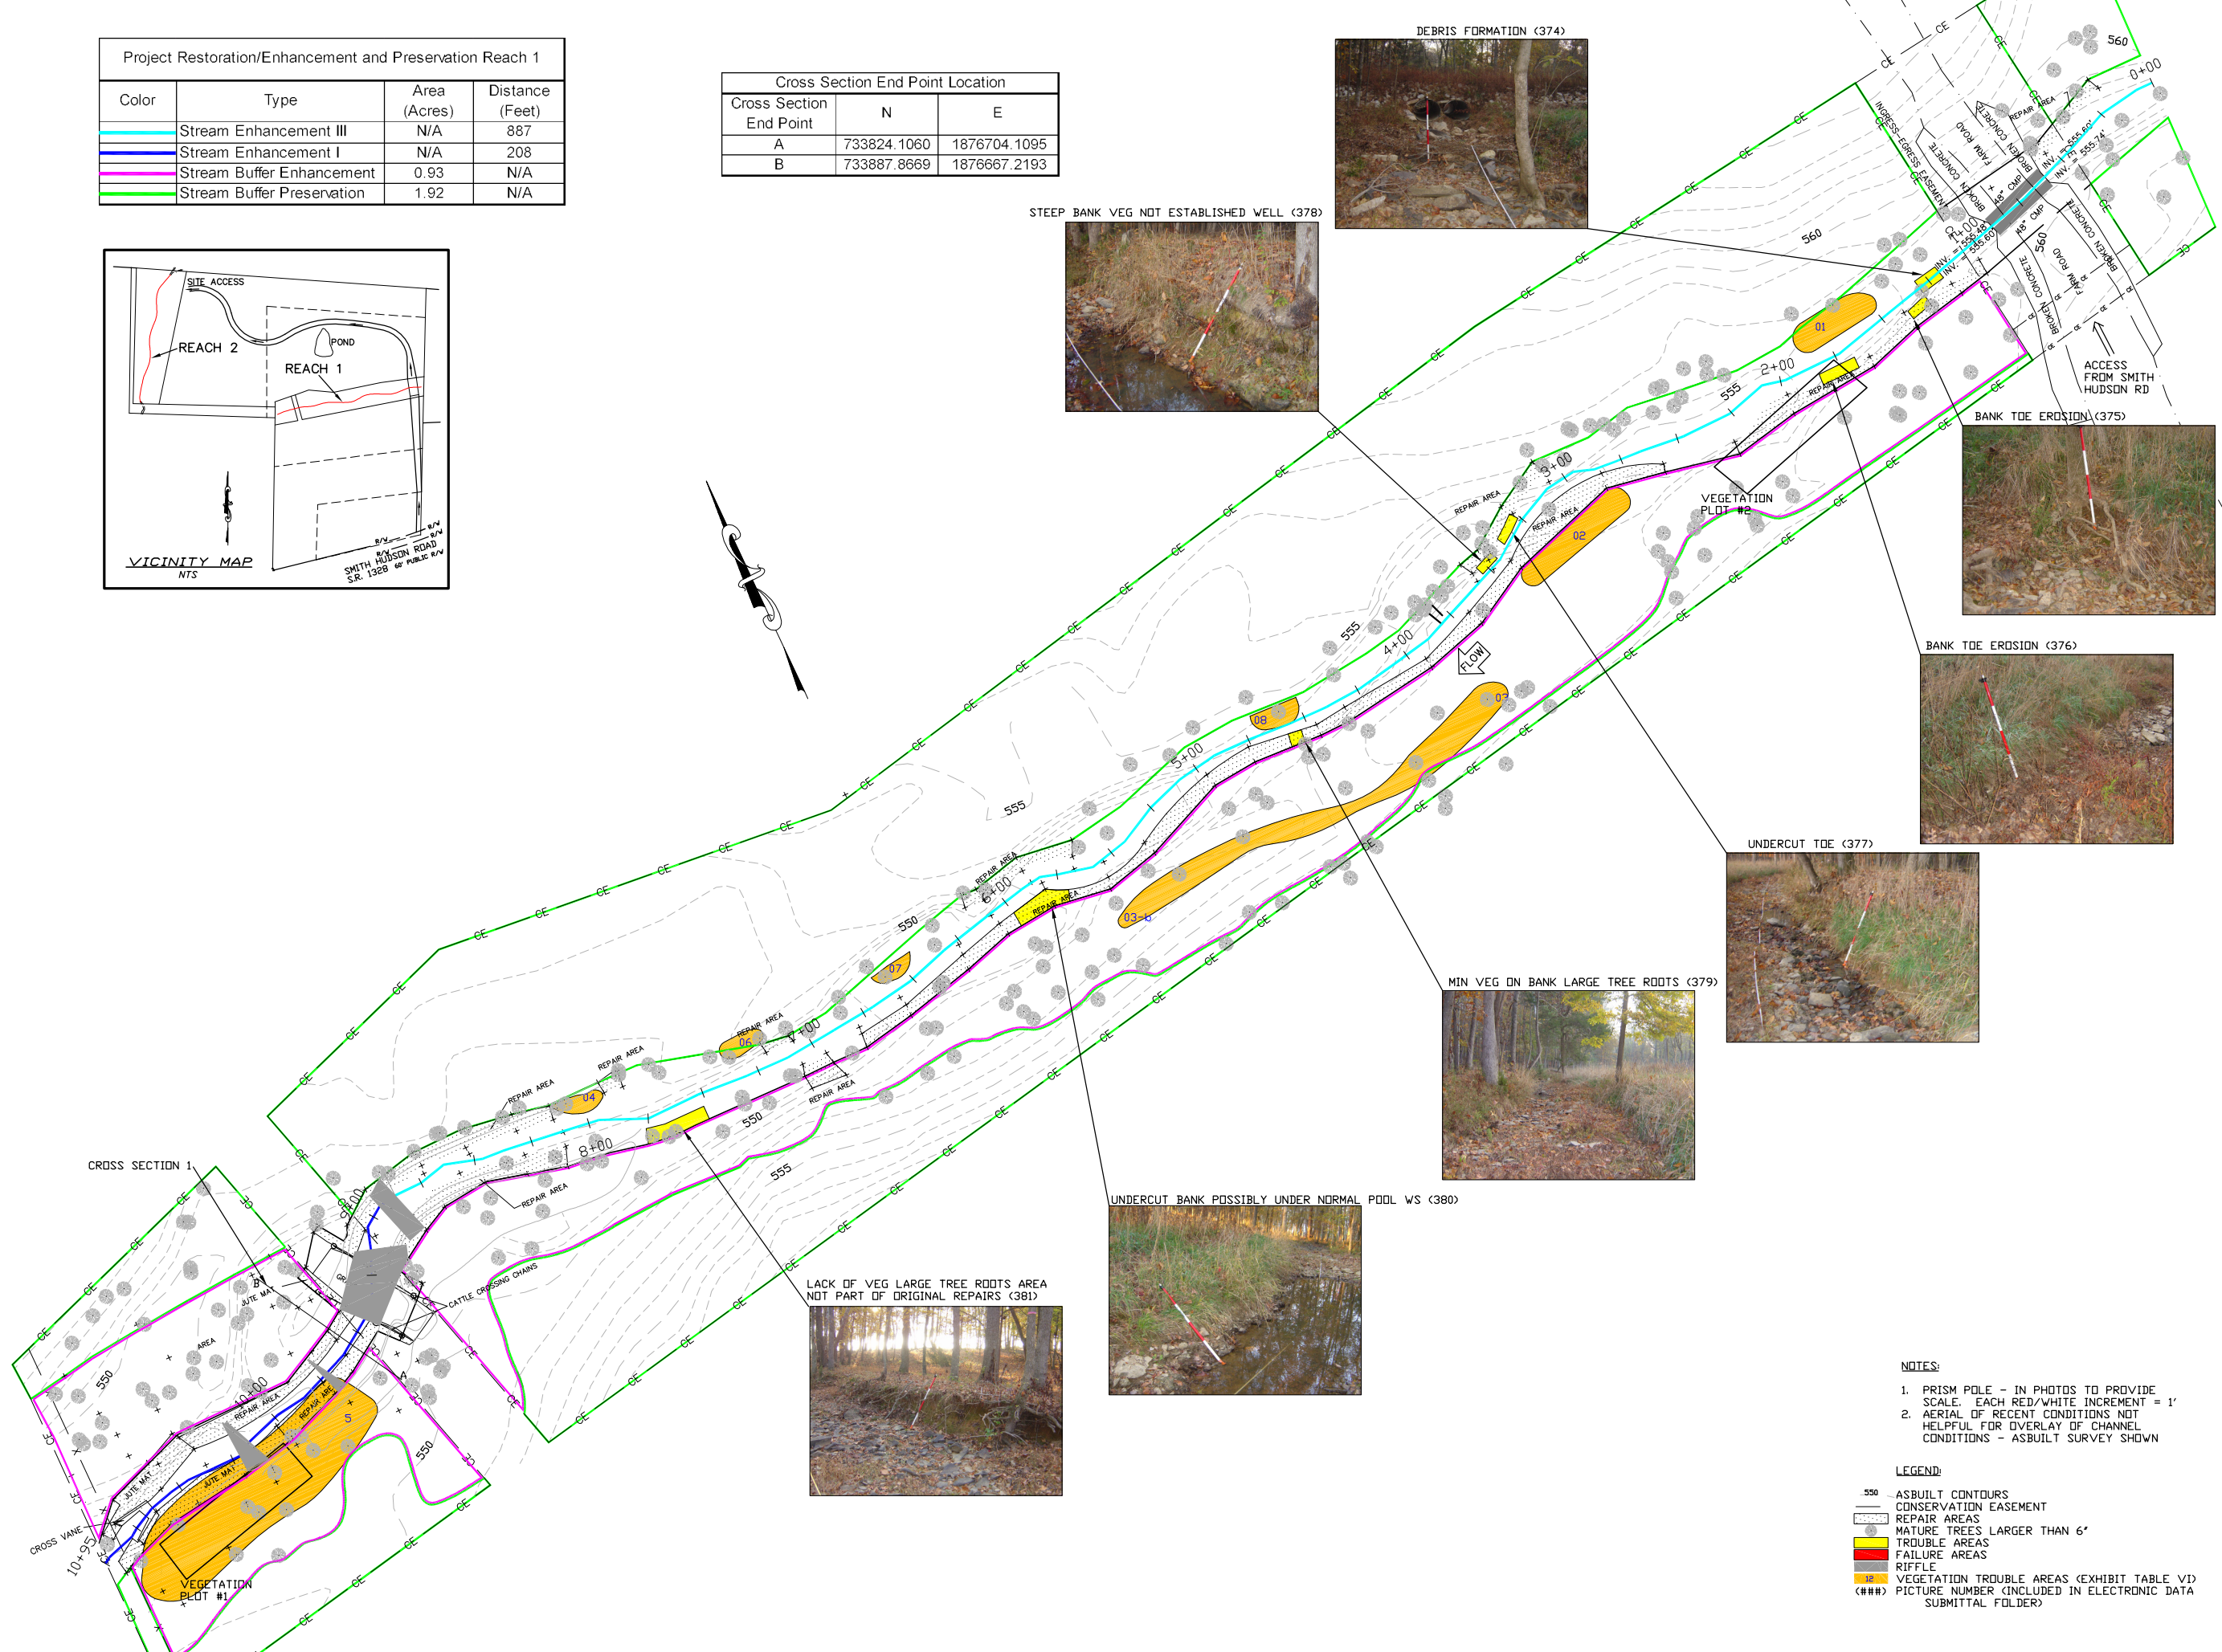
**SMITH TRACT REACH 1
 CURRENT CONDITIONS PLAN VIEW
 YEAR 1 MONITORING**

Reach 1: The overall stream conditions of the bank repairs and re-alignment are holding up very well. There are only a few areas along the stream that have minor toe erosion however the upper banks in these areas are well vegetated. At stream station 7+50 to 7+75 (photo 381) the bank is very vertical with large tree roots. This area was not part of the original repairs to the stream bank and the extensive tree roots in this area have stabilized the bank. All areas noted in Reach one have been identified as trouble areas that warrant future monitoring.

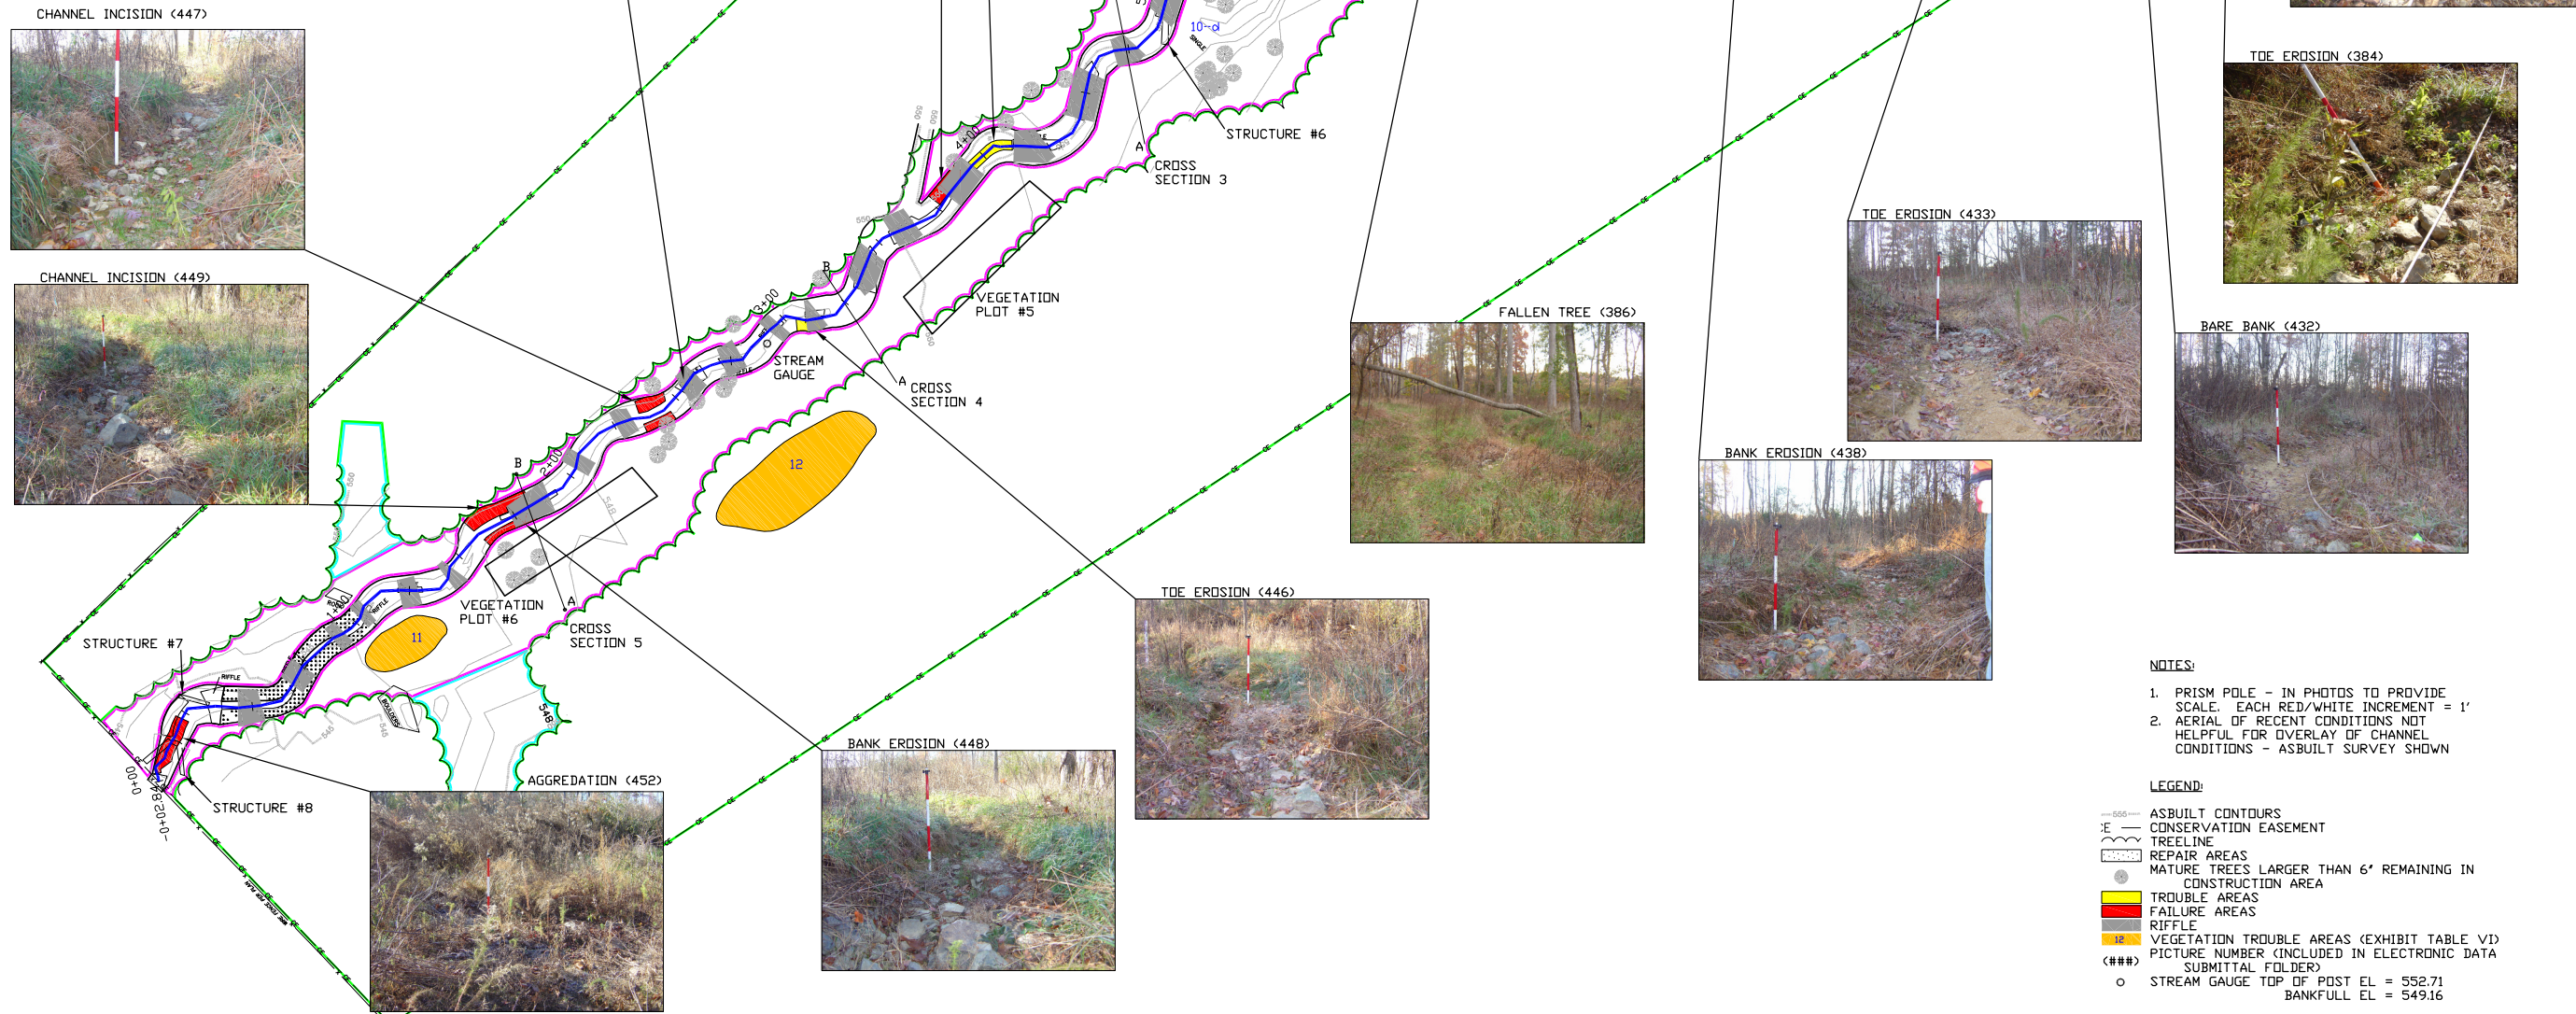
**SMITH TRACT REACH 2
CURRENT CONDITIONS PLAN VIEW
YEAR 1 MONITORING**

Shortly after construction was completed the adjacent property owner to the west cleared his entire property. A tributary from this property enters Reach 2 at stream station 3+70. Two locations downstream have experienced channel incision as illustrated in photographs 447 and 449. The channel has become narrower and deeper. At the end of Reach 2 the land owner below the project constructed a road and installed an 18" pipe in the channel. This restriction has caused aggregation of the channel for a distance of approximately 23 feet. The rock cross vane structure is currently buried in sediment. Ms. Melonie Allen the EEP project manager is currently in the process of obtaining an easement from Mr. Pike to allow the replacement of the current 18" pipe with a 36" pipe. This 36-inch pipe will have sufficient capacity to pass the bankfull storm event. As a part of the pipe retrofit the channel incision at stations 1+60 – 1+80 and station 2+35 to 3+45 will also be addressed for repairs.
