**UT ROCKY RIVER (SMITH TRACT) STREAM RESTORATION – NCEEP
Project #402**

2008 FINAL MONITORING REPORT – YEAR 2

**CONDUCTED FOR THE NORTH CAROLINA DEPARTMENT OF ENVIRONMENT
AND NATURAL RESOURCES**

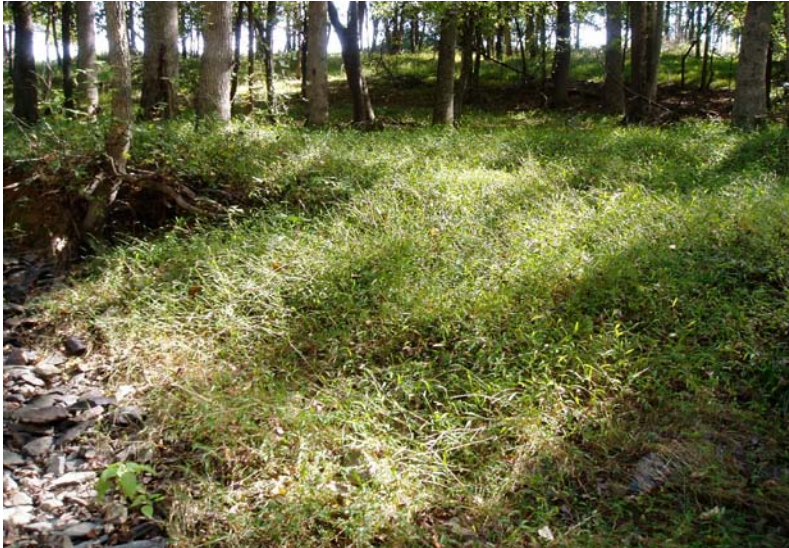
Problem	Station	Suspected Cause	Photo
Reach 1			
Non-native species (<i>Microstegium vimineum</i>)	175-235	Wet floodplain soils in the less shady areas	VP1
Bare soil on floodplain	300-325	Area of compacted soil near stream	VP2
Non-native species (<i>Microstegium vimineum</i>)	400-625	Wet floodplain soils in the less shady areas	VP1
Non-native species (<i>Microstegium vimineum</i>)	735-1010	Wet floodplain soils in the less shady areas	VP1
Reach 2			
Low planted stem density	75-125	Area on terrace, less contact with water table during drought	
Bare soil	100-120	Area of compacted soil near stream	VP2
Low planted stem density	100-130	Area on terrace, less contact with water table during drought

VP1. *Microstegium vimineum* (10/23/08)

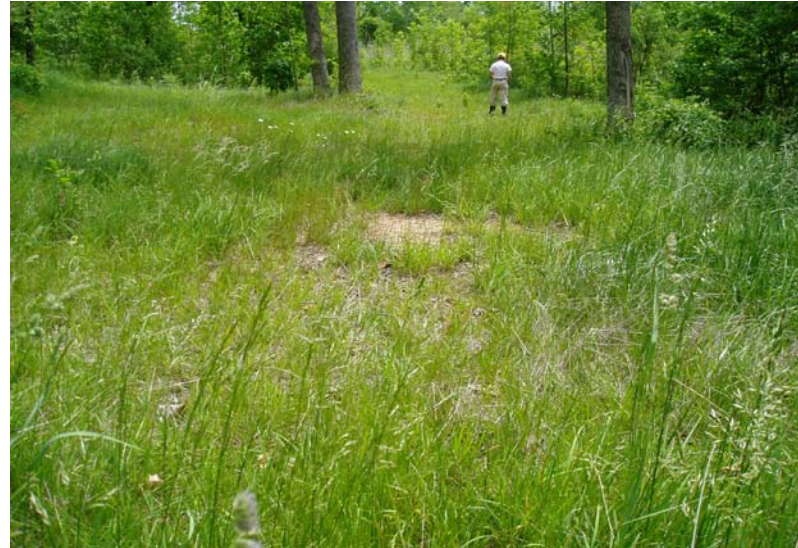
VP2. Bare soil on floodplain(10/23/08)

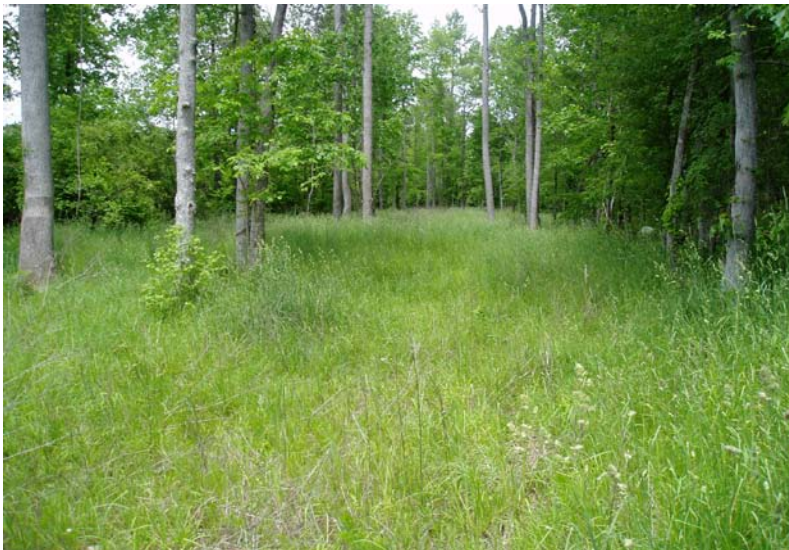
VP3. Low planted stem density(10/23/08)

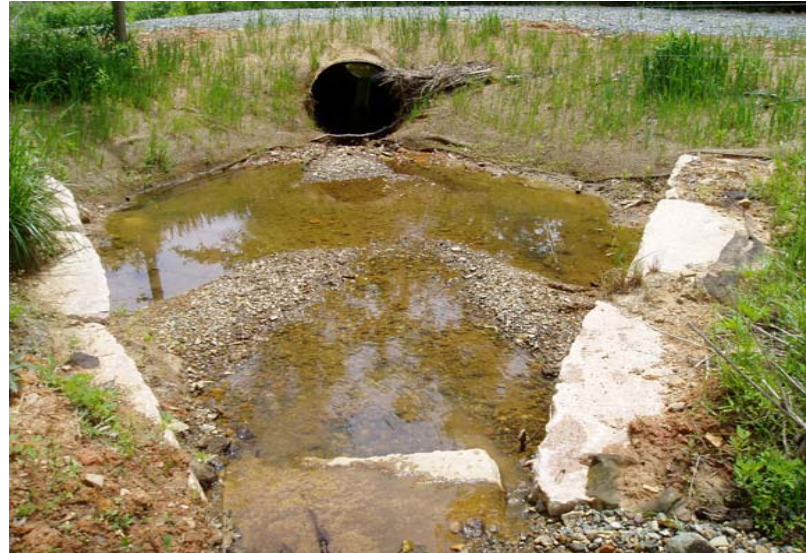
Feature/Issue	Station	Suspected Cause	Photo #
Reach 1			
No problem areas in fall 2008			
Reach 2			
Aggradation (Pool)	15-18	Above and below last structure, deposition due to previously existing pipe restriction	SP2
Bank Scour	147-165	Un-armored bank	SP4 & SP5
Bank Scour	910-918	Un-armored bank	SP4 & SP5
Exposed Bank	968	Loss of vegetation and resulting erosion	SP6
Exposed Bank	1057	Loss of vegetation and resulting erosion	SP6

SP2 - Aggradation below Cross Vane, Reach 2 (10/23/08)

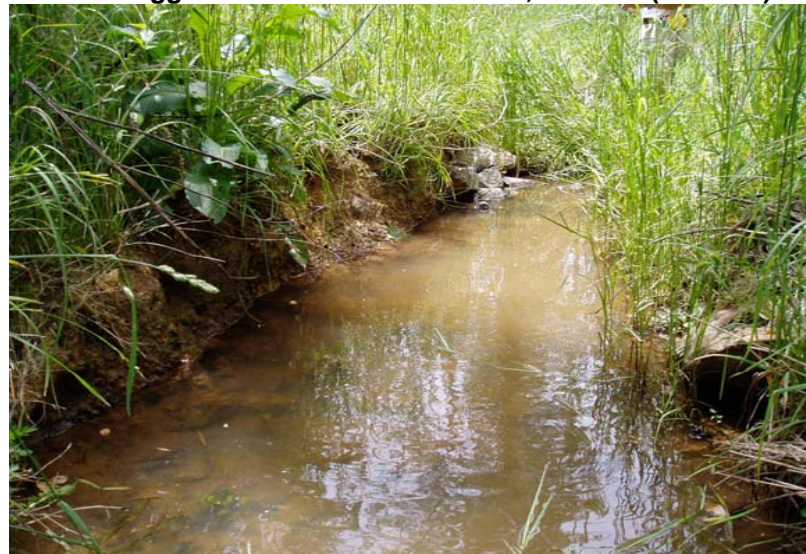
SP4 - Scour, Reach 2 (10/23/08)

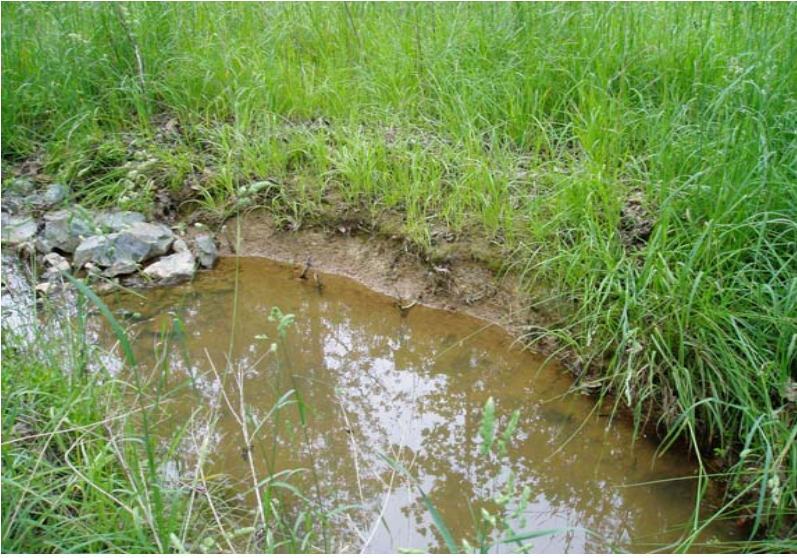
SP5 - Scour, Reach 2 (10/23/08)

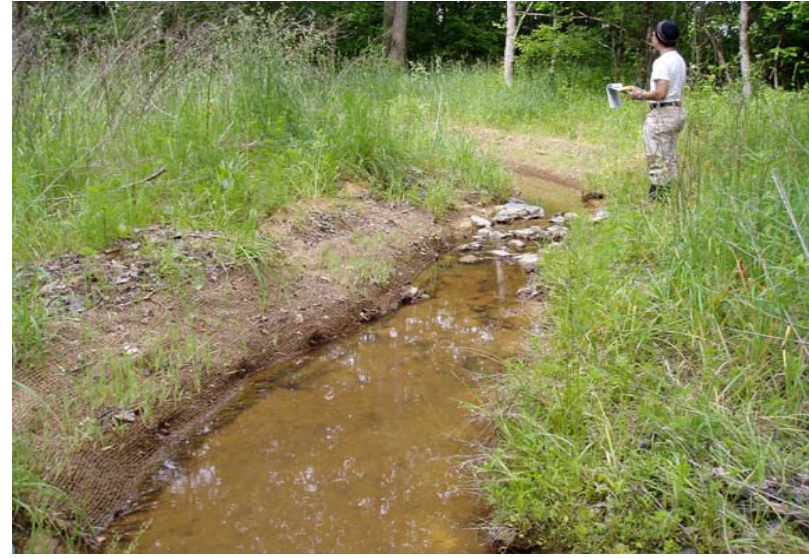
SP6 - Exposed Bank, Reach 2 (10/23/08)
