**UT ROCKY RIVER STREAM RESTORATION – NCEEP Project #402**  
2009 FINAL MONITORING REPORT – YEAR 3

CONDUCTED FOR THE NORTH CAROLINA DEPARTMENT OF ENVIRONMENT  
AND NATURAL RESOURCES

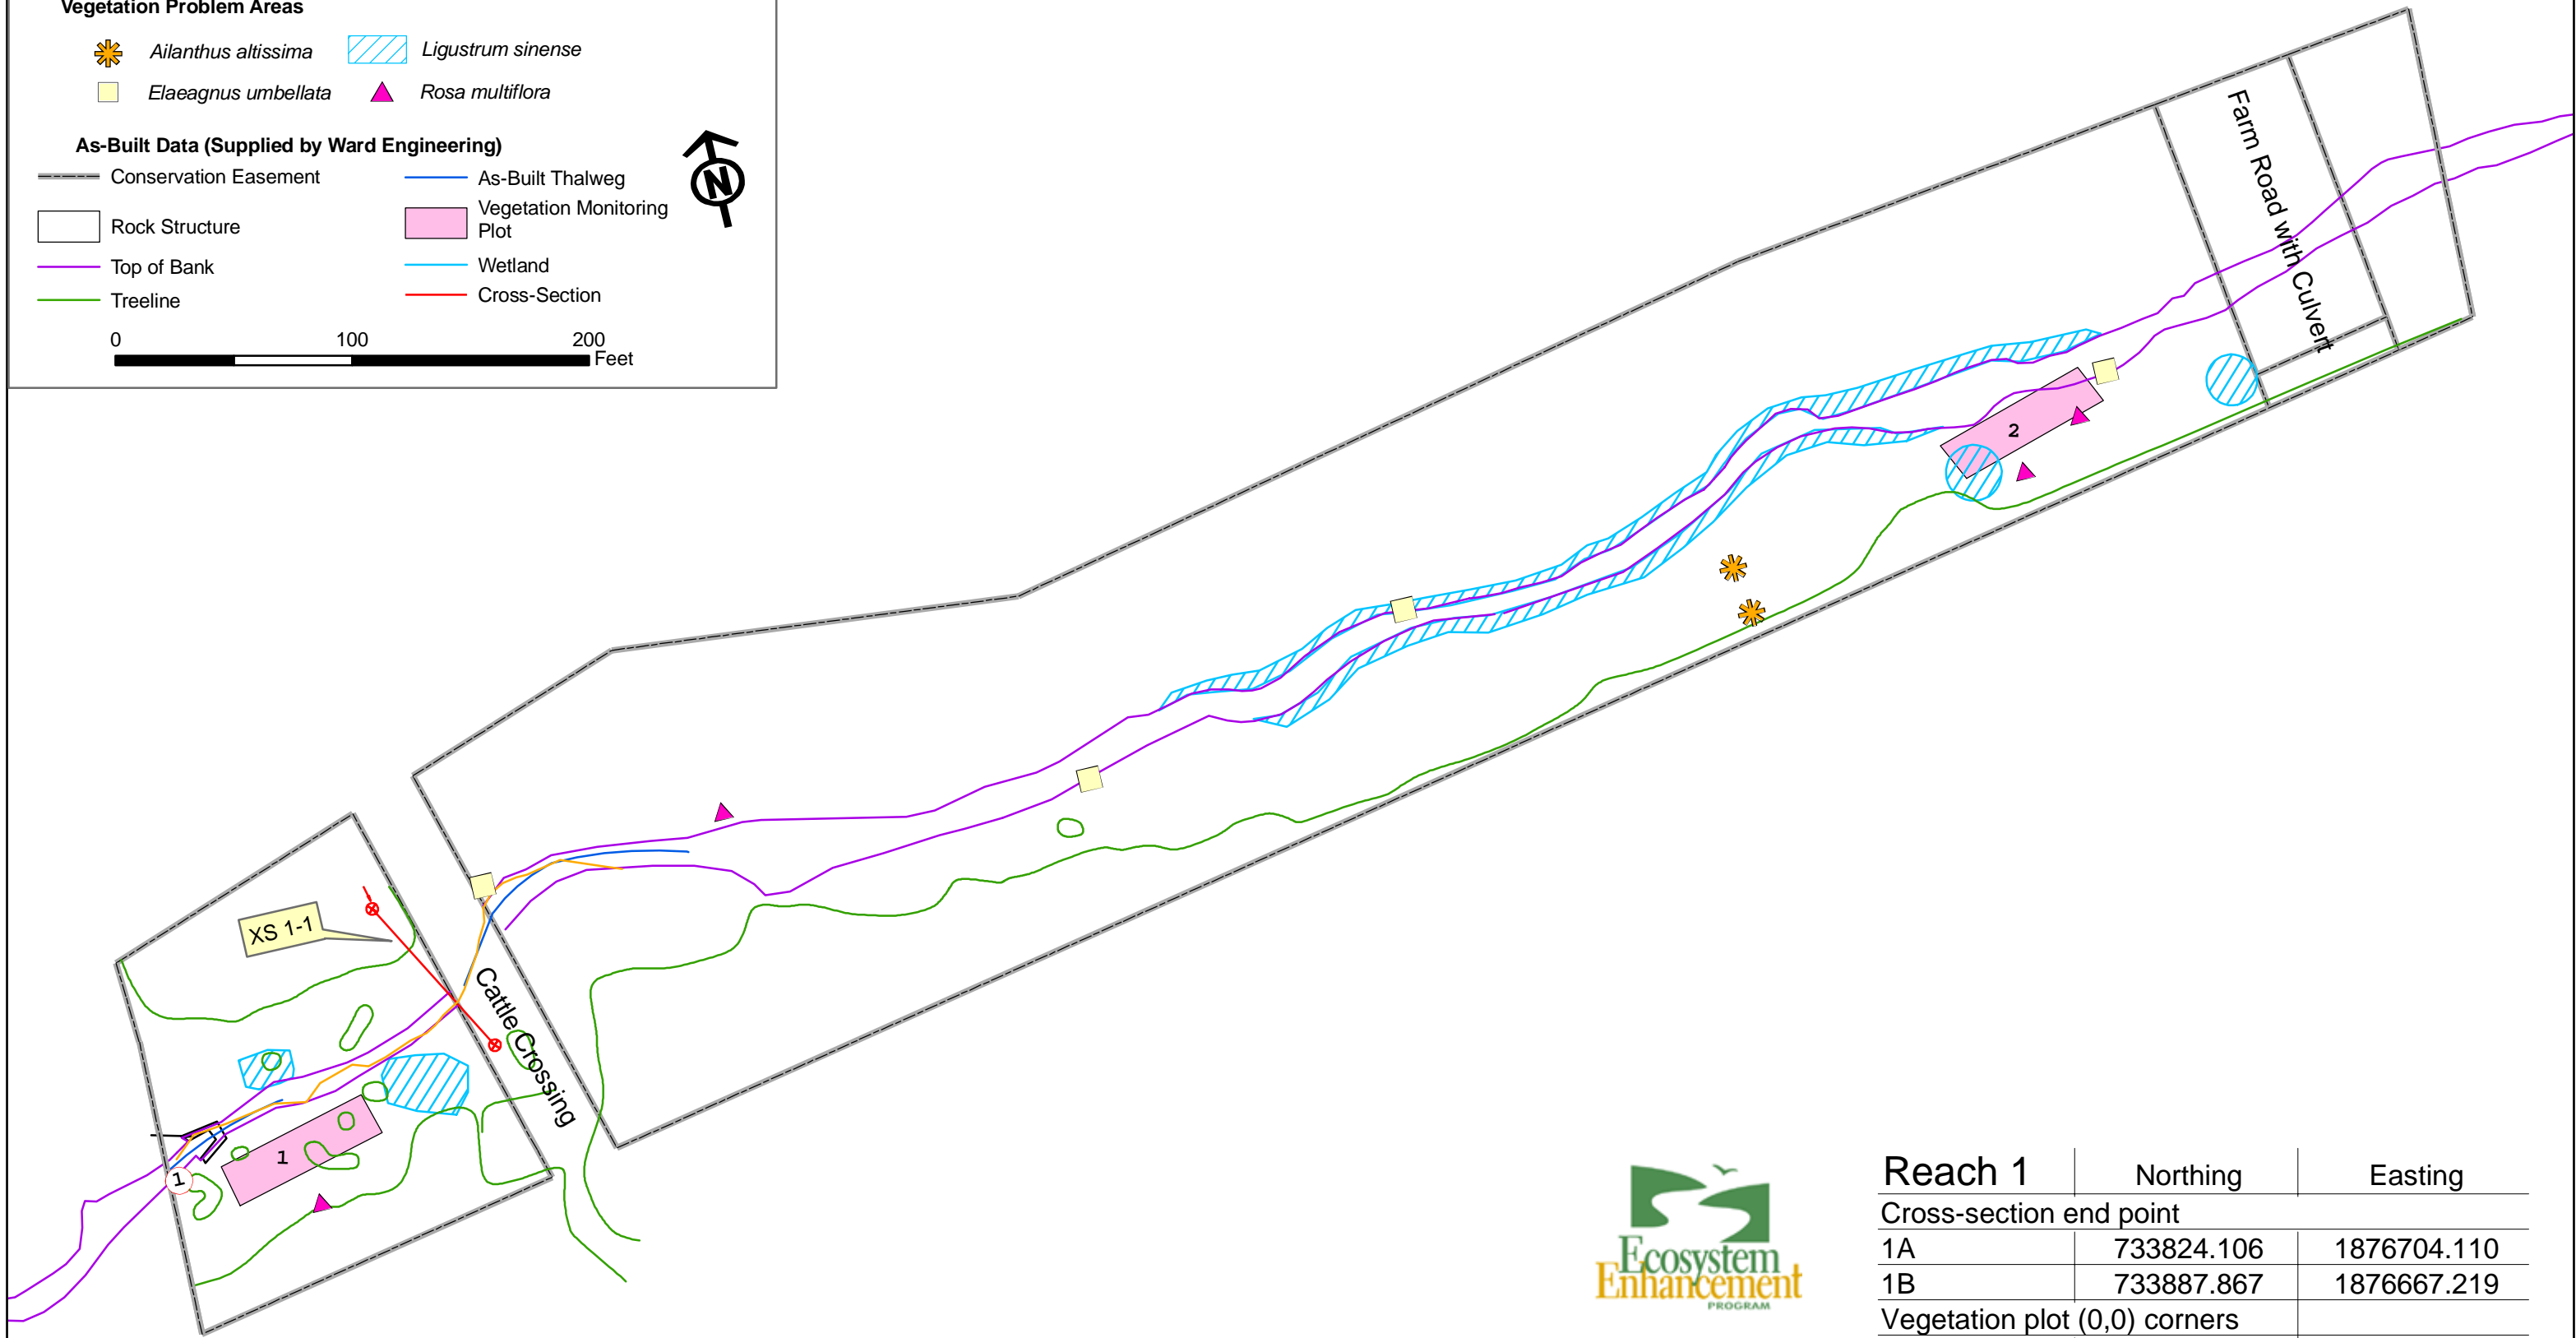
**Figure 2.0. Current Conditions Plan View. Rocky River (Reach 1) - 2009 Chatham County, NC - EEP Project #402**

✱ *Ailanthus altissima*      *Ligustrum sinense*  
  *Elaeagnus umbellata*    ▲ *Rosa multiflora*

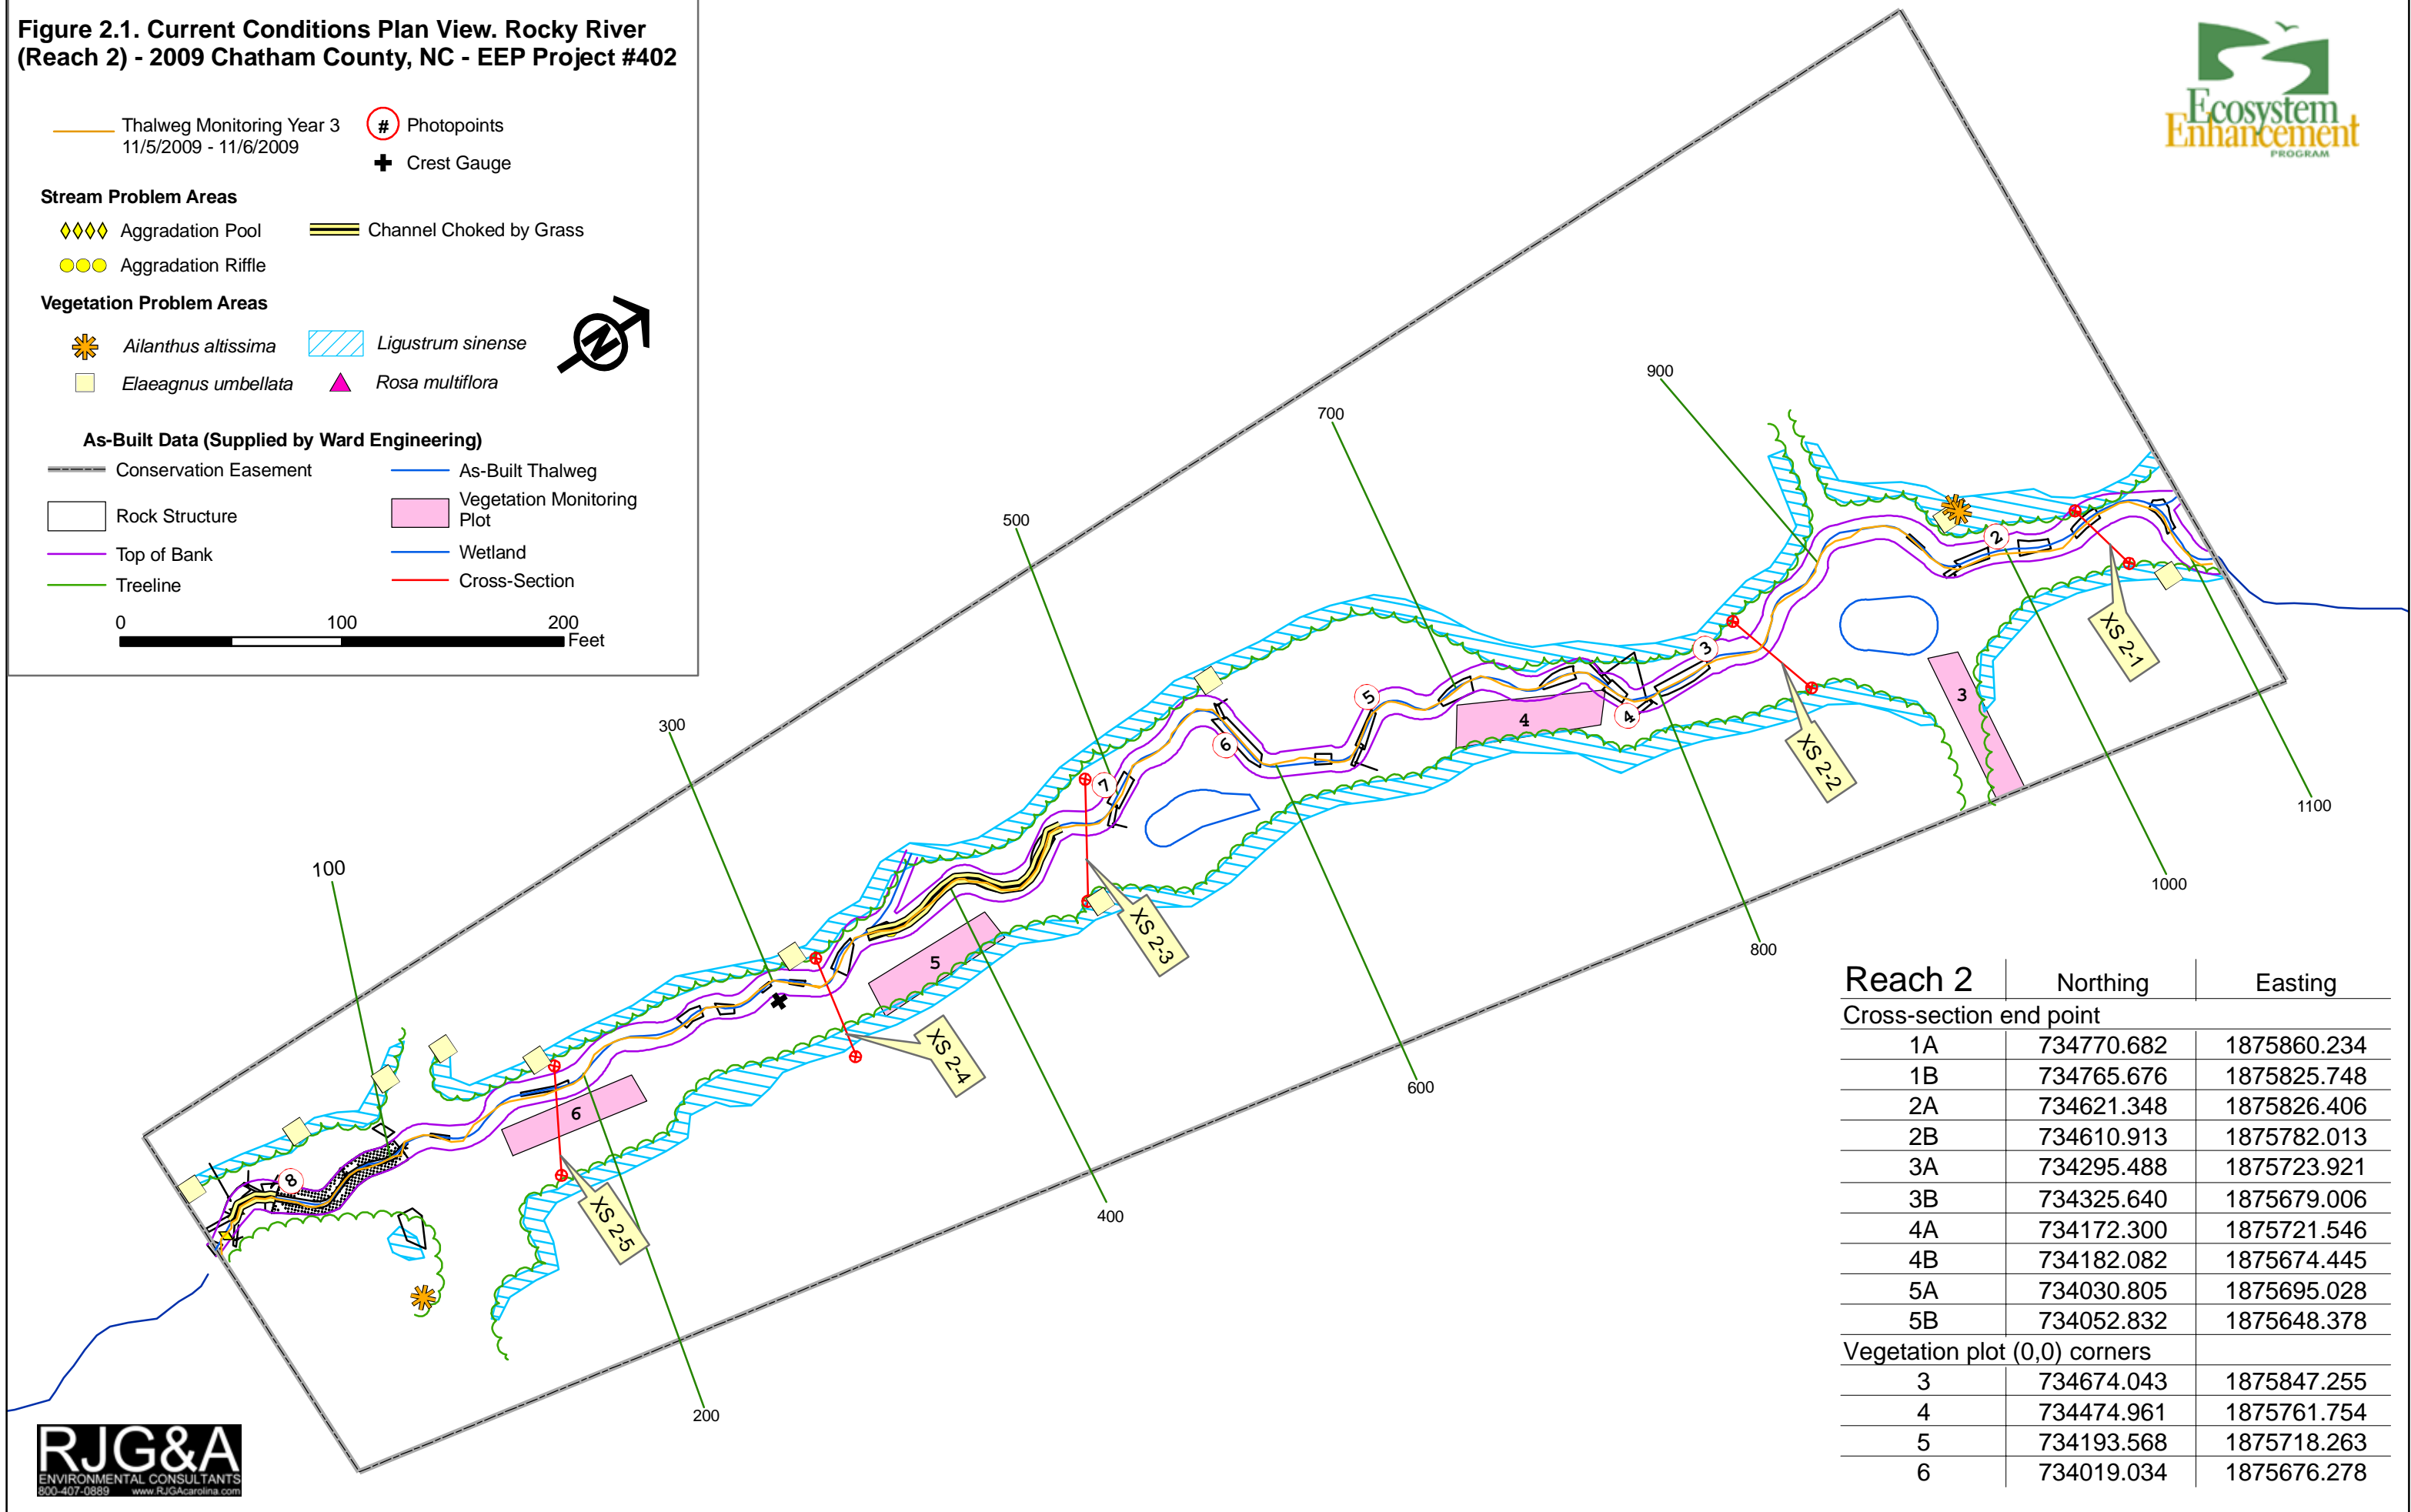
**Figure 2.1. Current Conditions Plan View. Rocky River (Reach 2) - 2009 Chatham County, NC - EEP Project #402**

Aggradation Pool  
Aggradation Riffle  
Channel Choked by Grass

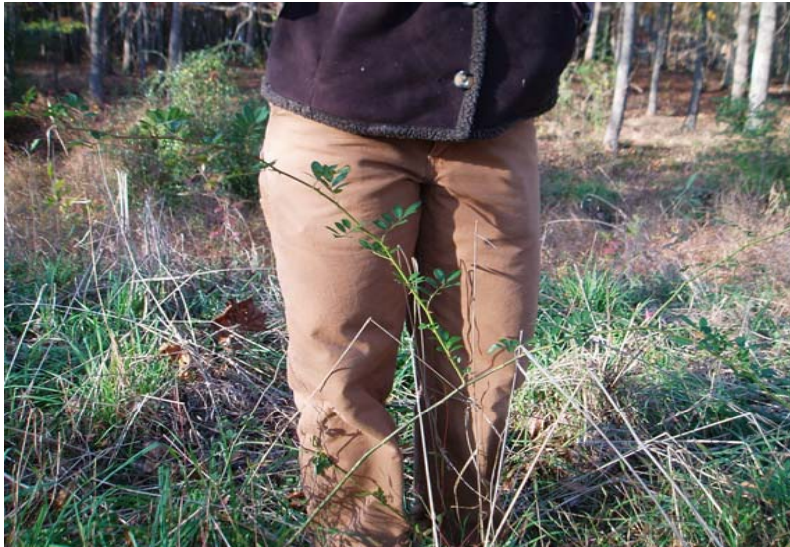
**SP1 - *Rosa multiflora* growing near channel in Reach 1 (11/5/09)**

Feature/Issue	Station	Suspected Cause	Photo #
<b>Reach 1</b>			
Exotic invasive species	Entire Reach	Intruding from forested buffer or off-site seed sources	VP1
<b>Reach 2</b>			
Exotic invasive species	Entire Reach	Intruding from forested buffer or off-site seed sources	VP2 & VP3

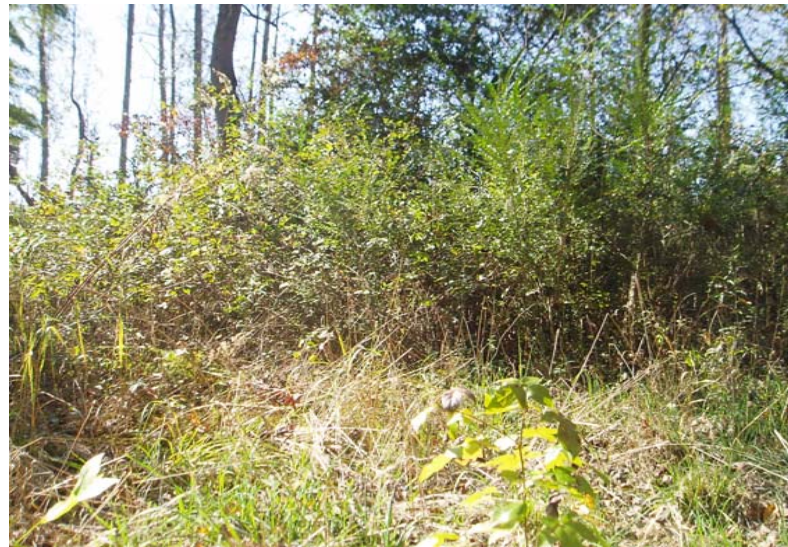
**SP2 - *Ligustrum sinense* growing along forest edge in Reach 2 (11/5/09)**

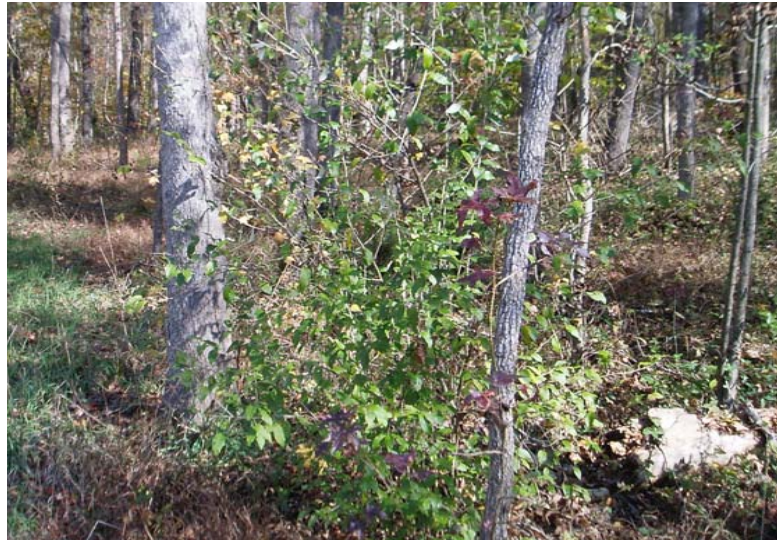
**SP3 - *Elaeagnus umbellata* at approximately station 470 in Reach 2 (11/5/09)**

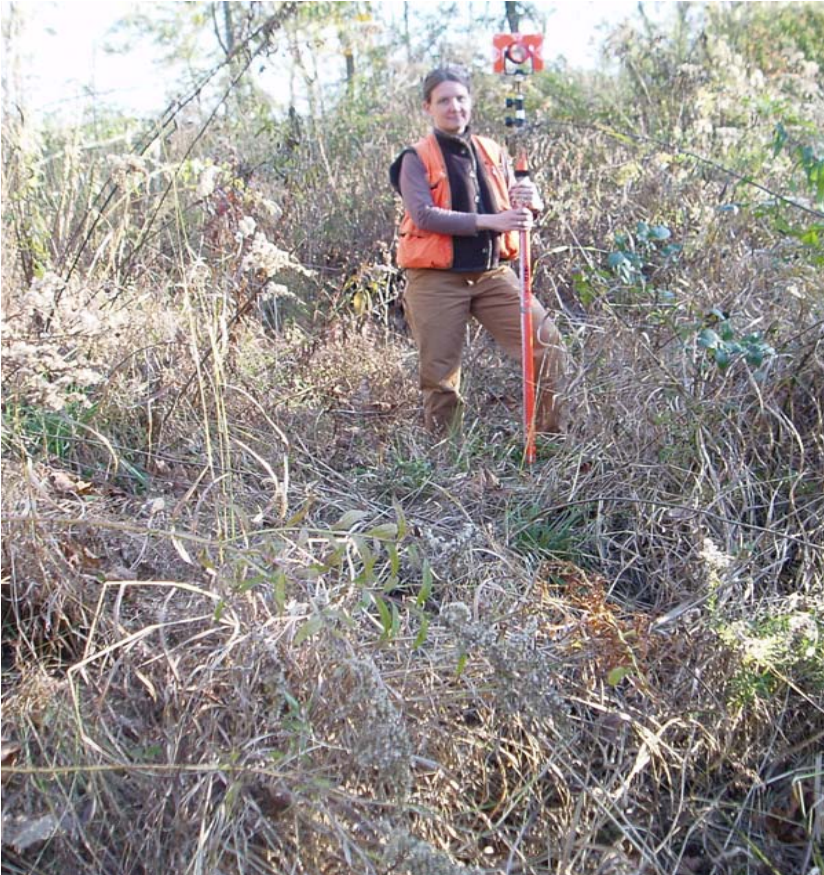
**SP1 - Standing on aggradation mid-channel, just upstream of last cross vane (11/6/09)**

Feature/Issue	Station	Suspected Cause	Photo #
<b>Reach 1</b>			
No problem areas in fall 2009			
<b>Reach 2</b>			
Aggradation (Pool)	15-18	Above and below last structure, deposition due to previously existing pipe restriction	SP1
Channel Choked by Terrestrial Grass	13-40	Insufficient flow	SP2
Channel Choked by Terrestrial Grass	350-460	Insufficient flow	SP3
Aggradation (Riffle)	360-367	Insufficient flow	SP

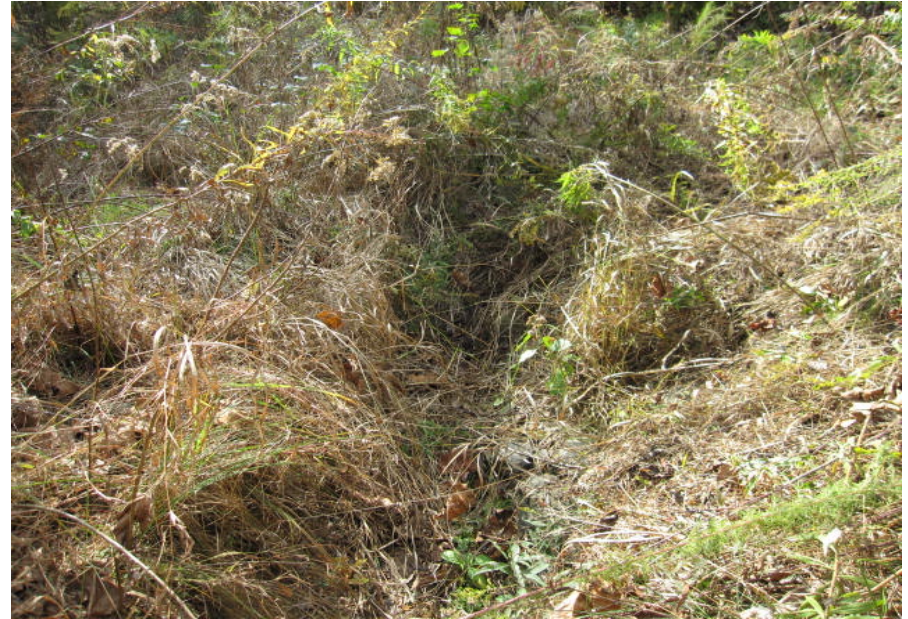
**SP2 - Terrestrial grass growing in channel, Reach 2 (10/29/09)**

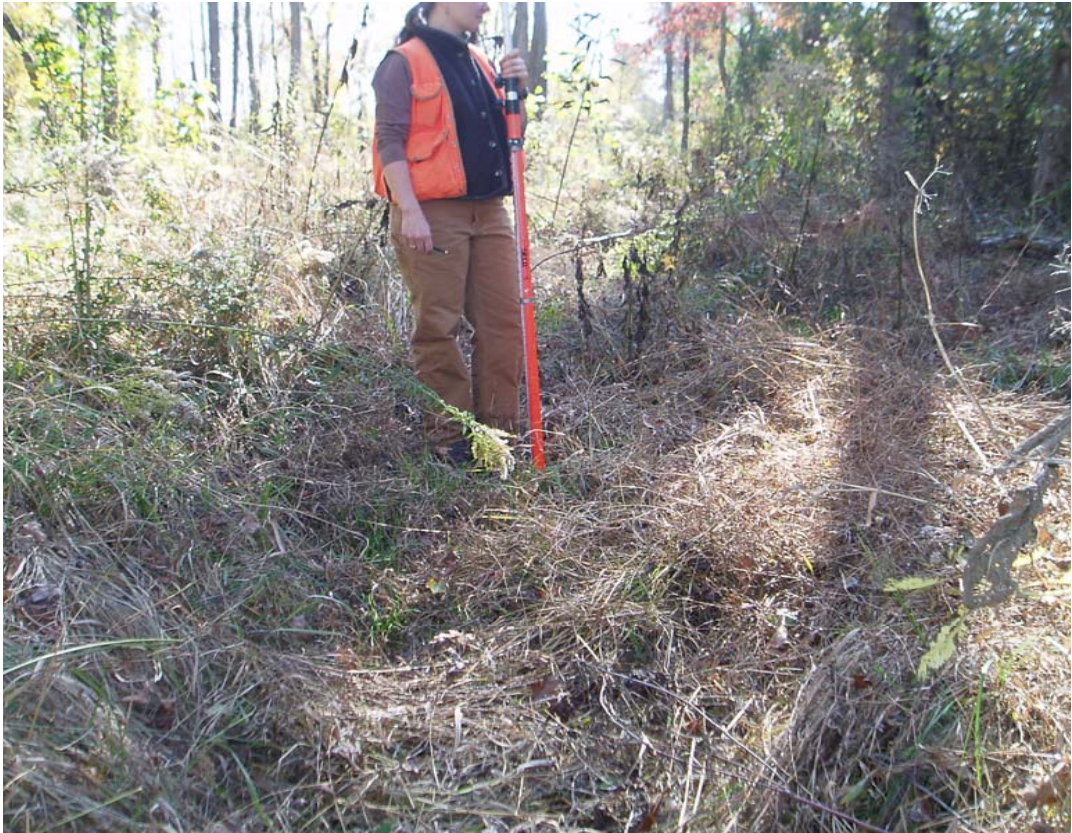
**SP3 - Standing on riffle aggradation mid-channel at approximately Station 370 (11/5/09)**
