UT ROCKY RIVER STREAM RESTORATION – NCEEP Project #402
2011 FINAL MONITORING REPORT – YEAR 5

CONDUCTED FOR THE NORTH CAROLINA DEPARTMENT OF ENVIRONMENT
AND NATURAL RESOURCES

Submitted on February 27, 2012 to:

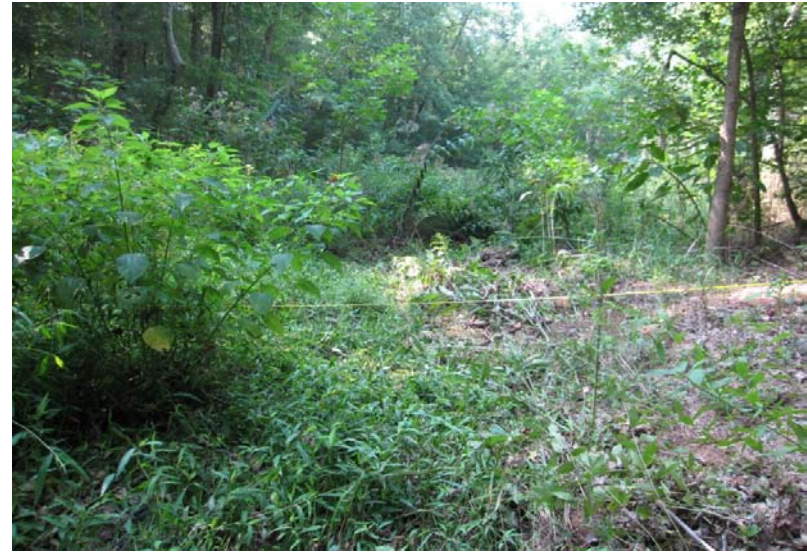
View of XS 2-1 looking downstream

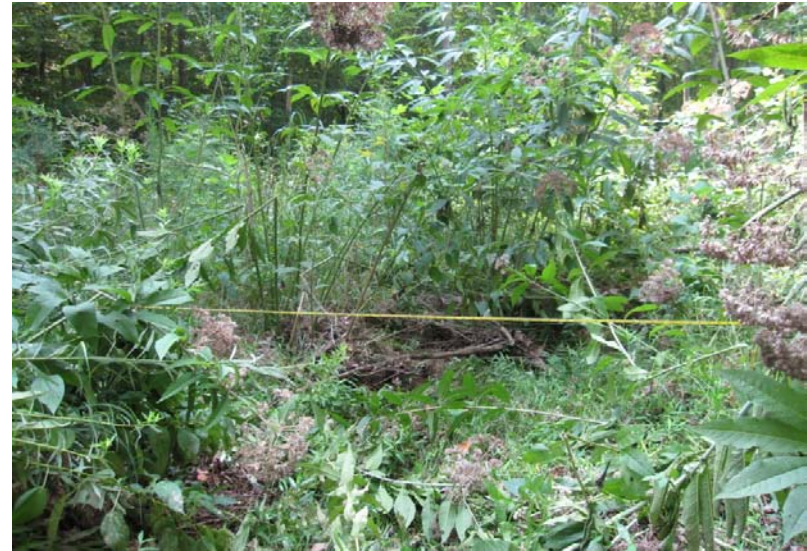
View of XS 2-2 looking downstream

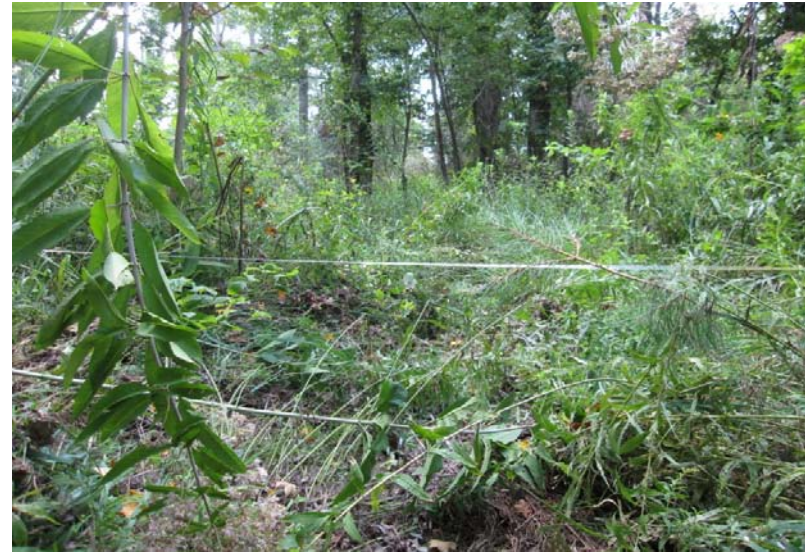
View of XS 2-3 looking downstream
