UT to Sandy Creek
Randolph County, North Carolina

First Year Monitoring Report
State Construction ID: 040611601
USGS HUC 03030003020010
EEP-08030

February 2009

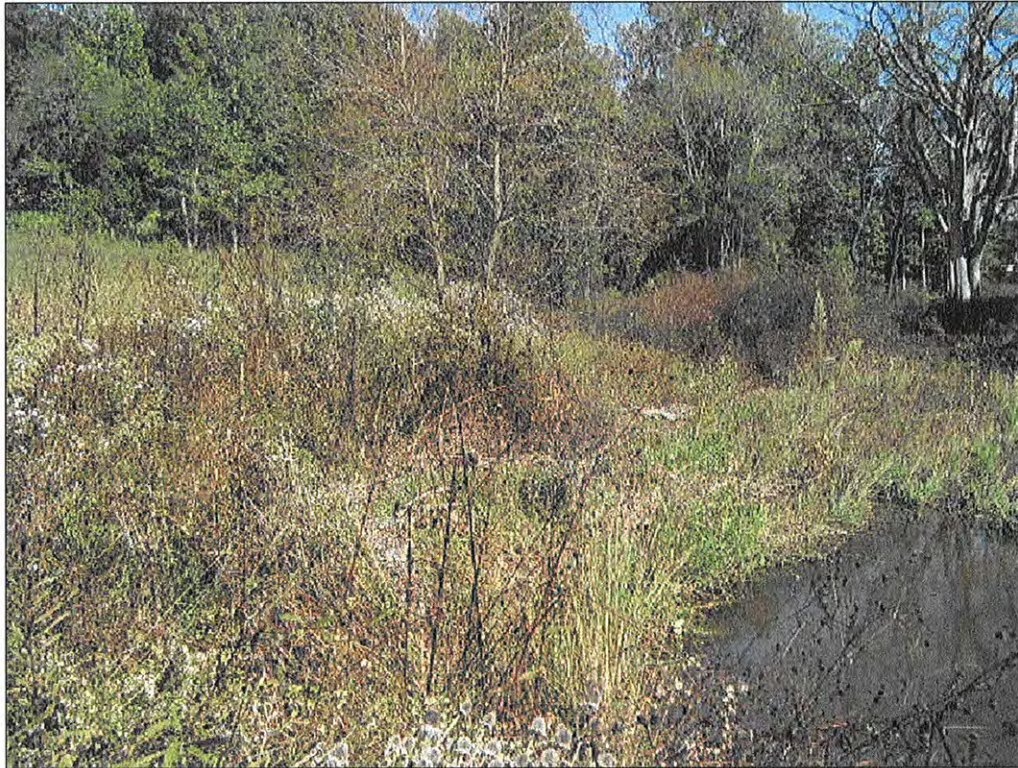
No crest gages are installed at UT to Sandy Creek to document bankfull events. Wrack lines were evident during a site visit in October 2008 indicating at least one bankfull event has occurred.

PHOTOGRAPH 79: WRACK LINES EVIDENT INDICATING BANKFULL EVENT WHICH OCCURRED ON OCTOBER 1, 2008.

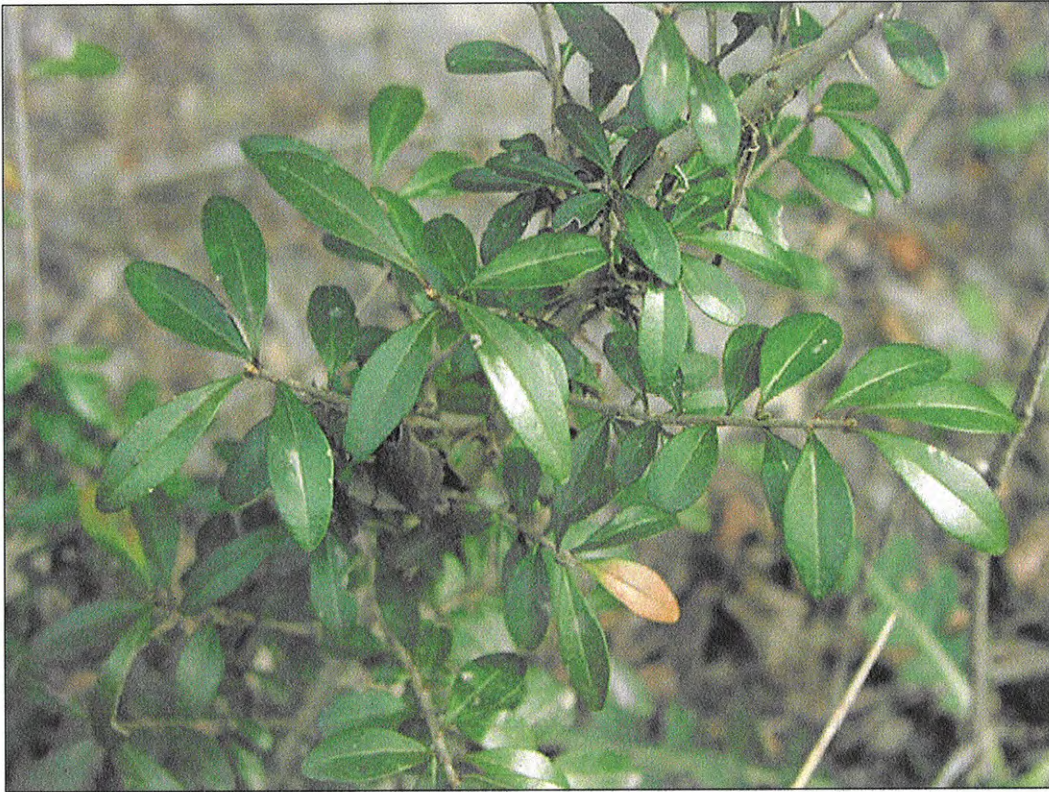
VEGETATION PROBLEM AREA 1: LIGUSTRUM SINENSE ENCROACHMENT.

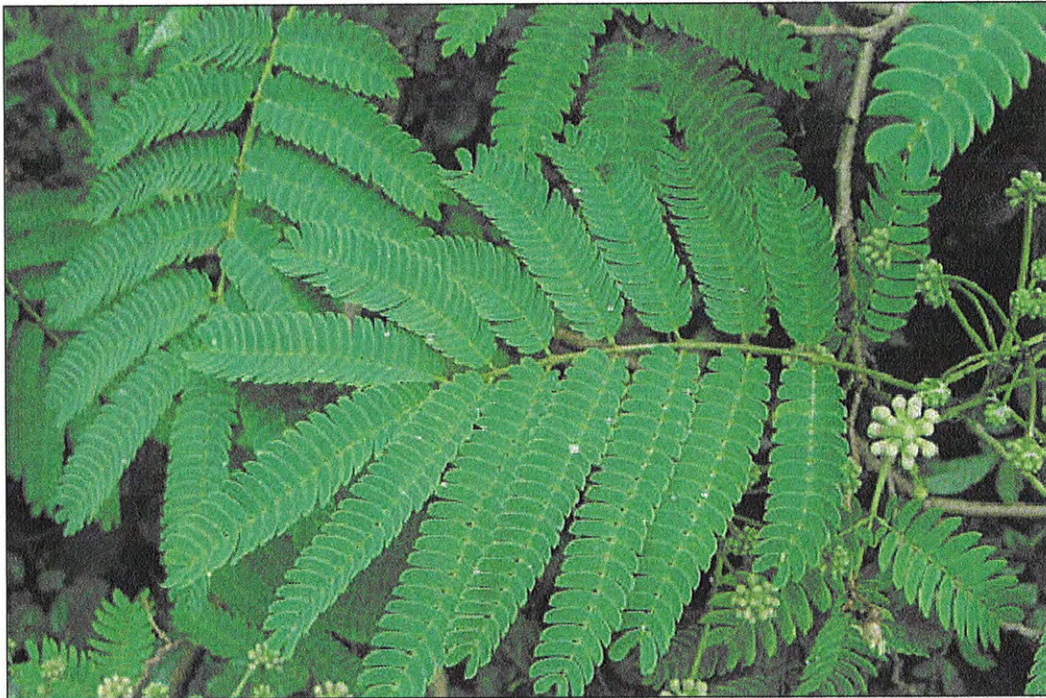
VEGETATION PROBLEM AREA 2: ALBIZIA JULIBRISSIN ENCROACHMENT.

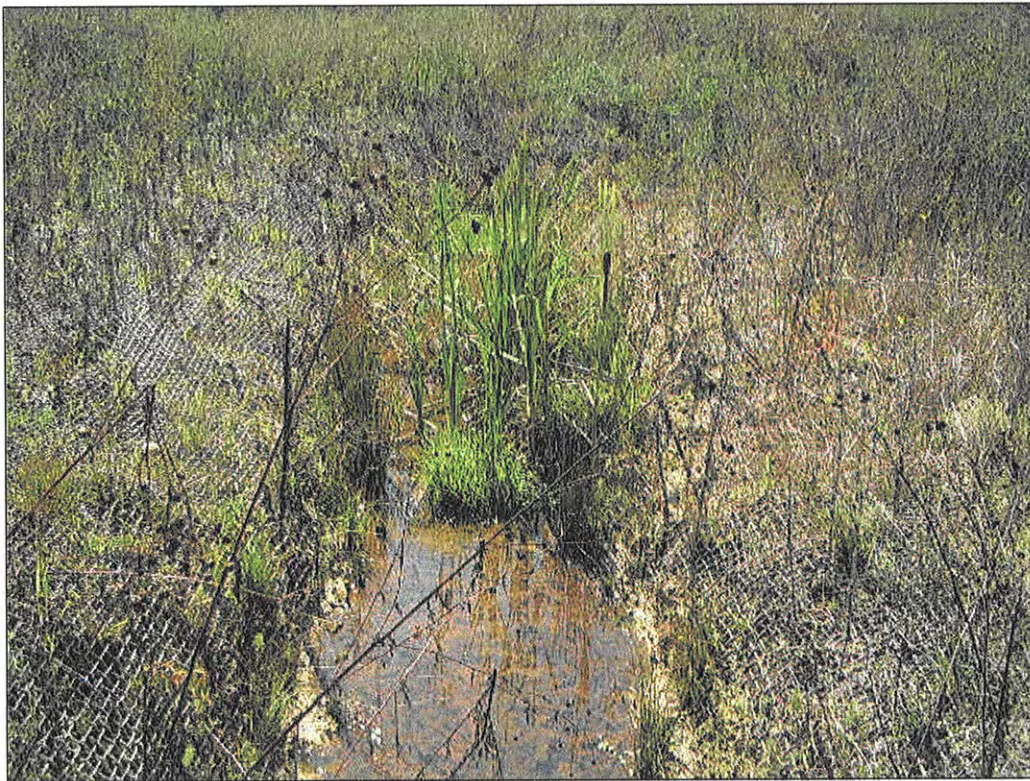
VEGETATION PROBLEM AREA 4: TYPHA LATIFOLIA ENCROACHMENT AT STATION 201+50.

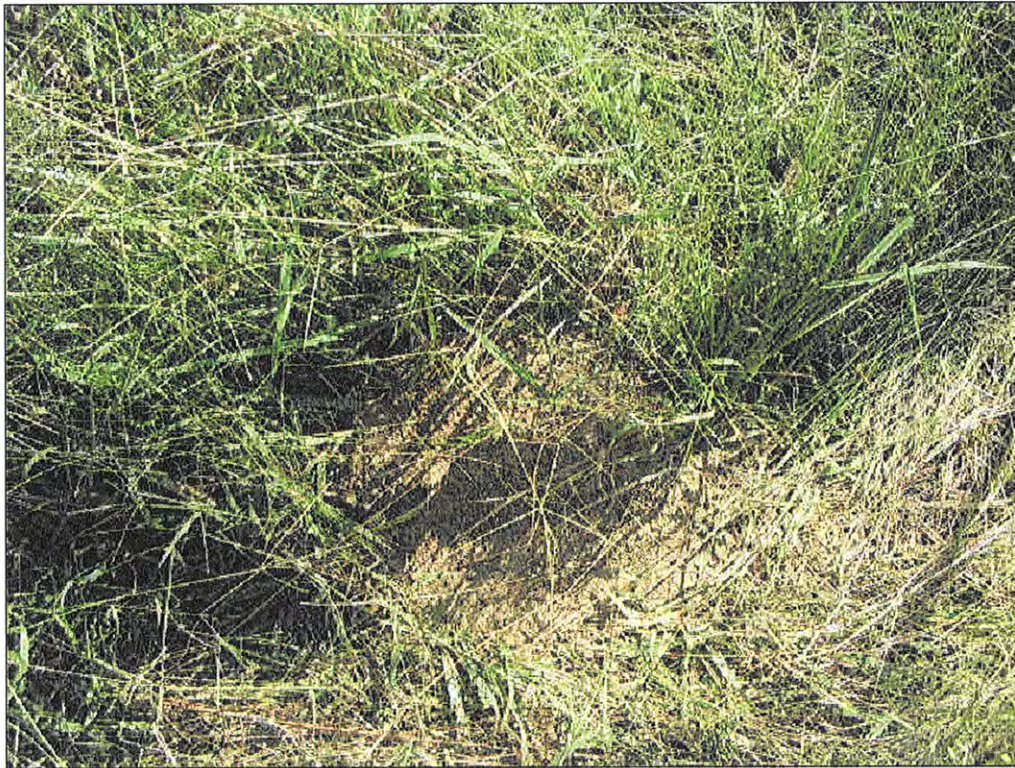
VEGETATION PROBLEM AREA 5. FIRE ANT ENCROACHMENT.

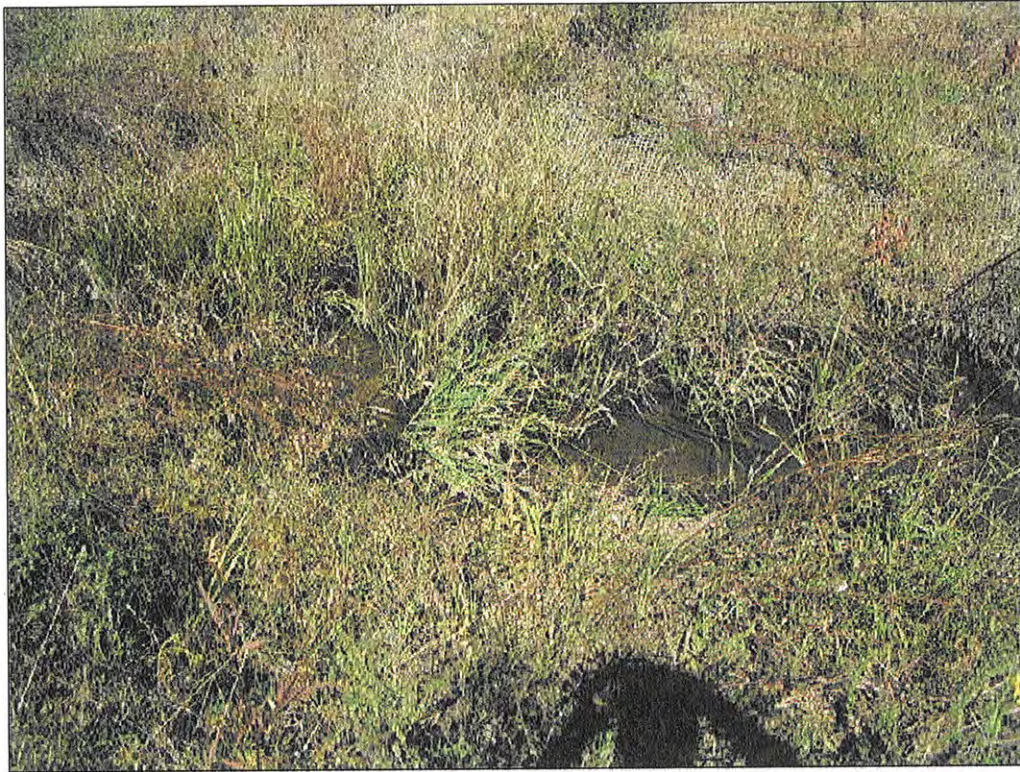
Within the upstream areas of the pond tributary (Stations 200+00 to 202+00), the stream channel contains thick vegetation which maybe due to over seeding and/or low flow or absent flow conditions within the channel. Channel morphology has been influenced by the thick vegetation causing flow patterns within the channel to be altered.

VEGETATION PROBLEM AREA 7. THICK HERBACEOUS GROWTH WITHIN STREAM CHANNEL AT STATION 118+25.

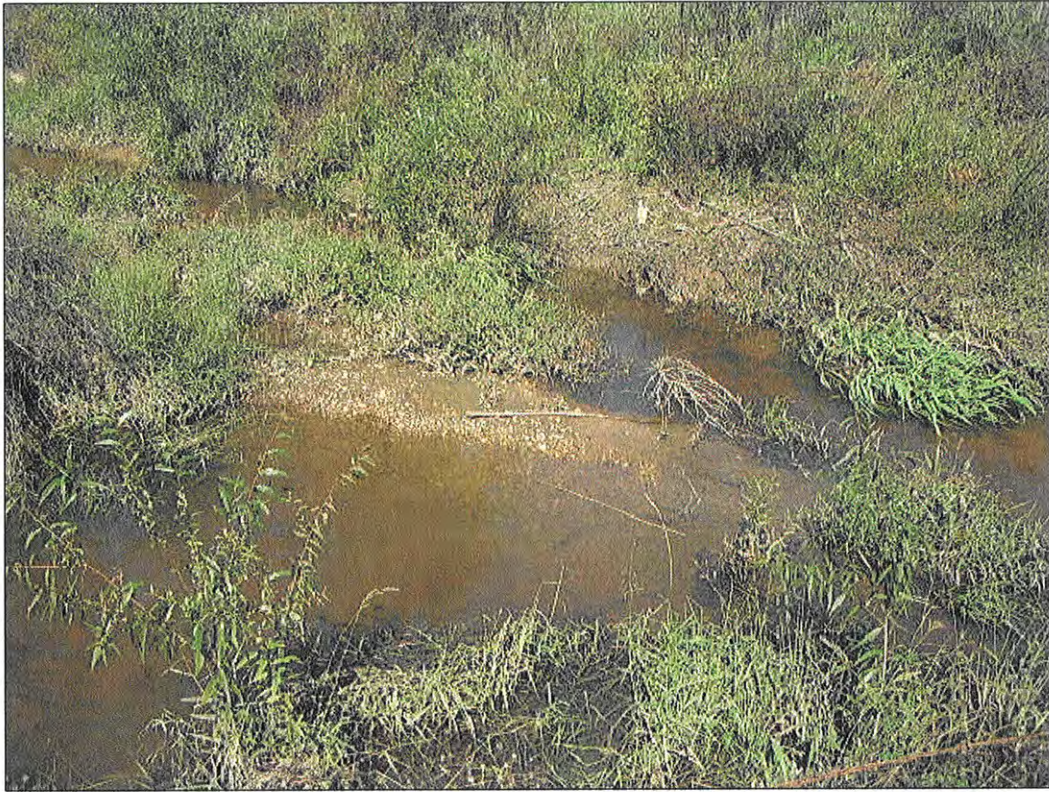
STREAM PROBLEM AREA 1: SAND BAR LOCATED AT STATION 120+10.

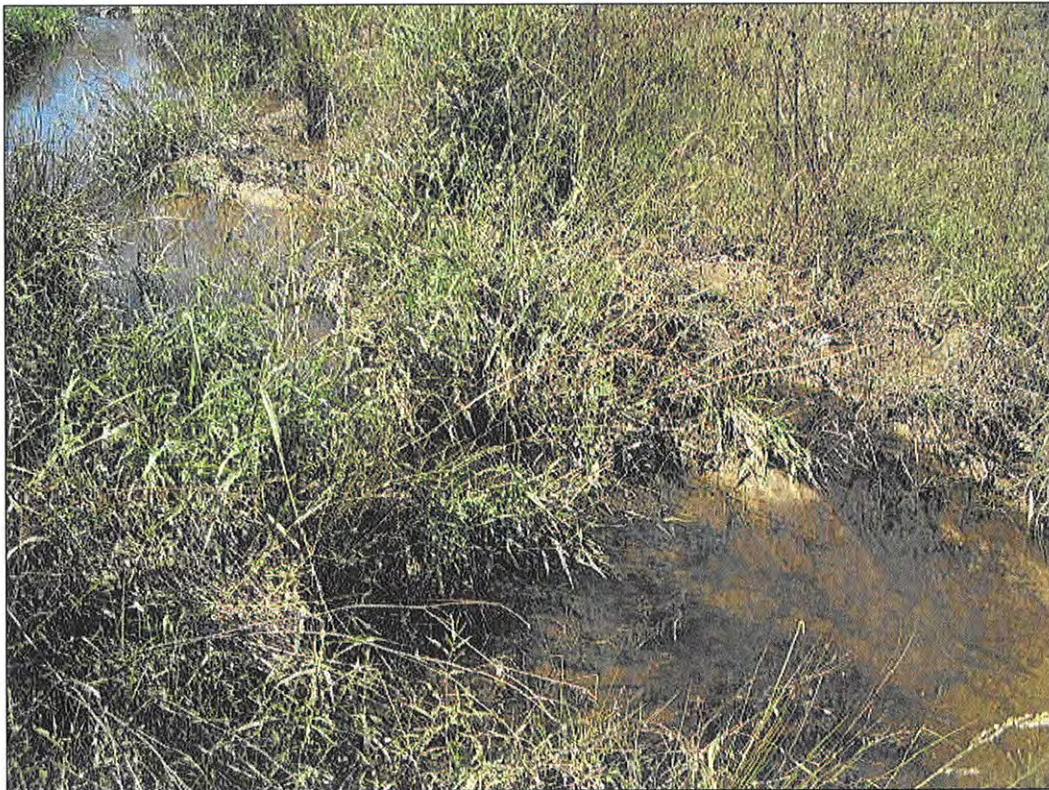
STREAM PROBLEM AREA 2: AGGRADATION AND VEGETATION IN CHANNEL INFLUENCING CHANNEL MORPHOLOGY AT STATION 118+80.

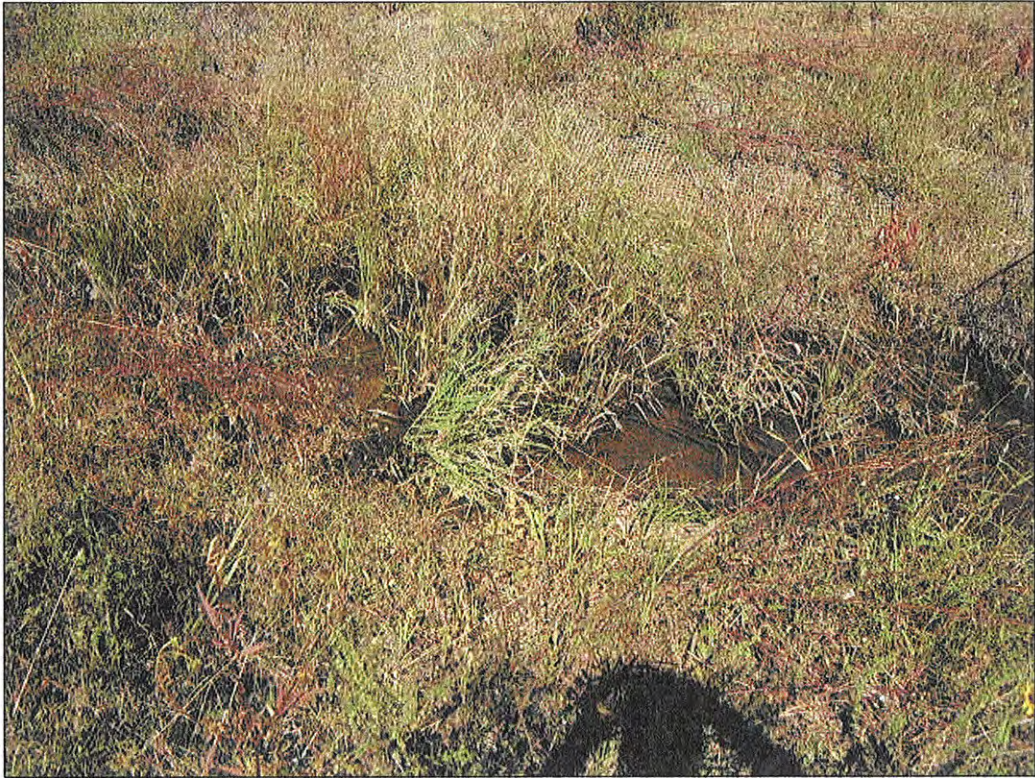
STREAM PROBLEM AREA 3: AGGRADATION AND VEGETATION IN CHANNEL INFLUENCING CHANNEL MORPHOLOGY AT STATION 118+25.

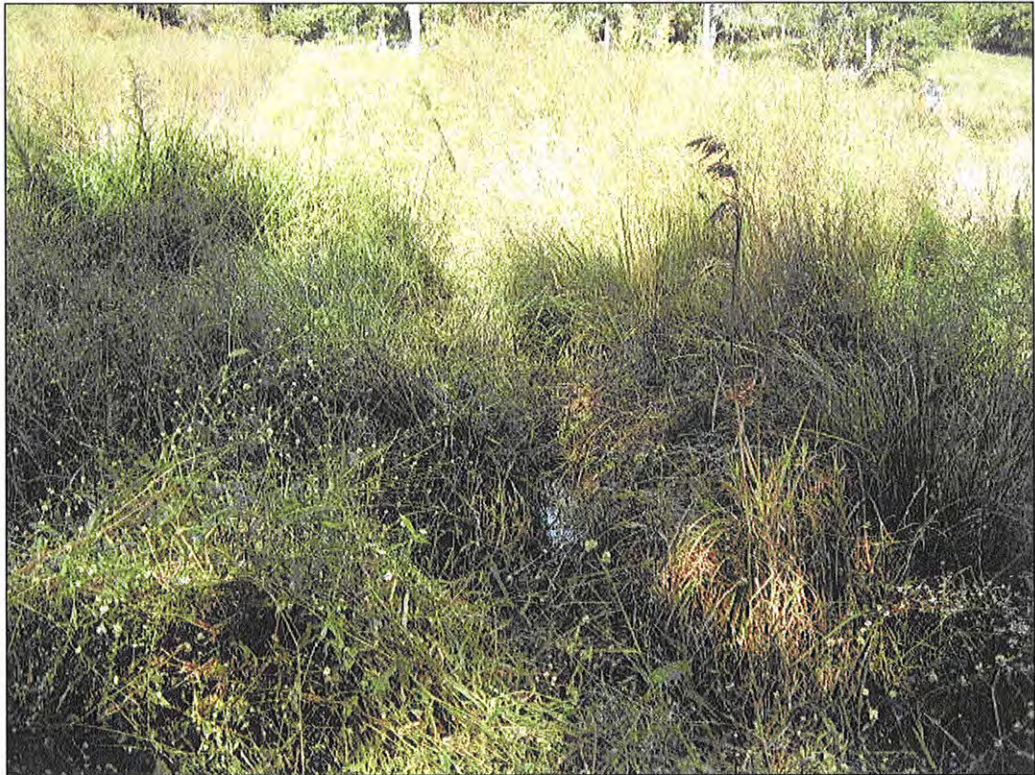
STREAM PROBLEM AREA 4: AGGRADATION AND VEGETATION IN CHANNEL INFLUENCING CHANNEL MORPHOLOGY AT STATION 200+00 - 202+00.

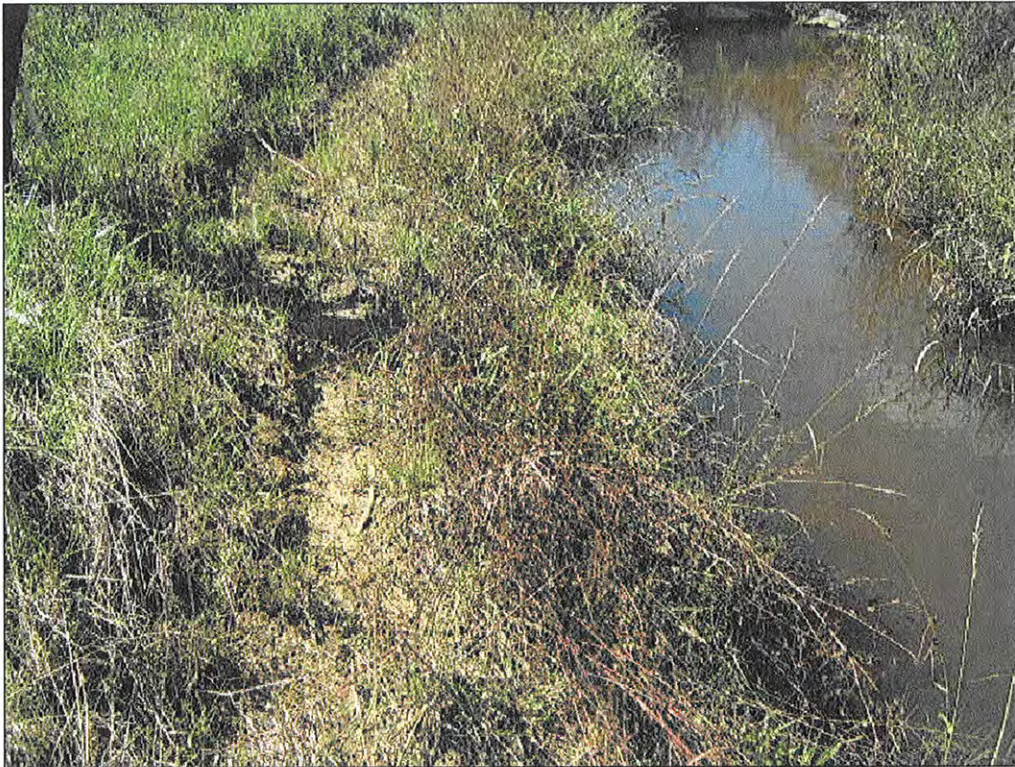
STREAM PROBLEM AREA 7. ERODING BANKS AT STATION 116+92 - 117+10.
