**UT to South Fork Creek (Stephens)
Stream and Wetland Restoration Project
Alamance County, North Carolina
EEP Project #405**

MY-04 Monitoring Report

**UT to South Fork Creek
Stream and Wetland Restoration
EEP Project #405
Liberty, North Carolina
Alamance County**

**MY-04 Monitoring Report
Prepared By:**

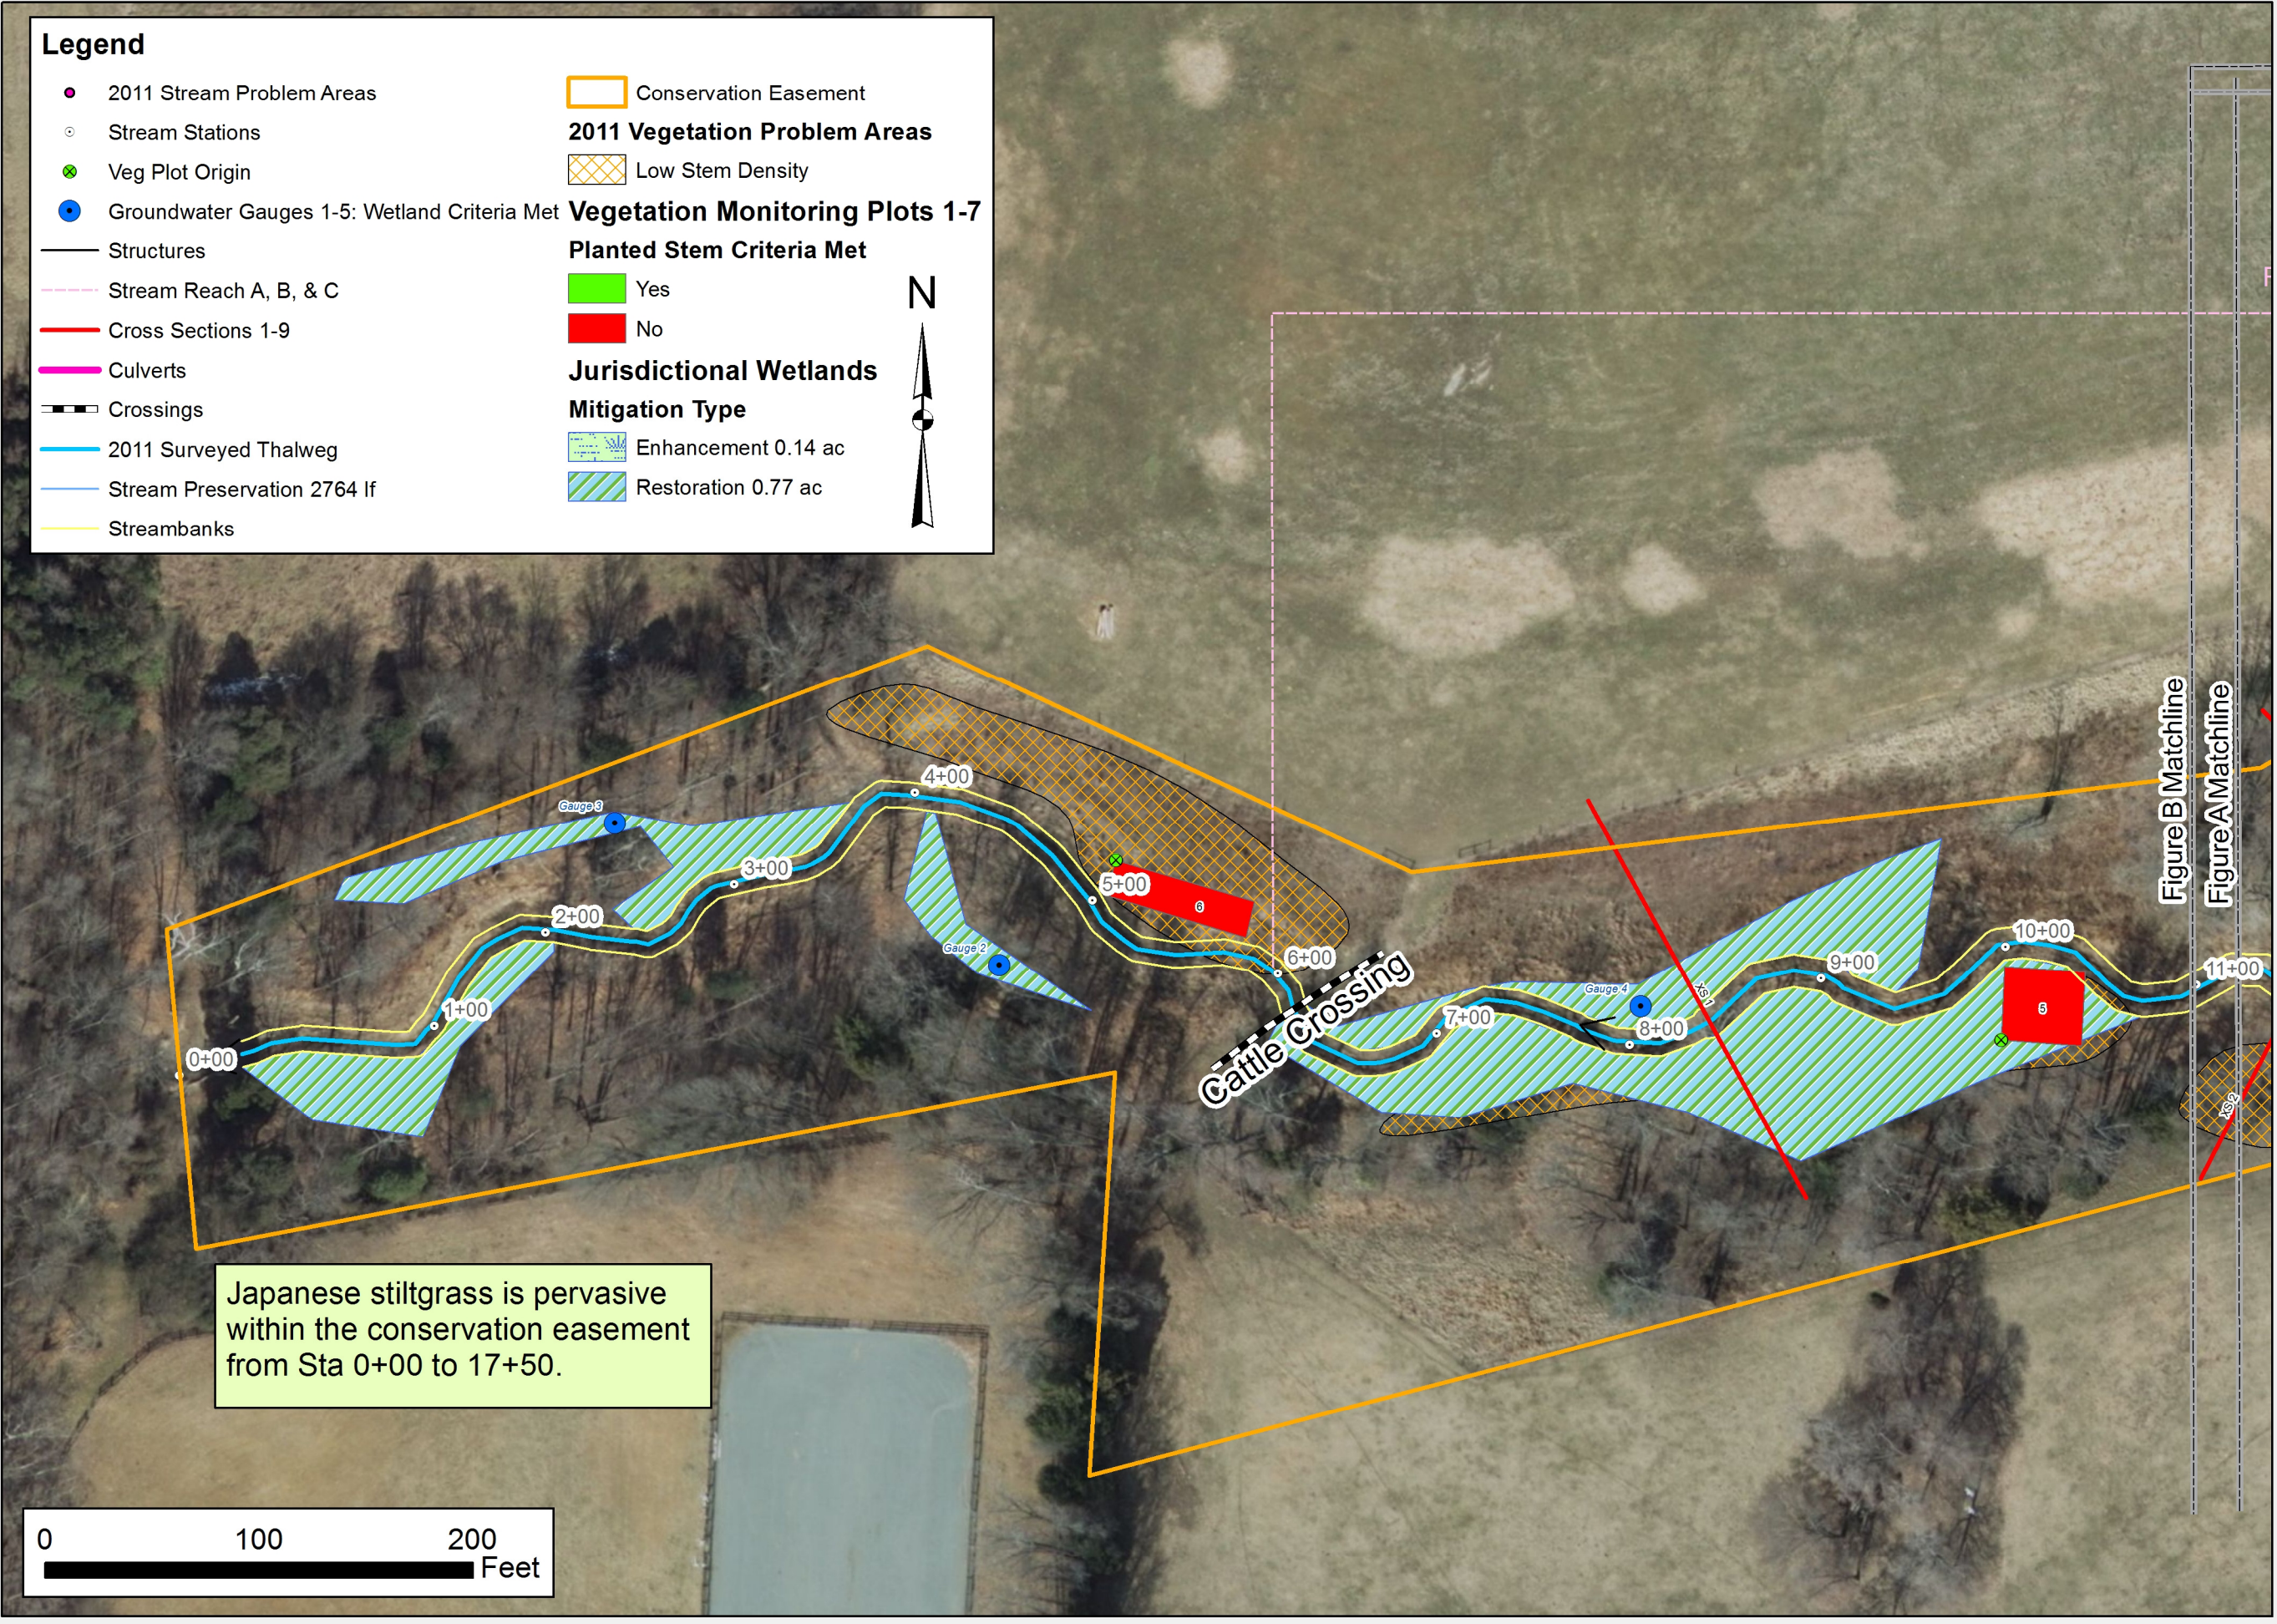
Figure
2A

Japanese stiltgrass is pervasive within the conservation easement from Sta 0+00 to 17+50.

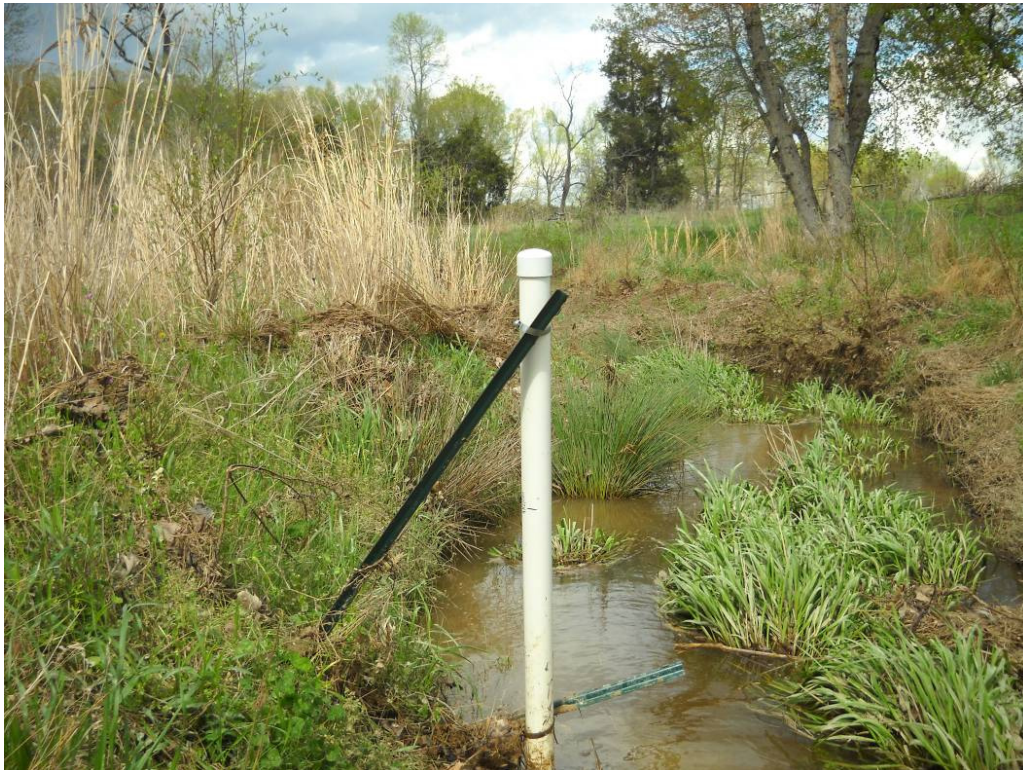
Photo 17. Wrack line at the top of the left bank (April 12, 2011)

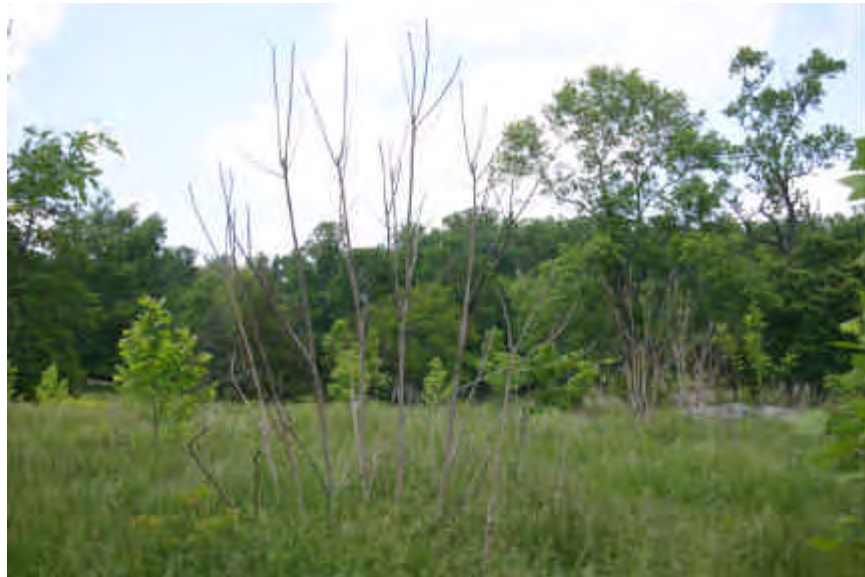
Results of Treatment II, *Ailanthus altissima*

A foliar application was applied to the heavy infestation of *Ligustrum sinense* within the western half of the easement specifically at the far western edge. An additional sweep was made of the entire site, focusing on the previously applied areas of *Ligustrum sinense*, and through-out the easement itself. A check for how other *Ailanthus* stands faired from treatment I and II was also conducted, and re-treatment was applied when needed, however rarely. In Treatment IV we will monitor the areas previously treated while also systematically re-walking the site.

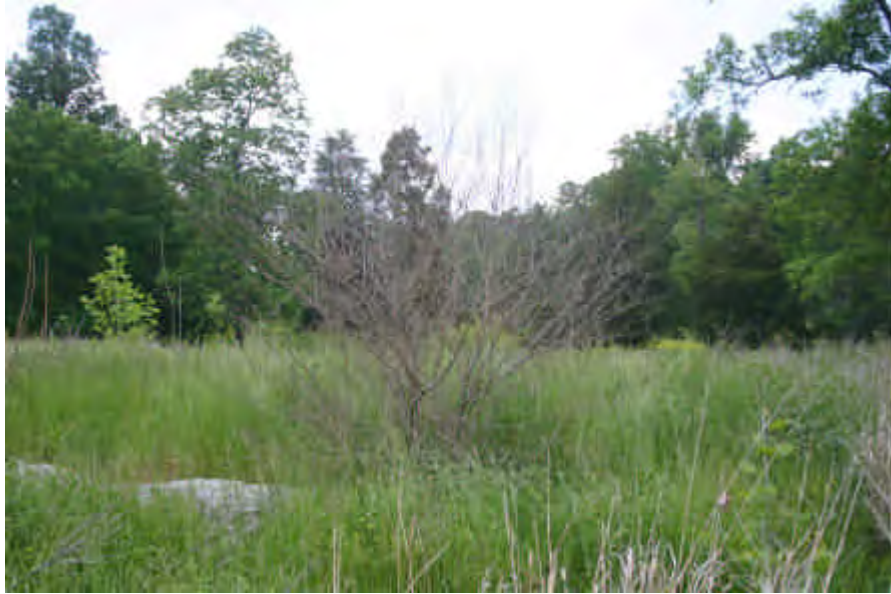
Results of Treatment II, *Ligustrum sinense*

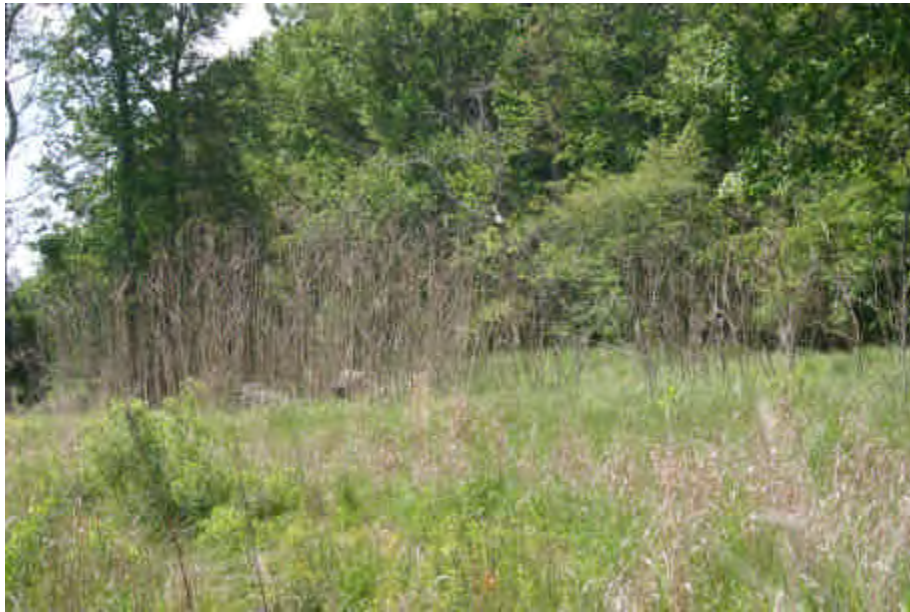
Results of Treatment II, *Ailanthus altissima*

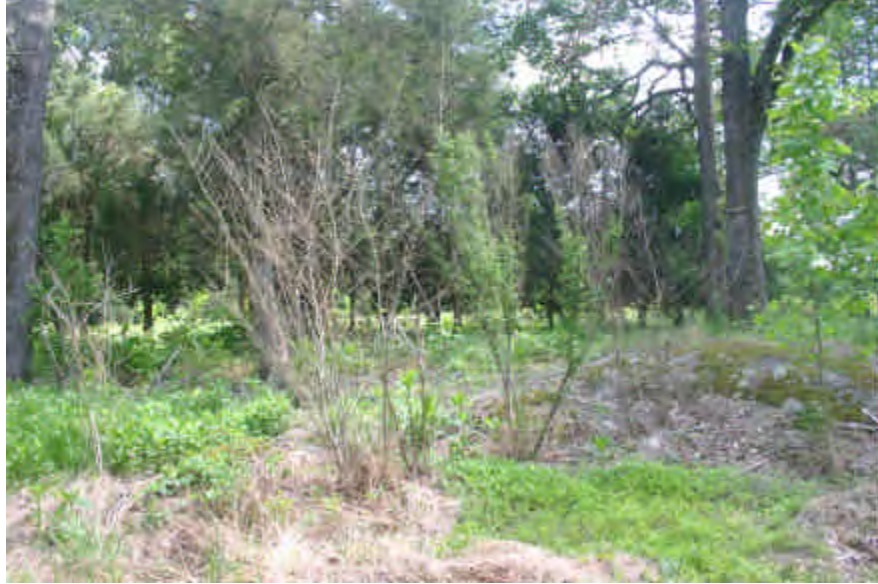
Results of Treatment III, *Ligustrum sinense*

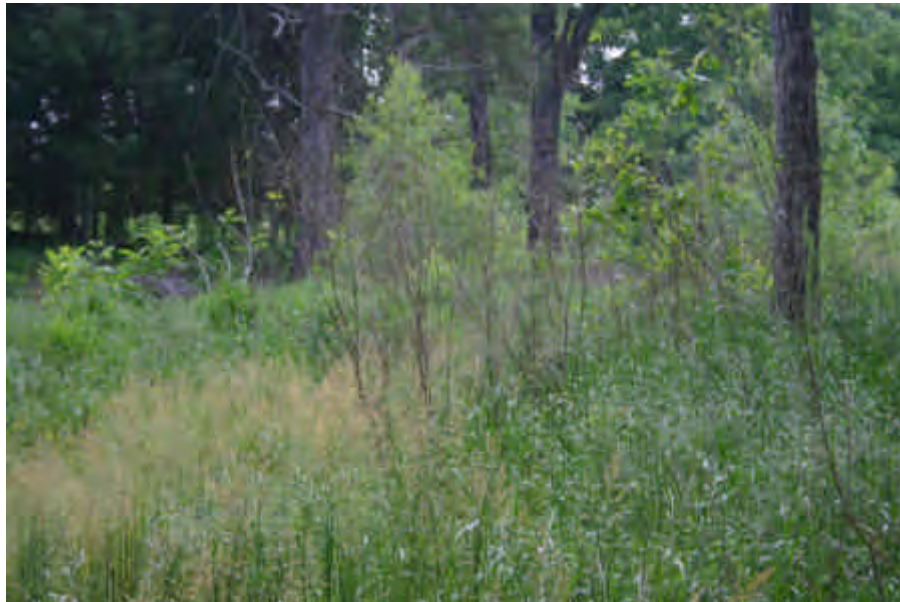
Results of Treatment III, *Ligustrum sinense*
