**UT to South Fork Creek (Stephens)
Stream and Wetland Restoration Project
Alamance County, North Carolina**

**EEP Project #405
Contract #D09079s**

MY-05 Monitoring Report

**Ward Consulting Engineers, P.C.
Firm License Number C-2619
Project Manager: Becky Ward, P.E.
8368 Six Forks Road, Suite 104
Raleigh, NC 27615-5083
Ph: 919-870-0526
Fax: 919-870-5359**

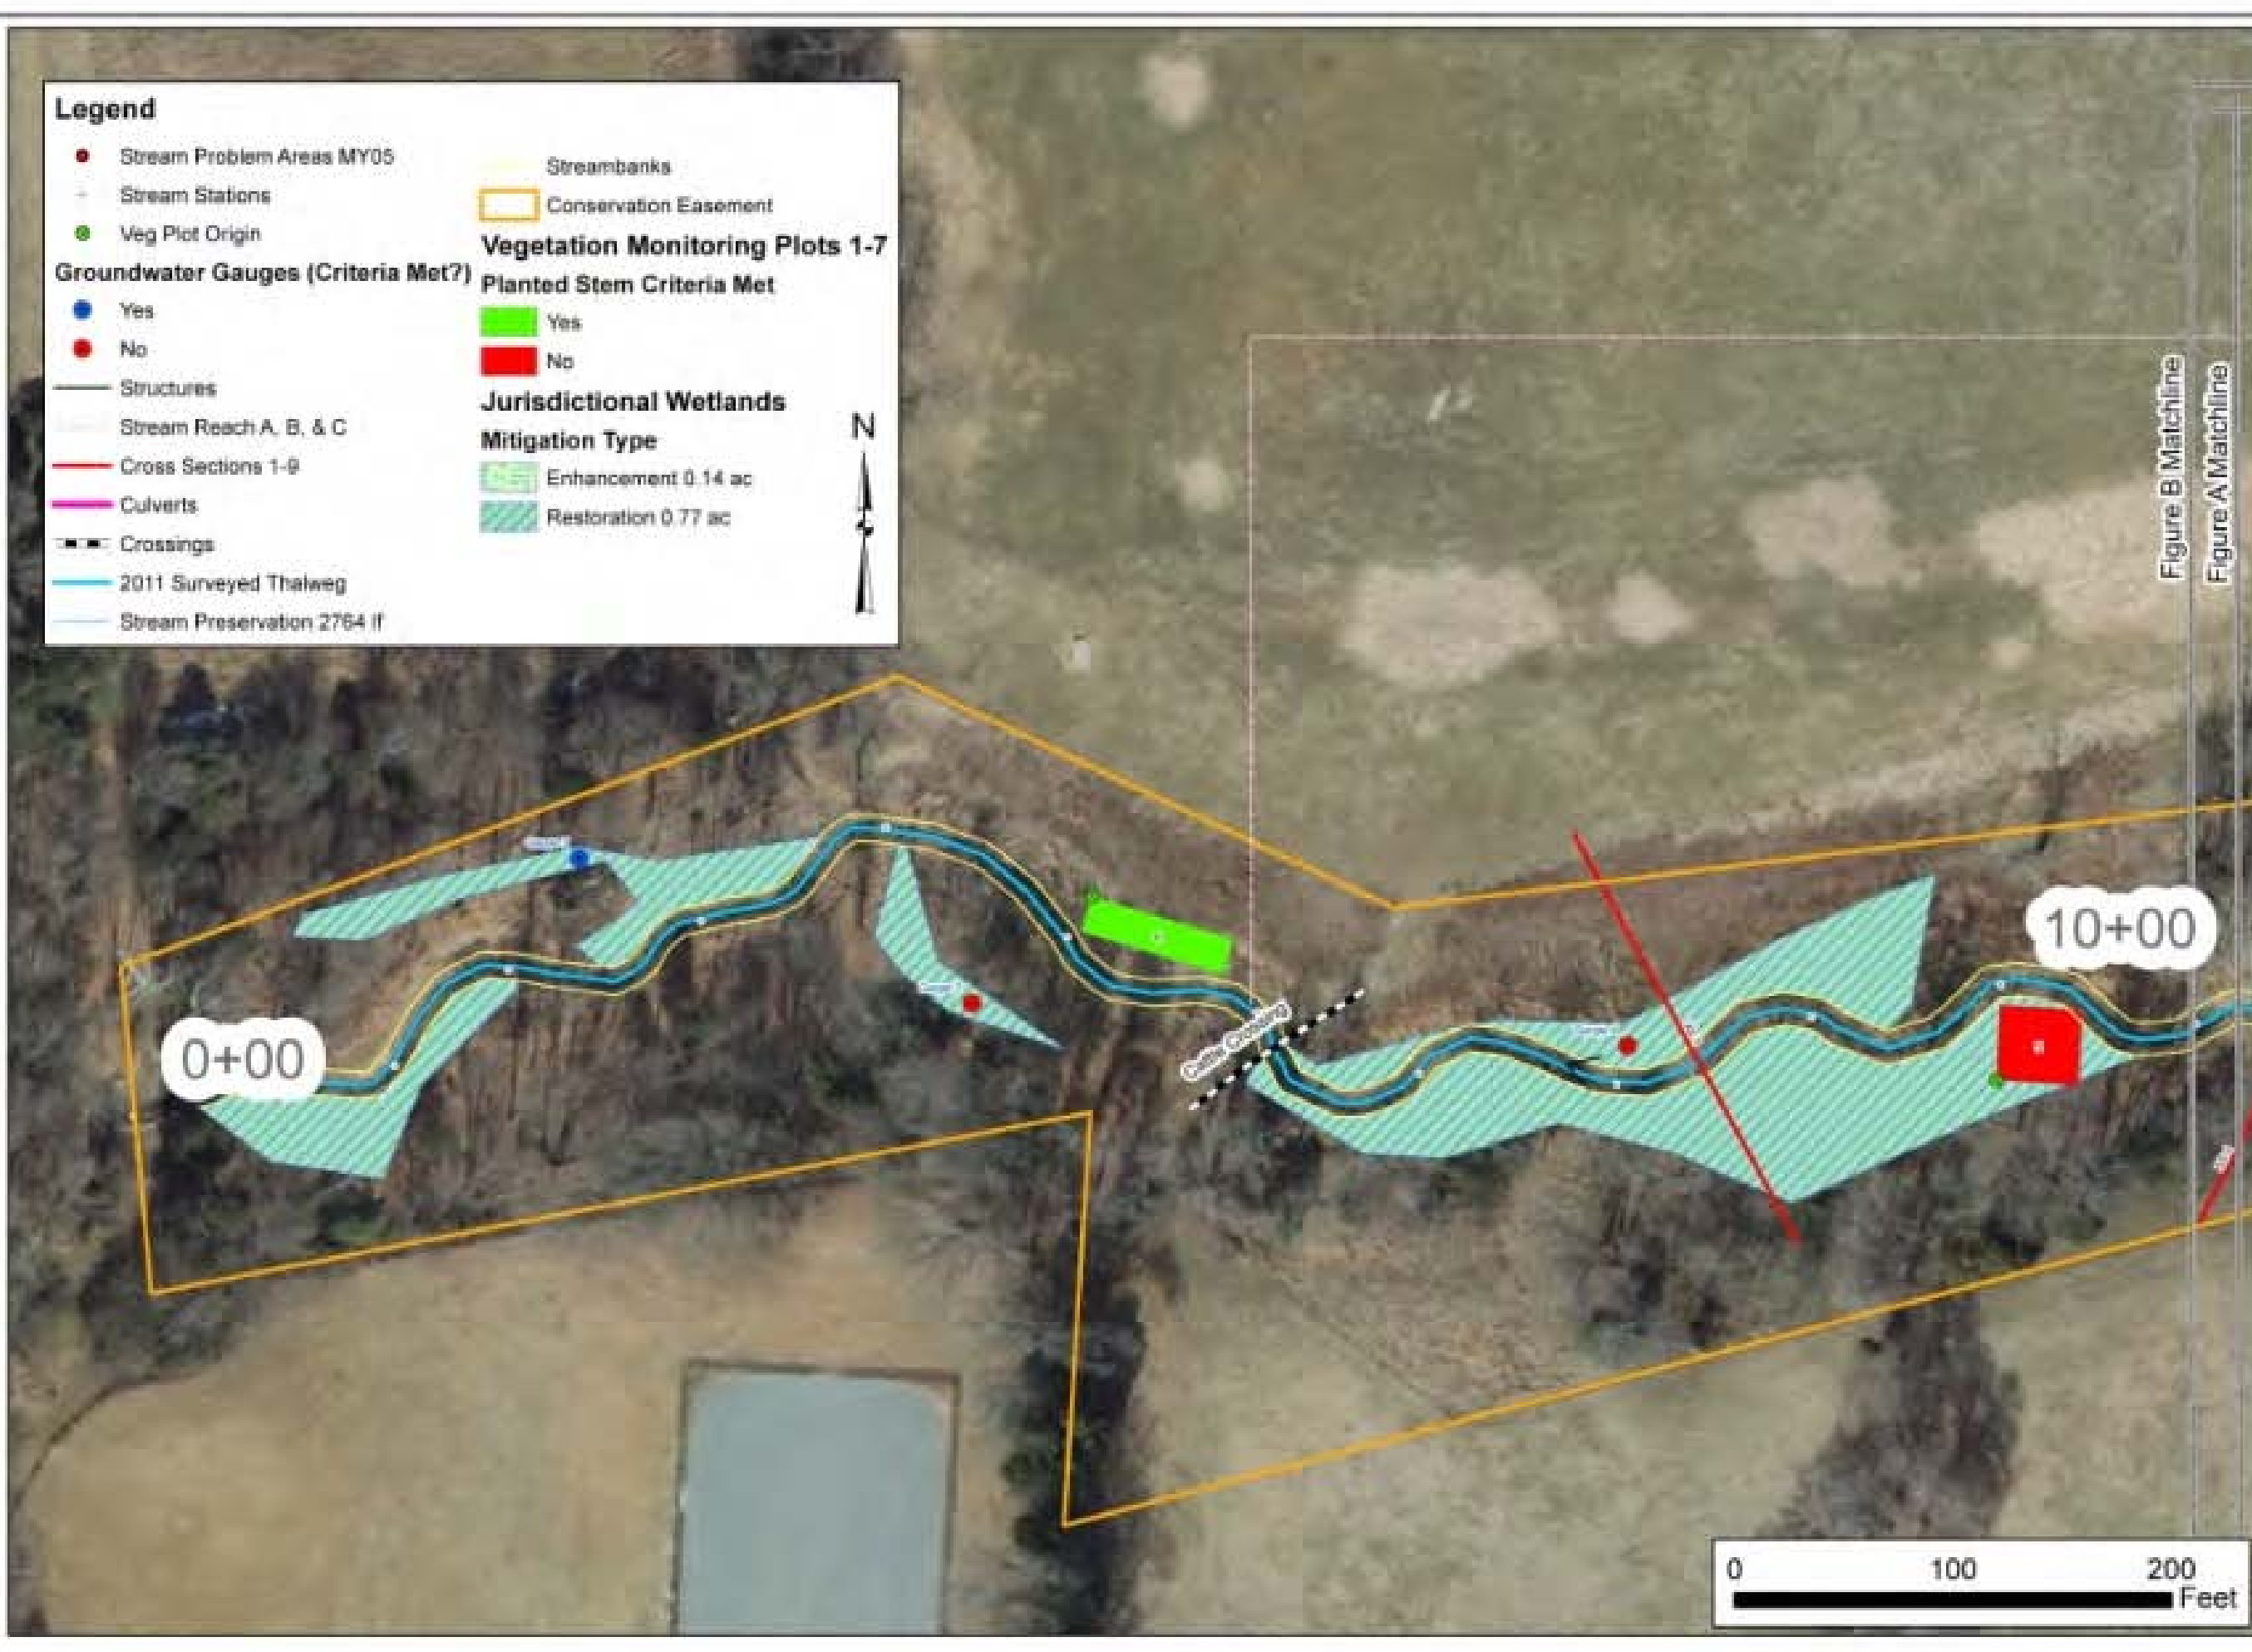
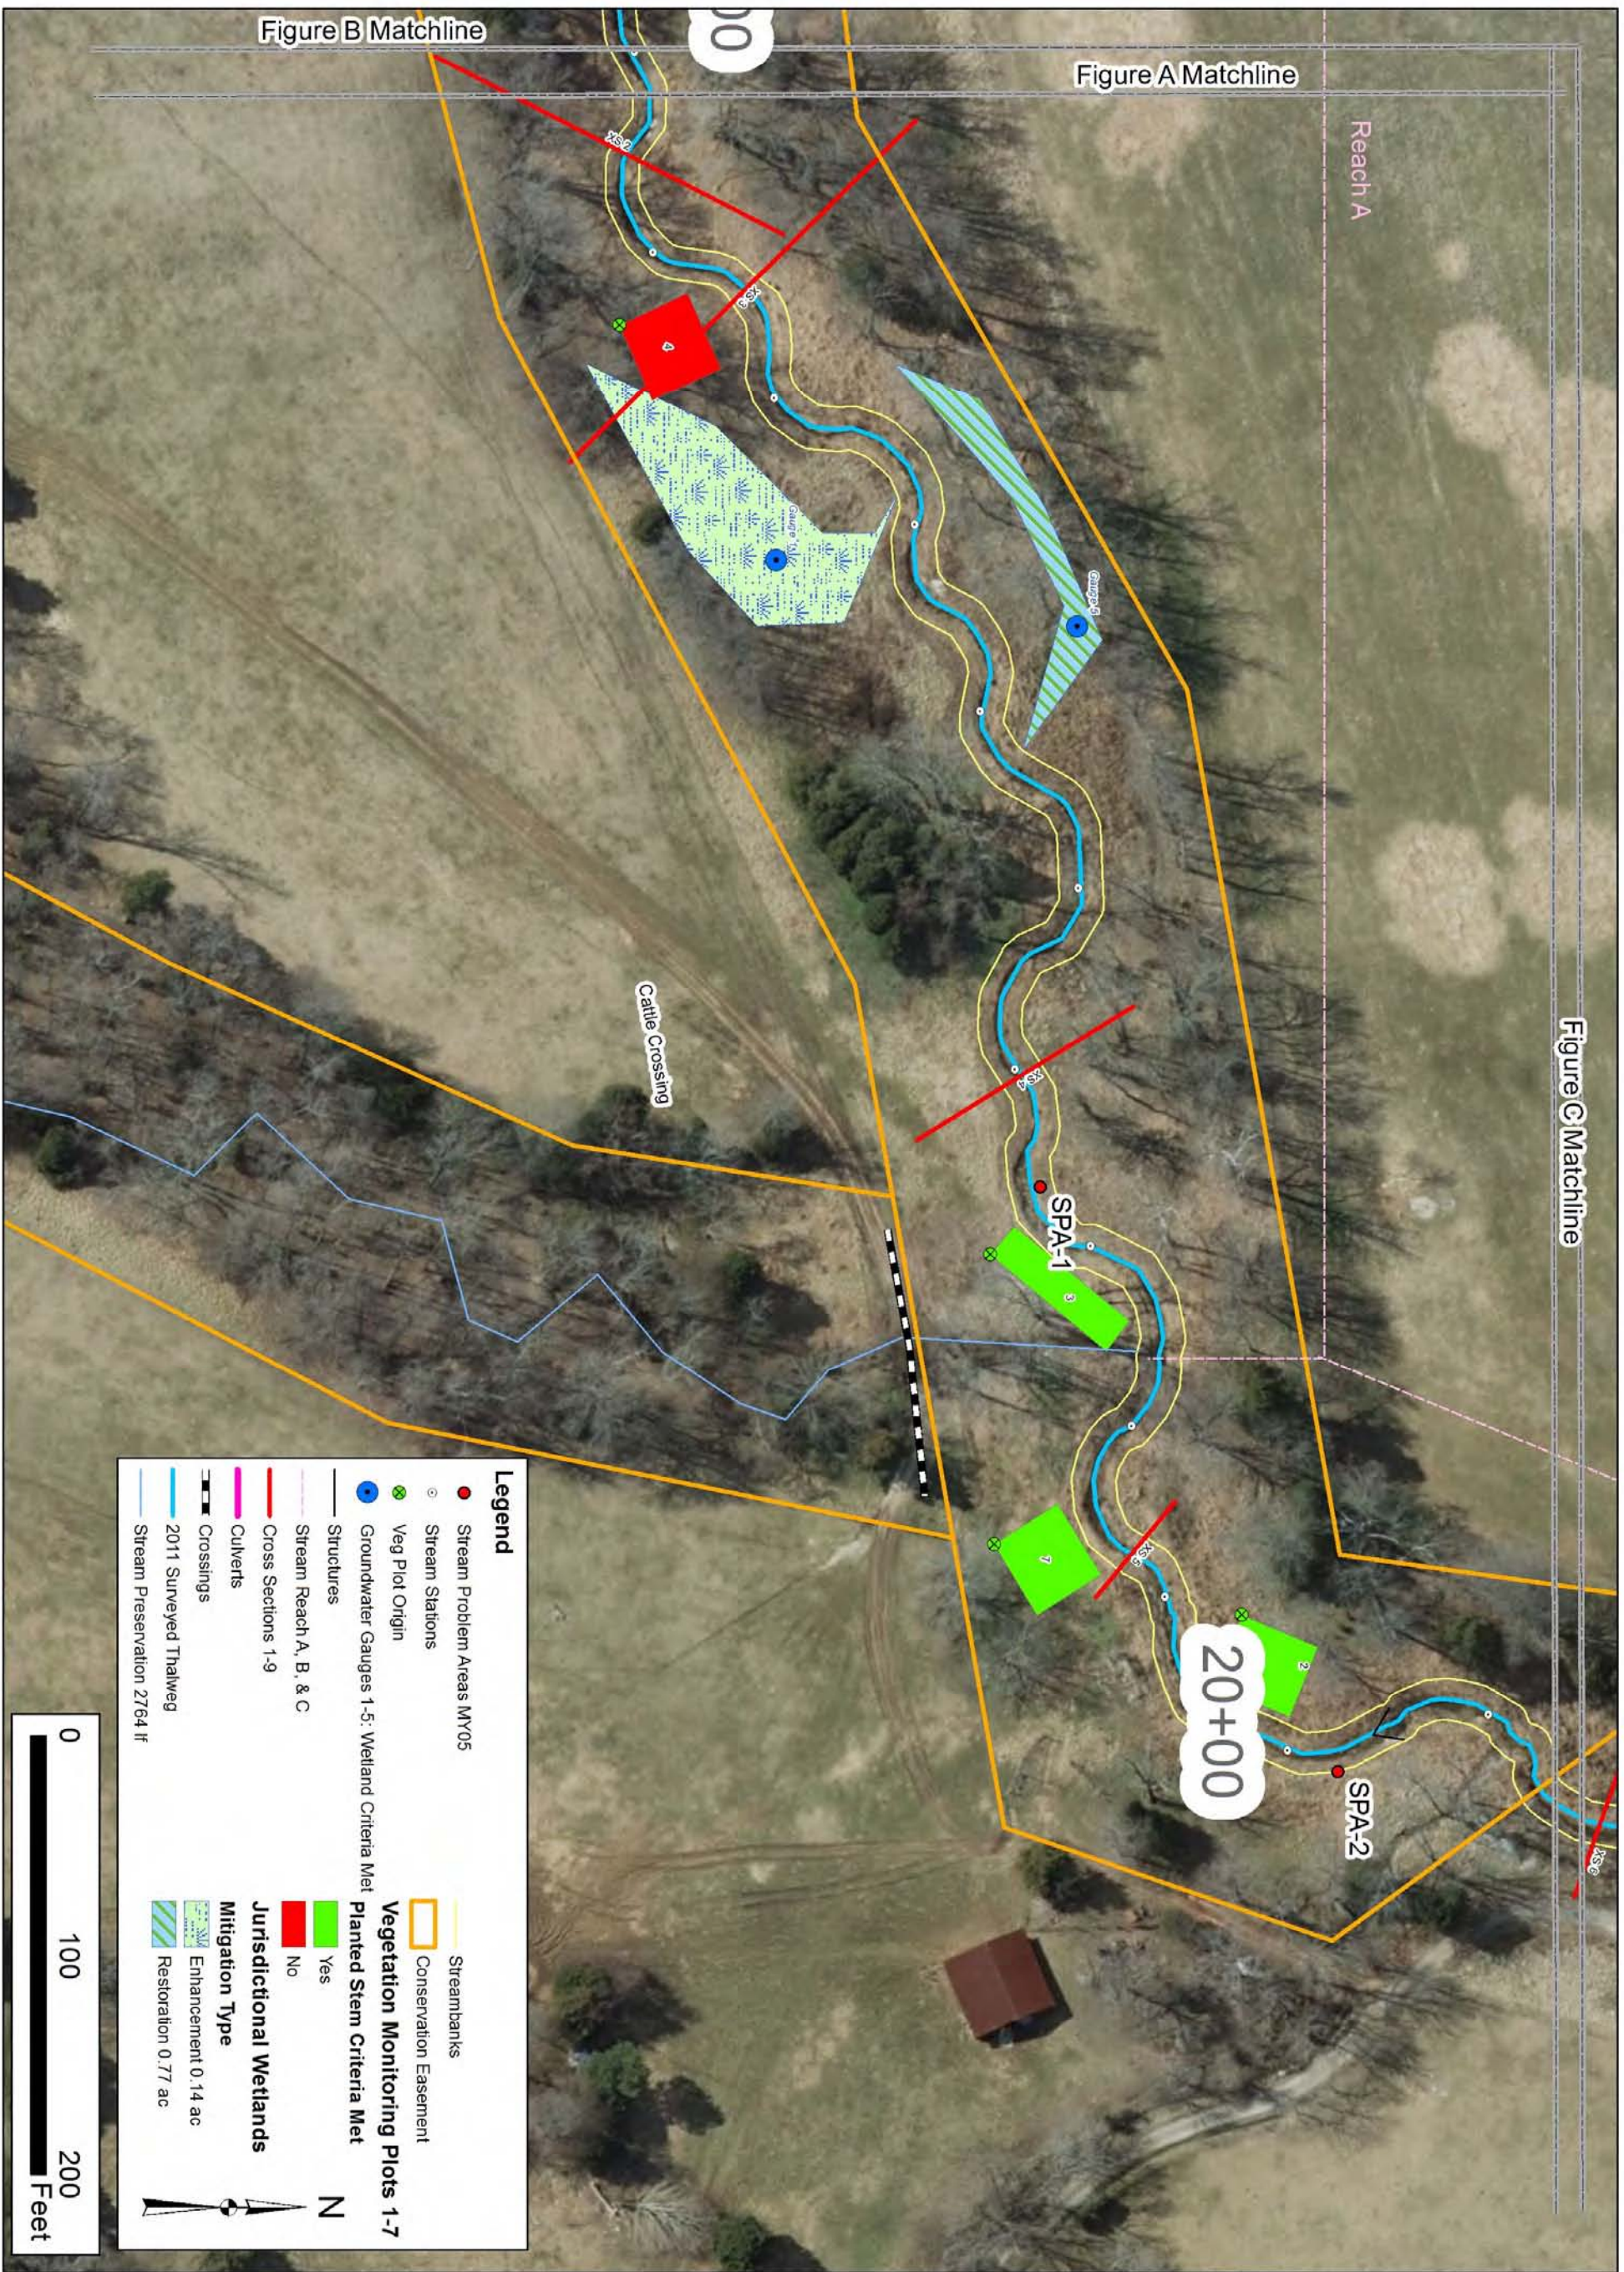
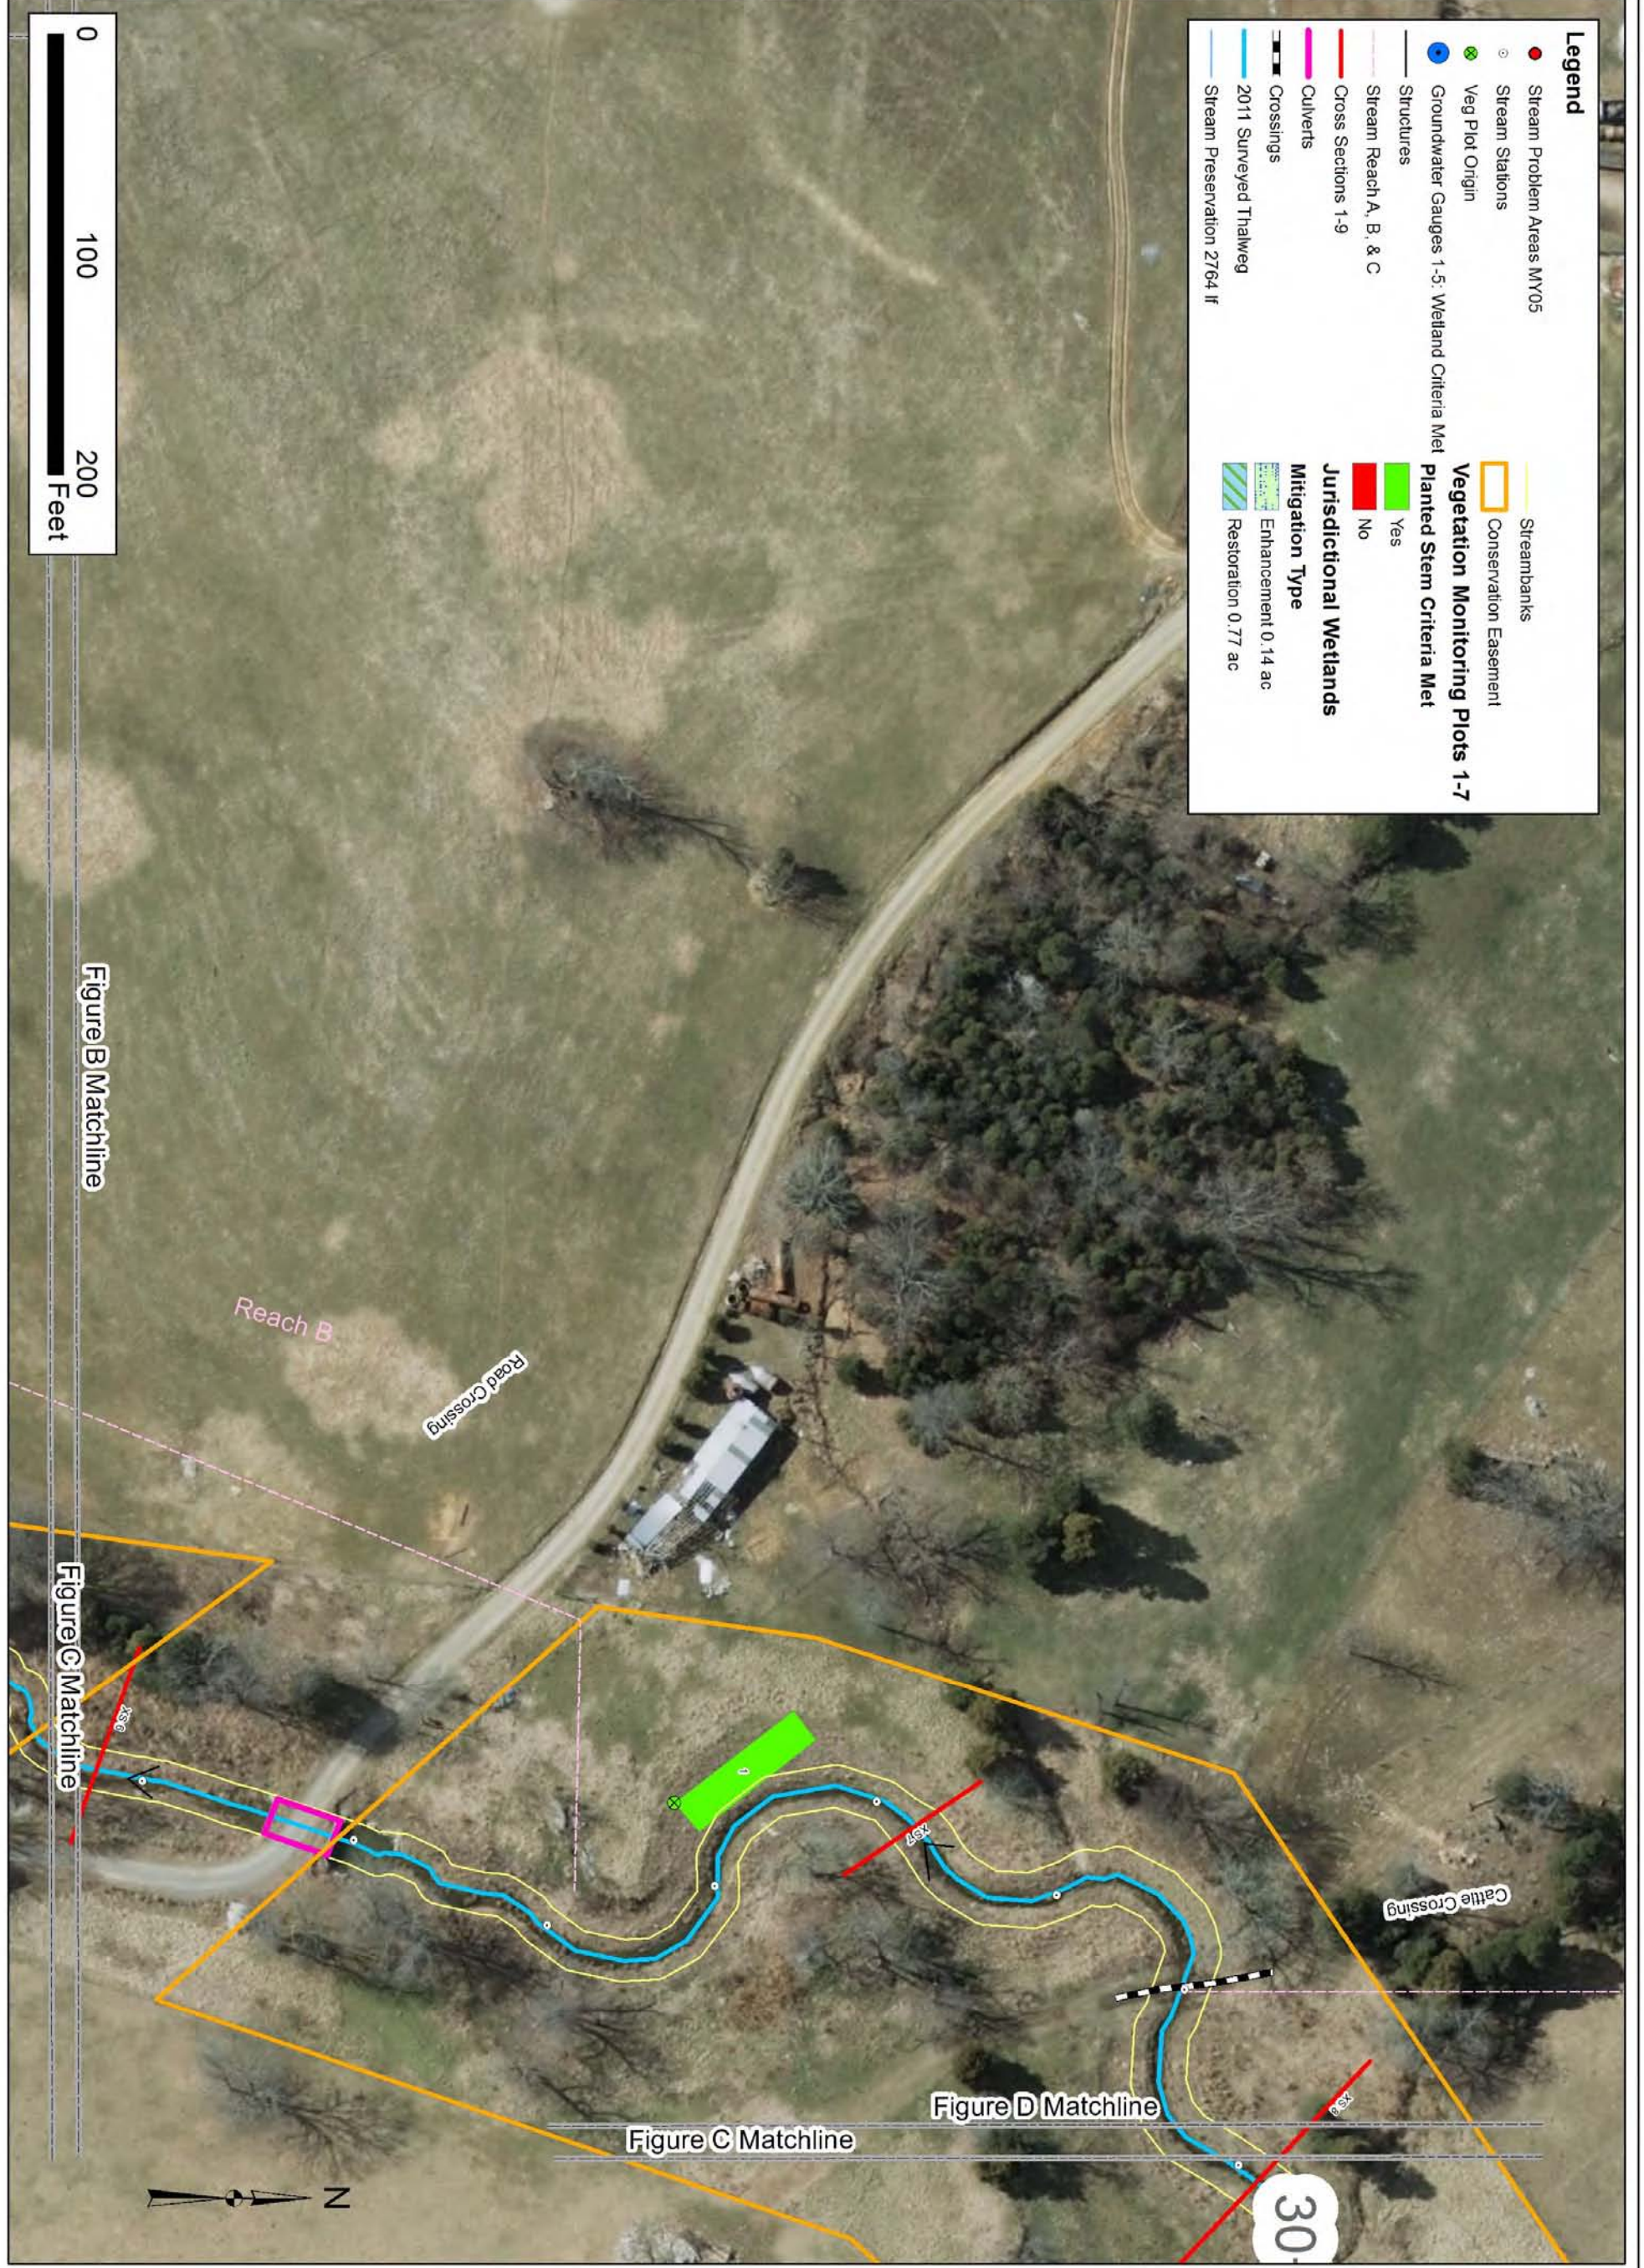
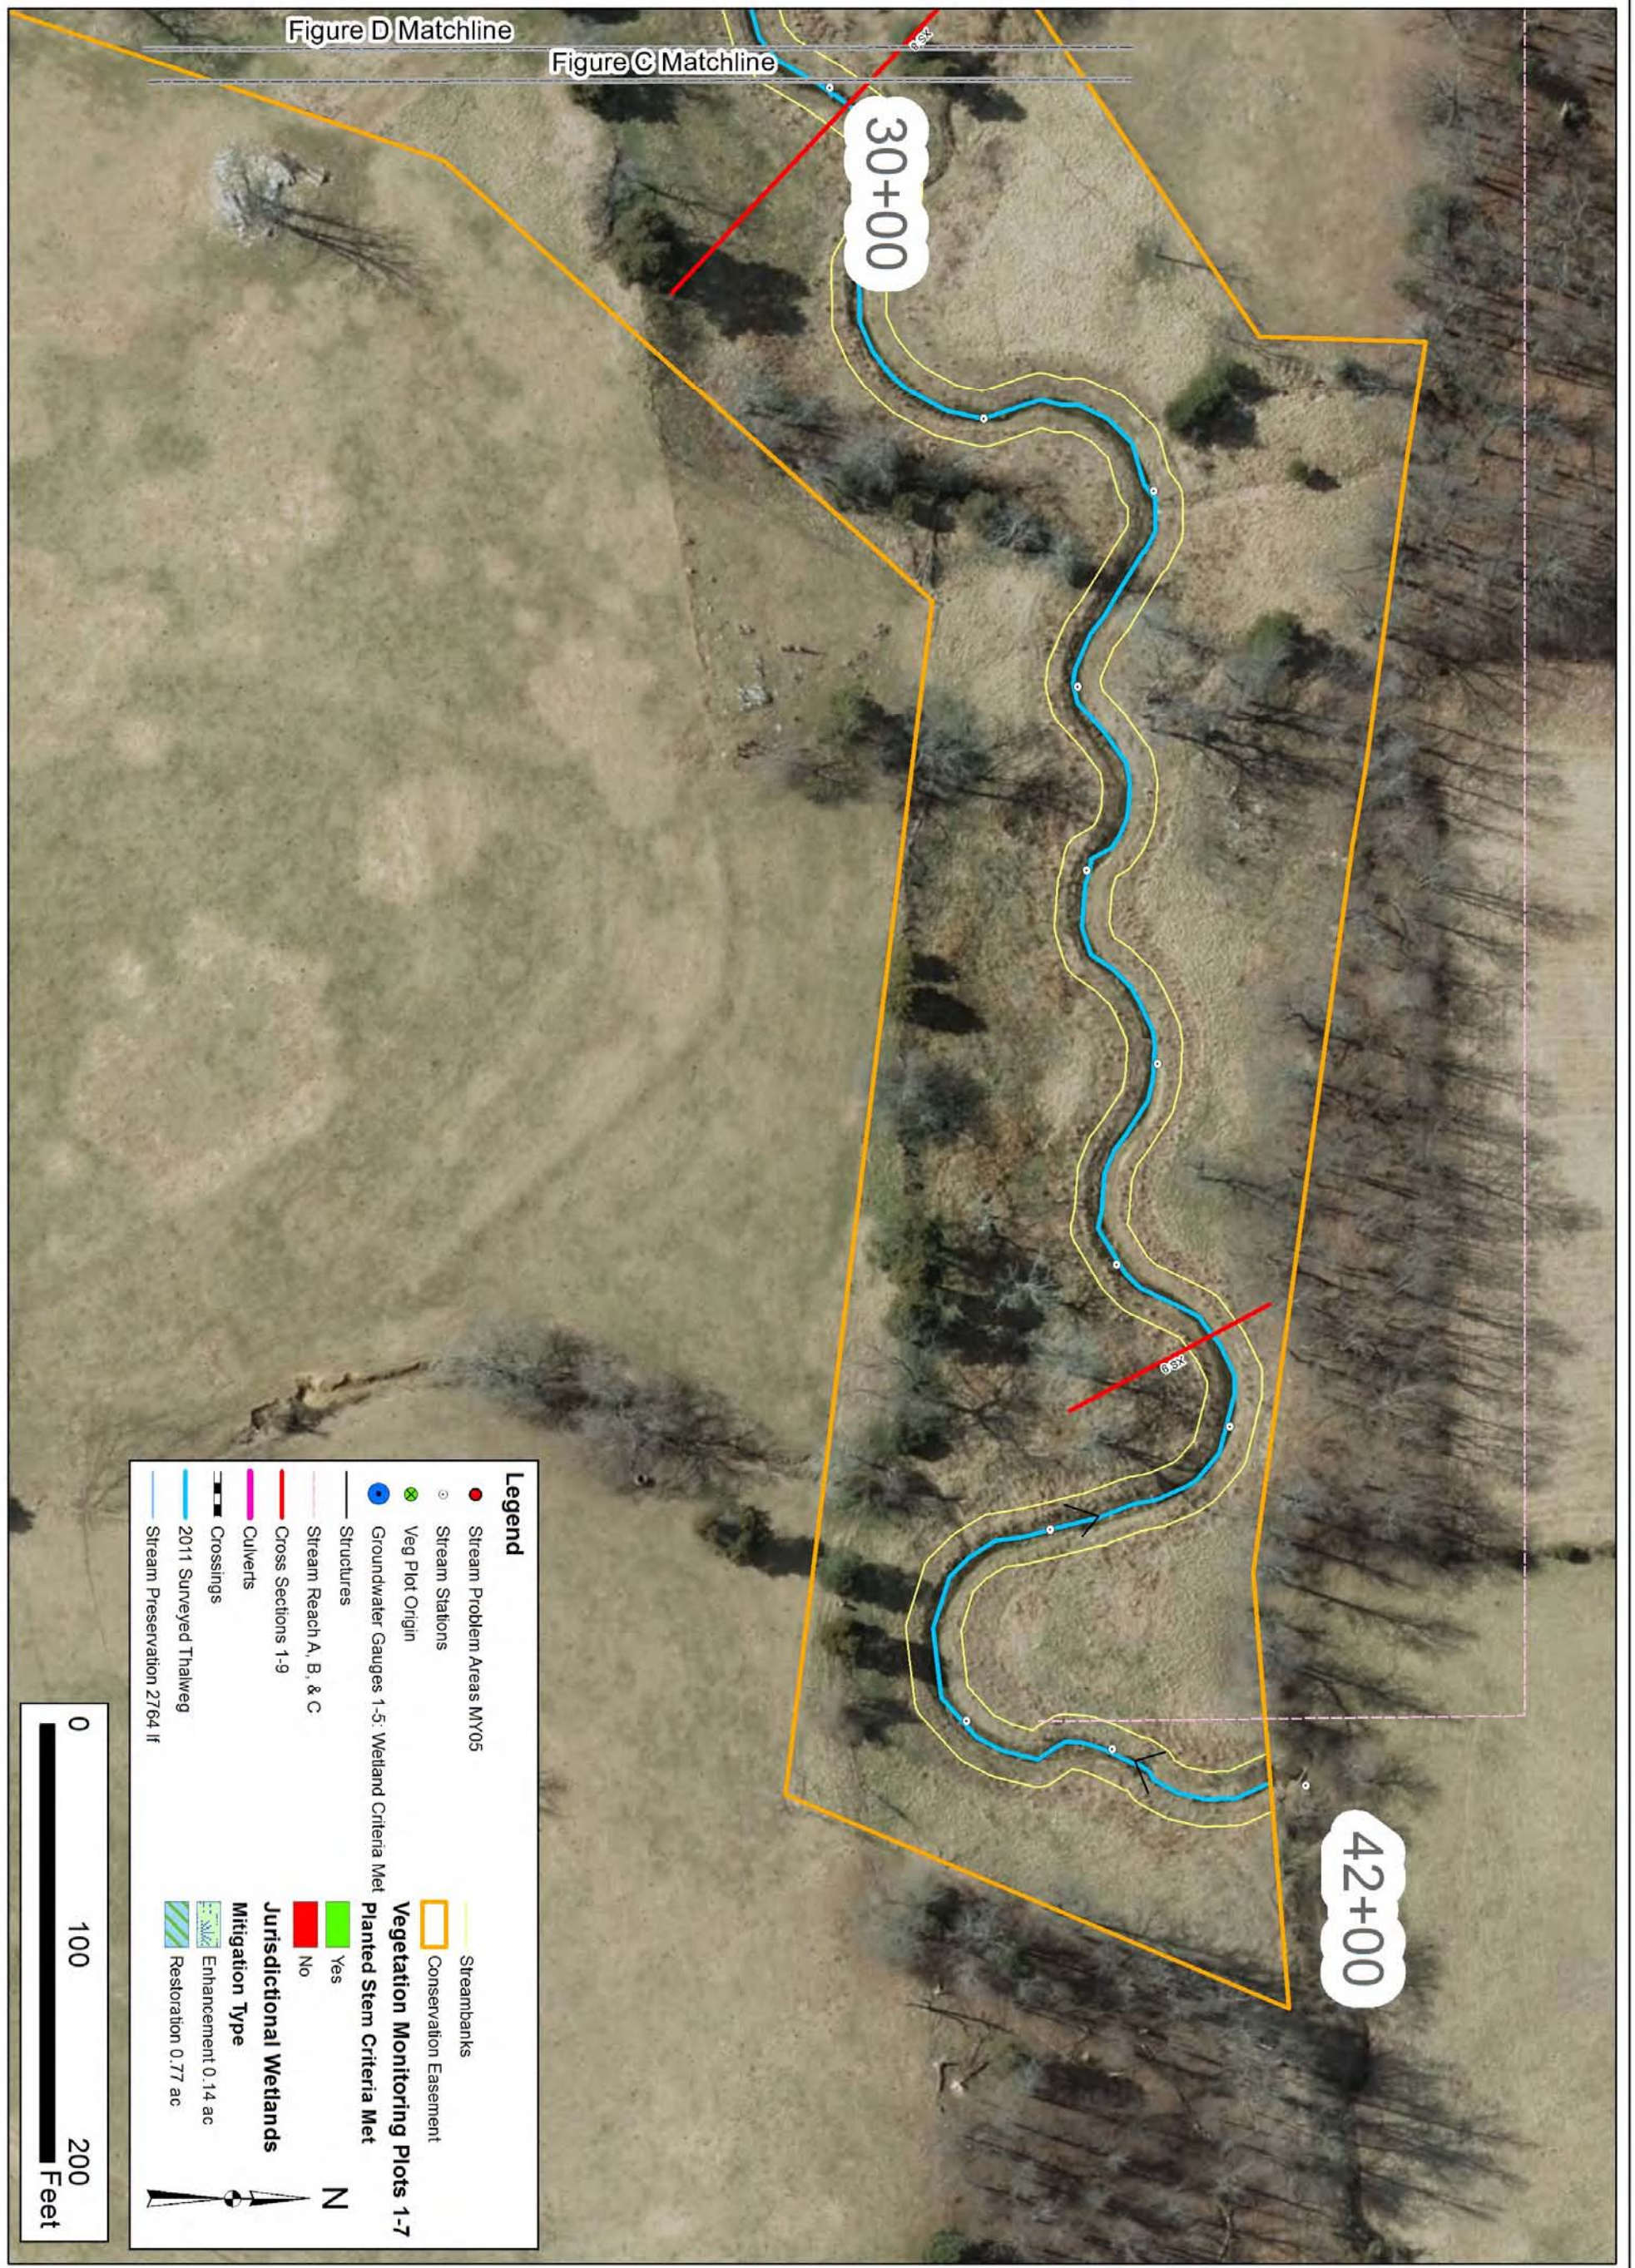
Current Conditions Plan View MY-05

Only one structure throughout the entire stream has been reported as an issue on the Current Condition Plan. The cause of the issue is minor piping at rock cross vane at station 20+80, in monitoring Reach B. This cross vane, although not maintaining its intended water surface elevation, is otherwise functioning. Bank erosion problems are only evident in 1% of Reach A. Previously reported bank erosion areas have apparently stabilized as woody stem vegetation is developing on these banks. No further erosion was observed in these previous bank erosion areas. The current bank erosion contributing to the 1% exists sporadically throughout Reaches A and B, particularly in the vicinity of cross sections 1 and 4, and is attributed to cattle that have entered into the conservation easement. This cattle access issue is considered limited and should continue to be monitored for further signs of encroachment.
