**UT to South Fork Creek (Stephens)
Stream and Wetland Restoration Project
Alamance County, North Carolina
EEP Project #405
Contract #D09079s**

MY-06 Monitoring Report

**UT to South Fork Creek
Stream and Wetland Restoration
EEP Project #405
Liberty, North Carolina
Alamance County**

**MY-06 Monitoring Report
Prepared By:**

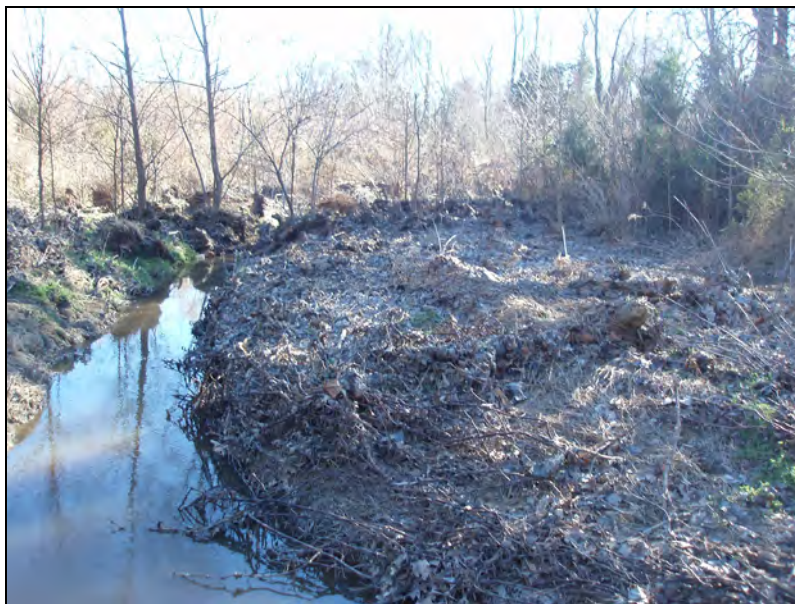
Photo 17. Bankfull indicators (wrack lines and flatten brush) - 1/3/2014
