**UT TO SOUTH FORK
FINAL MONITORING REPORT
YEAR 1 OF 5
2006**

**EEP Project # 435
Alamance County, North Carolina**

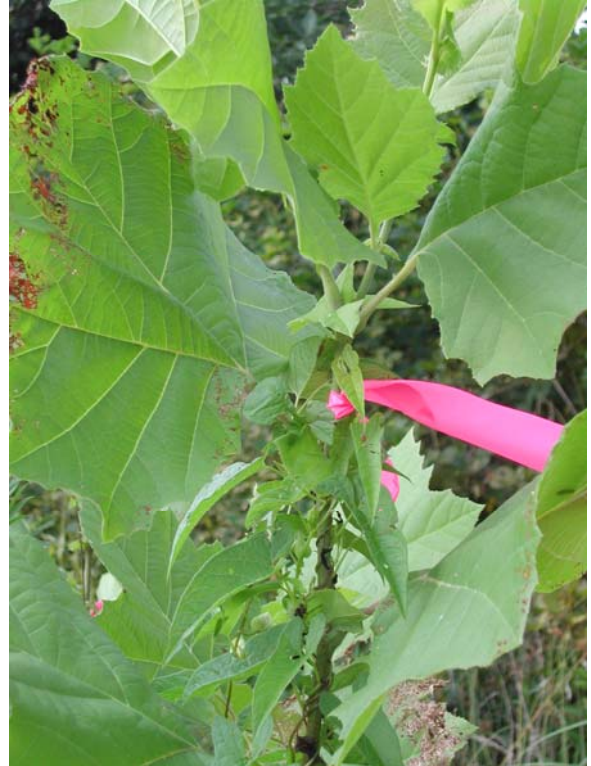
Table VI. Vegetative Problem Areas			
Feature/Issue	Station # / Range	Probable Cause	Photo #
Bare Flood Plain	13+20 - Reach 2 Right Bank	Seed wash and compact ground	3
Invasive/Exotic Populations		species migration from upland off of property	4

Photo 4: Morning Glory wraps around sycamore tree

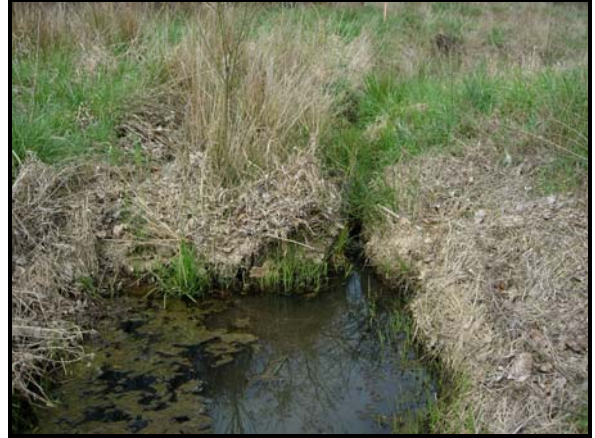
Narrowing of channel/grass slump

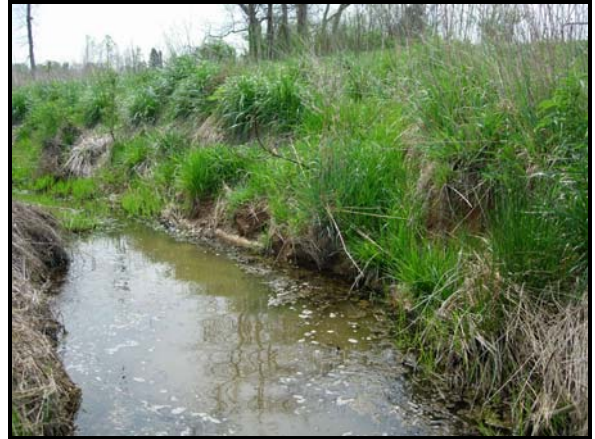
Toe Erosion along left bank (photo taken looking upstream)
