**UT TO SOUTH FORK  
FINAL MONITORING REPORT  
YEAR 2 OF 5  
2007**

**EEP Project # 435  
Alamance County, North Carolina**

## Executive Summary

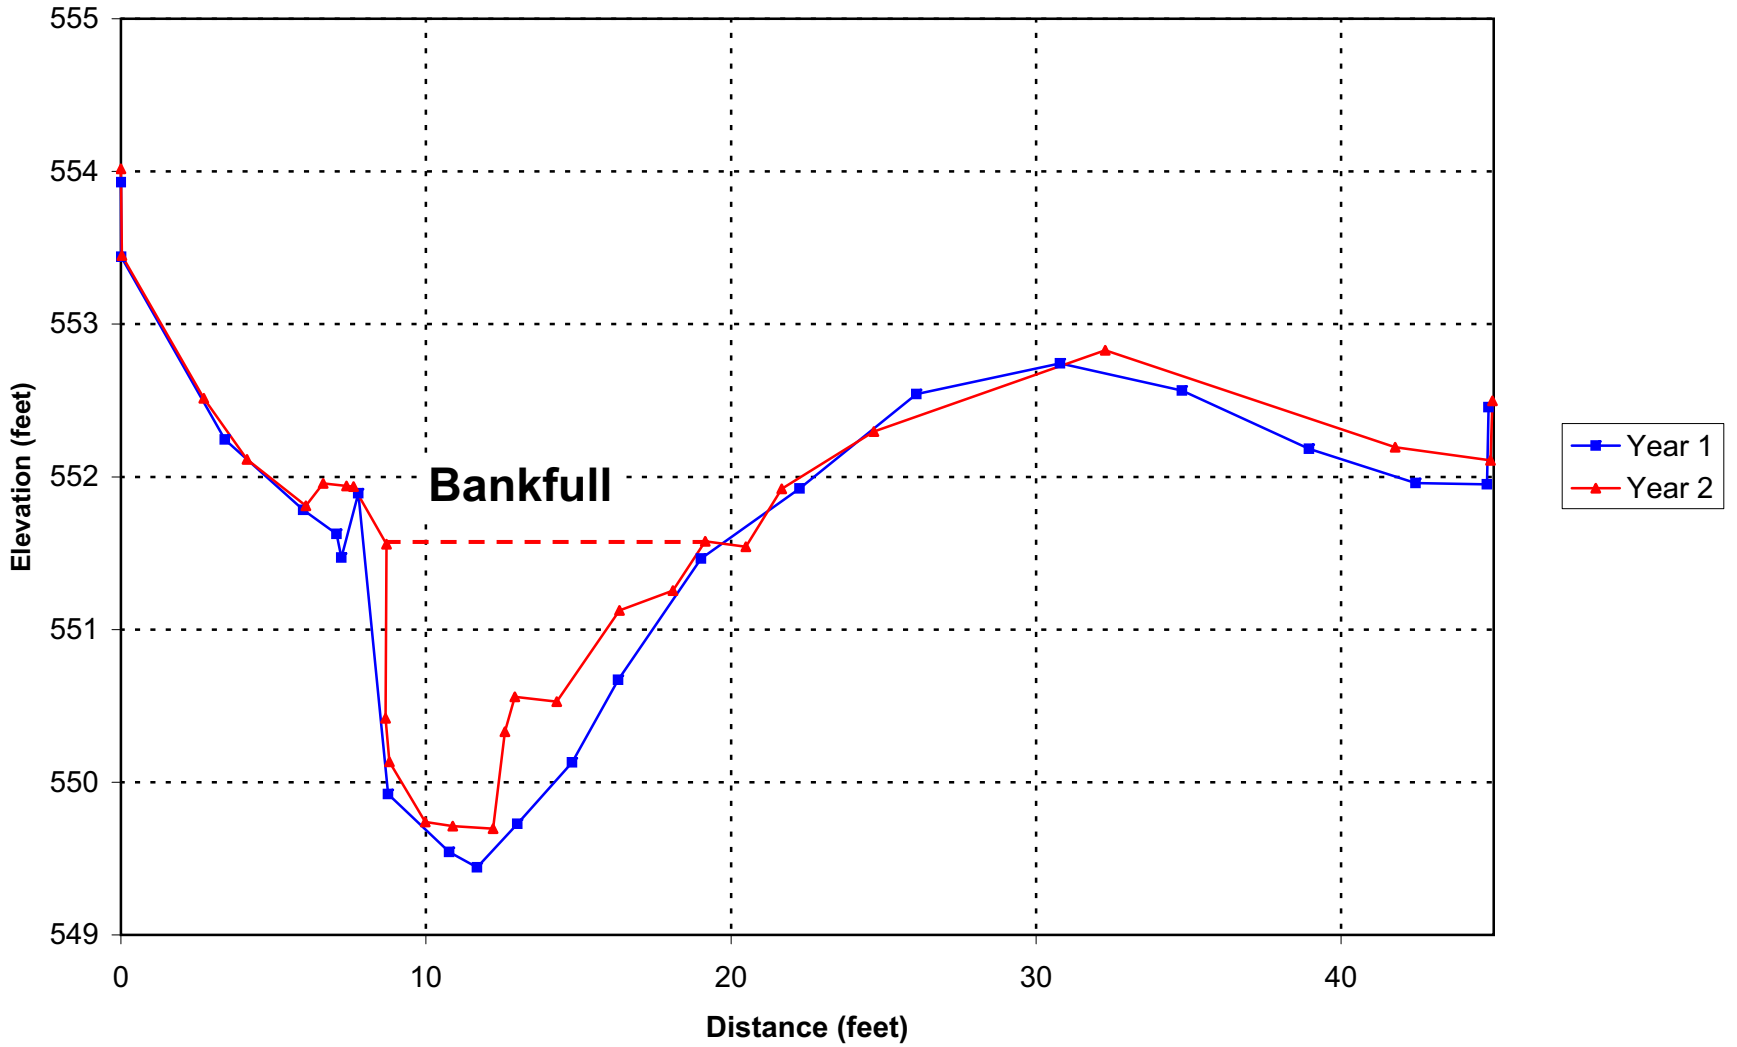
**Cross Section Overlay (Years 1 & 2)**  
**UT to South Fork - Reach 1**  
**Cross Section #4 (Pool)**

No cross sections have specific problem areas associated with them. However, there is a bank erosion (right) located just downstream of cross section #4 in Reach 1. This erosion has not affected the dimension of the cross section, but the area should be observed closely during future monitoring years to track any changes. All cross-section graphs are located in Appendix B.
