**UT TO SOUTH FORK
FINAL MONITORING REPORT
YEAR 3
2008**

EEP Project # 435
Alamance County, North Carolina

Original Design Firm:
ARCADIS G&M of North Carolina, Inc.
801 Corporate Center Drive, Suite 300
Raleigh, NC 27607

Monitoring Firm:

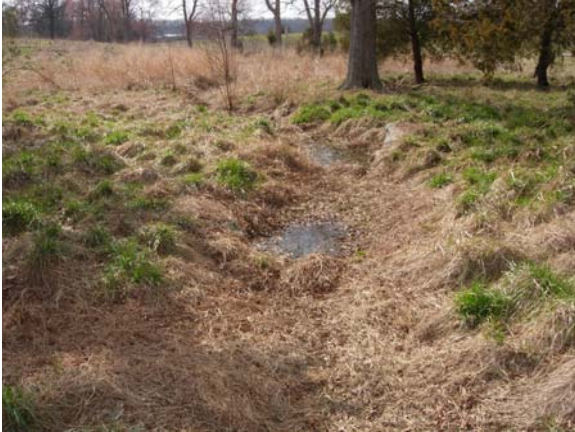
Photo 1: Representative *Microstegium virmineum* and *Festuca spp.*-dominated problem areas. *Microstegium virmineum* is the dry brown grass dominating the channel in foreground of the photo, and *Festuca spp.* is the green grass on floodplain (Station No. 14+35; view downstream on 3-03-2008).

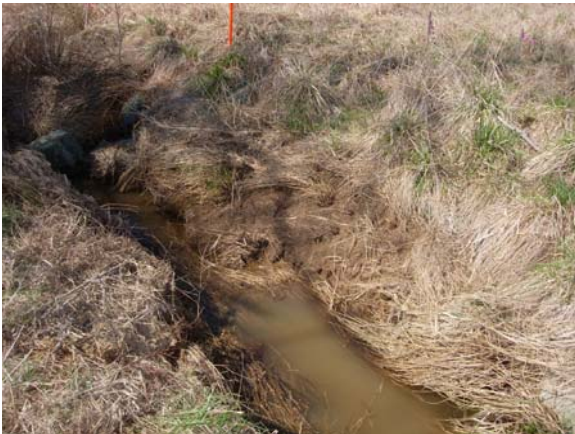
Table A2. Vegetative Problem Areas			
Feature/Issue	Station # / Range	Probable Cause	Photo #
Stream Reach 1			
<i>Ligustrum sinense</i> (Left Bank)	SR1 - 10+00	Invasive vegetative opportunism	
<i>Rosa multiflora</i> (Right Bank)	SR1 - 11+25	Invasive vegetative opportunism	
<i>Rosa multiflora</i> (Left Bank)	SR1 - 13+54	Invasive vegetative opportunism	
<i>Ligustrum sinense</i> (Right Bank)	SR1 - 13+56	Invasive vegetative opportunism	
<i>Ligustrum sinense</i> (Right Bank)	SR1 - 14+17 to 14+58	Invasive vegetative opportunism	
<i>Microstegium virmineum</i> (Both Banks)	SR1 - 14+27 to 14+39	Invasive vegetative opportunism	Photo 1
<i>Rosa multiflora</i> (Left Bank)	SR1 - 14+36	Invasive vegetative opportunism	
<i>Rosa multiflora</i> (Left Bank)	SR1 - 16+71	Invasive vegetative opportunism	
<i>Ligustrum sinense</i> (Left Bank)	SR1 - 18+40	Invasive vegetative opportunism	
Bare Bench/Bank	SR1 - 18+61 to 18+66	Lack of vegetation/erodible soil texture	Photo 2

Photo 2: Representative bare bank problem area (Station No. 18+61 – 19+67; view upstream; 3-05-2008).

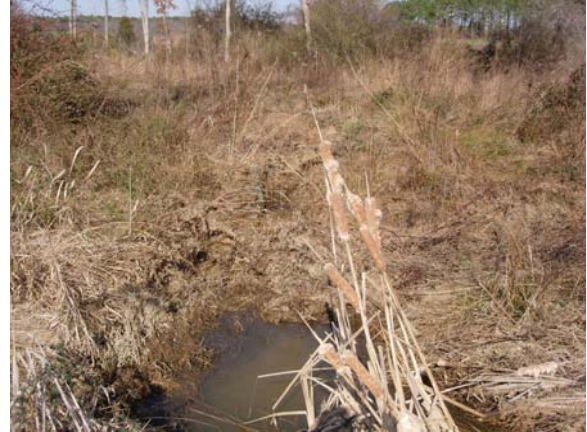
Photo 2: Although not considered a 'problem,' it should be noted that cattails, which are sometimes invasive, were noted along all three reaches. This is a representative cattail (*Typha latifolia*) growth area on Monitoring Reach 2 (Station No. 11+00; view downstream on 3-06-2008). Also there is a large multiflora rose (*Rosa multiflora*) located on the left bank in the upper left-hand corner of the photo.

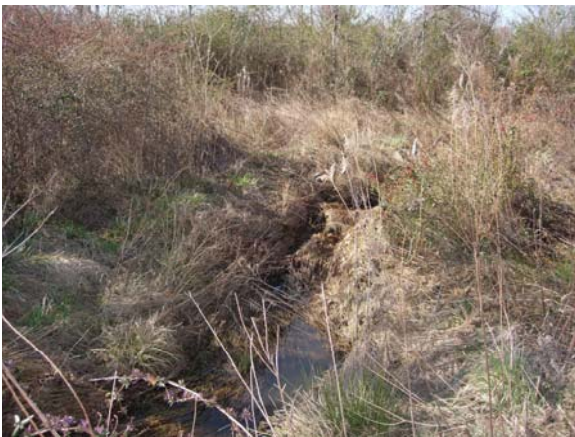
<i>Microstegium virmineum</i> (Left Bank)	SR1 - 19+83 to 20+09	Invasive vegetative opportunism	
<i>Ligustrum sinense</i> (Left Bank)	SR1 - 19+80	Invasive vegetative opportunism	
<i>Ligustrum sinense</i> (Left Bank)	SR1 - 20+09 to 20+24	Invasive vegetative opportunism	
<i>Ligustrum sinense</i> (Left Bank)	SR1 - 20+46	Invasive vegetative opportunism	
<i>Festuca</i> spp.	SR1 - entire reach	Invasive vegetative opportunism - Fescue has dominated most of the herbaceous understory.	Photo 1
Stream Reach 2			
<i>Rosa multiflora</i> (Left Bank)	SR2 - 10+04 to 14+29	Invasive vegetative opportunism	
<i>Rosa multiflora and Ligustrum sinense</i> (Left Bank)	SR2 - 10+51 to 14+08	Invasive vegetative opportunism	
<i>Ligustrum sinense</i> (Right Bank)	SR2 - 10+68 10+94	Invasive vegetative opportunism	Photo 1
<i>Rosa multiflora</i> (Right Bank)	SR2 - 11+30 to 11+41	Invasive vegetative opportunism	
<i>Rosa multiflora</i> (Left Bank)	SR2 - 11+17 to 11+71	Invasive vegetative opportunism	Photo 3

Photo 3: Representative multiflora rose (*Rosa multiflora*) problem area (Station No. 11+60; view downstream on 3-06-2008). Rose is located on left bank in upper left corner of photo.

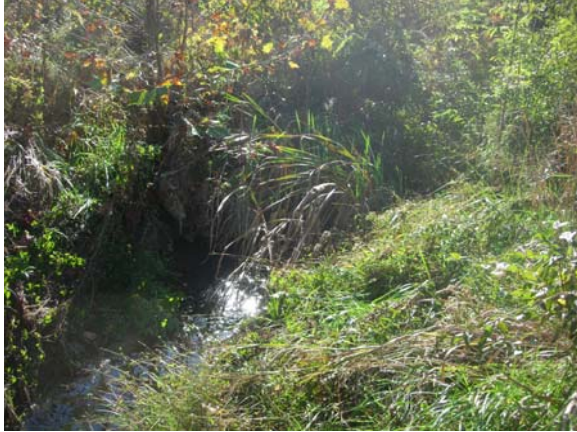
Photo 1: Although not considered a ‘problem,’ it should be noted that cattails, which are sometimes invasive, were noted along all three reaches. This is a representative cattail (*Typha latifolia*) growth area on Monitoring Reach 3 (Station No. 11+10; view upstream on 10-22-2008). Cattails are growing in channel at center of photo

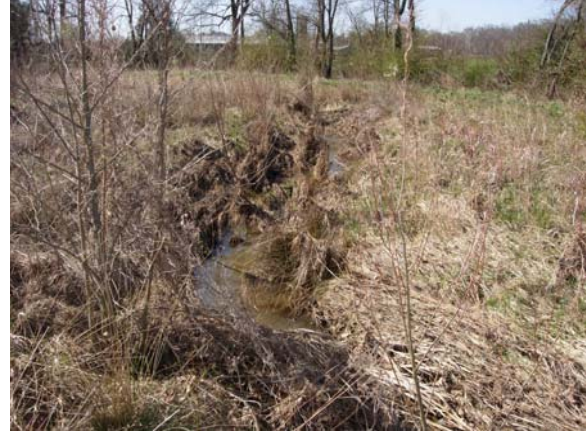
Photo 2. Representative Chinese privet (*Ligustrum sinense*) problem area (Approximate Station No. 13+10 – 13+50; view upstream on 3-17-2008). Privet are the green shrubs located on the floodplain along the Western side of the project (i.e., along the top of the photo in the background).
