**FINAL**  
**Baseline Monitoring Document and As-Built Baseline Report**  
**UT to Cane Creek Restoration Project**

Alamance County, North Carolina

EEP Project ID No. 95729

**Data Collection Period – July 2014**

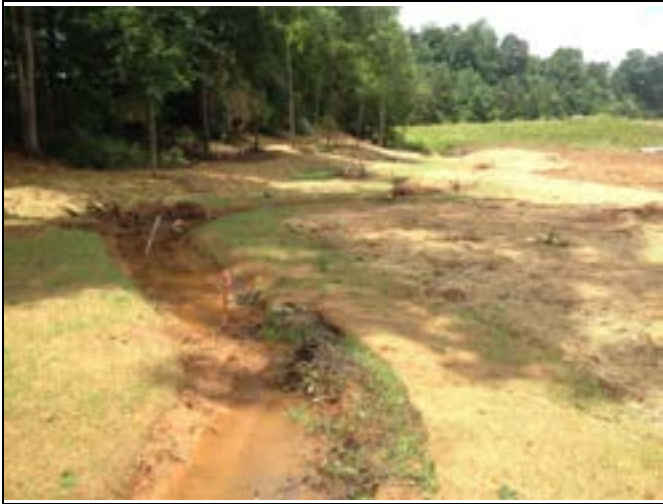
Reach 1, view upstream towards dam at station 12+50  
(June 12, 2014)

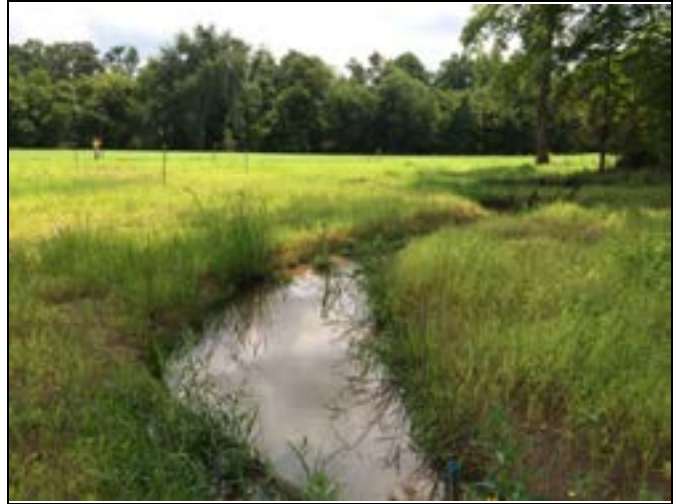
Reach 1, view downstream at station 12+50  
(July 30, 2014)

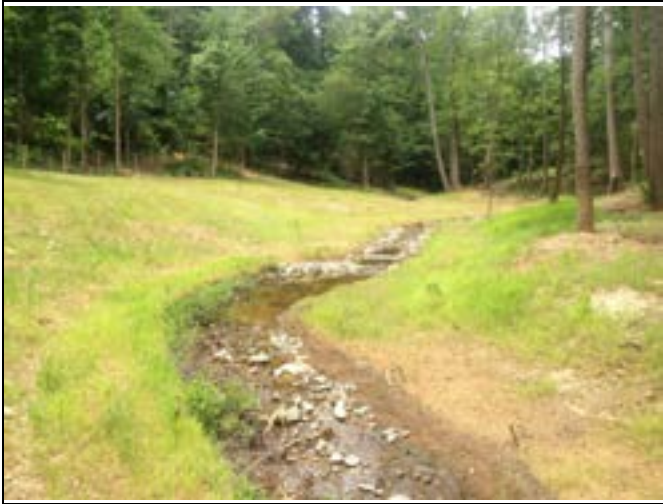
Reach 3, view upstream at station 12+50 (June 5, 2014)

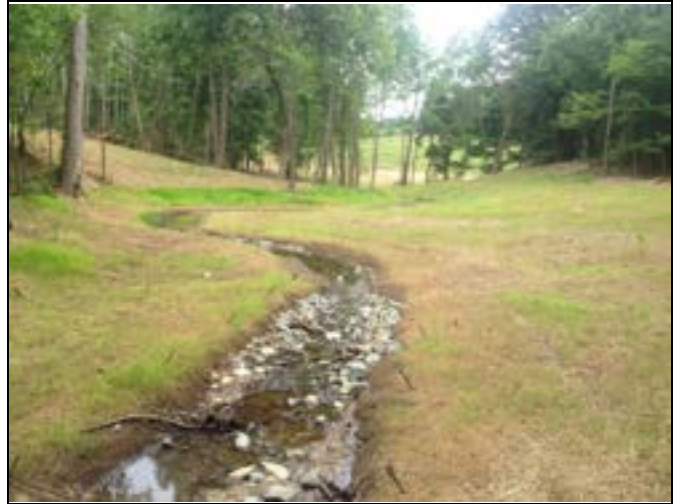
Reach 3, view downstream at station 10+90 (June 5, 2014)

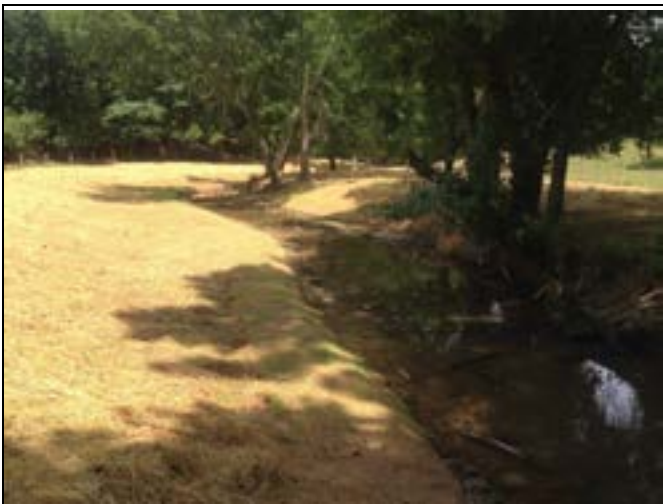
Reach 4, view upstream at 55+00 (June 5, 2014)

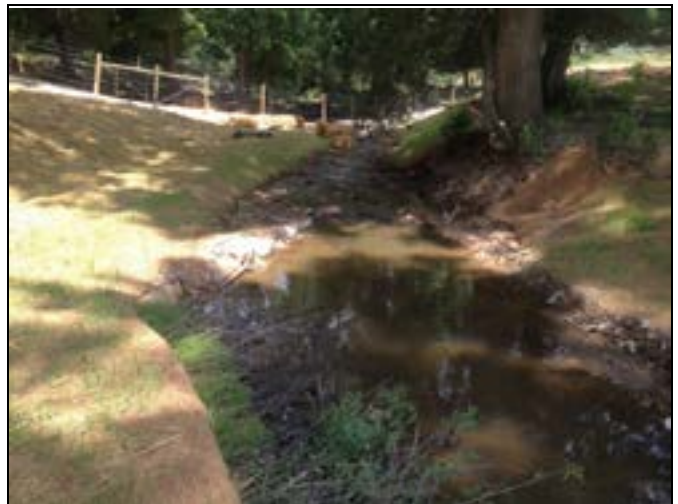
Reach 4, rock J-Hook, view upstream at station 53+75  
(June 5, 2014)

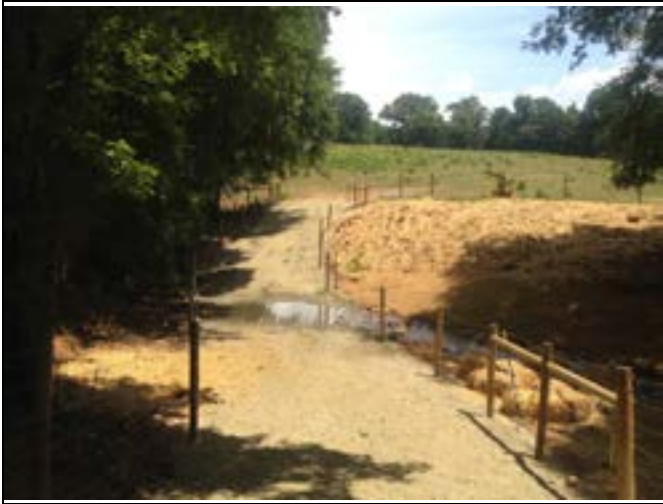
Reach 4, crossing at station 53+00 (June 5, 2014)

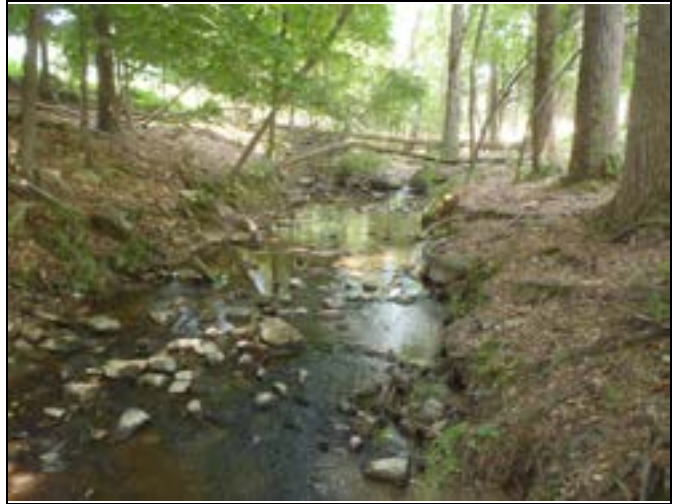
Reach 4, view upstream at station 34+00 (May 27, 2014)

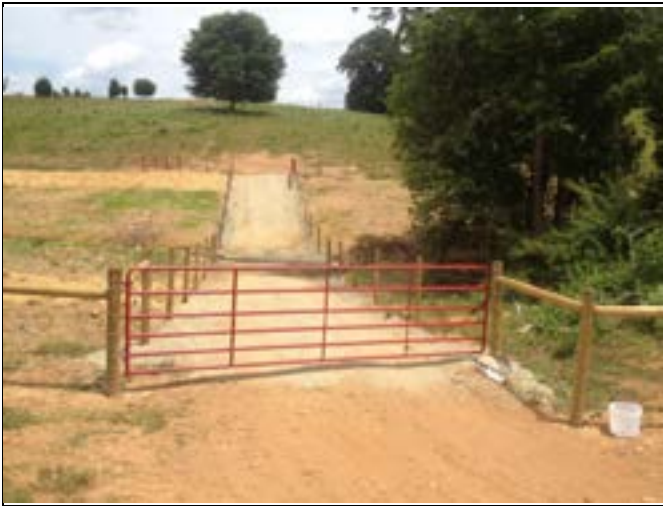
Reach 4, crossing at station 33+00 (June 5, 2014)

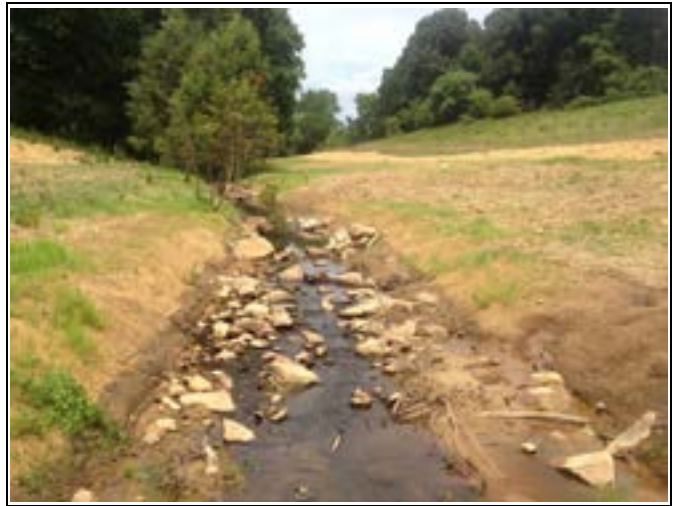
Reach 4, view upstream at station 32+00 (June 5, 2014)

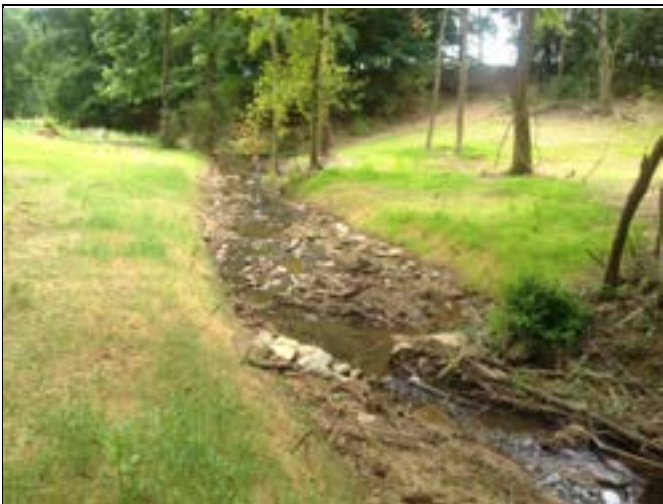
Reach 5, view downstream at station 28+00 (June 5, 2014)

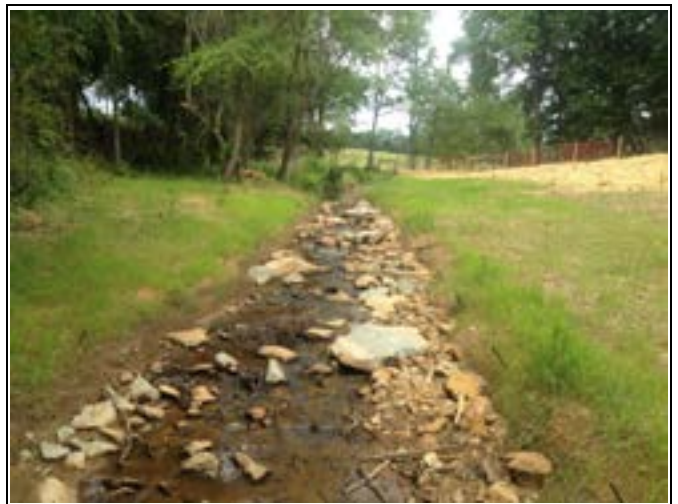
Reach 5, view upstream at station 27+75 (June 5, 2014)

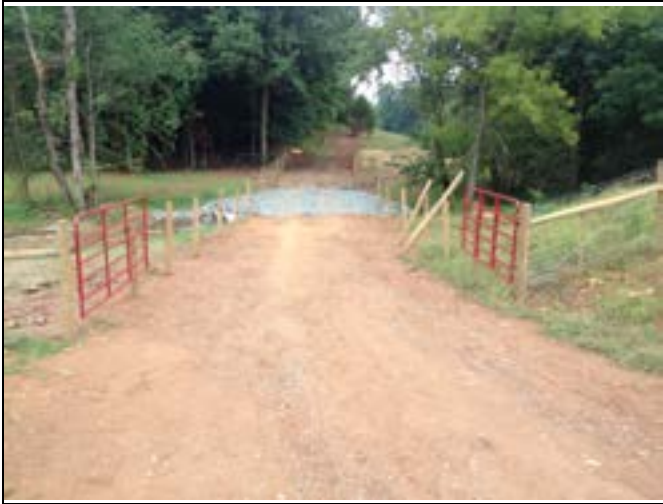
Reach 5, crossing at station 24+75 (June 12, 2014)

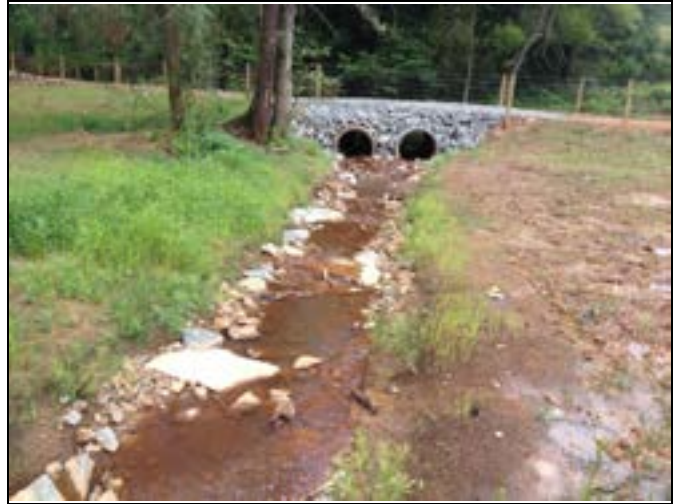
Reach 5, view downstream at station 24+00 (June 12, 2014)

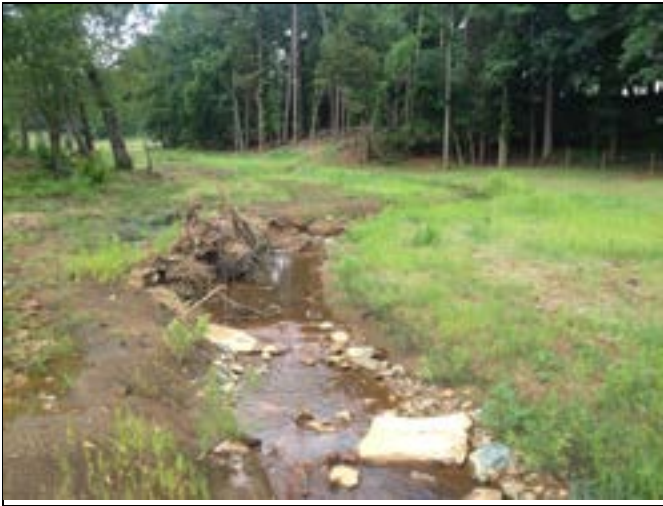
Reach 5, view upstream at station 24+25 (June 12, 2014)

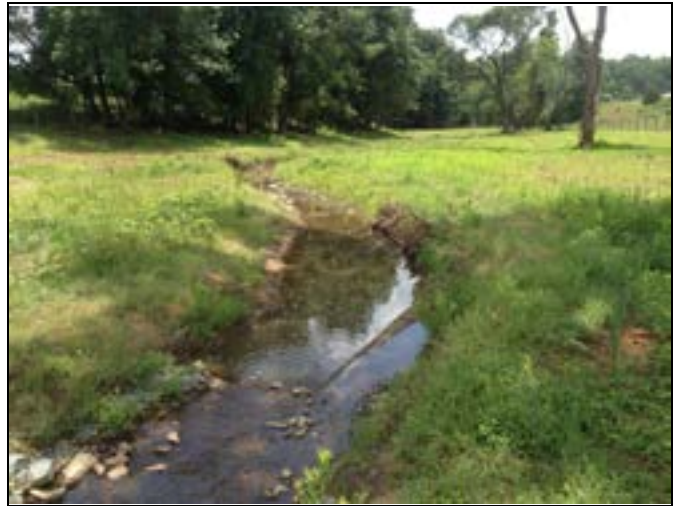
Reach 5, view downstream at station 17+75 (June 12, 2014)

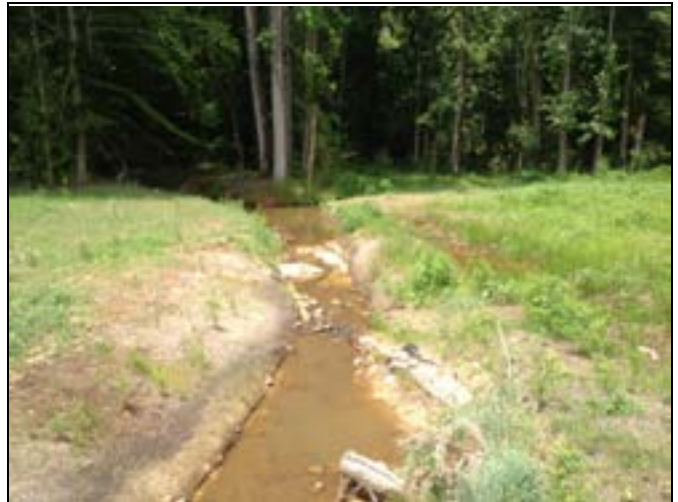
Reach 5, view upstream at station 11+50 (June 12, 2014)
