# **UT to Cane Creek Restoration Project Year 1 Monitoring Report**

**Alamance County, North Carolina  
NCDENR DMS Project ID Number – 95729**

Report Prepared and Submitted by Michael Baker Engineering, Inc.  
NC Professional Engineering License # F-1084

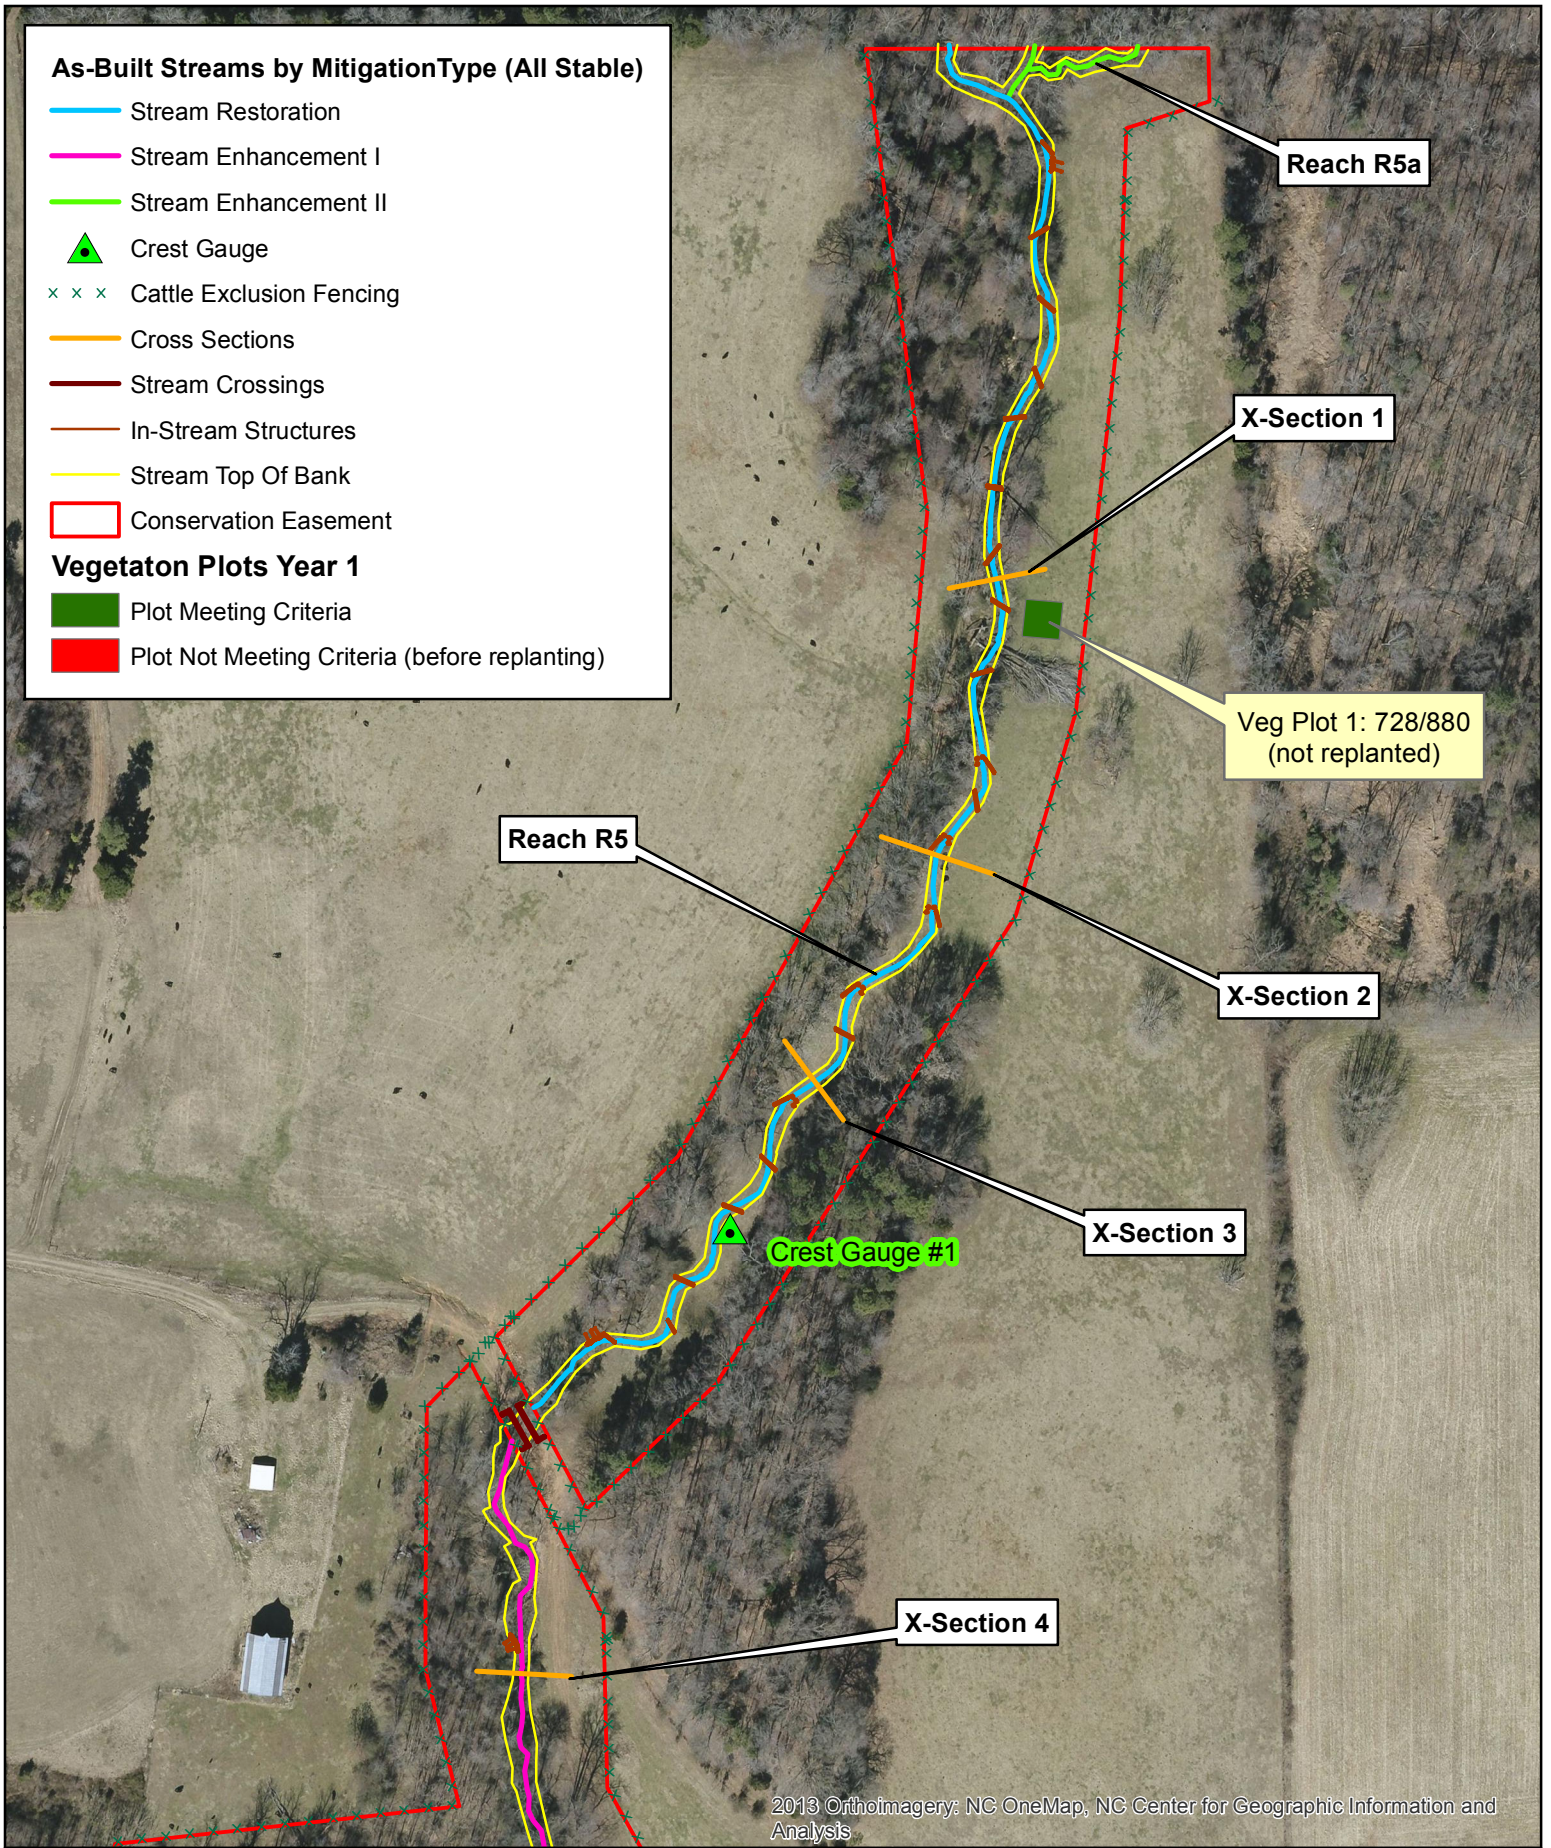
**Current Condition**  
Plan View - Figure 2B  
UT to Cane Creek Site  
Alamance County, NC

Veg Plot 1: 728/880  
(not replanted)

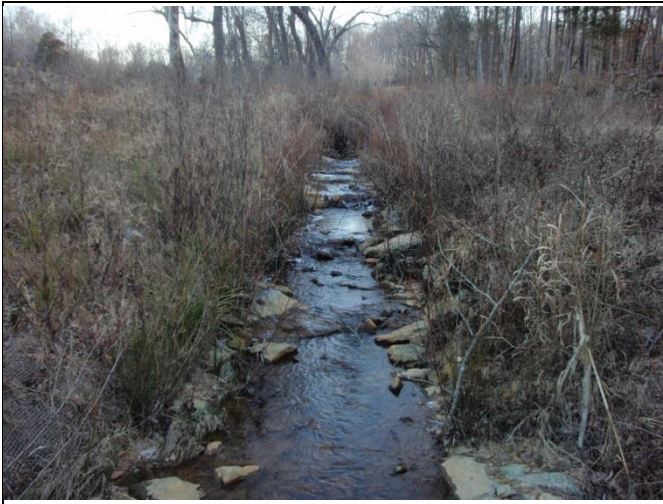
Reach R5 – View upstream of culvert, Station 24+75

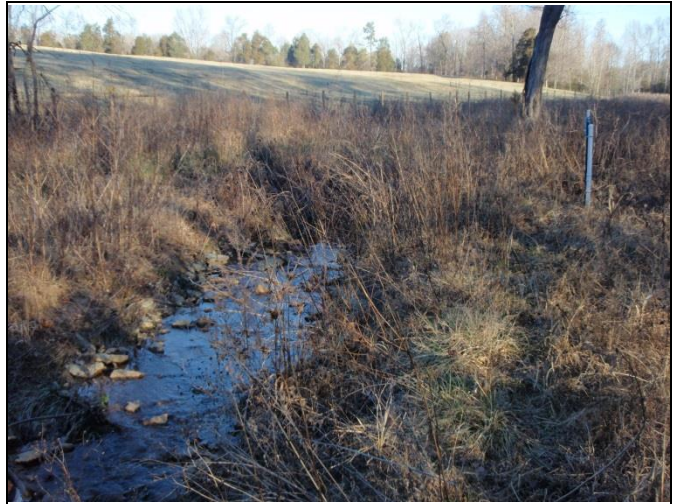
Reach R5 – View upstream towards crest gauge, Station 22+00

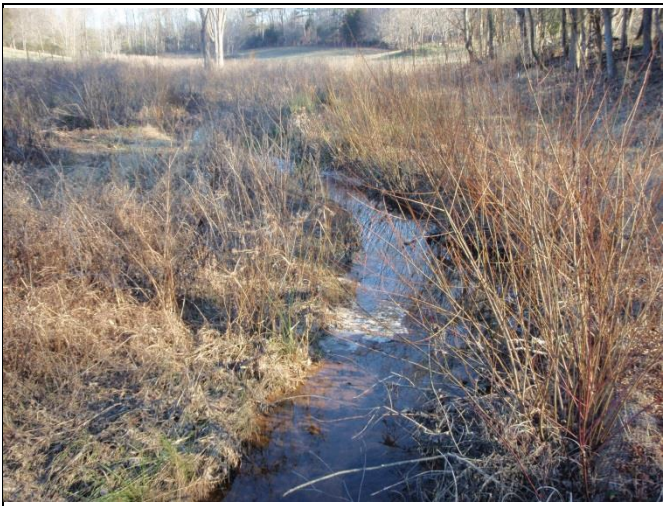
Reach R5 – View upstream, Station 20+00

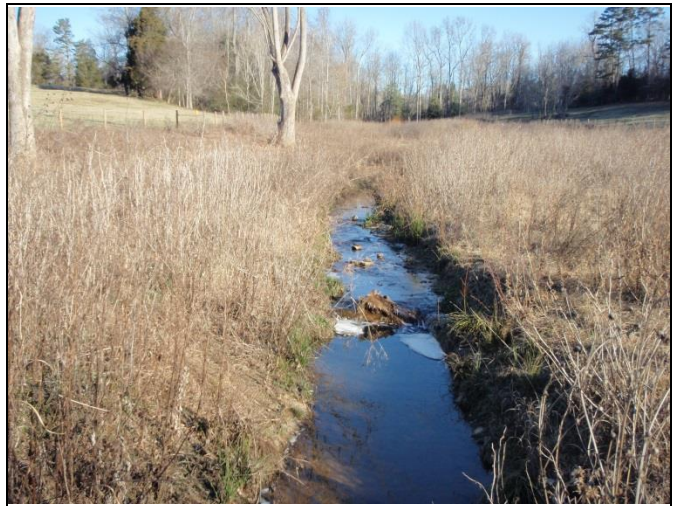
Reach R5 – View upstream, Station 18+50

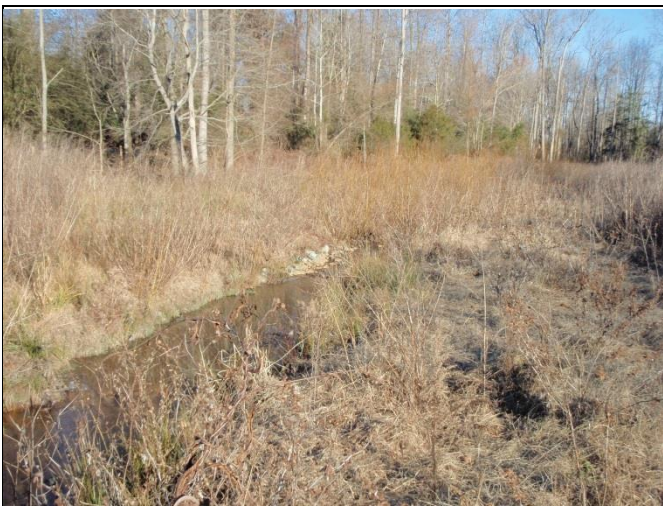
Reach R5 – View upstream, Station 17+00

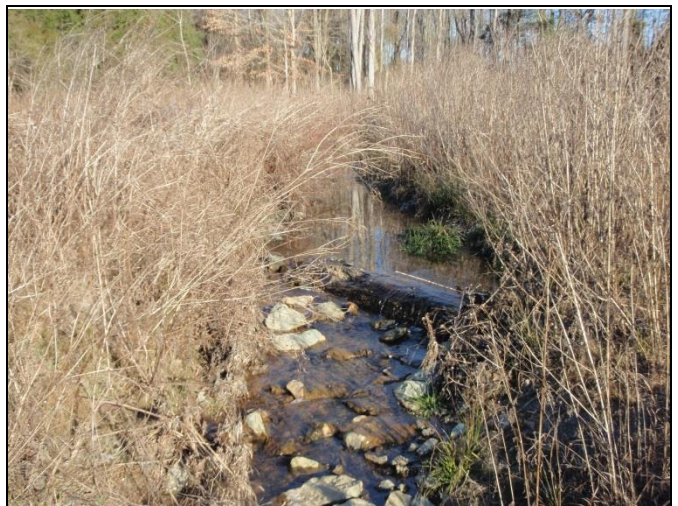
Reach R5 – View upstream, Station 13+75

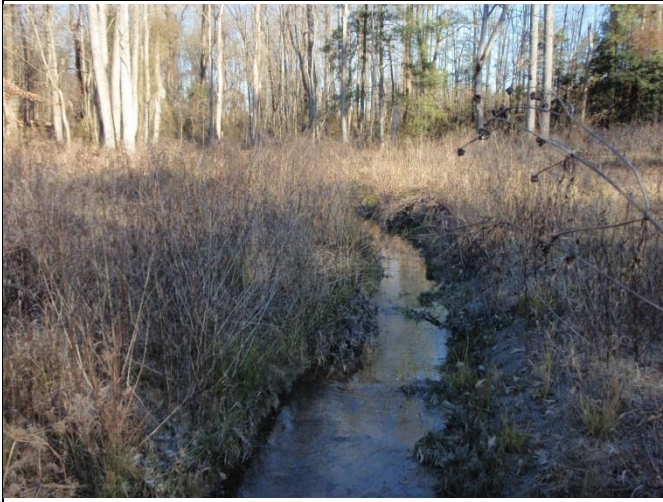
Reach R5 – View upstream, Station 12+00

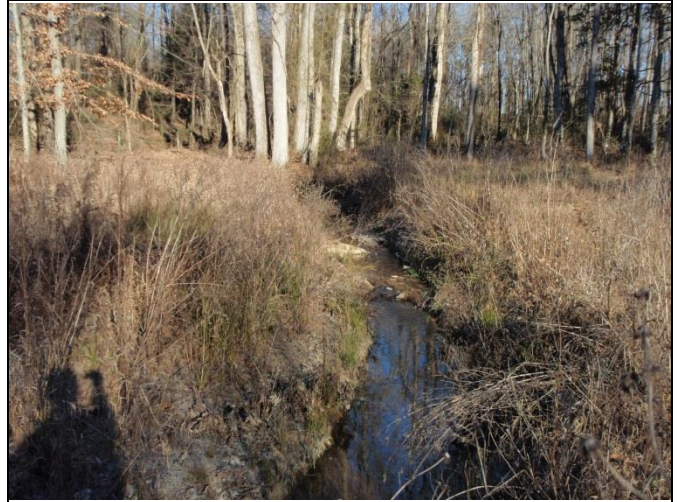
Reach R5 – View upstream, Station 11+50

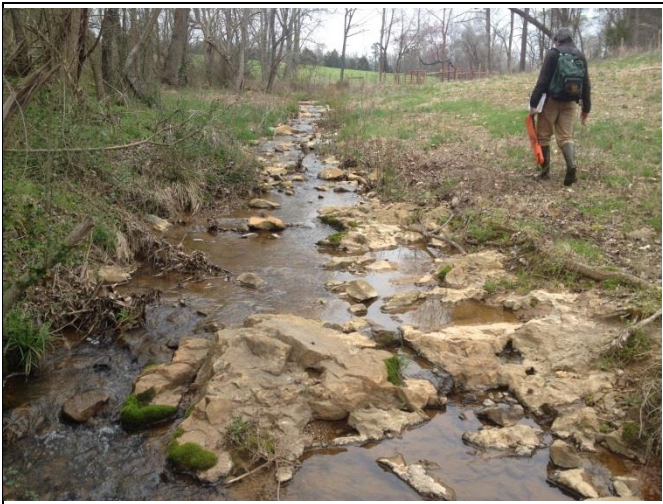
Reach R4 – View upstream, Station 26+00

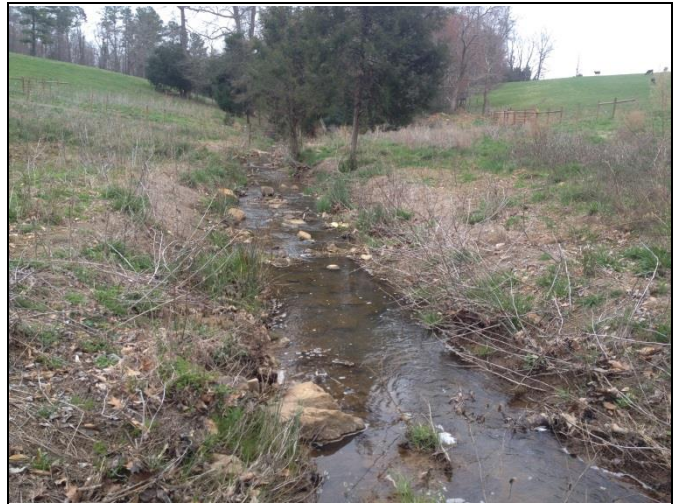
Reach R4 – View downstream, Station 31+75

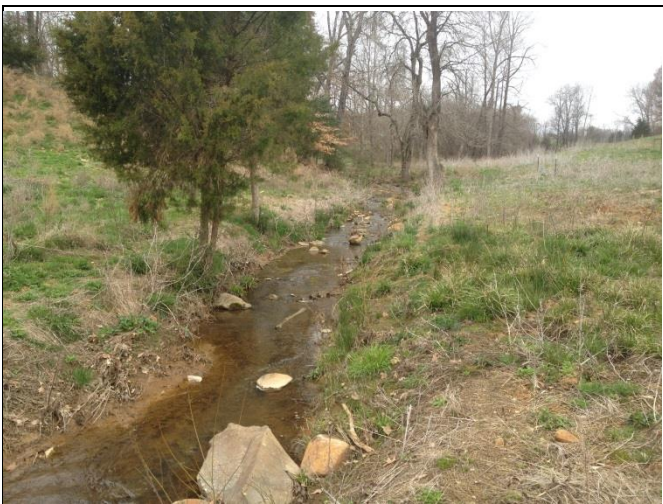
Reach R4 – View upstream, Station 32+50

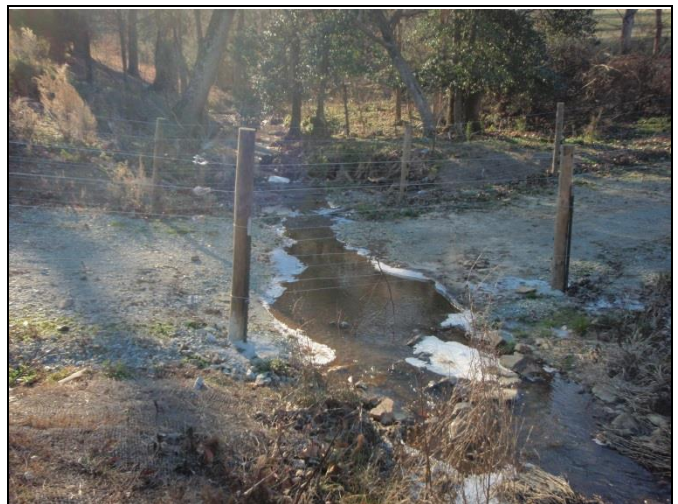
Reach R4 – View downstream, stream crossing,  
Station 33+00

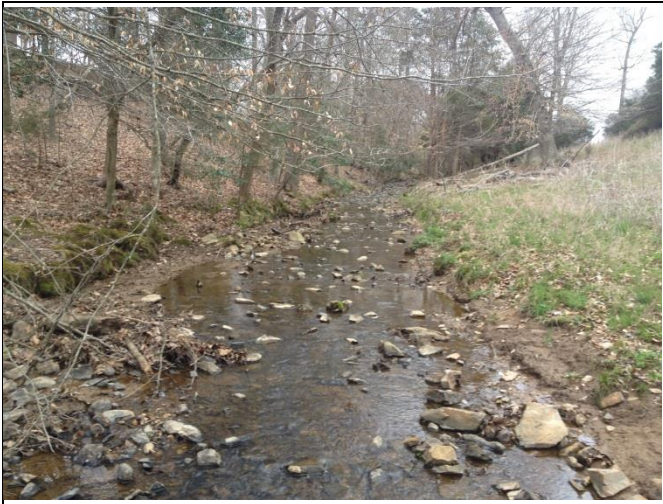
Reach R4 – View upstream, enhancement area,  
Station 37+50

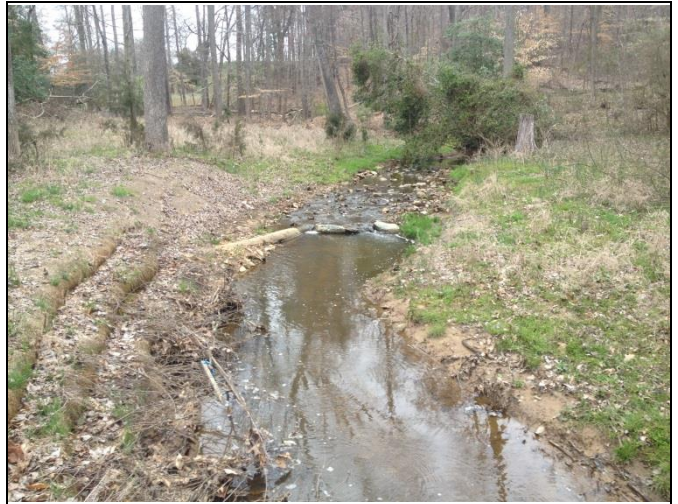
Reach R4 – View upstream, enhancement area  
(Log J-Hook), Station 43+50

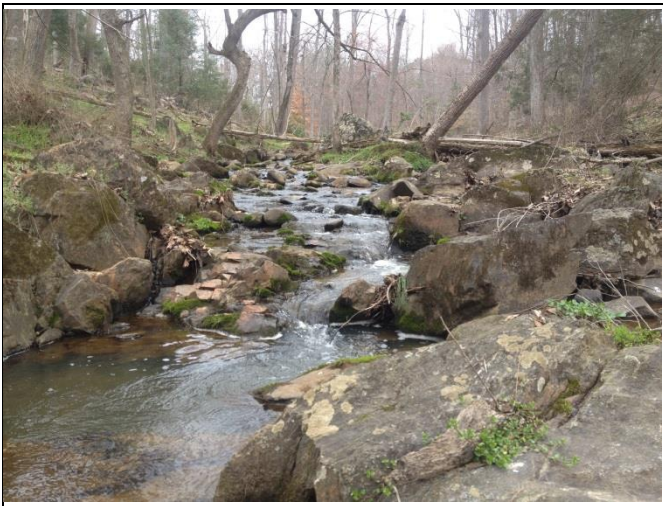
Reach R4 – View upstream, enhancement area,  
Station 48+50

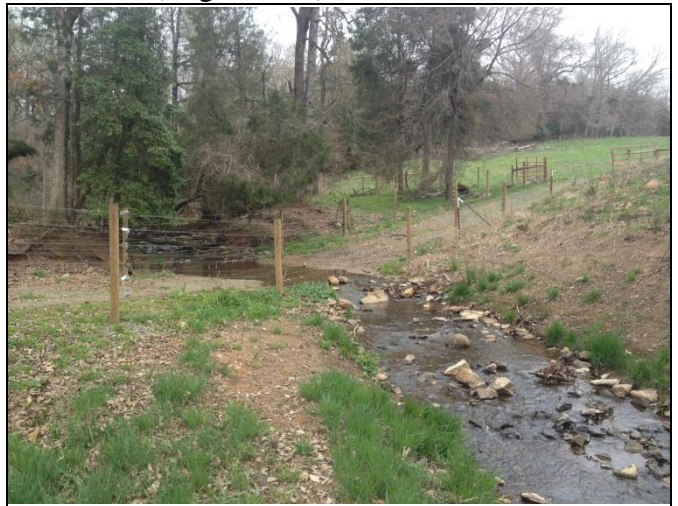
Reach R4 – View upstream, stream crossing,  
Station 53+50

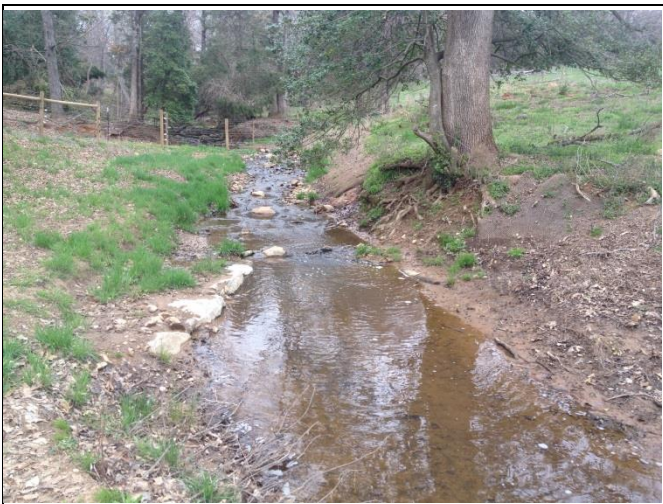
Reach R4 – View upstream, Station 55+50

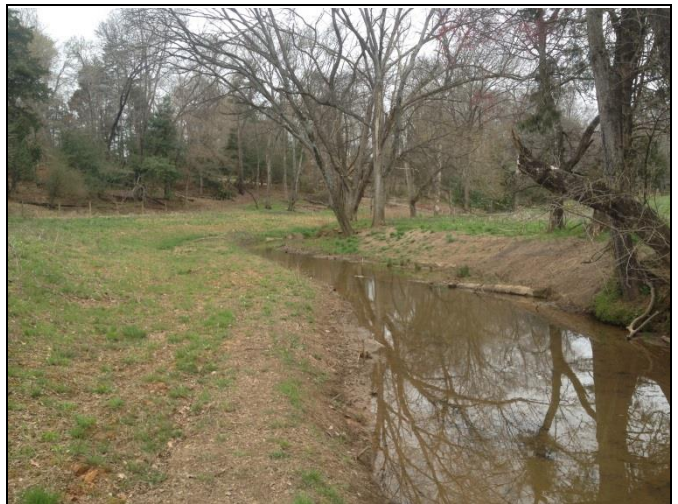
Reach R4 – View upstream, Station 56+75

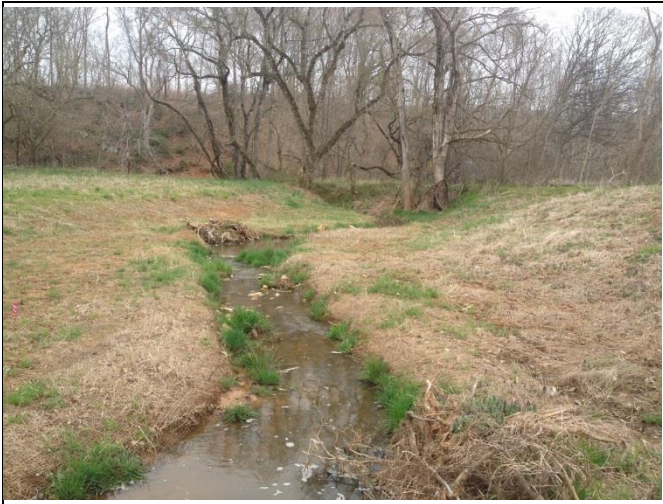
Reach R1 – View downstream, Station 20+00

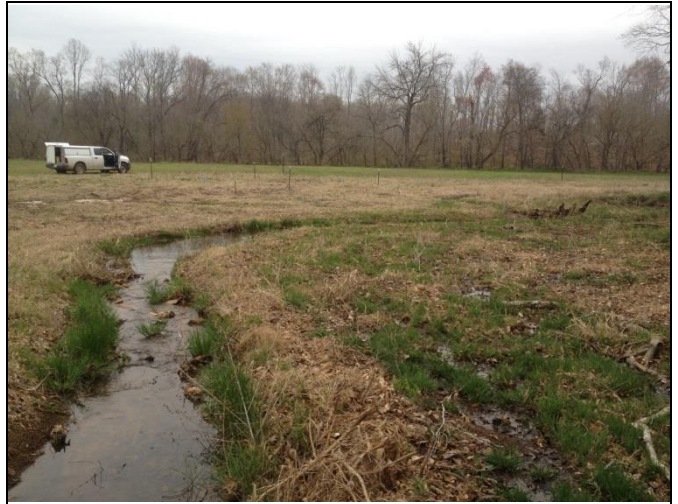
Reach R1 – View downstream, Station 13+75

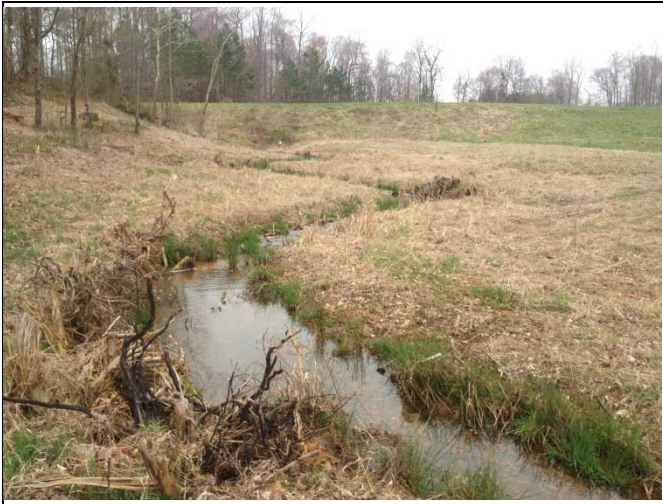
Reach R1 – View upstream, Station 12+25

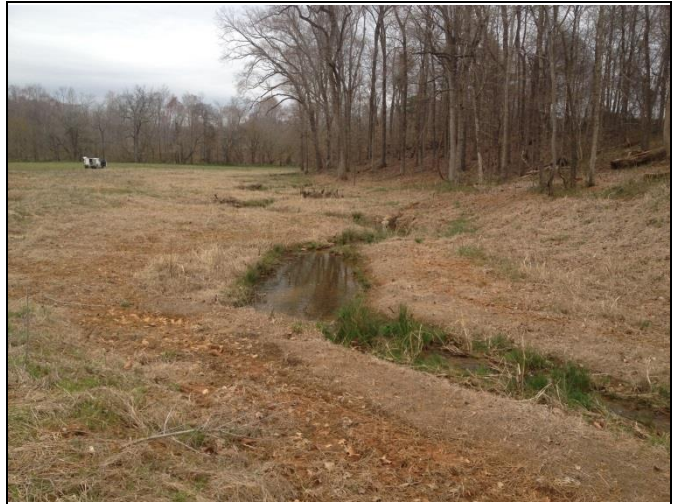
Reach R1 – View downstream, Station 10+50

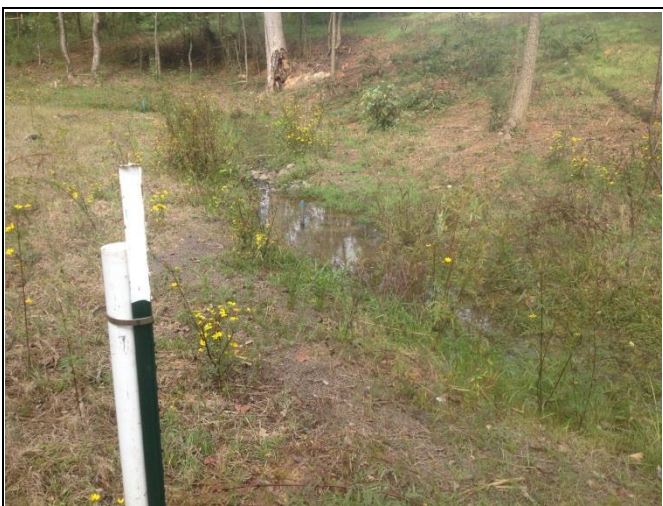
Reach R3 – Crest gauge location

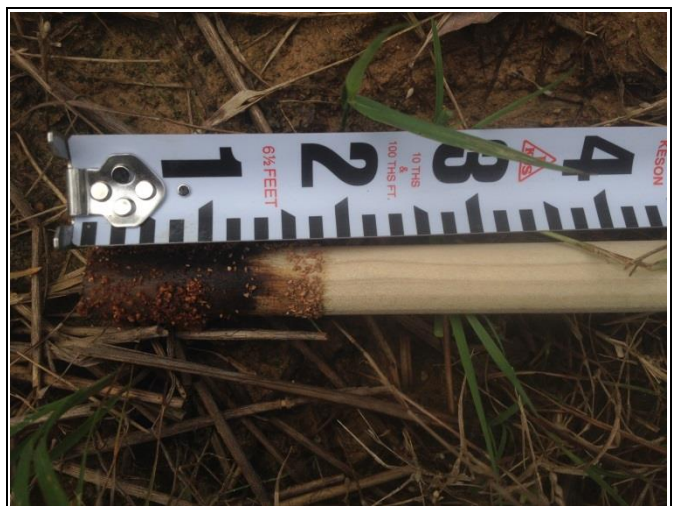
During Year 1 monitoring, no flow events above bankfull stage were documented by the Reach R5 crest gauge. However, an above bankfull reading of 0.18 feet (2.16 inches) was measured on Reach R3 during a flow event on or about July 16, 2014. Crest gauge readings are presented in Appendix E.

Reach R3 – Crest gauge reading, 0.18 inches, on October 1, 2014 (bankfull event ~July 16, 2014)
