UT to Cane Creek Restoration Project Year 2 Final Monitoring Report

**Alamance County, North Carolina
NC DEQ-DMS Project ID Number – 95729**

Report Prepared and Submitted by Michael Baker Engineering, Inc.
NC Professional Engineering License # F-1084

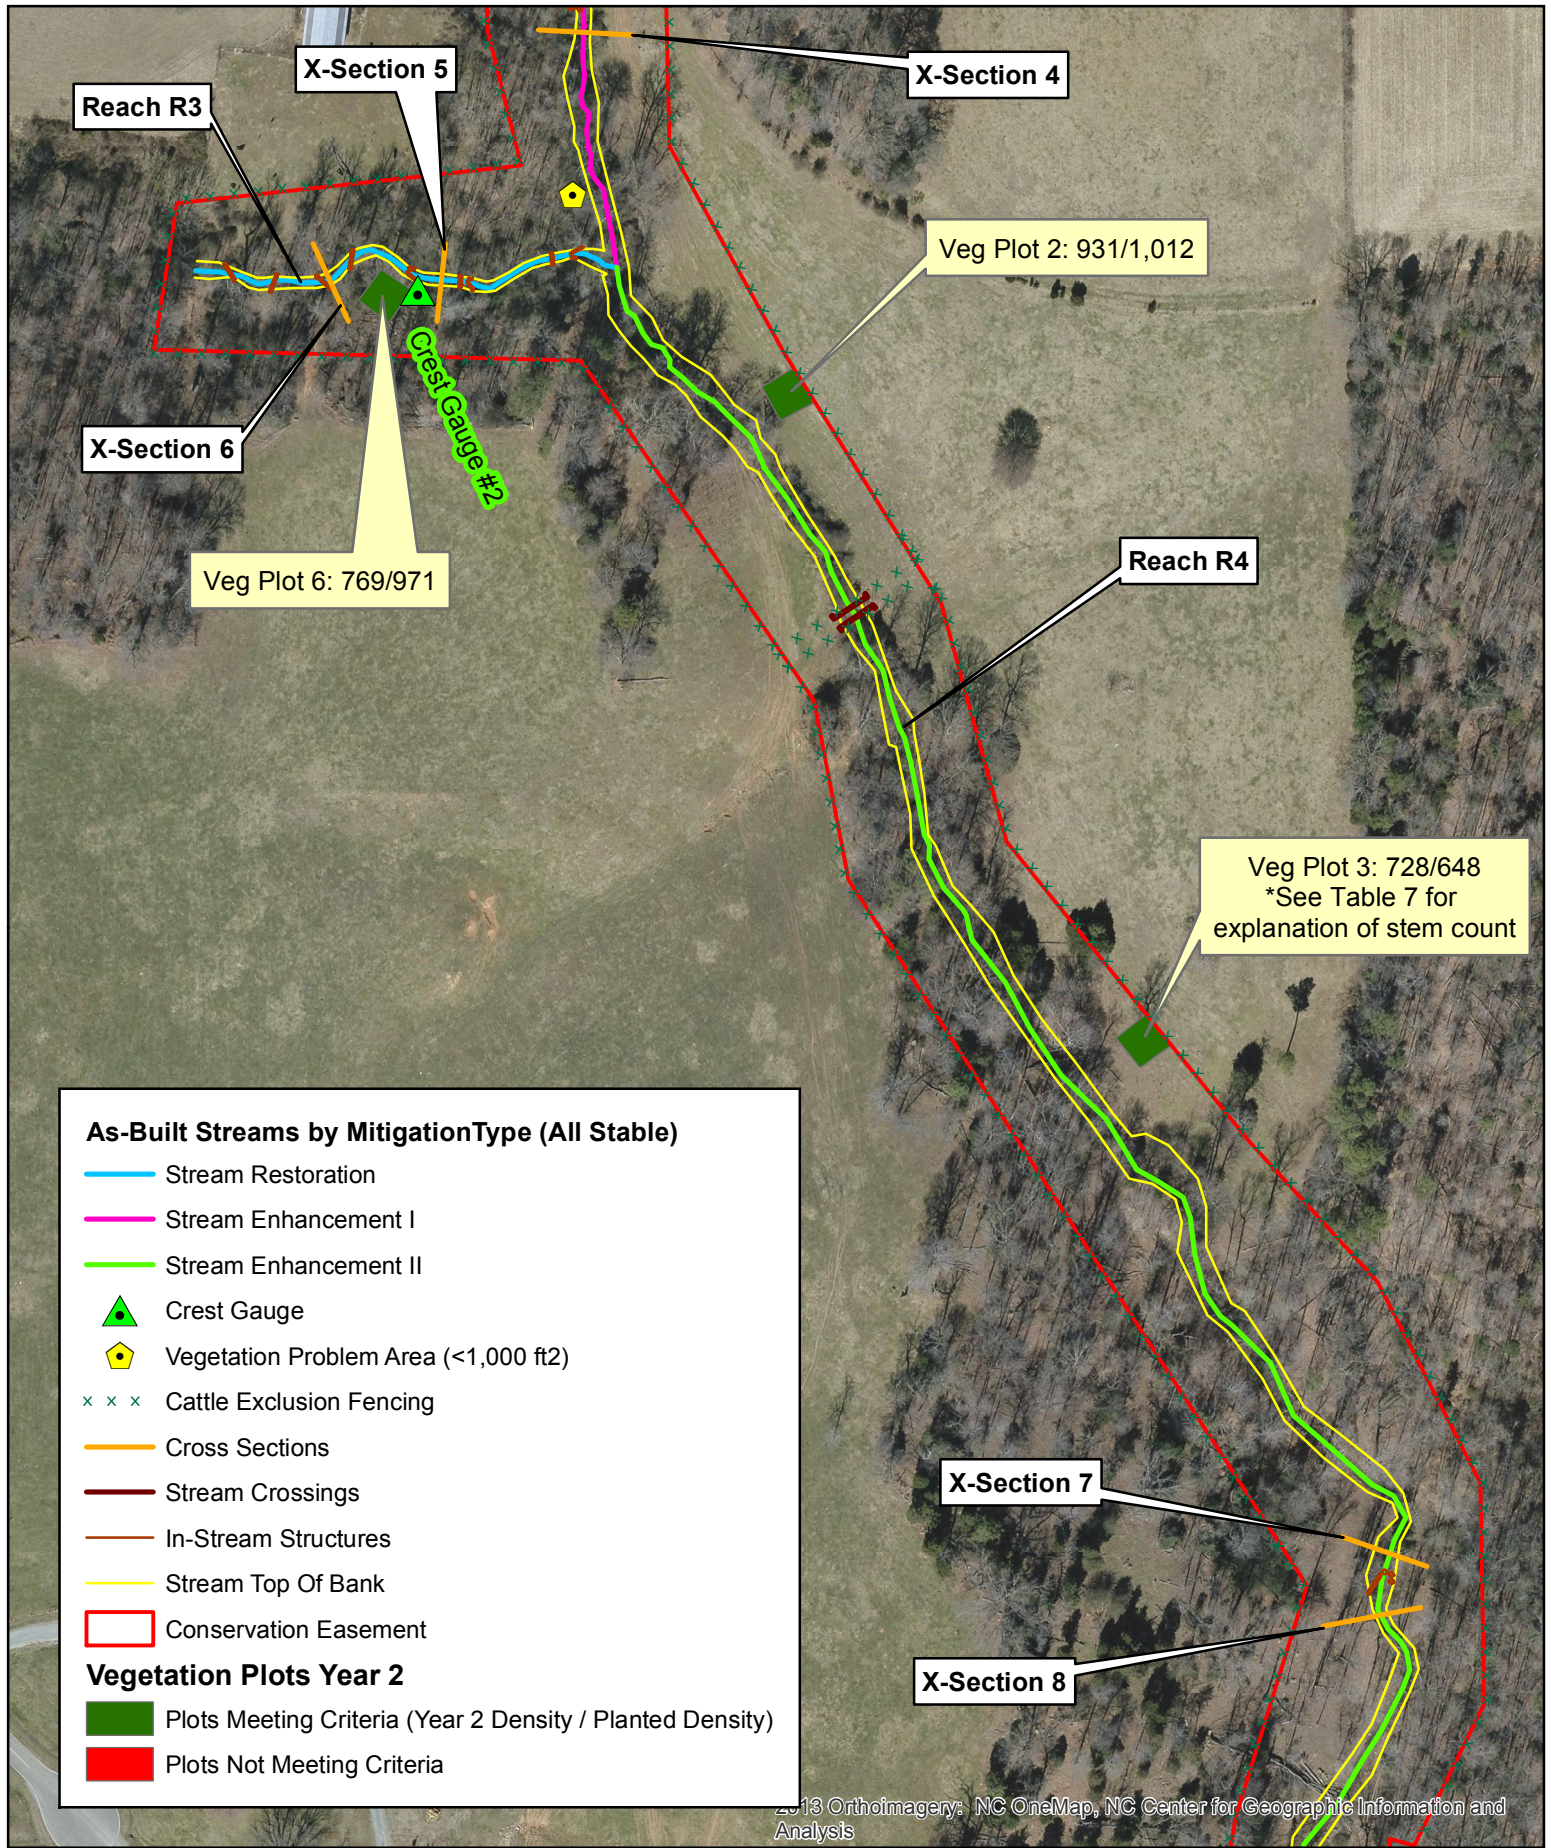
**Current Condition
 Plan View - Figure 4B
 Monitoring Year 2
 UT to Cane Creek Site**

One area of invasive species vegetation was observed during Year 2 monitoring. It is noted that re-sprouts of *Ligustrum sinense* (Chinese privet) was noted along Reach 5 near the confluence with Reach 3. The Chinese privet plants observed consist of an area less than 1000 square feet and is shown on the Current Condition Plan View (CCPV) map in the Appendix B.

* See Figure 4B for location of invasive species

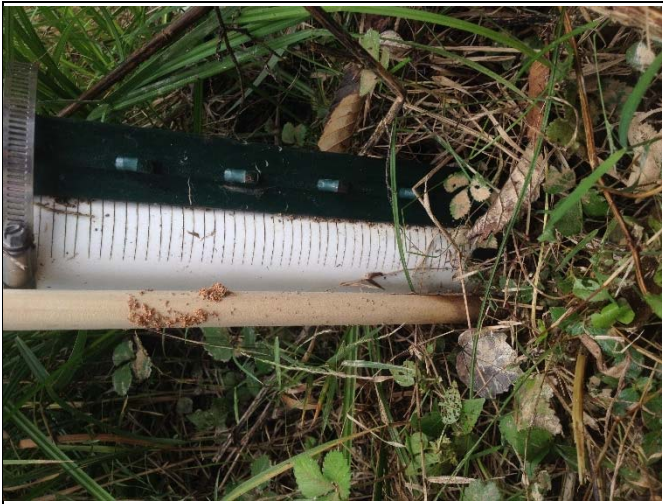
During Year 2 monitoring, the Reach R3 crest gauge (crest gauge 2) documented at least two post-construction bankfull events. Additionally, the Reach R5 crest gauge (crest gauge 1) recorded one bankfull event during Year 2 monitoring.

Reach R5 – Crest Gauge 1, 0.62 feet. October 13, 2015

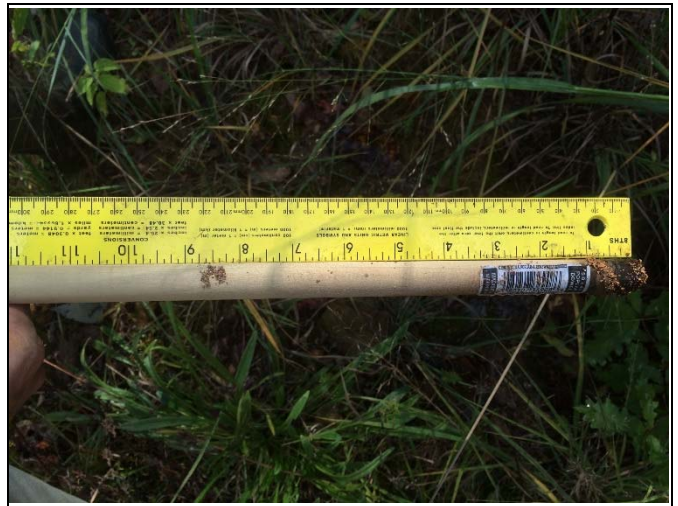
Reach R3 – Crest Gauge 2, 0.79 feet. October 13, 2015

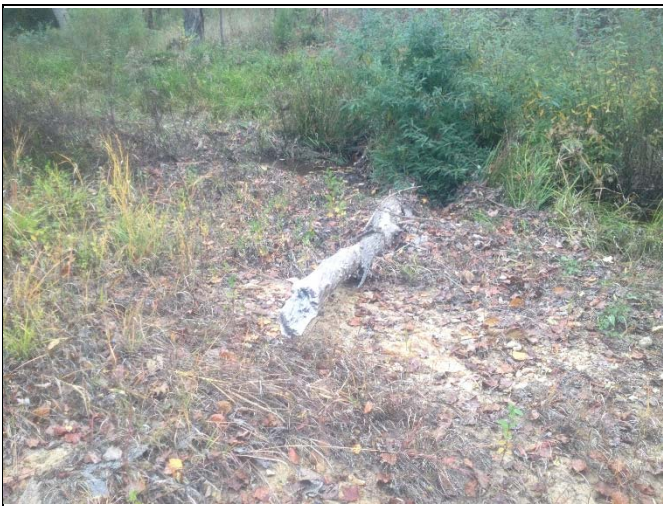
Reach R5 lower – Bankfull evidence, October 26, 2015

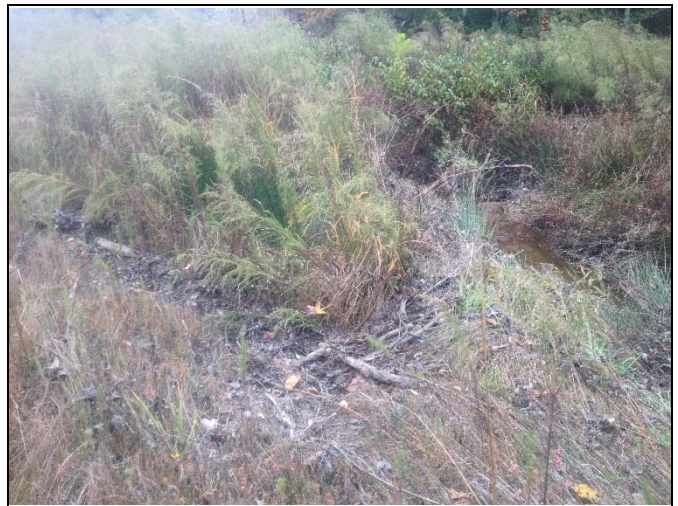
Reach R5 upper – Bankfull evidence, October 26, 2015

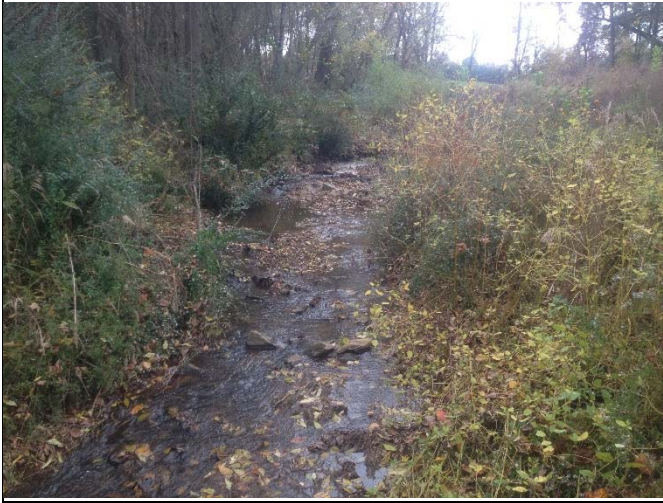
One area of Chinese privet less than 1,000 square feet was noted at Station 28+50 on the downstream portion of Reach 5. This area will be closely monitored during Year 3 and appropriate actions will be taken if deemed necessary.

Table 6b. Vegetation Problem Areas (VPAs)			
UT to Cane Creek Restoration Project: DMS Project ID No. 95729			
Feature Issue	Station Number	Suspected Cause	Photo Number
Chinese privet (<i>Ligustrum sinense</i>)	*Reach 5, Station ~28+50	Re-sprout	VPA 1, 2, 3

1) Vegetation Problem Area #1 – Vicinity of Reach 5 Station 28+50, October 2015

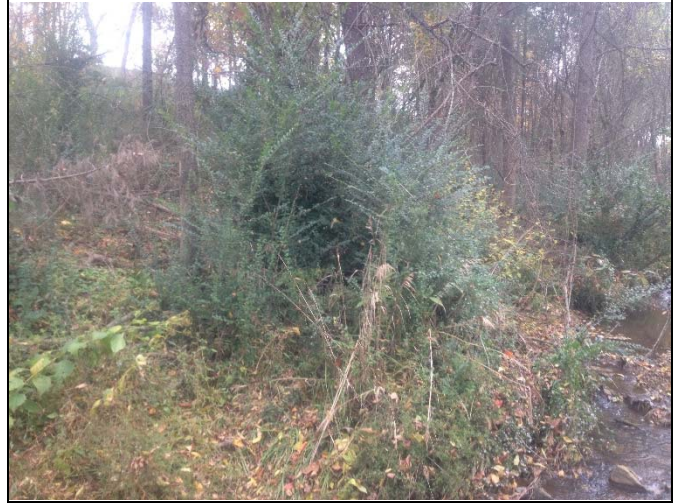
2) Vegetation Problem Area #1 – Vicinity of Reach 5 Station 28+50, October 2015

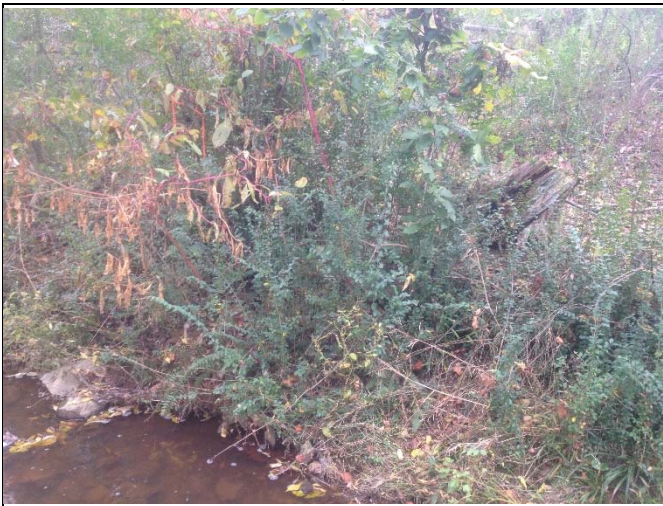
3) Vegetation Problem Area #1 – Vicinity of Reach 5 Station 28+50, October 2015
