UT to Cane Creek Restoration Project Year 3 Final Monitoring Report

Alamance County, North Carolina

DMS Project ID Number – 95729, DEQ Contract No. 4951

Monitoring Year: 3 of 7

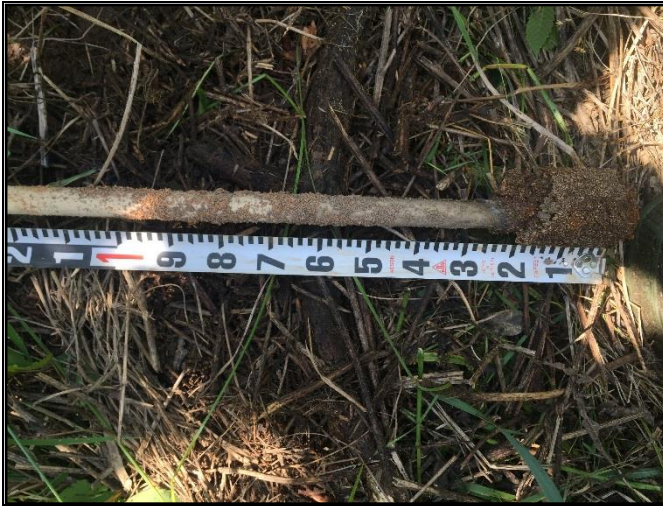
Reach R5: Crest Gauge #1, 1.21 feet. July 21, 2016

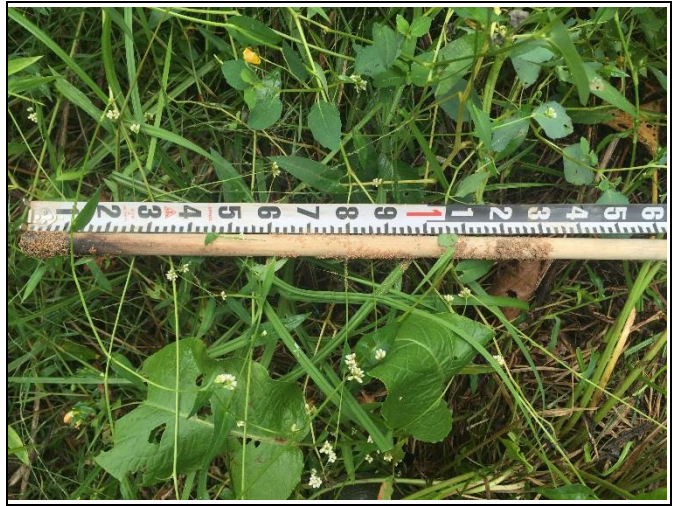
Reach R5: Crest Gauge #1, 1.31 feet. Sept. 30, 2016

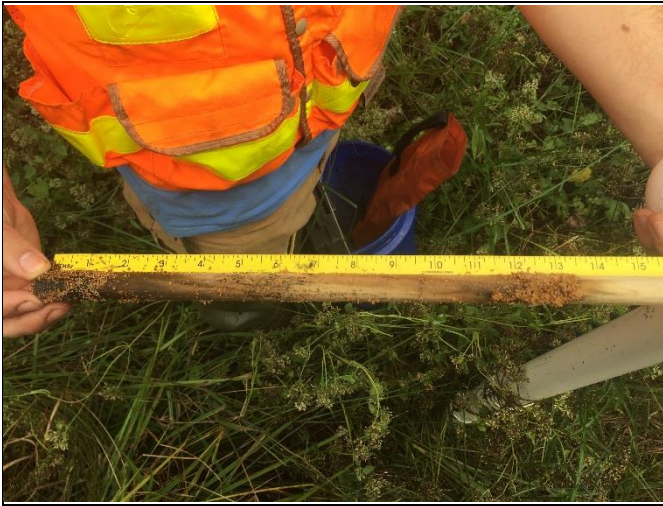
Reach R3: Crest Gauge #2, 1.12 feet. Sept. 30, 2016

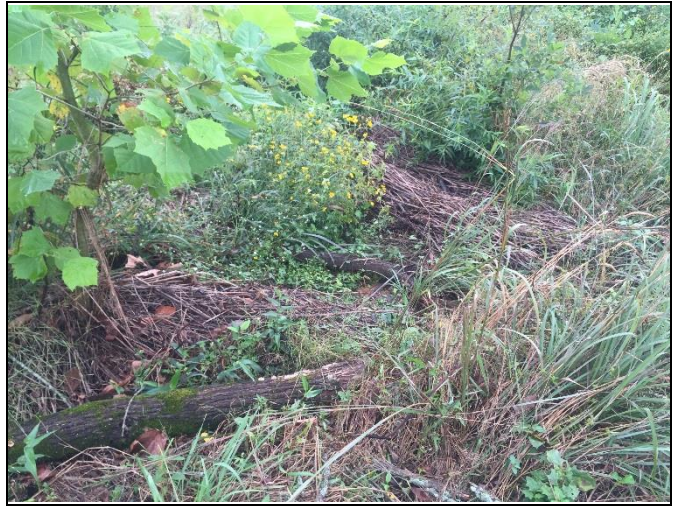
Reach R5 upper – Bankfull evidence, Sept. 30, 2016

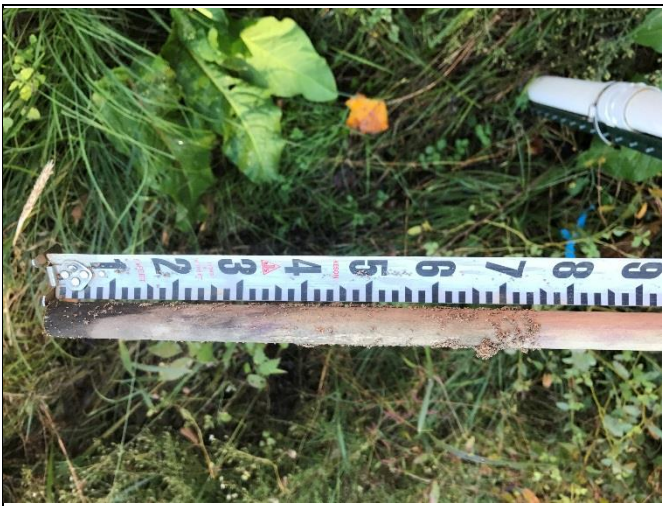
Reach R5: Crest Gauge #1, 0.75 feet, Nov. 7, 2016

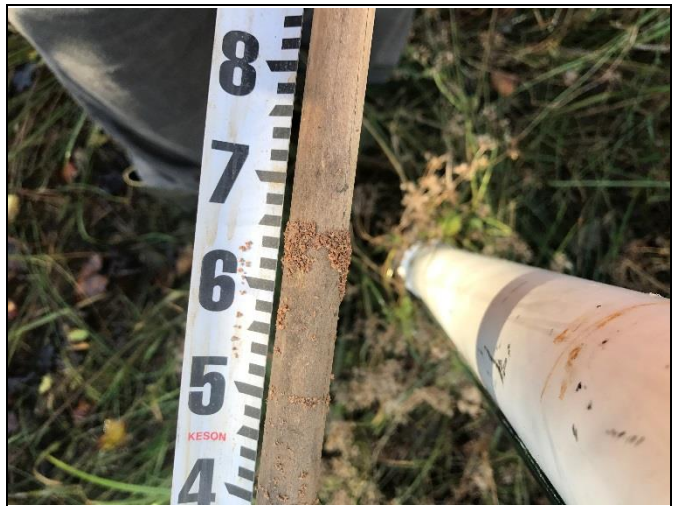
Reach R3: Crest Gauge #2, 0.66 feet, Nov. 7, 2016

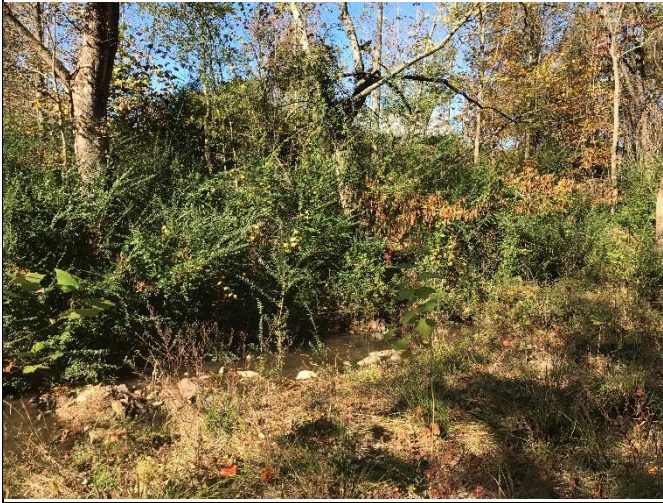
Two areas of Chinese privet totaling a combined 0.103 acres were noted near Station 28+50 on the downstream portion of Reach 5, and along the right bank of Reach 4 just below the lower crossing near Station 53+50 as shown in Figure 4. In order to keep these areas of privet under control, the privet is scheduled to be treated in 2017.

1) Vegetation Problem Area #1 – Right bank of Reach 5 near Station 28+50, October 2016

Two areas of invasive species vegetation were observed during Year 3 monitoring. Re-sprouts of *Ligustrum sinense* (Chinese privet) were noted along Reach 5 near the confluence with Reach 3, and along the right bank of Reach 4 just below the lower crossing. The total combined area of the observed privet plants is 0.103 acres and their locations are shown on the Current Condition Plan View (CCPV) maps in the Appendix B. In order to keep these areas of privet under control, the privet is scheduled to be treated in 2017.

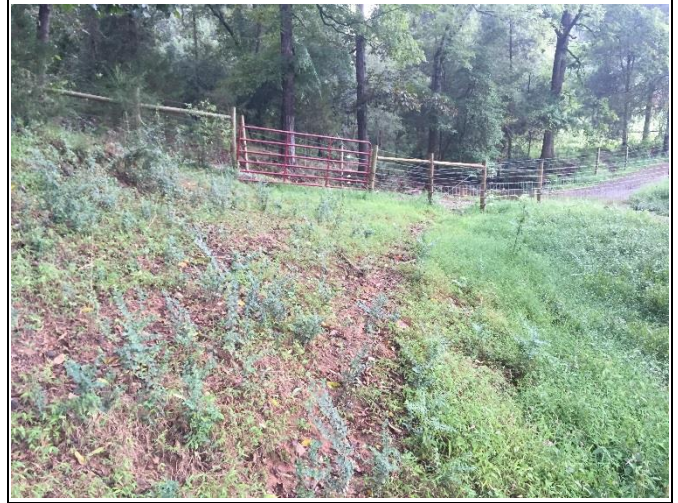
Table 6b. Vegetation Problem Areas (VPAs)			
UT to Cane Creek Restoration Project: DMS Project ID No. 95729			
Feature Issue	Station Number *	Suspected Cause	Photo Number
Chinese privet (<i>Ligustrum sinense</i>)	Reach 5, Station ~28+50	Re-sprout	VPA Photo 1
Chinese privet (<i>Ligustrum sinense</i>)	Reach 4, Station ~53+50	Re-sprout	VPA Photo 2

2) Vegetation Problem Area #2 – Right bank of Reach 4 near Station 53+50, Sept. 2016
