UT to Cane Creek Restoration Project Year 4 Final Monitoring Report

Alamance County, North Carolina

DMS Project ID Number – 95729, DEQ Contract No. 4951

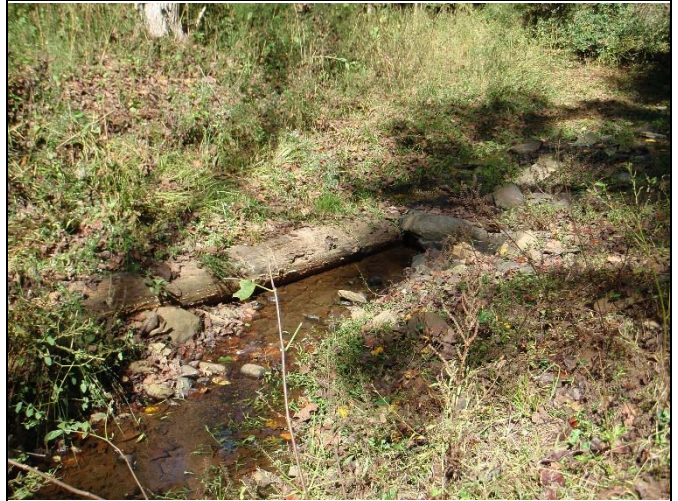
Reach R4 – View upstream, enhancement area
(Log J-Hook), Station 43+50

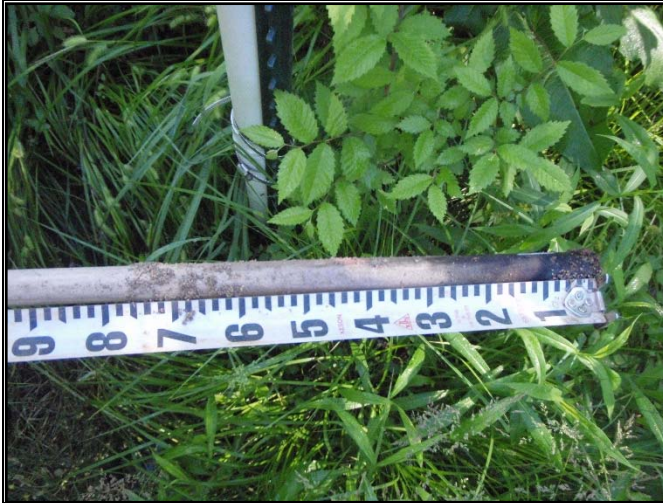
During Year 4 monitoring, one above-bankfull stage event was documented by both Crest gauge 1 and Crest gauge 2. The crest gauge readings are presented in Appendix E, with photographic documentation presented in Appendix B.

Reach R5: Crest Gauge #1, 0.76 feet on May 3, 2017

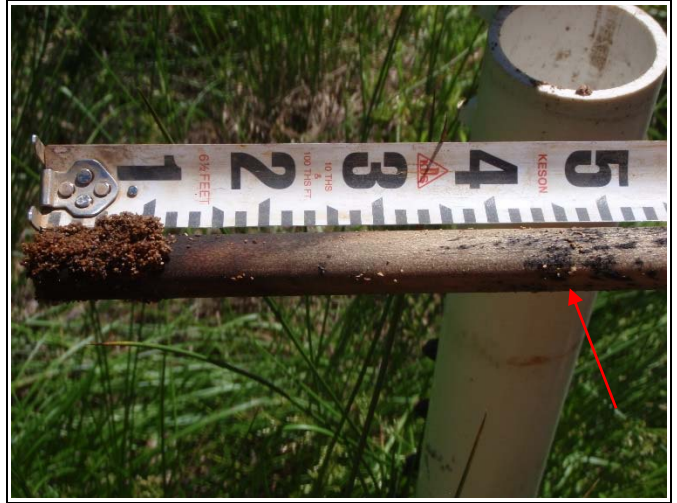
Reach R3: Crest Gauge #2, 0.46 feet on May 3, 2017

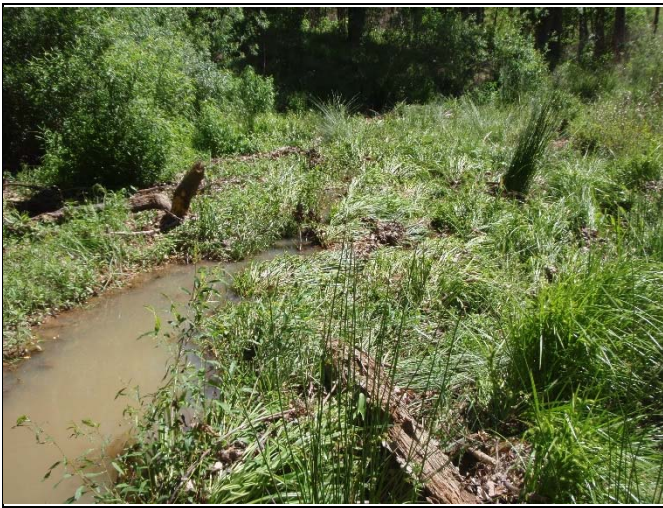
Reach R3: Bankfull evidence on May 3, 2017

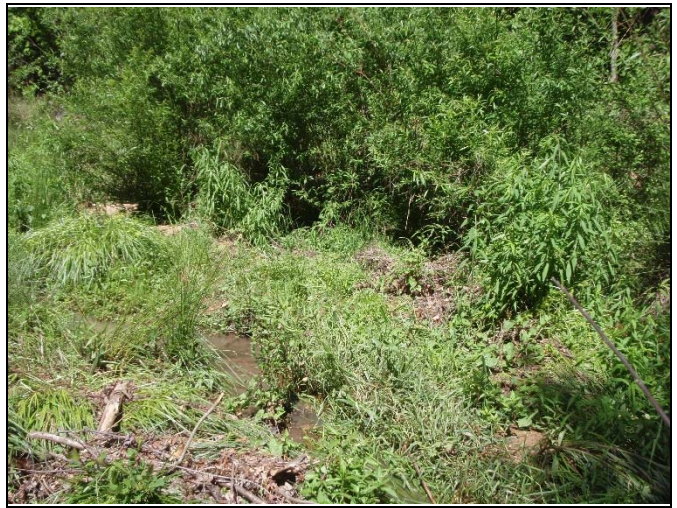
Reach R3: Bankfull evidence, May 3, 2017

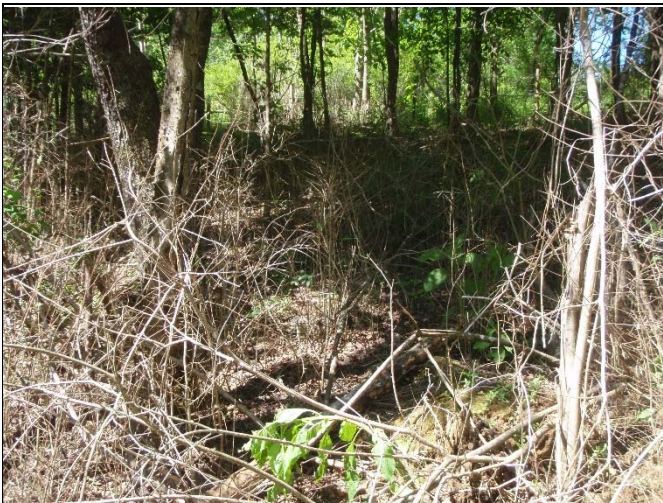
There were a few areas of scattered Chinese privet (*Ligustrum sinense*) previously identified as Vegetation Problem Areas (VPAs) in Year 3 that were treated in February of 2017 through spraying and/or cutting depending on plant size. A total of ~0.25 acres of scattered privet were treated at the confluence of Reach R5 and Reach R3, and a total of ~0.54 acres of scattered privet were treated along the right bank of lower Reach R4, as shown in Figure 4 (Appendix B). These areas will be observed closely in the future for any sign of re-sprouting. One new area of Chinese privet totaling ~0.14 acres was discovered in the Year 4 monitoring effort in the middle section of Reach R4, and will be treated in the winter of 2017-2018. This was the only identified VPA for Year 4.

Reach R5/R3: Dead privet sprayed in Feb. 2017

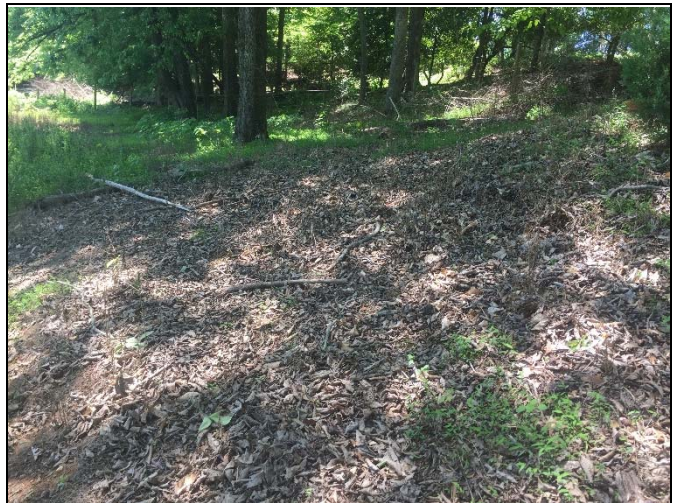
Reach R4: Dead privet sprayed in Feb. 2017

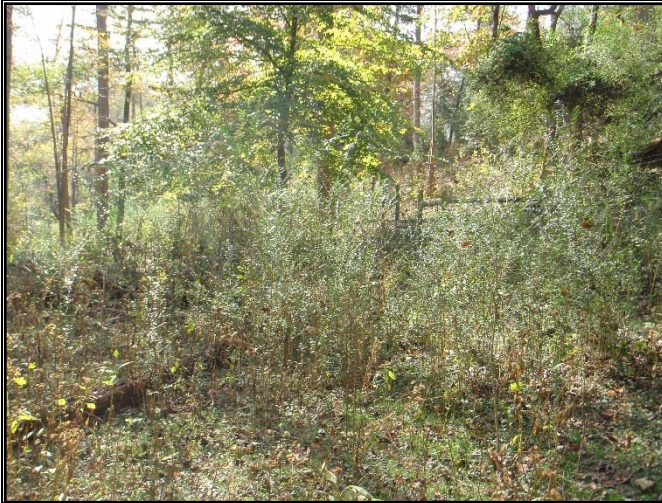
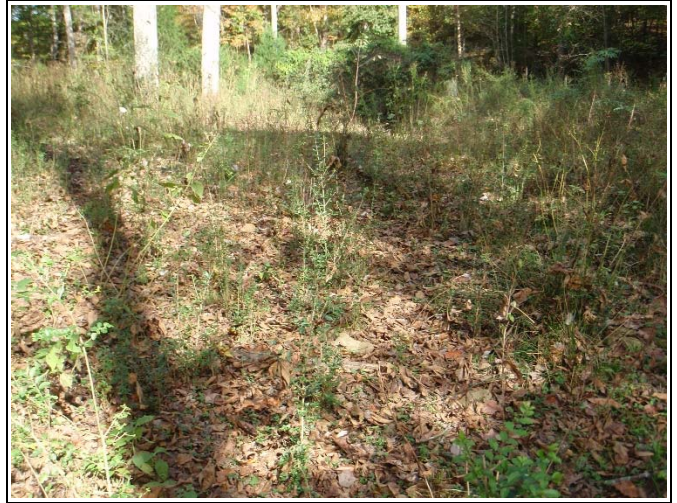
Table 6b. Vegetation Problem Areas (VPAs)			
UT to Cane Creek Restoration Project: DMS Project ID No. 95729			
Feature Issue	Station Number	Suspected Cause	Photos
Chinese privet (<i>Ligustrum sinense</i>)	Reach R4, Station 44+00	re-sprouts	Appendix B

Reach R4: Privet re-sprouts, Station 44+00
