# **UT to Cane Creek Restoration Project Year 5 FINAL Monitoring Report**

**Alamance County, North Carolina**

**DMS Project ID Number – 95729, DEQ Contract No. 4951**

Monitoring Year: 5 of 7

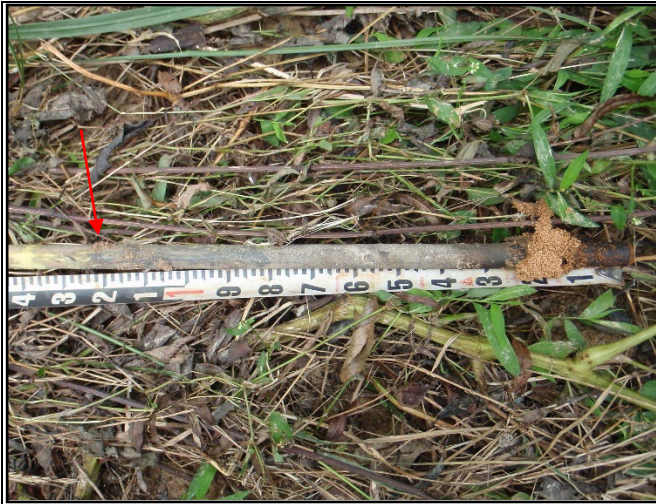
Reach R5: Crest Gauge #1, 1.22 feet on 9/24/18

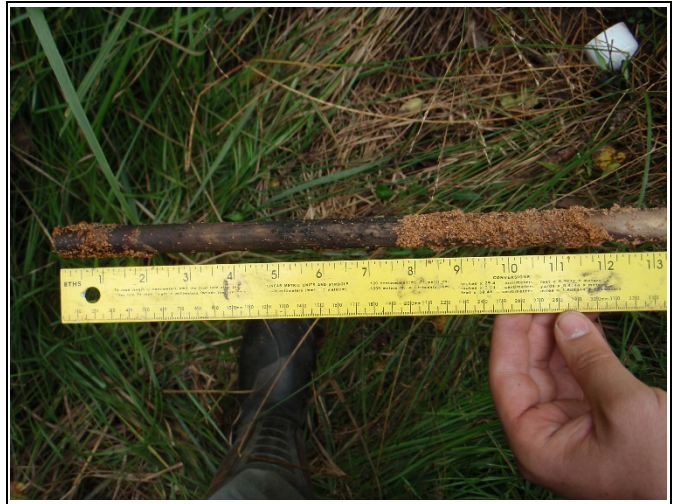
Reach R3: Crest Gauge #2, 1.08 feet on 9/24/18

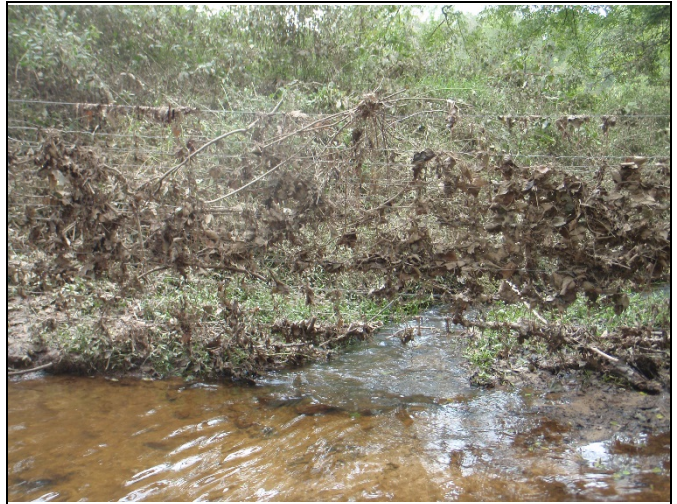
Reach R5: Debris caught in fence in the crossing at Station 53+00

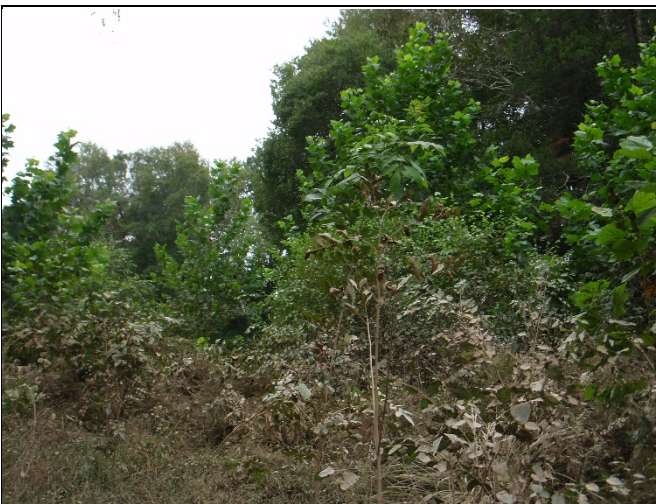
Reach R4: Leaf staining in the trees at Station ~54+00

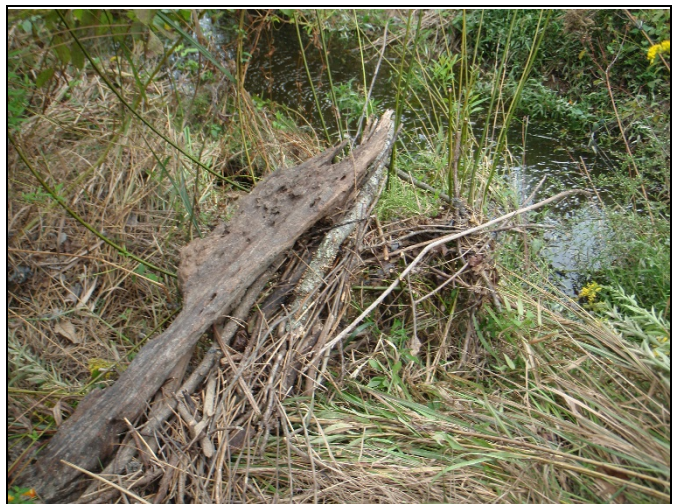
Reach R5: Debris/wrack lines on floodplain at Station ~14+00.

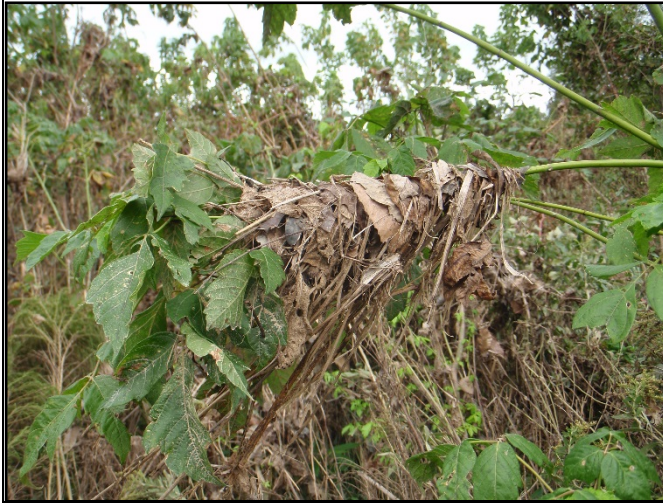
Reach R1: Debris caught in trees, Station ~18+00

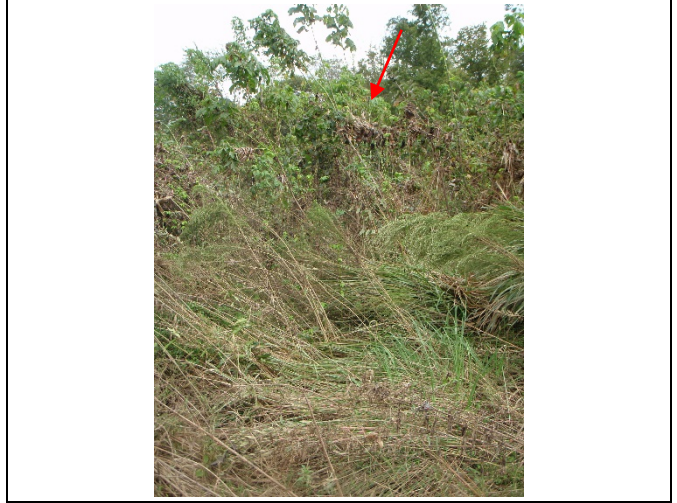
Reach R1: That same debris as observed from the stream at Station ~18+00

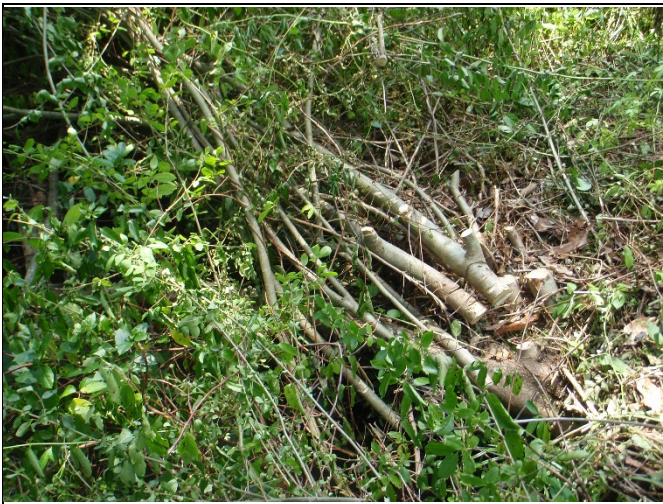
Reach R5 upper: Privet treated (Feb 2018)

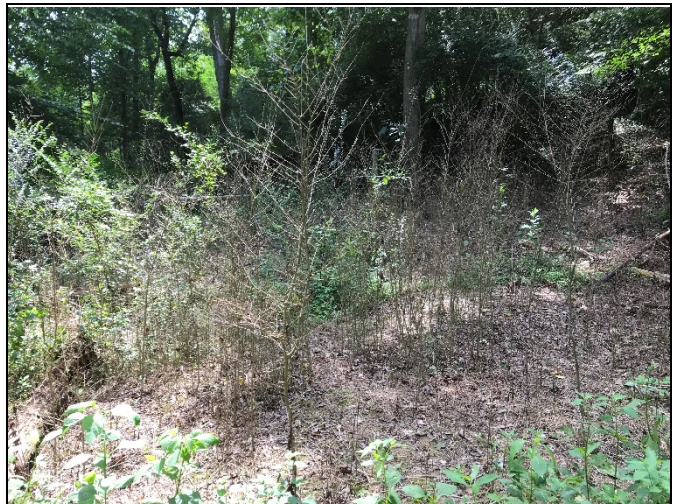
Reach R4 middle: Privet treated (Feb 2018)

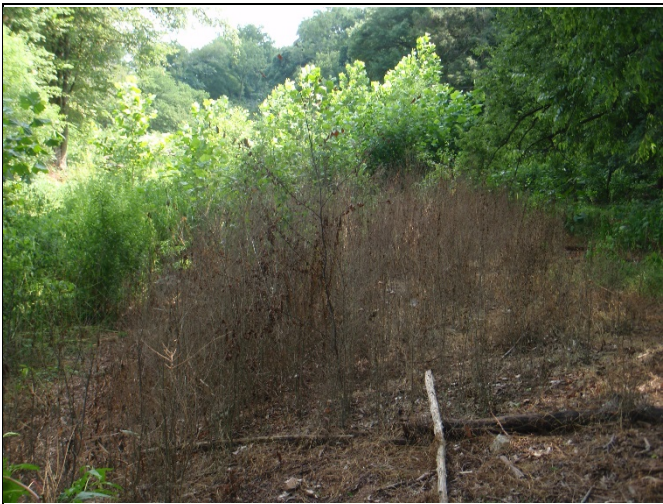
Reach R4 lower: Privet treated (Feb 2018)

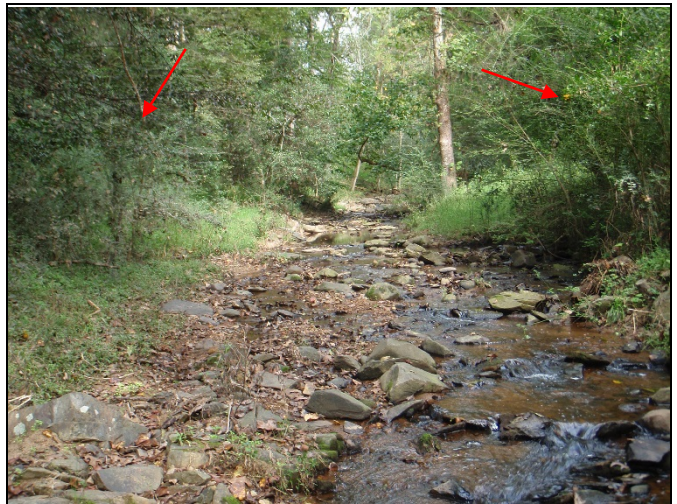
There was one Vegetation Problem Area (VPA) observed during the Year 5 monitoring. A few small areas of scattered resprouts of the invasive species Chinese privet (*Ligustrum sinense*) were discovered along the middle and lowers sections of Reach R4 as detailed in Table 6a and 6b. The total combined area of the scattered privet is 0.71 acres in size. Their locations are shown on the Current Condition Plan View (CCPV) maps in the Appendix B along with representative photographs.

Three areas of scattered Chinese privet (*Ligustrum sinense*) resprouts were discovered along the middle and downstream portions of Reach 4, totaling a combined 0.71 acres, as shown on the CCPV in Appendix B. The privet found in these areas will be treated in 2019.

<b>Table 6b. Vegetation Problem Areas (VPAs)</b>			
<b>UT to Cane Creek Restoration Project: DMS Project ID No. 95729</b>			
<b>Feature Issue</b>	<b>Station Numbers</b>	<b>Suspected Cause</b>	<b>Photos</b>
Chinese privet ( <i>Ligustrum sinense</i> )	Reach R4: Stations 47+00 to 51+00 (both banks), and 55+00 to 56+00 (left bank)	Re-sprouts	Appendix B

VPA: Privet scattered along both banks of middle Reach R4 (~47+00 to 51+00)

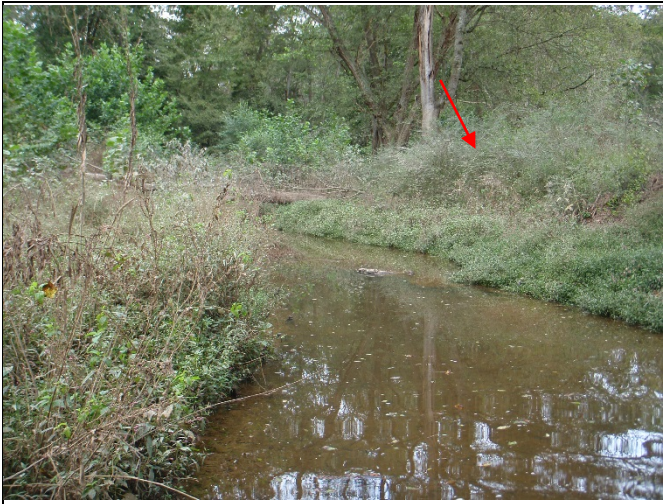
VPA: Privet scattered along left bank of lower Reach R4 (~55+00 to 56+00)

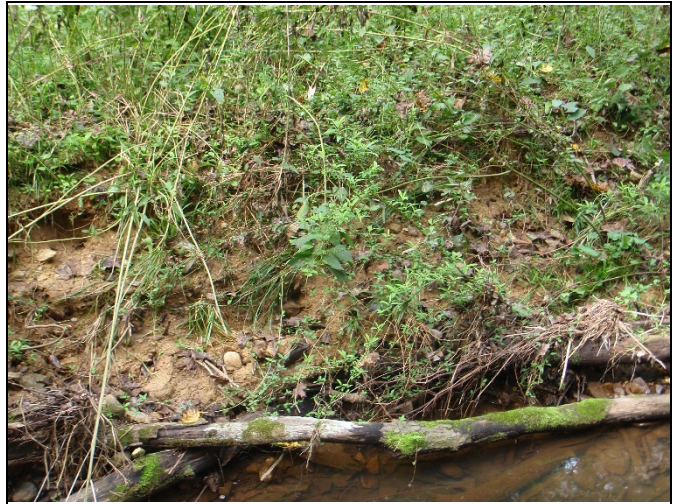
One Stream Problem Area (SPA) was observed during the Year 5 monitoring. During the post-Hurricane Florence site inspection, an approximately 30 ft section of bank scour was discovered along the outer right bank of a pool bend located in the middle of Reach R4. The bank scour was a direct result of the high flows associated with Florence, which dropped approximately six inches of rain on the site over a 24-hour period between September 16 and 17. The bank scour resulted in the loss of a significant portion of the livestake vegetation that had been growing in the bank. Cross-section 8 is located within this section and reveals the resulting scour in its graph. The visual inspection of the bank revealed that there is still a substantial amount of living, established livestake vegetation growing in the bank and during the winter of 2018-2019, Baker will supplement with additional livestakes and transplants, likely consisting of black willow (*Salix nigra*) and silky dogwood (*Cornus amomum*) species. The SPA is reported in Tables 5a and 5b, representative photographs can be found in the photolog, and its exact location is shown on the CCPV, all of which are found in Appendix B.

<b>Table 5b. Stream Problem Areas (SPAs)</b>			
<b>UT to Cane Creek Restoration Project: DMS Project ID No. 95729</b>			
<b>Feature Issue</b>	<b>Station Numbers</b>	<b>Suspected Cause</b>	<b>Photos</b>
Bank Scour	43+40 to 43+70 (30' in length)	High flow from Hurricane Florence	Appendix B

SPA: Bank scour along Reach R4 (~43+50)

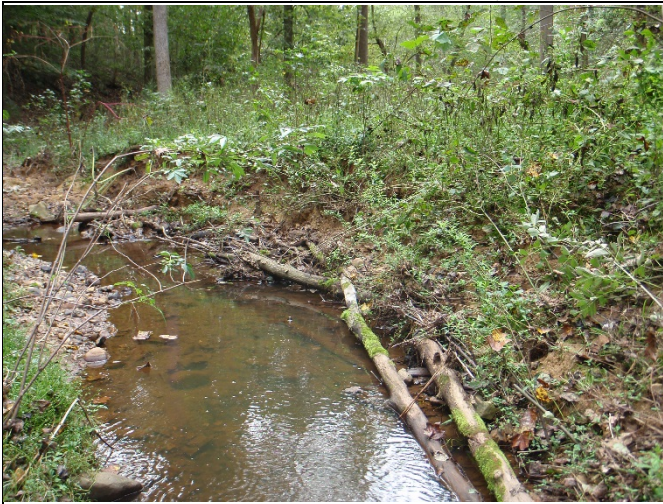
SPA: Bank scour along Reach R4 (~43+50), looking downstream
