UT to Cane Creek Restoration Project Year 6 Final Monitoring Report

Alamance County, North Carolina

DMS Project ID Number – 95729, DEQ Contract No. 4951

Report Prepared and Submitted by Michael Baker Engineering, Inc.

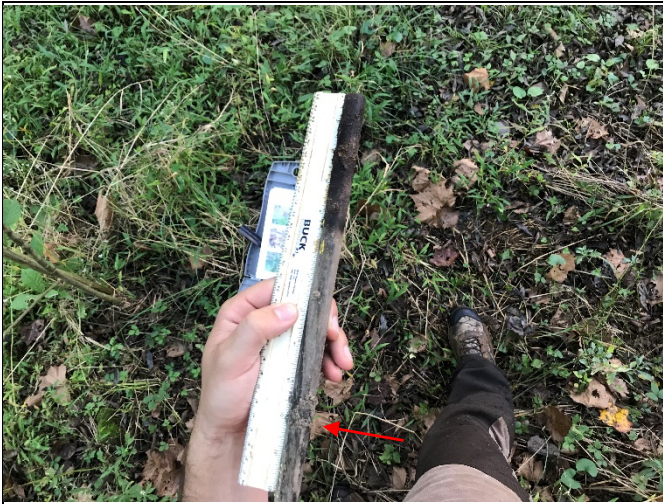
During Year 6 monitoring, one above-bankfull stage event was documented by both Crest gauge #1 and Crest gauge #2 from a large storm on April 14, 2019. The crest gauge readings are presented in Appendix E, with photographic documentation presented in Appendix B.

Reach R5: Crest Gauge #1, 0.83 feet on 6/6/19

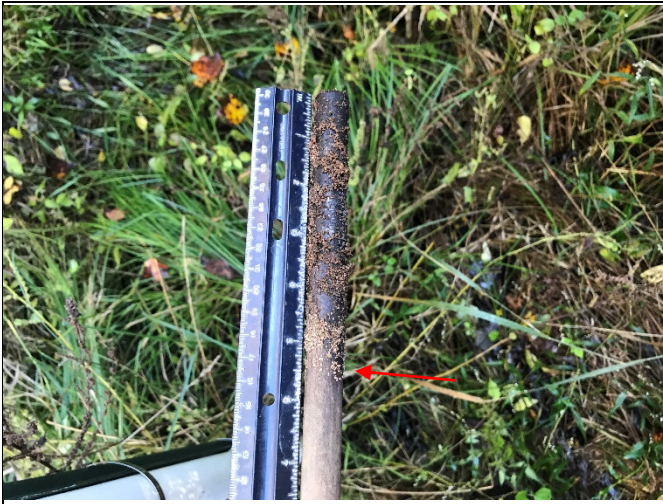
Reach R3: Crest Gauge #2, 0.46 feet on 6/6/19

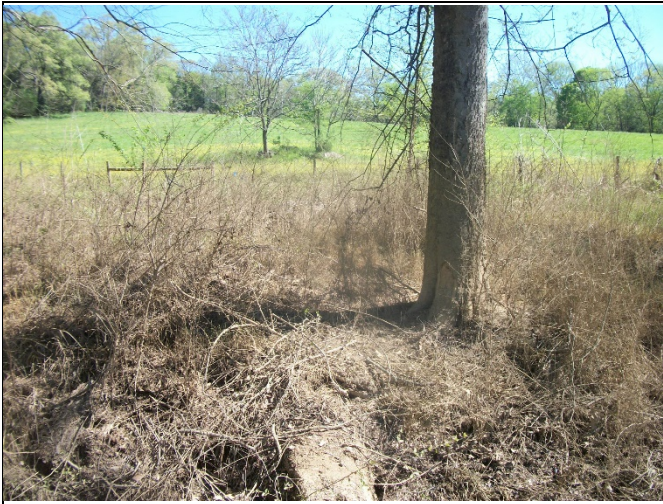
Reach R4 lower: Privet treated in April 2019

Additionally, there were a few areas of scattered privet previously identified as Vegetation Problem Areas (VPAs) in Year 5 that were treated in early April of 2019 through spraying and/or cutting depending on plant size. A total of approximately 0.88 acres of scattered privet were treated along sections of the lower Reach R4 as shown in Figure 4 and in the project photographs (both found in Appendix B). Some of these treated areas overlap with the current VPA privet locations and are simply re-sprouts. These areas will continue to be observed closely in the future for any sign of new re-sprouting.

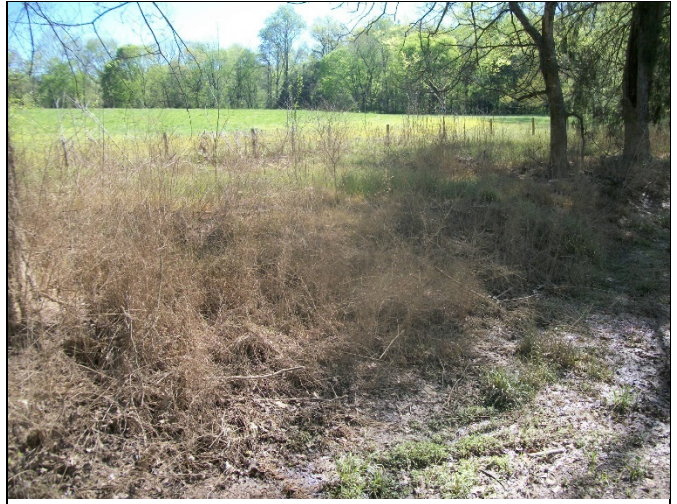
Reach R4 lower: Privet treated in April 2019

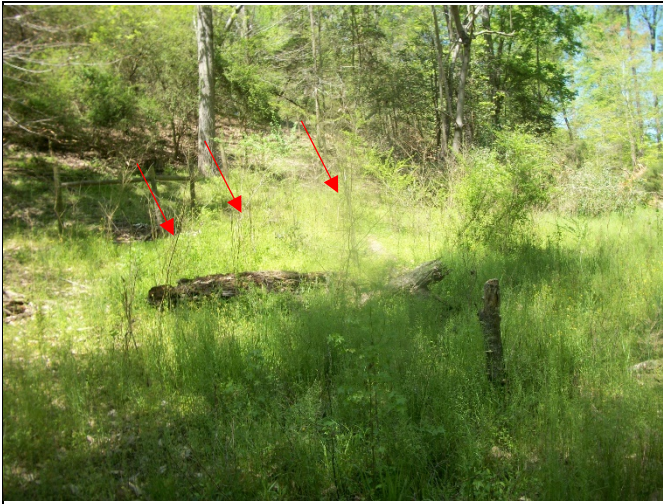
Reach R4 middle: Privet treated in April 2019
(bare stems difficult to see in photograph)

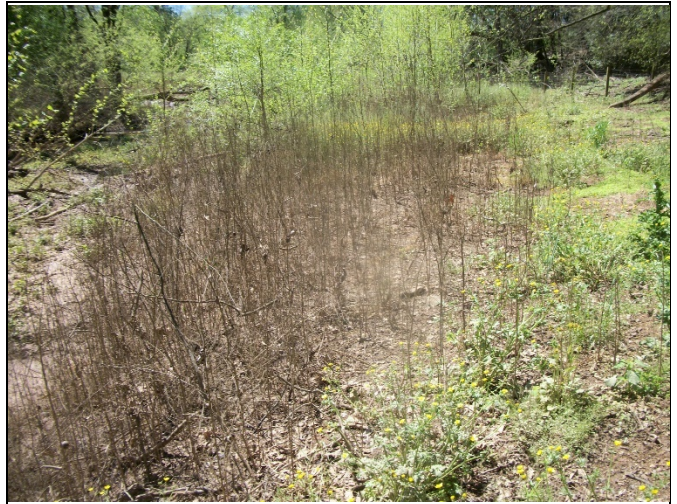
Reach R4 middle: Privet treated in April 2019

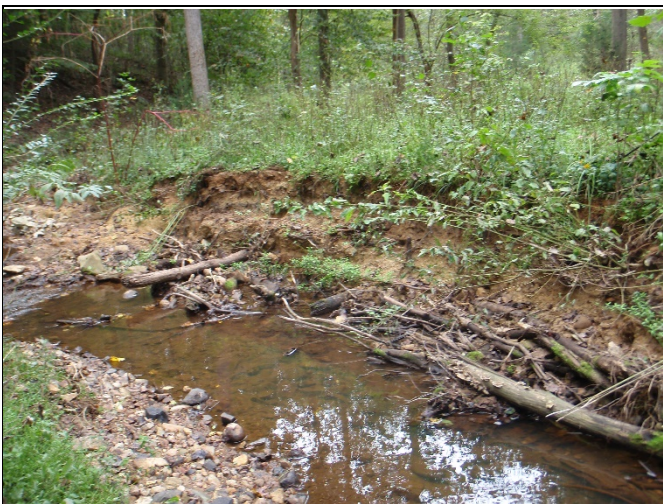
As discussed in the Year 5 monitoring report, Baker had previously noted a Stream Problem Area (SPA) consisting of a section of bank scour along lower Reach R4 resulting from Hurricane Florence. This section of bank was initially planted with a dense livestake and several one-gallon plants in Feb 2019. However, continued rainfall throughout the late winter and early spring hampered plant establishment, so in June of 2019 the area was graded back in sections and matting was placed along the slope (allowing as many of the previously planted stems to come through the matting as possible). Additional inspections of this area in August and September of 2019 show that the area now appears to be stable and the planted vegetation is establishing. This area will be closely observed in the future to confirm continued stability. This bank repair work is shown on Figure 4 and in the project photographs found in Appendix B.

Reach R4 Station 43+50: Previously documented stream bank scour from Hurricane Florence in Sept 2018
