# UT to Cane Creek Restoration Project Year 7 Final Monitoring Report

Alamance County, North Carolina

DMS Project ID Number – 95729, DEQ Contract No. 4951

Monitoring Year: 7 of 7

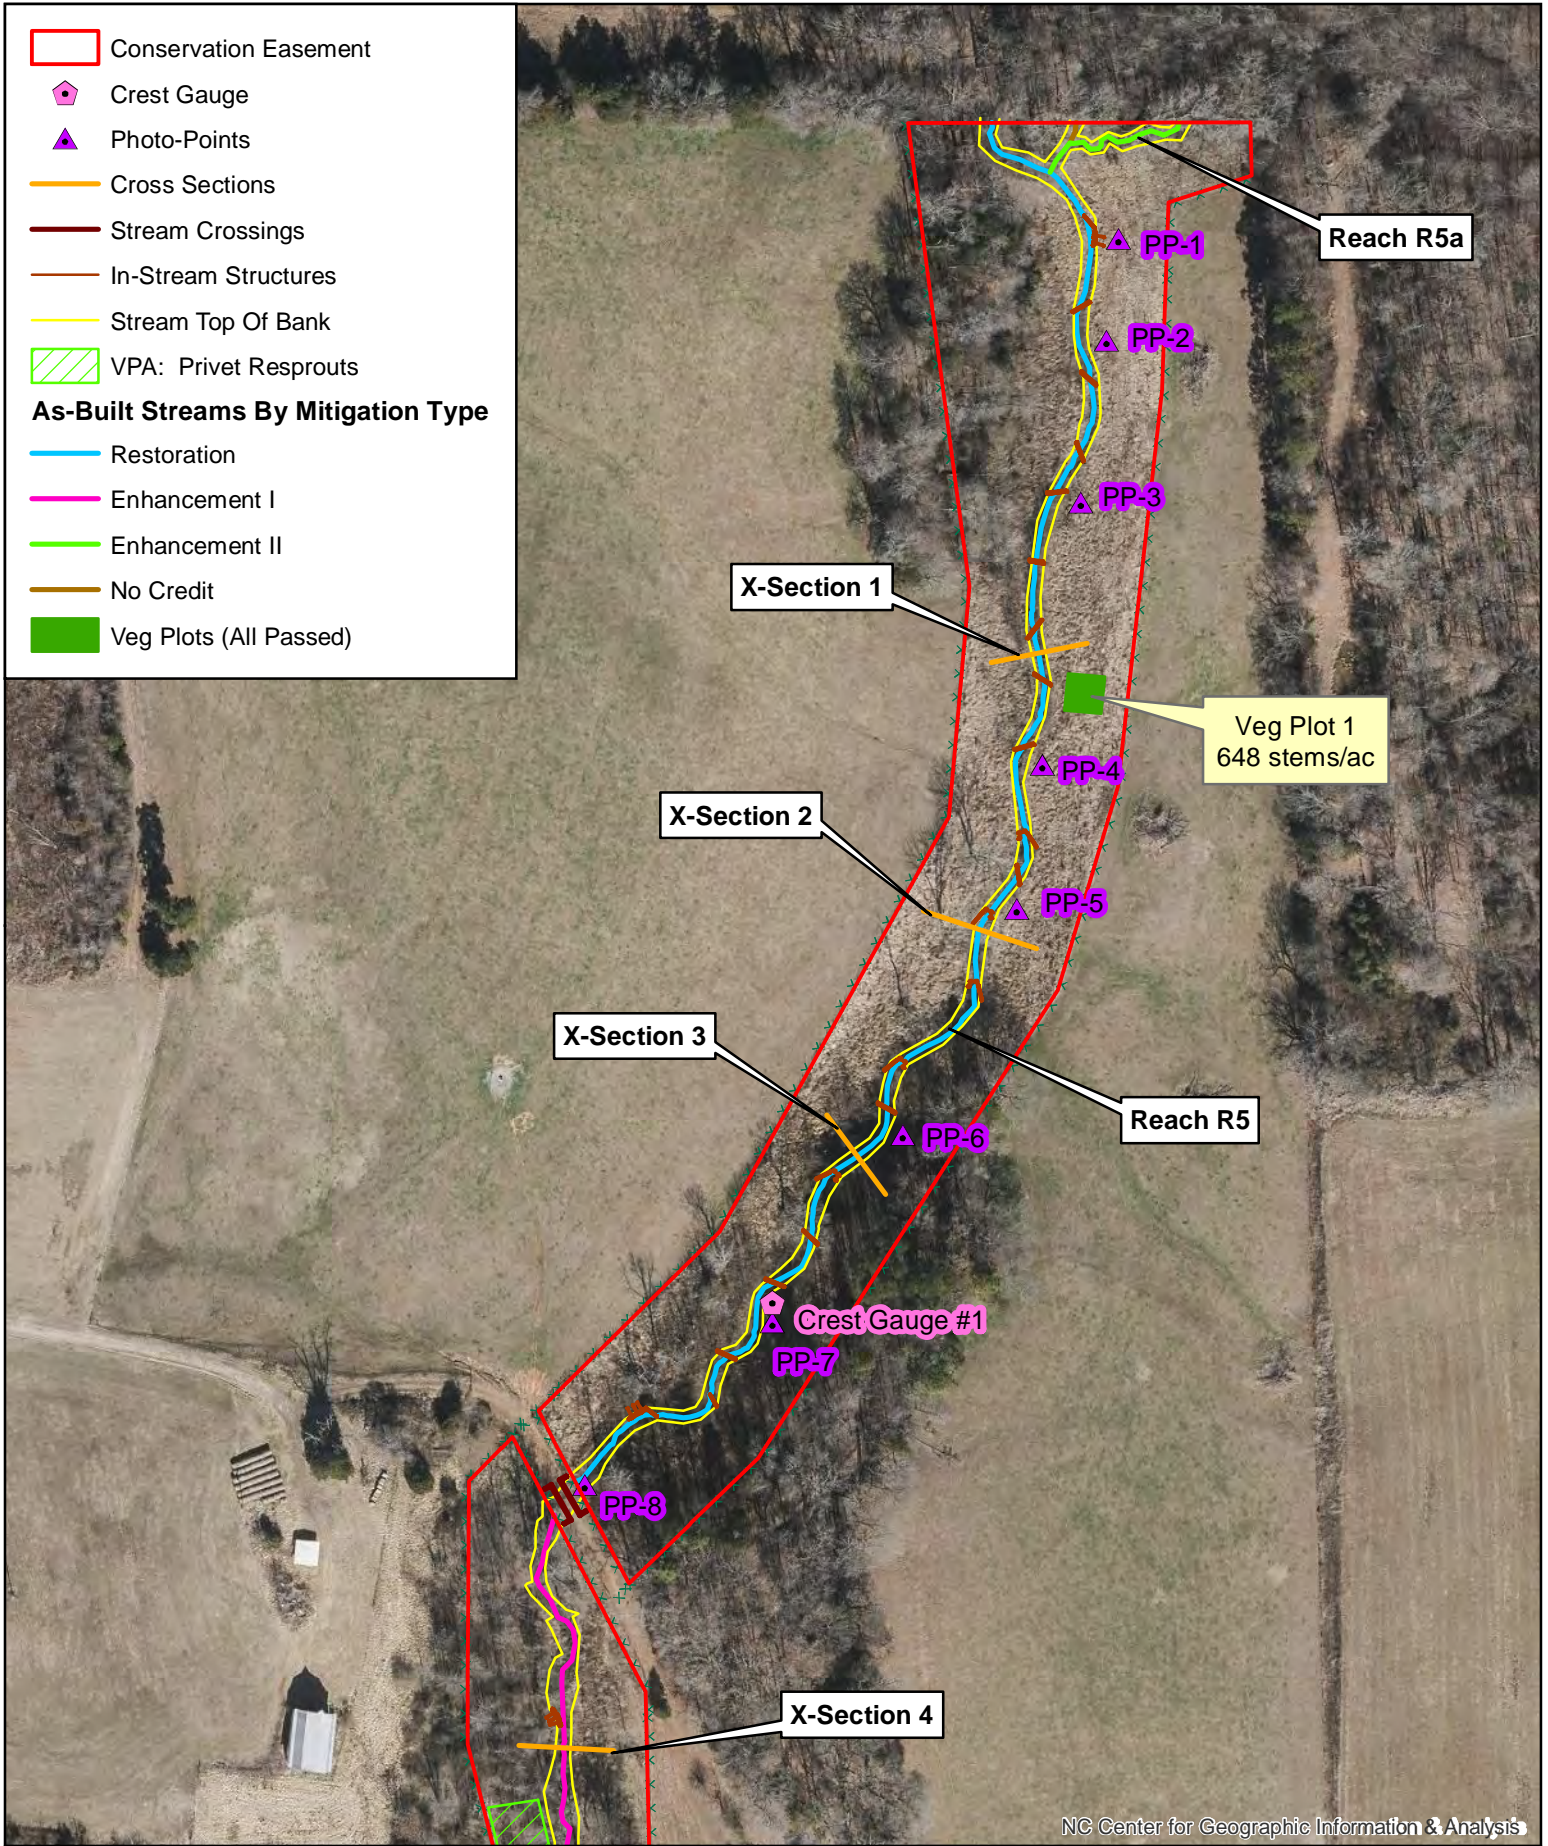
**Current Condition  
Plan View - Figure 4A  
Monitoring Year 7  
UT to Cane Creek Site**

There were a few Vegetation Problem Areas (VPA) observed during the Year 7 monitoring. They each consist of scattered resprouts of the invasive species Chinese privet (*Ligustrum sinense*) found along the middle and lower sections of Reach R4 and along lower Reach R3, as detailed in Table 6a and 6b. The total combined area of the scattered privet is approximately 1.8 acres in size. They are almost entirely located within the mature forested area along the project enhancement reach. Their locations are shown on the Current Condition Plan View (CCPV) maps in the Appendix B. They will be treated in the spring of 2021.

Additionally, the scattered Chinese privet noted in the Year 6 report was treated in March of 2020 in the lower section of Reach R4, in an area approximately 0.5 acres in size. Much of this treated area overlaps with the current VPA privet locations and represents continued resprouts.

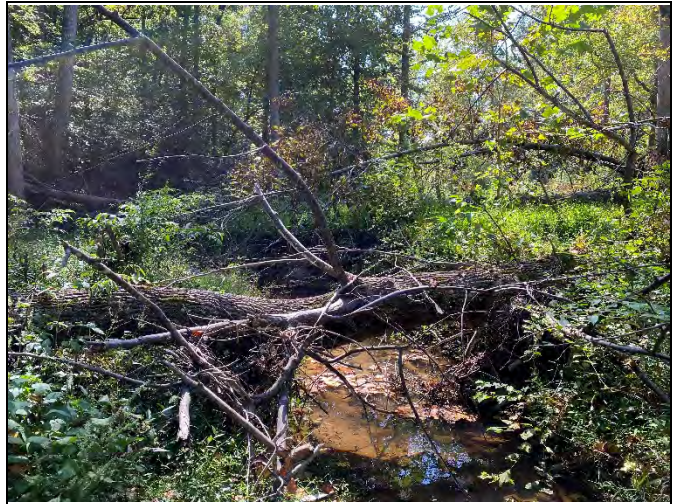
There were no Stream Problem Areas (SPAs) observed during the Year 7 monitoring. The previously reported section of bank scour along Reach R4 from Year 5 has continued to stabilize with livestock vegetation establishing well based on visual observations made during the monitoring year. Baker will continue to evaluate this area and supplement with additional livestock transplants over the winter to ensure continued stability. Additionally, a beaver dam was discovered towards the top of Reach R1 in early 2020 (see CCPV for location) and was removed in March 2020. The beaver likely came up the reach from the adjacent Cane Creek but the dam has not been reestablished. This reach will be closely monitored for additional beaver activity.

Reach R4 Station 43+50: Stabilizing and vegetating from previously documented bank scour from Hurricane Florence in Sept 2018 (photo from Oct 2020)

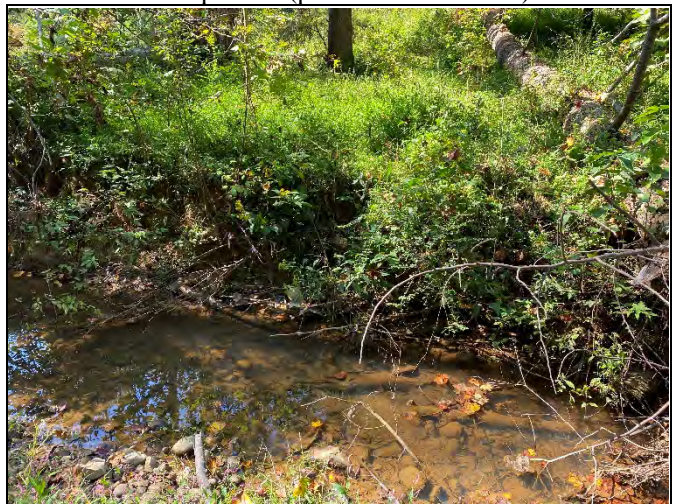
Reach R4 Station 43+50: Stabilizing and vegetating from previously documented bank scour from Hurricane Florence in Sept 2018 (photo from Oct 2020)

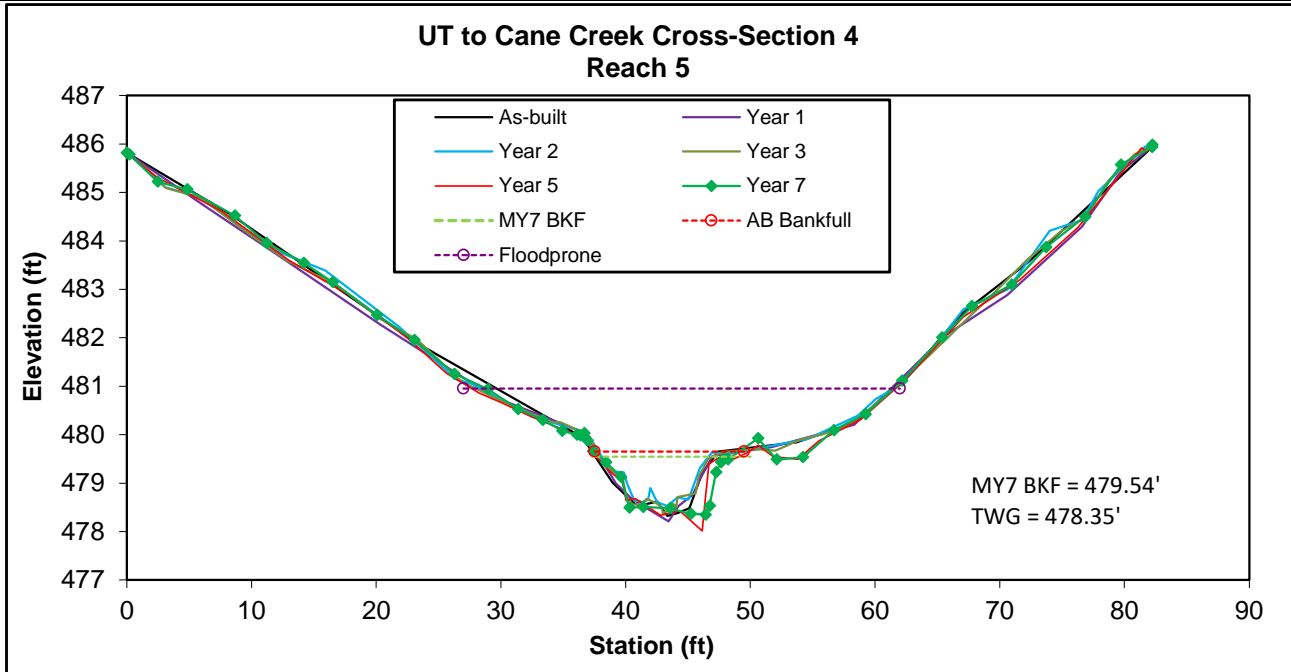
## Permanent Cross-Section 4, Reach 5

- c. Please verify bank height ratio calculations. Ensure that the elevation that achieves the MY0 bankfull area in the MY7 channel is being used in these calculations. For example: Cross Section 4 should have a BHR of 1.09, and should be using bankfull elevation of 479.54 to achieve the MY0 cross sectional area.

**Response: Baker checked each of the BHR calculations and verified that they are all correct with the exception of XS-4 as noted. The bankfull elevation derived from the as-built area for XS-4 was determined to be 479.54' (as noted) using the Mecklenburg spreadsheet and was used to determine the BHR shown, but just wasn't correctly brought into the project cross-section figure. However, using this elevation provides a BHR of 0.97, which rounds to the 1.0 shown in the cross-section tables. For clarity, the calculation was made using the following elevations (as provided in the XS-4 figure) and equation:**

$$\text{BHR} = (\text{Low bank elevation} - \text{TWG elevation}) / (\text{MY7 Bkf elevation} - \text{TWG elevation})$$
$$\text{BHR} = (479.51' - 478.35') / (479.54' - 478.35') = 1.16 / 1.19 = 0.97$$

Feature	Stream Type	BKF Area	BKF Width	BKF Depth	Max BKF Depth	W/D	BH Ratio	ER	AB BKF Elev	TOB Elev
Riffle	C	9.5	11.7	0.8	1.3	14.3	1.0	2.8	479.65	479.51
