UT to Town Creek Restoration Project – Option A Year 7 Monitoring Report/Closeout Report

Stanly County, North Carolina

DMS Project ID Number – 94648; NC DEQ Contract No. 003277

Monitoring Year: 7

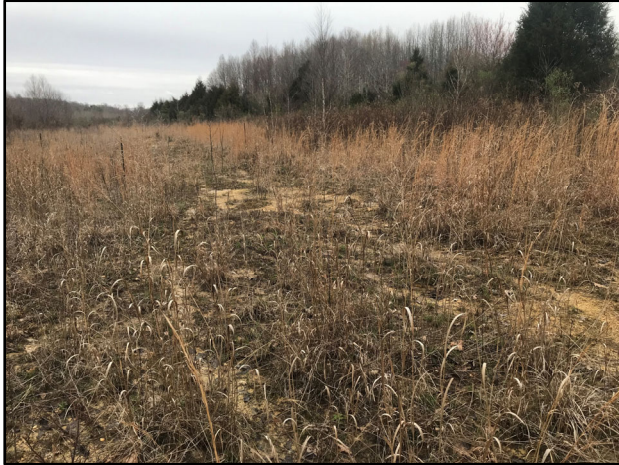
During Year 7 monitoring, vegetation conditions were performing at over 90% for planted acreage and close to 100% for invasive/encroachment area categories. As noted in Table 6b, an area (VPA7-1) of low herbaceous vegetation and poor growth rates has continued to persist from MY2. This area is located along Reach 2 between Vegetation Plot 14 and 13 and consists of approximately 0.06 acres. This area was supplemental planted with gallon plants, annual seed, perennial grass plugs and appropriate amount of lime in May 2020, but due to harsh temperatures and compacted clay soils this area is expected to have a high mortality. Michael Baker added lime in May 2022 in efforts to improve the soil quality. Although this area has continually been a vegetation problem area, Michael Baker has seen improvements with each monitoring year. VPA data and photographic documentation collected during Year 7 monitoring are located in Appendix B. See Tables 6a through 6b for VPA data documentation.

**VPA 7-1– Photo of poor growth rates.
(3/10/22)**

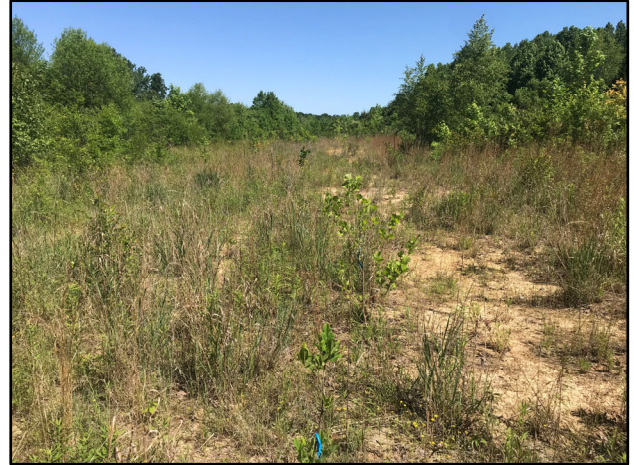
**VPA 7-1 – Photo of poor growth rates.
(5/17/22)**

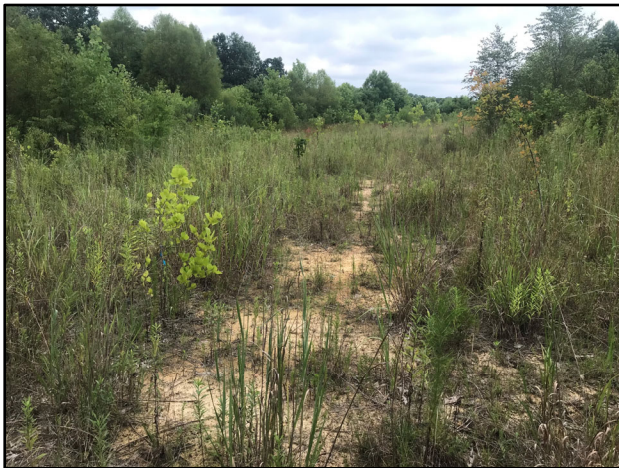
**VPA 7-1 – Photo of bare areas and areas of
poor growth rates.
(7/21/22)**

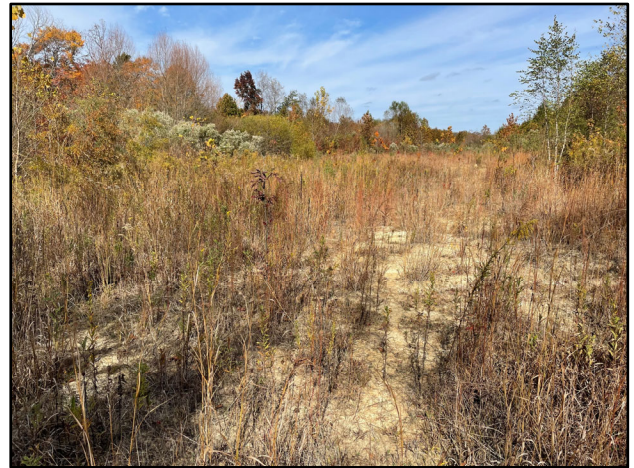
**VPA 7-1 Photo of poor growth rates.
(10/27/22)**

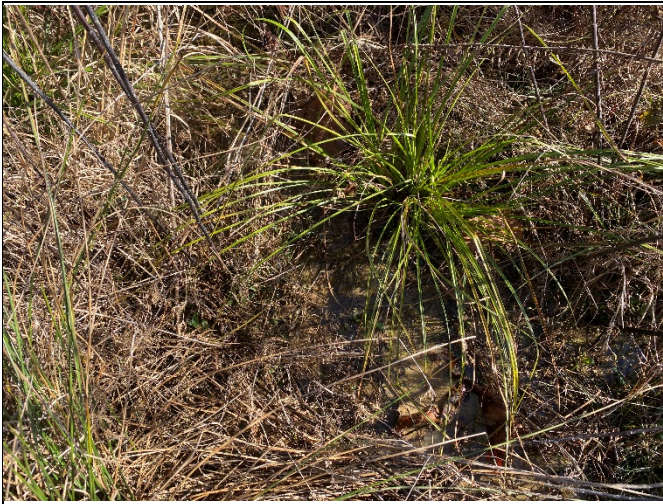
Soft rush in area with shallow standing water

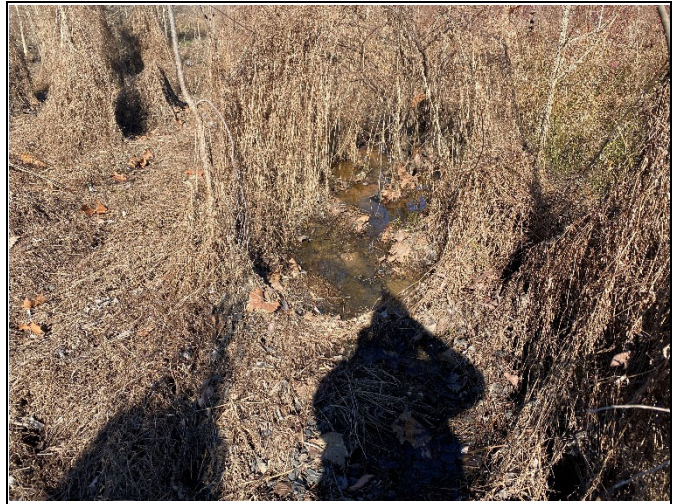
Wetland vegetation and standing water in floodplain

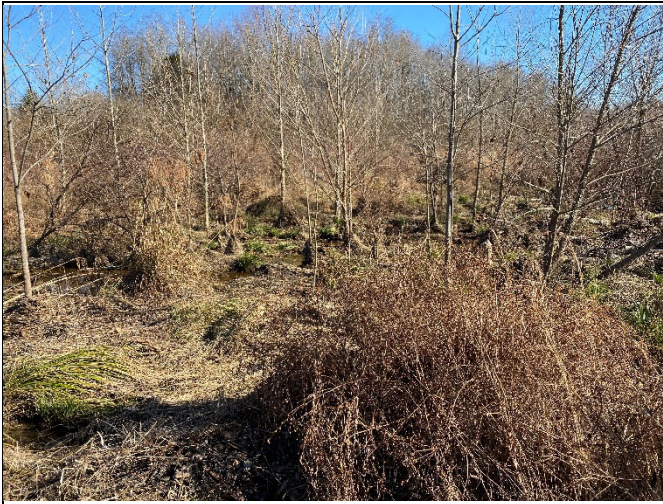
Wetland vegetation and standing water in floodplain

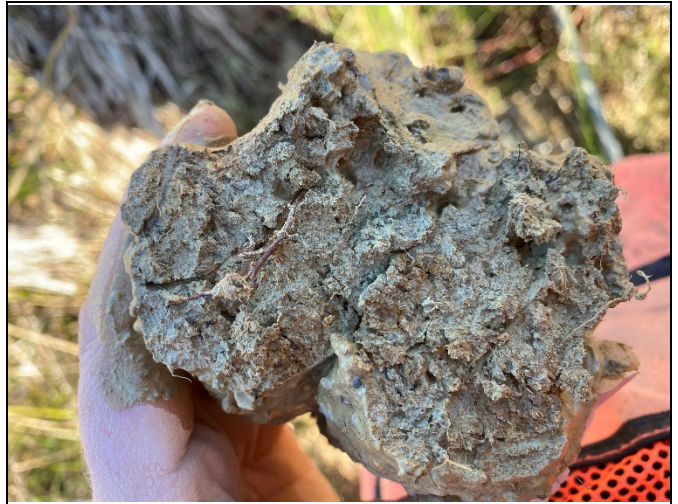
Hydric soil

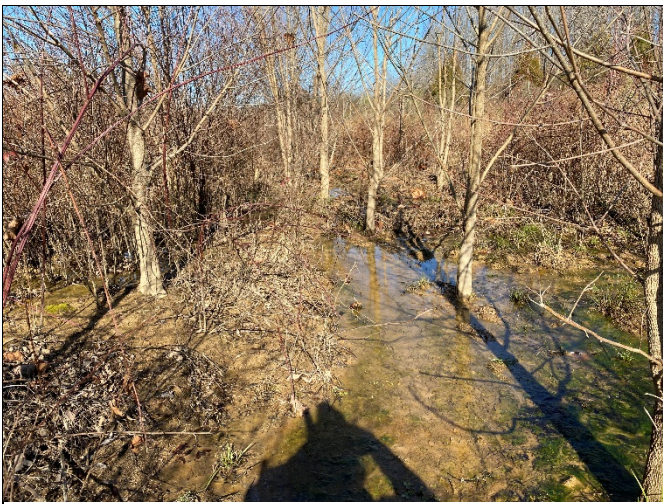
Wetland vegetation and standing water in floodplain

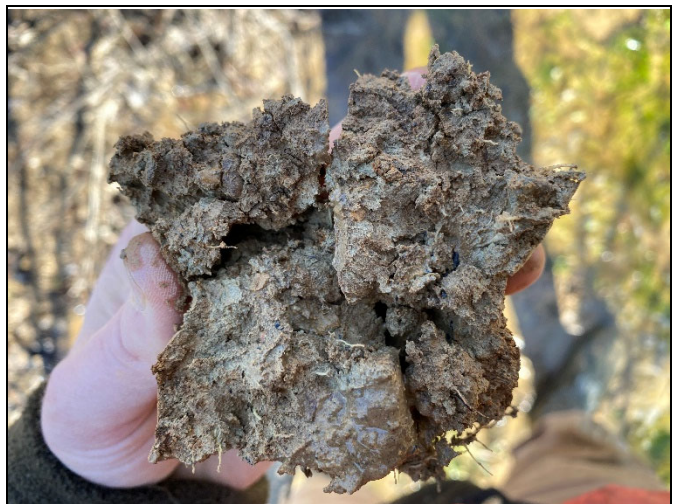
Hydric soil

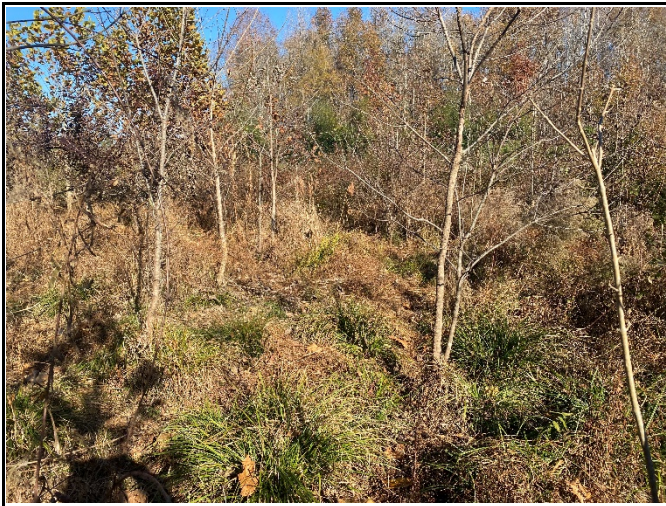
Abundant, tall, diverse vegetation present

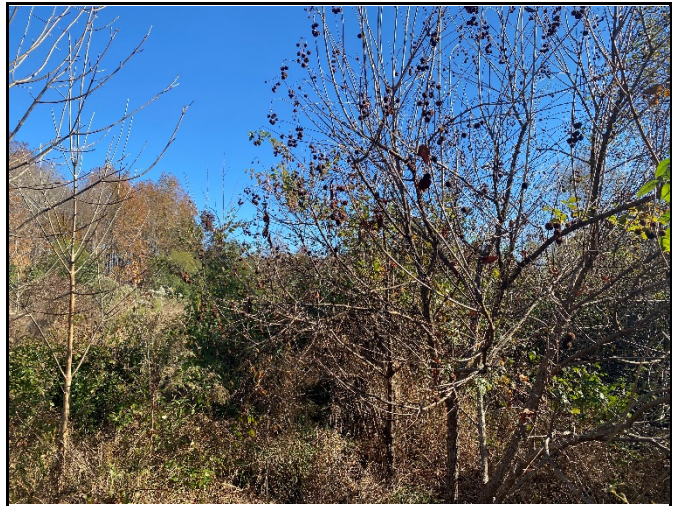
Abundant, tall, diverse vegetation present (buttonbush in foreground)

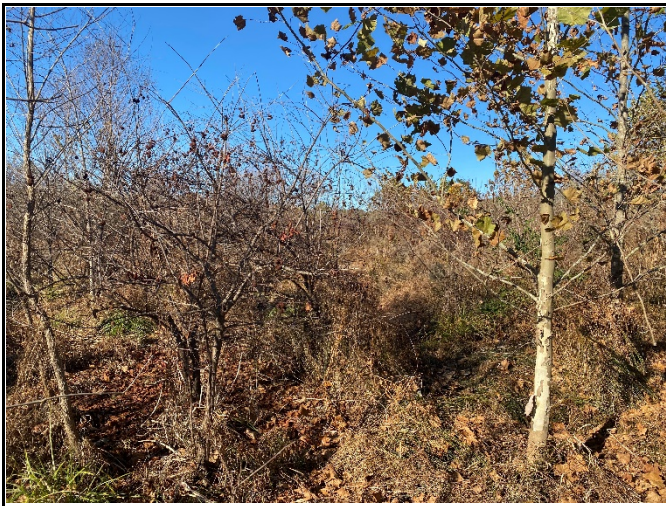
Abundant, tall, diverse vegetation present (buttonbush and sycamore in foreground)

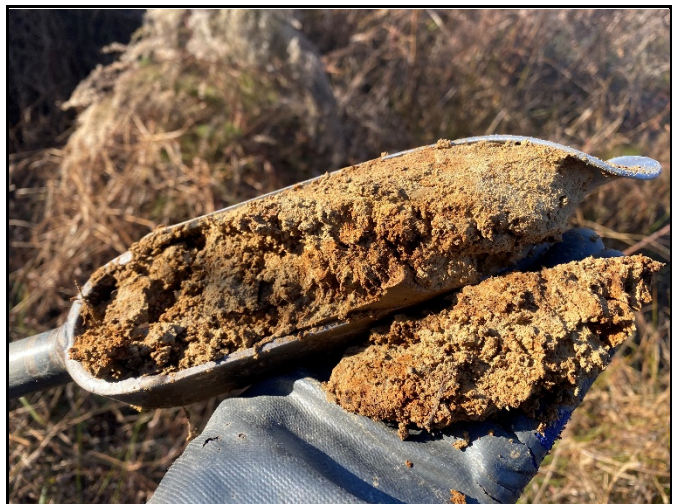
Hydric soil present throughout

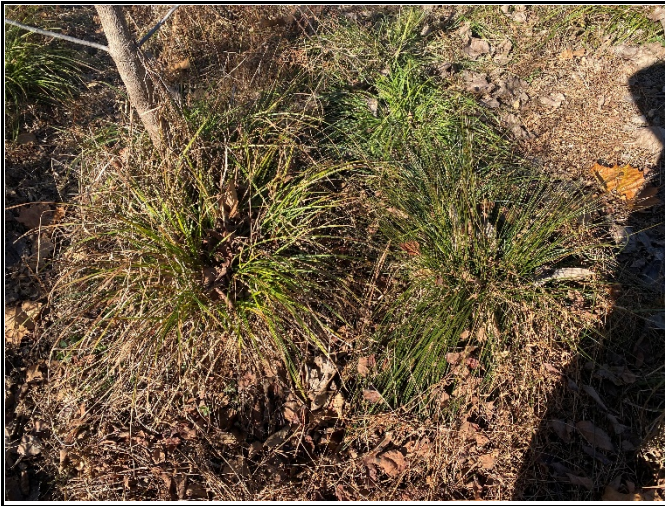
Dense herbaceous layer present dominated by tearthumb and various rushes and sedges

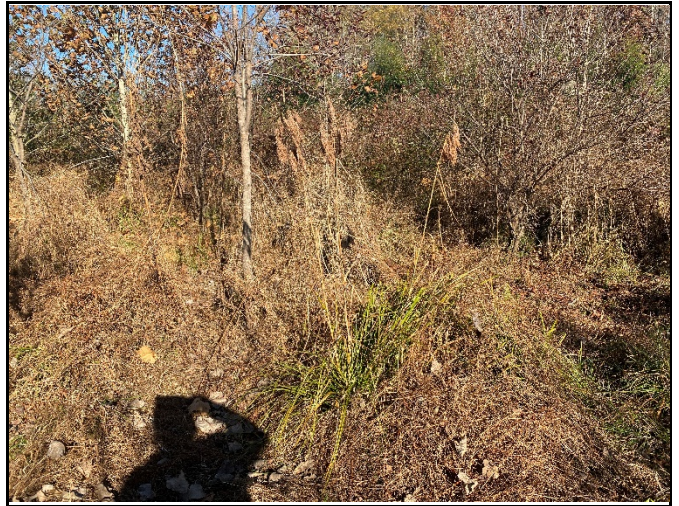
Dense herbaceous layer present dominated by tearthumb and various rushes and sedges
