**UT to Town Creek Restoration Project – Option A
Year 2 Monitoring Report**

Stanly County, North Carolina

DMS Project ID Number – 94648; NC DEQ Contract No. 003277

Monitoring Year: 2 of 7

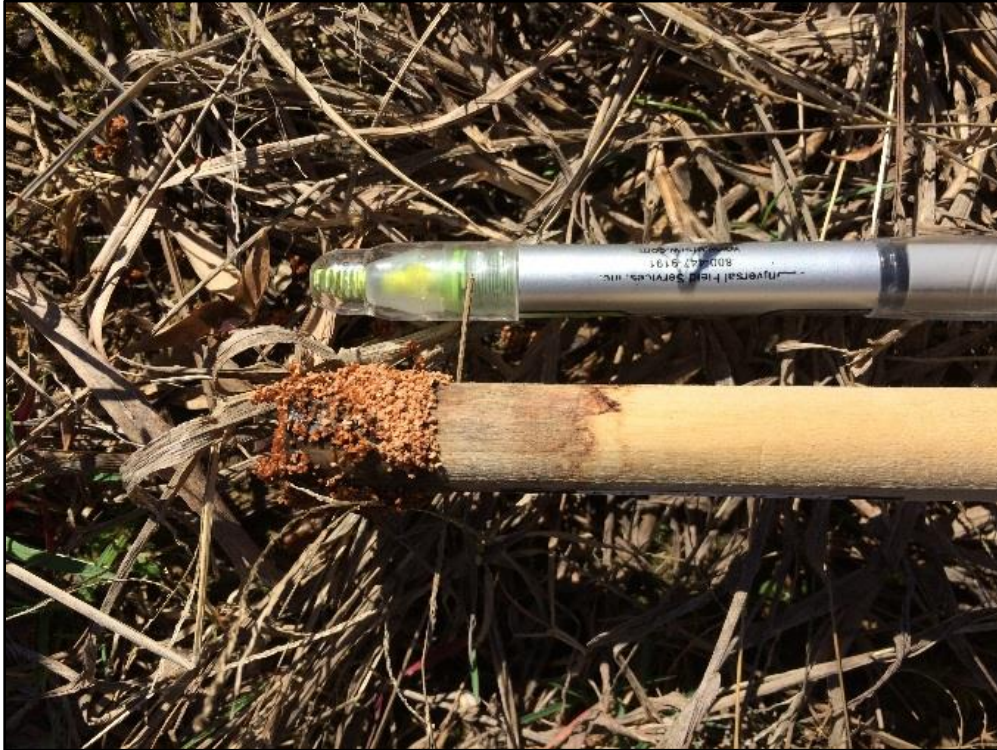
Crest Gauge Photo MY2-1 (01/25/2017)

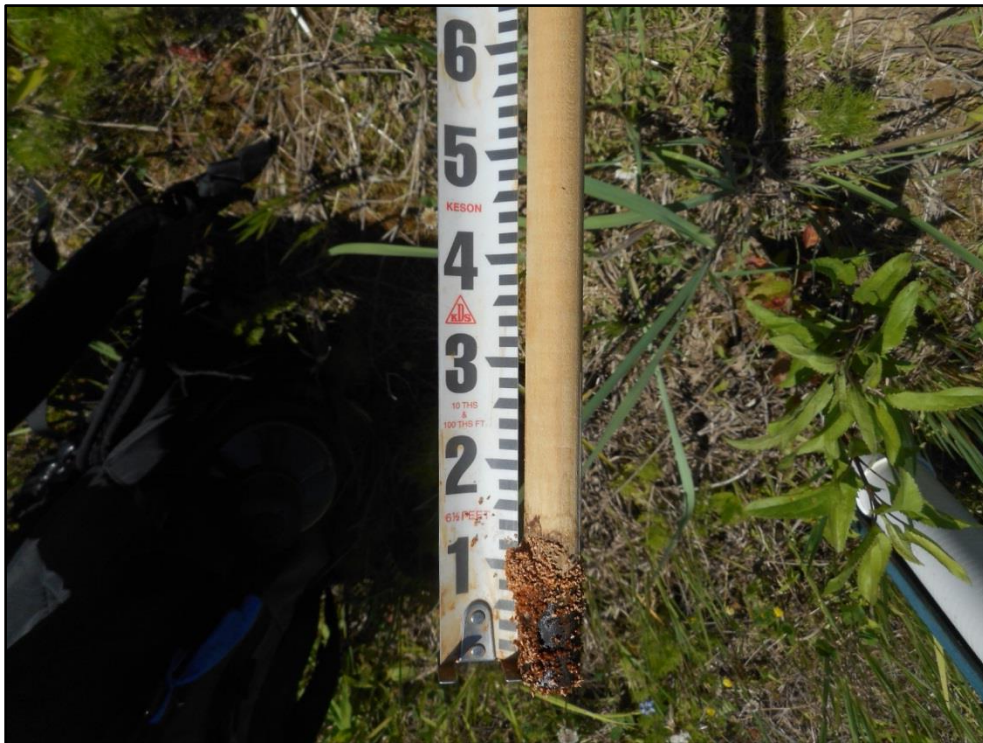
Crest Gauge Photo MY2-2 (05/03/2017)

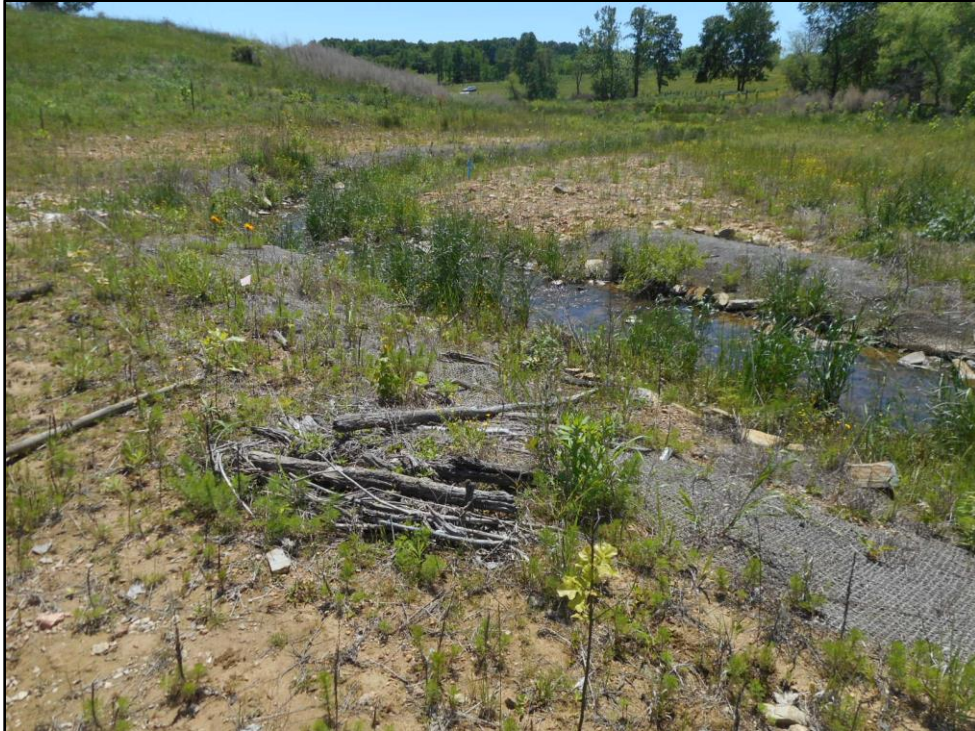
Wrack Line on Reach 2 (05/03/2017)

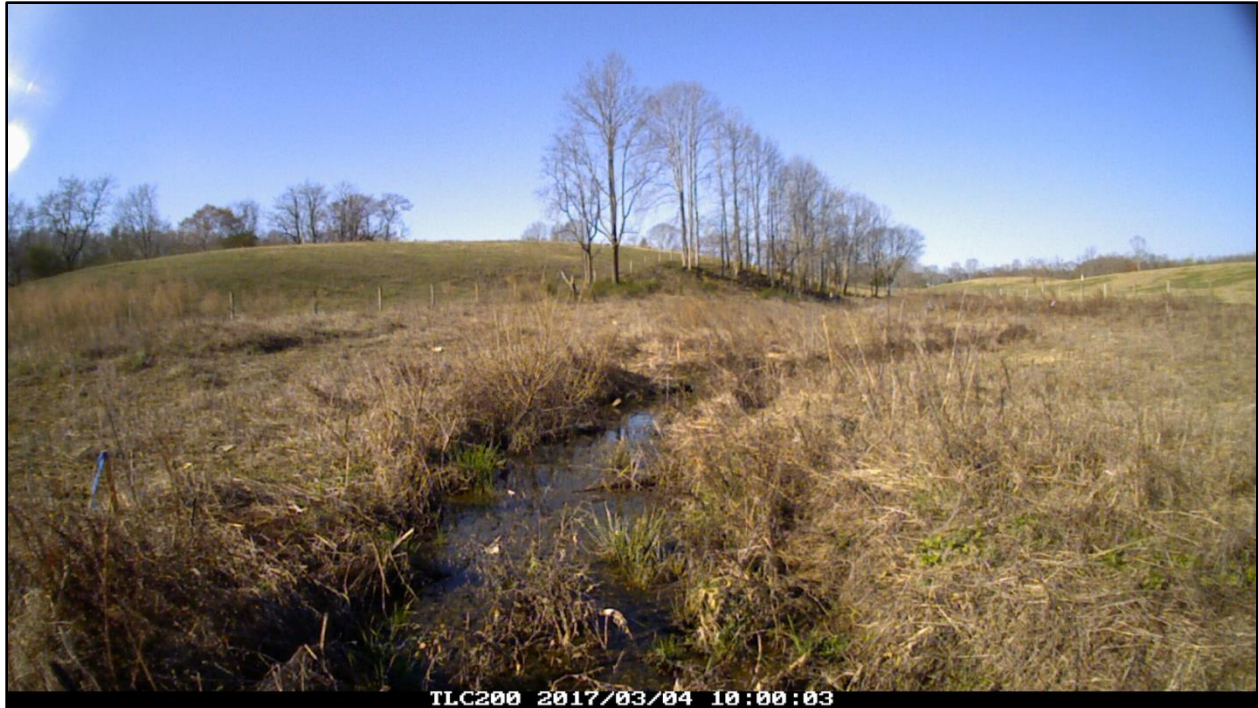
Flow Documentation Photo – R6_W2 (03/04/2017)
