Mitigation Project Name UT to Town Creek Stream and Wetland Restoration Site
 DMS ID 94648
 River Basin Yadkin
 Cataloging Unit 03040105

County Stanly
 Date Project Instituted 8/20/2010
 Date Prepared 8/27/2018

Stanly County, North Carolina

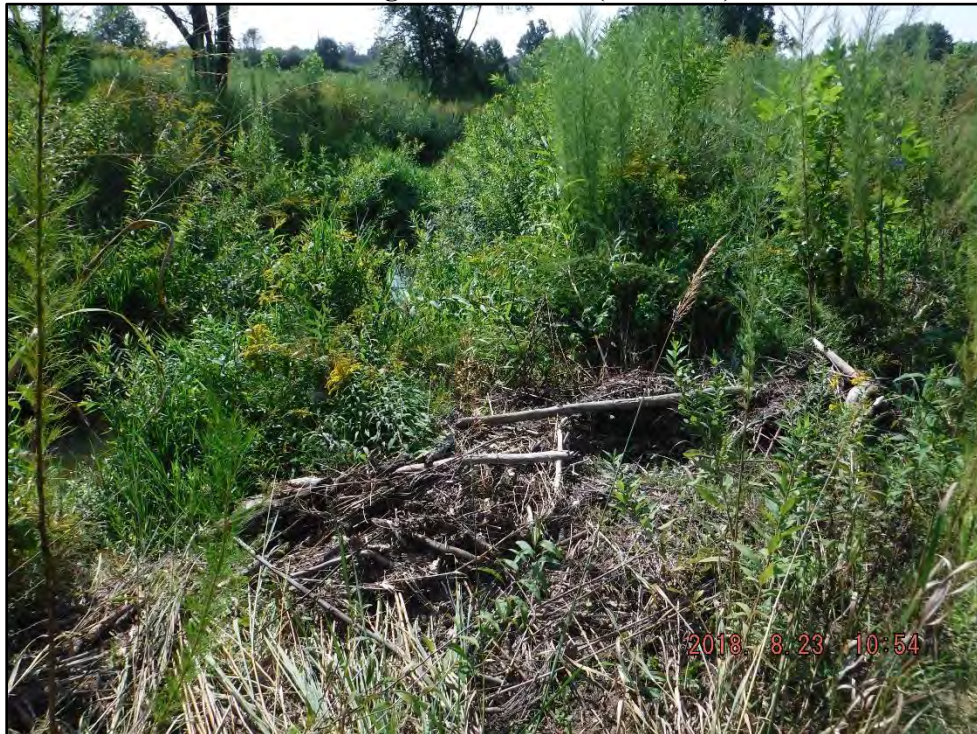
Wrack Line Photo on Reach 2 - MY3-4 (8/23/2018)

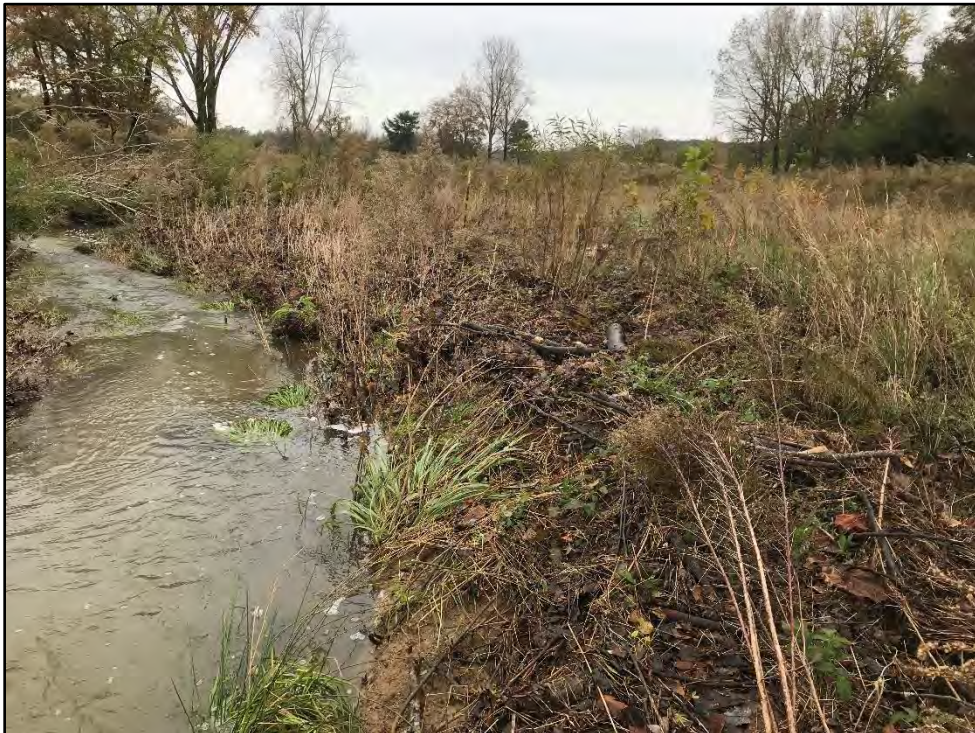
Wrack Line Photo on Reach 1 - MY3-8 (11/14/2018)
