UT to Town Creek Restoration Project – Option A Final Monitoring Report/Closeout Report

Stanly County, North Carolina

DMS Project ID Number – 94648; NC DEQ Contract No. 003277

Monitoring Year: 5

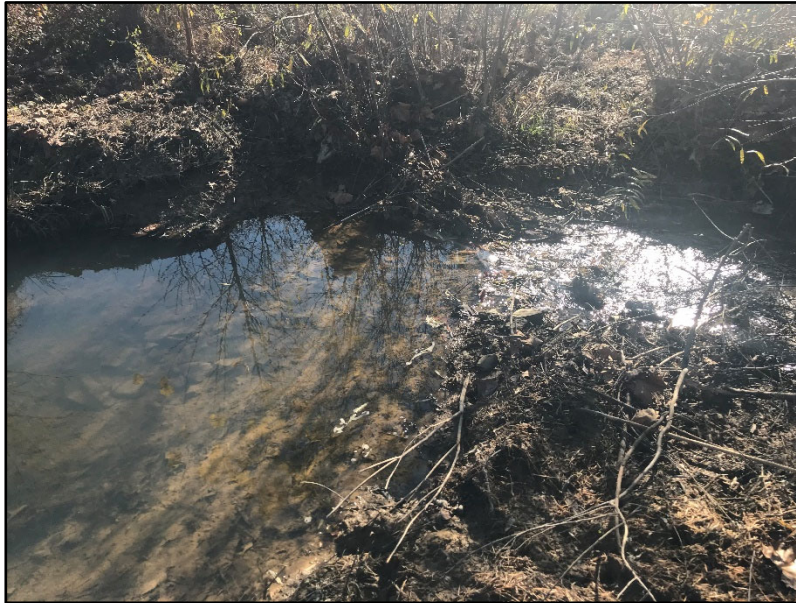
UT to Town Creek – Reach 2

SPA 5-1 - Station 35+50 – Former beaver dam downstream of culvert caused water to back up and banks to lose vegetation (11/24/20)

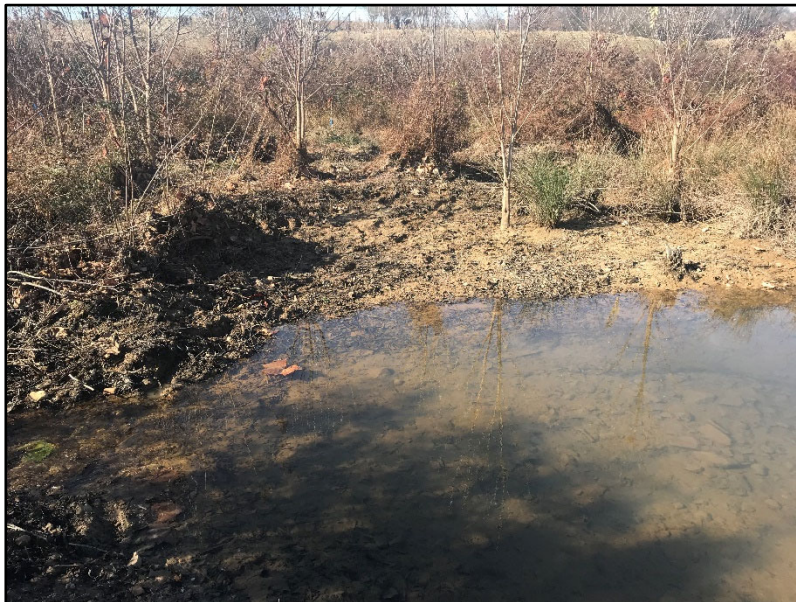
UT to Town Creek – Reach 2

SPA 5-1 - Station 35+50 – Former beaver dam downstream of culvert caused water to back up and banks to lose vegetation (11/24/20)

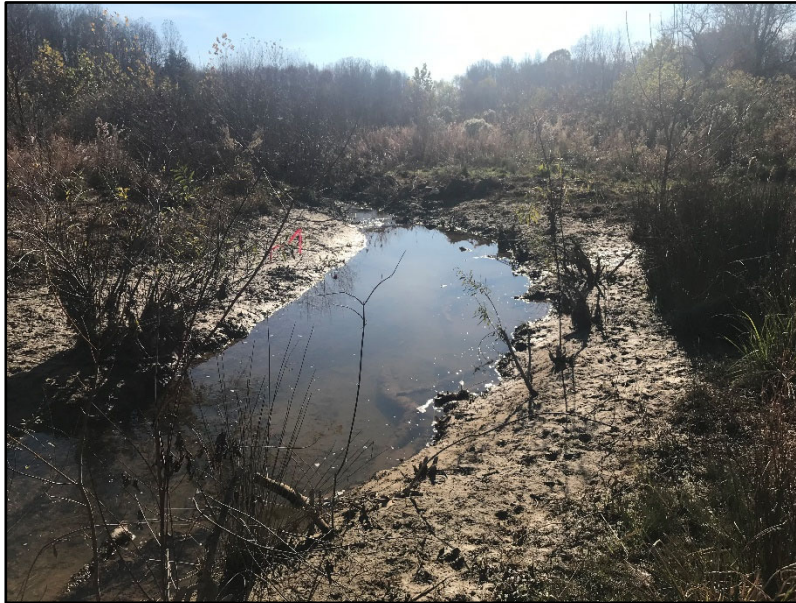
UT to Town Creek – Reach 2

SPA 5-2 - Station 36+50 – Former beaver dam caused water to back up and banks to lose vegetation (11/24/20)

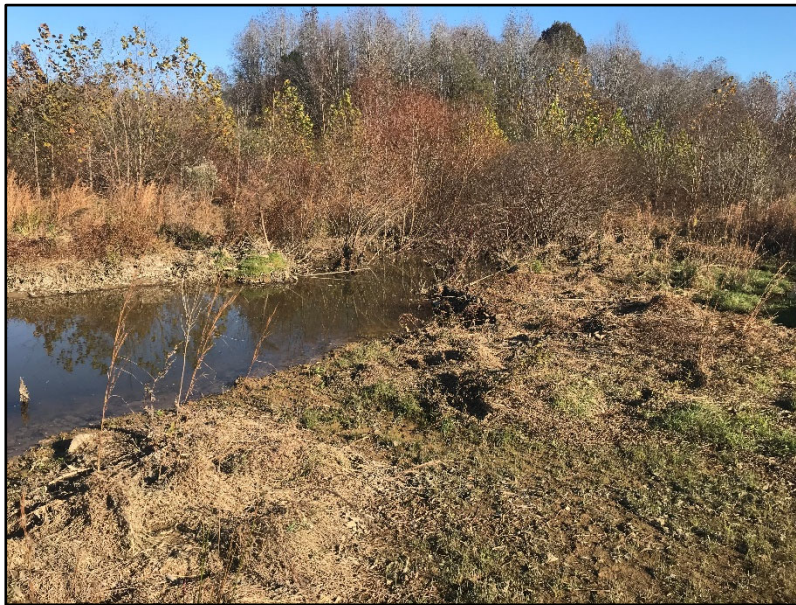
UT to Town Creek – Reach 2

SPA 5-2 - Station 36+50 – Former beaver dam caused water to back up and banks to lose vegetation (10/15/20)

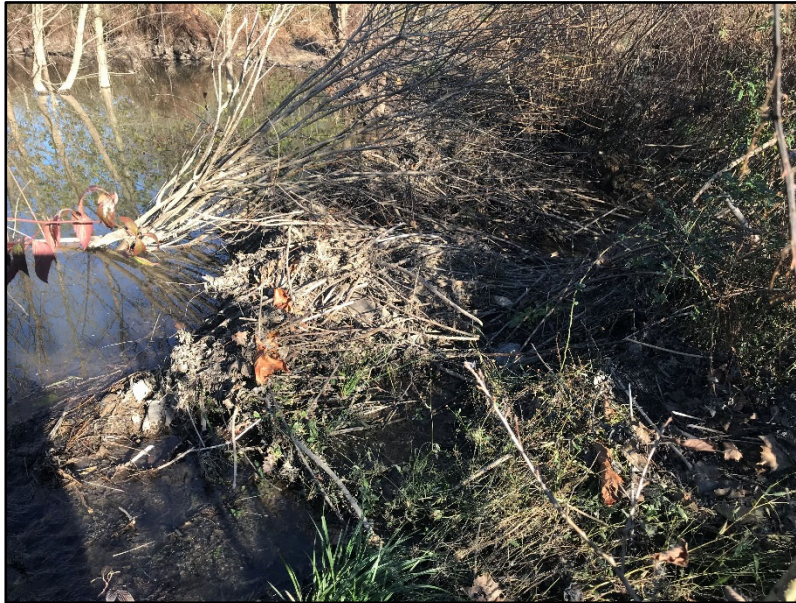
UT to Town Creek – Reach 2

SPA 5-3 - Station 39+50 to 40+20 – Beaver dam caused water to back up and banks to lose vegetation (10/15/20)

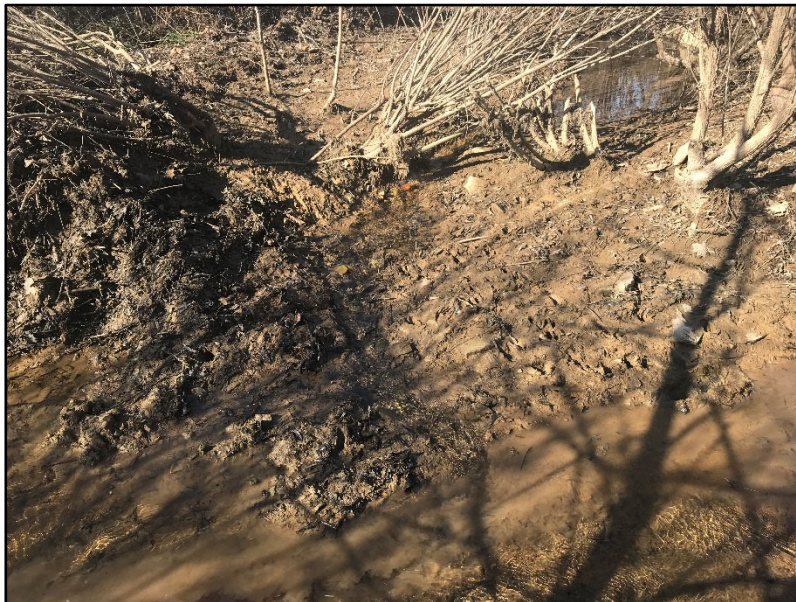
UT to Town Creek – Reach 2

SPA 5-3 - Station 39+50 to 40+20 – Former beaver dam caused water to back up and banks to lose vegetation (11/24/20)

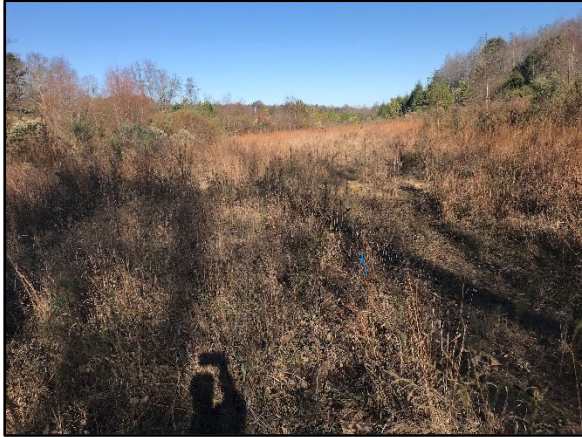
During Year 5 monitoring, vegetation conditions were performing over 90% for planted acreage and close to 100% for invasive/encroachment area categories. As noted in Table 6b, an area (VPA5-1) of low herbaceous vegetation and poor growth rates has continued to persist from MY2. This area is located along Reach 2 between Vegetation Plot 14 and 13 and consists of approximately 0.11 acres. This area has been supplemental planted with gallon plants, annual seed, perennial grass plugs and appropriate amount of lime in May 2020, but due to harsh temperatures and compacted clay soils this area is expected to have a high mortality.

VPA 5-1– Photo of bare areas, areas of poor growth rates, and areas where supplemental plantings were installed. (11/18/20)
