*Final*  
**Year 4 Monitoring Report**

**UT to Uwharrie River Stream Restoration Project  
Randolph County, North Carolina  
DMS Project No. 847**

Construction Completed: March 2011  
Vegetation Data Collected: August 2015  
Morphology Data Collected: November 2015  
Submission Date: March 2016

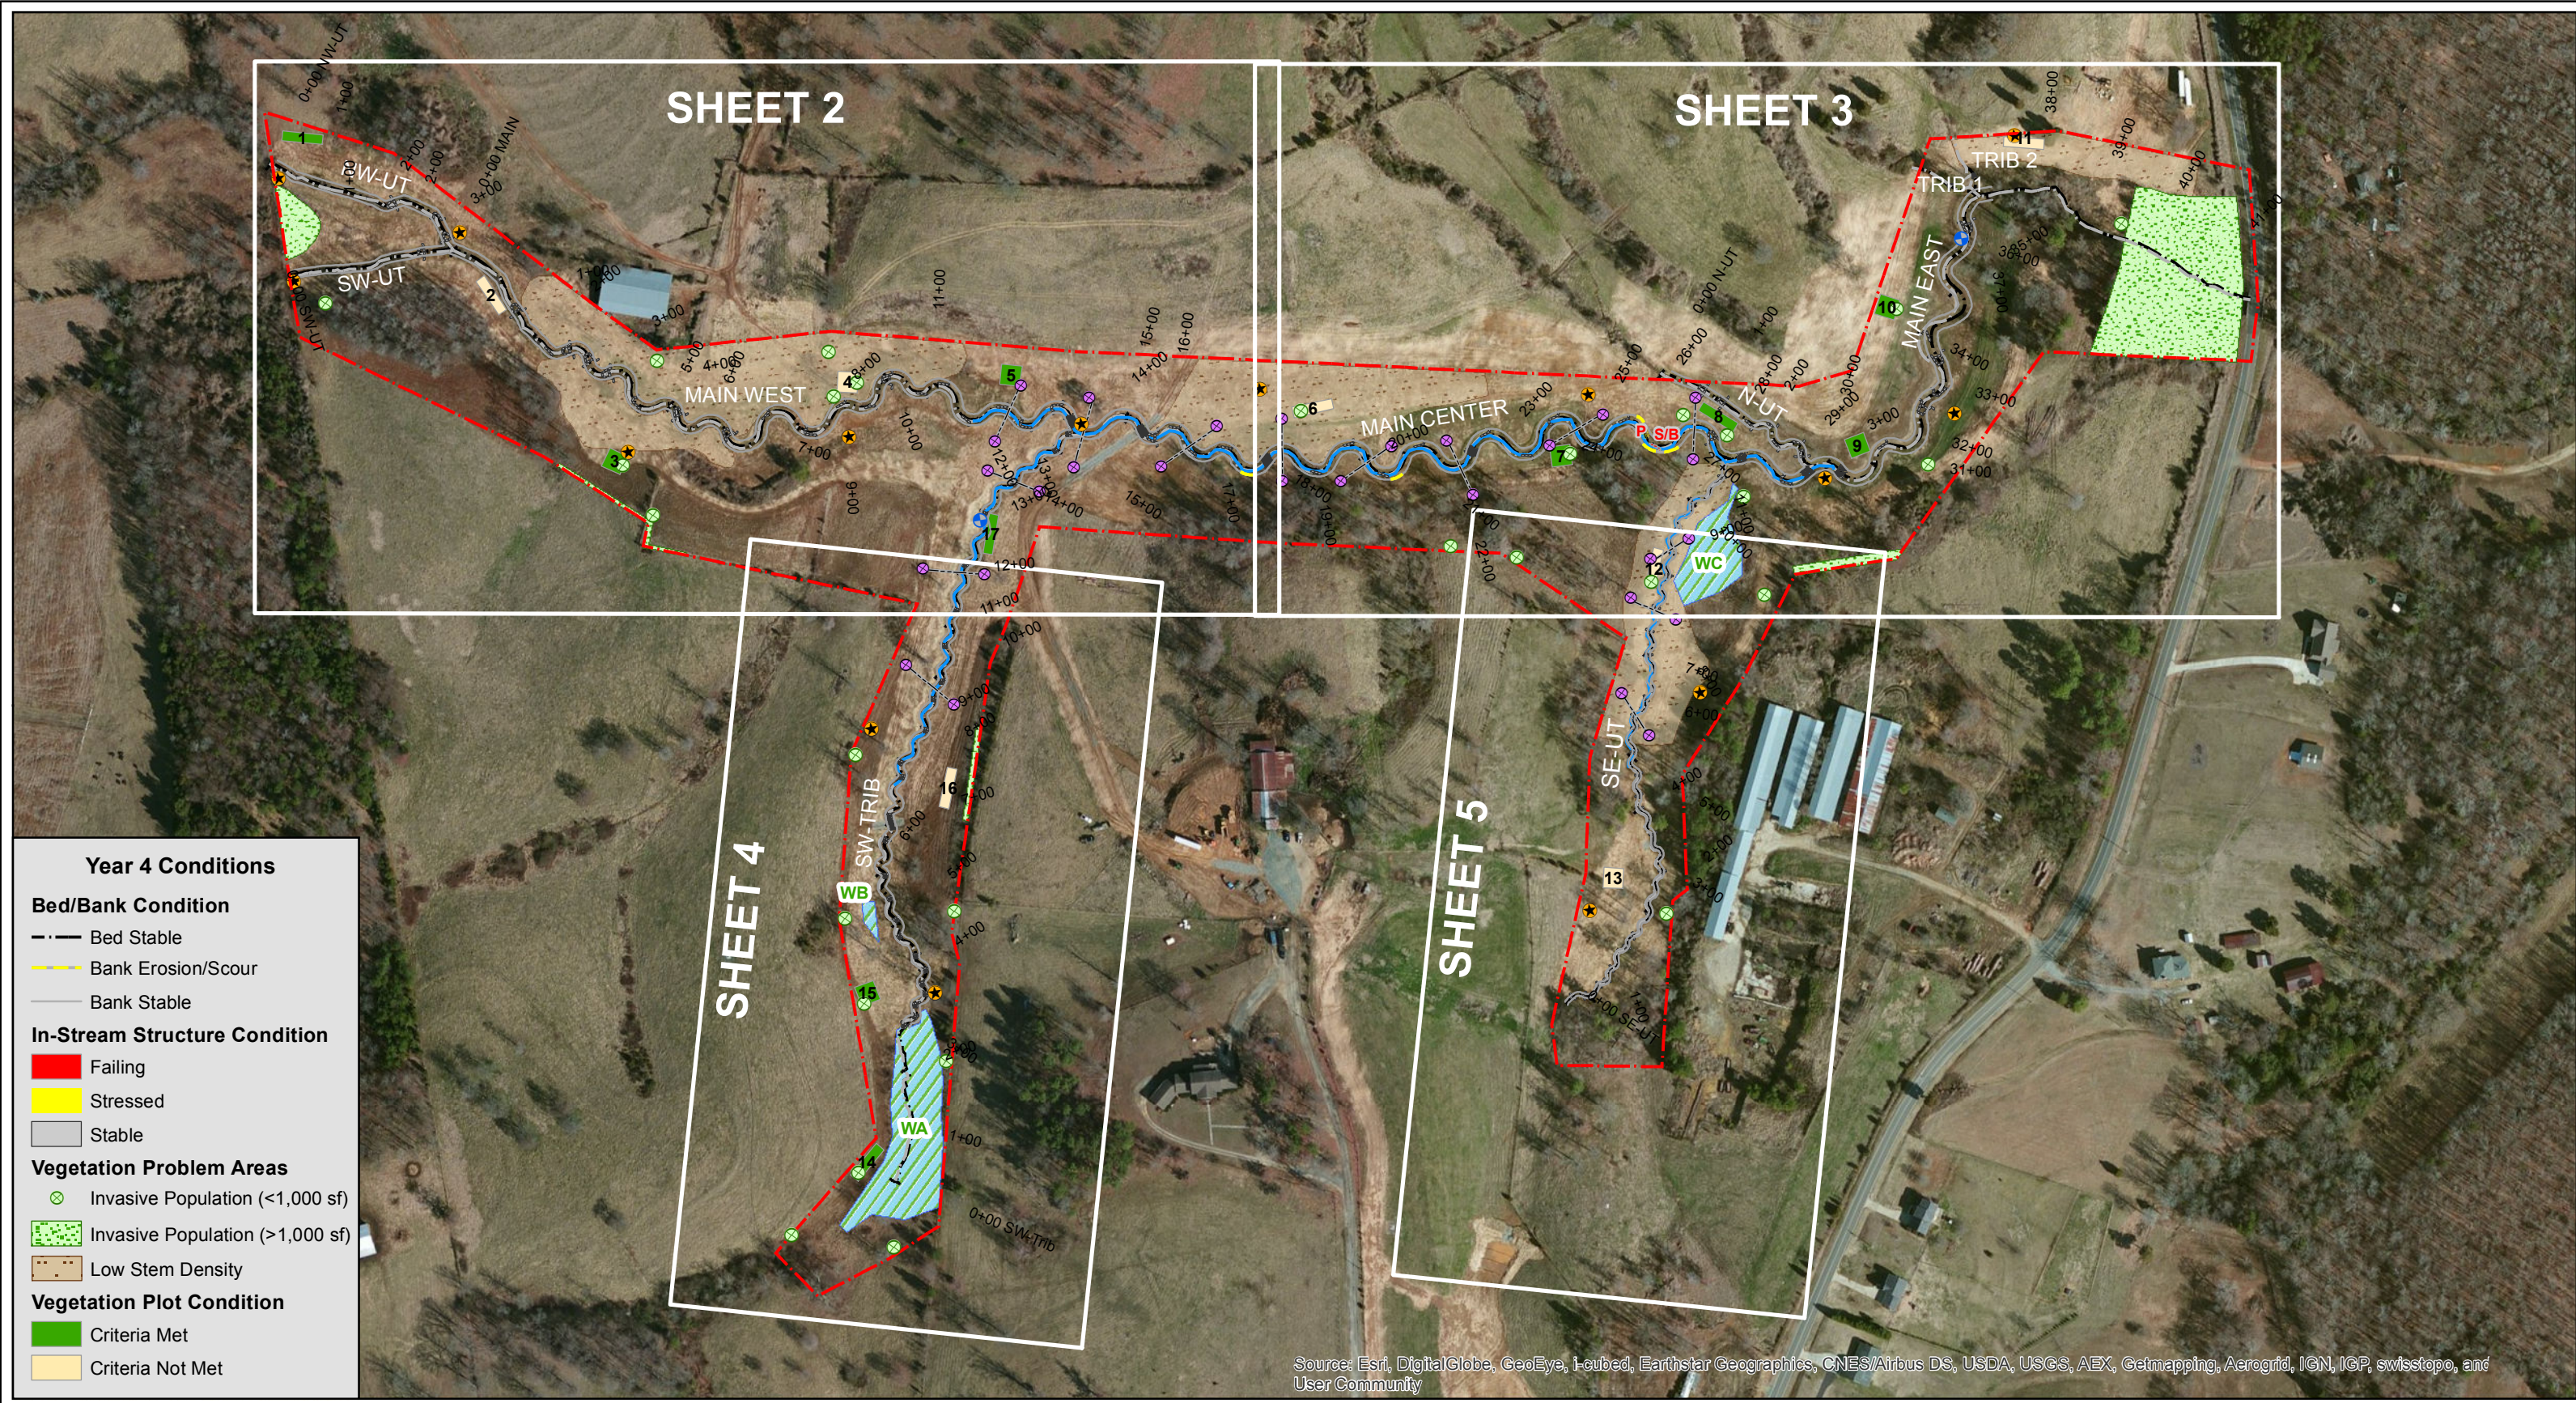
**FIGURE 2. CURRENT CONDITION PLAN VIEW**  
**UT TO UWHARRIE RIVER STREAM RESTORATION PROJECT**  
**RANDOLPH COUNTY, NORTH CAROLINA**

Year 4 monitoring surveys along UT to Uwharrie occurred in November 2015. Four areas of instability were noted during longitudinal surveys and are documented on the CCPV (Figure 2). These areas of bank erosion were observed along the Main Center reach at Stations 17+50, 20+50, and between Stations 26+00 to 27+00. One rock vane has been compromised as a result of stream bank erosion around the vane arm. Additionally, one constructed riffle is stressed within this station range. Both of these structures were noted in previous years and do not appear to have worsened. No areas of instability were observed during longitudinal surveys of the SW-Trib, SE-UT or Main West.

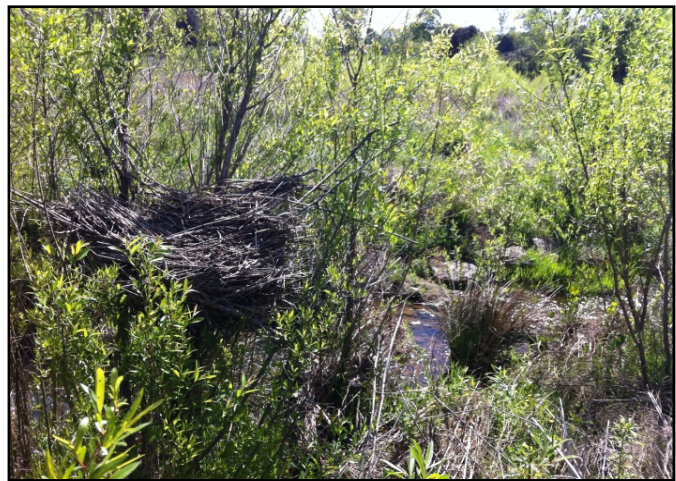
Photo 1: Wrack Lines on Main Center Following Bankfull Event - Spring 2013

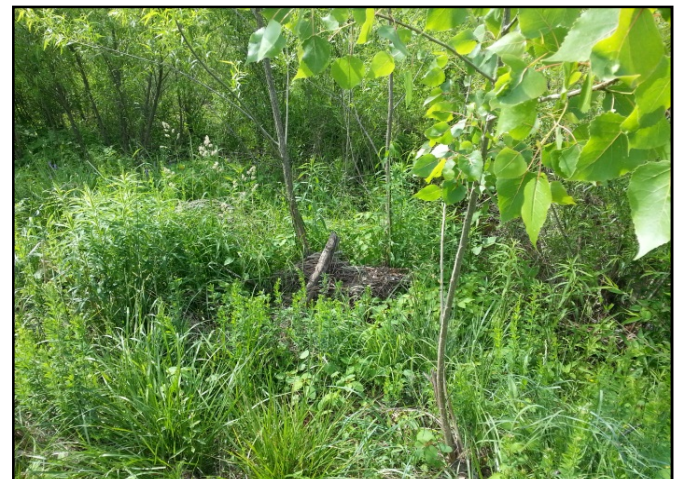
Photo 3: Crest Gauge (Main East) Leaning Over Following Bankfull Event - Fall 2013

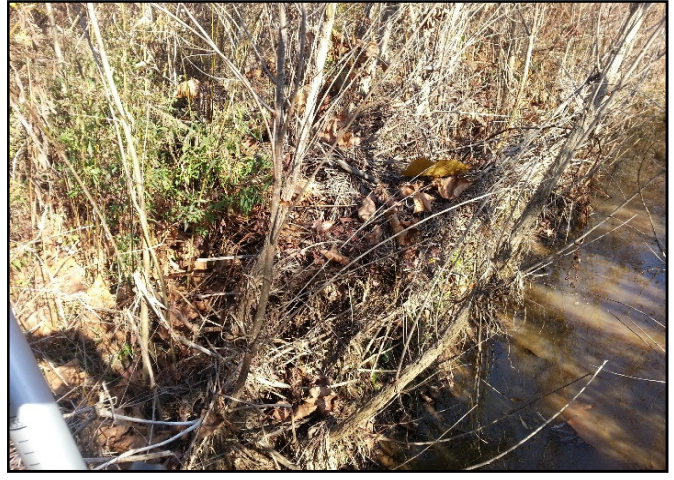
Photo 5: Wrack Lines on Main East  
Following Bankfull Event - Spring 2014
