**Final
Year 5 Monitoring Report**

**UT to Uwharrie River Stream Restoration Project
Randolph County, North Carolina
DMS Project No. 847**

Construction Completed: March 2011
Vegetation Data Collected: September 2016
Morphology Data Collected: November 2016
Submission Date: January 2017

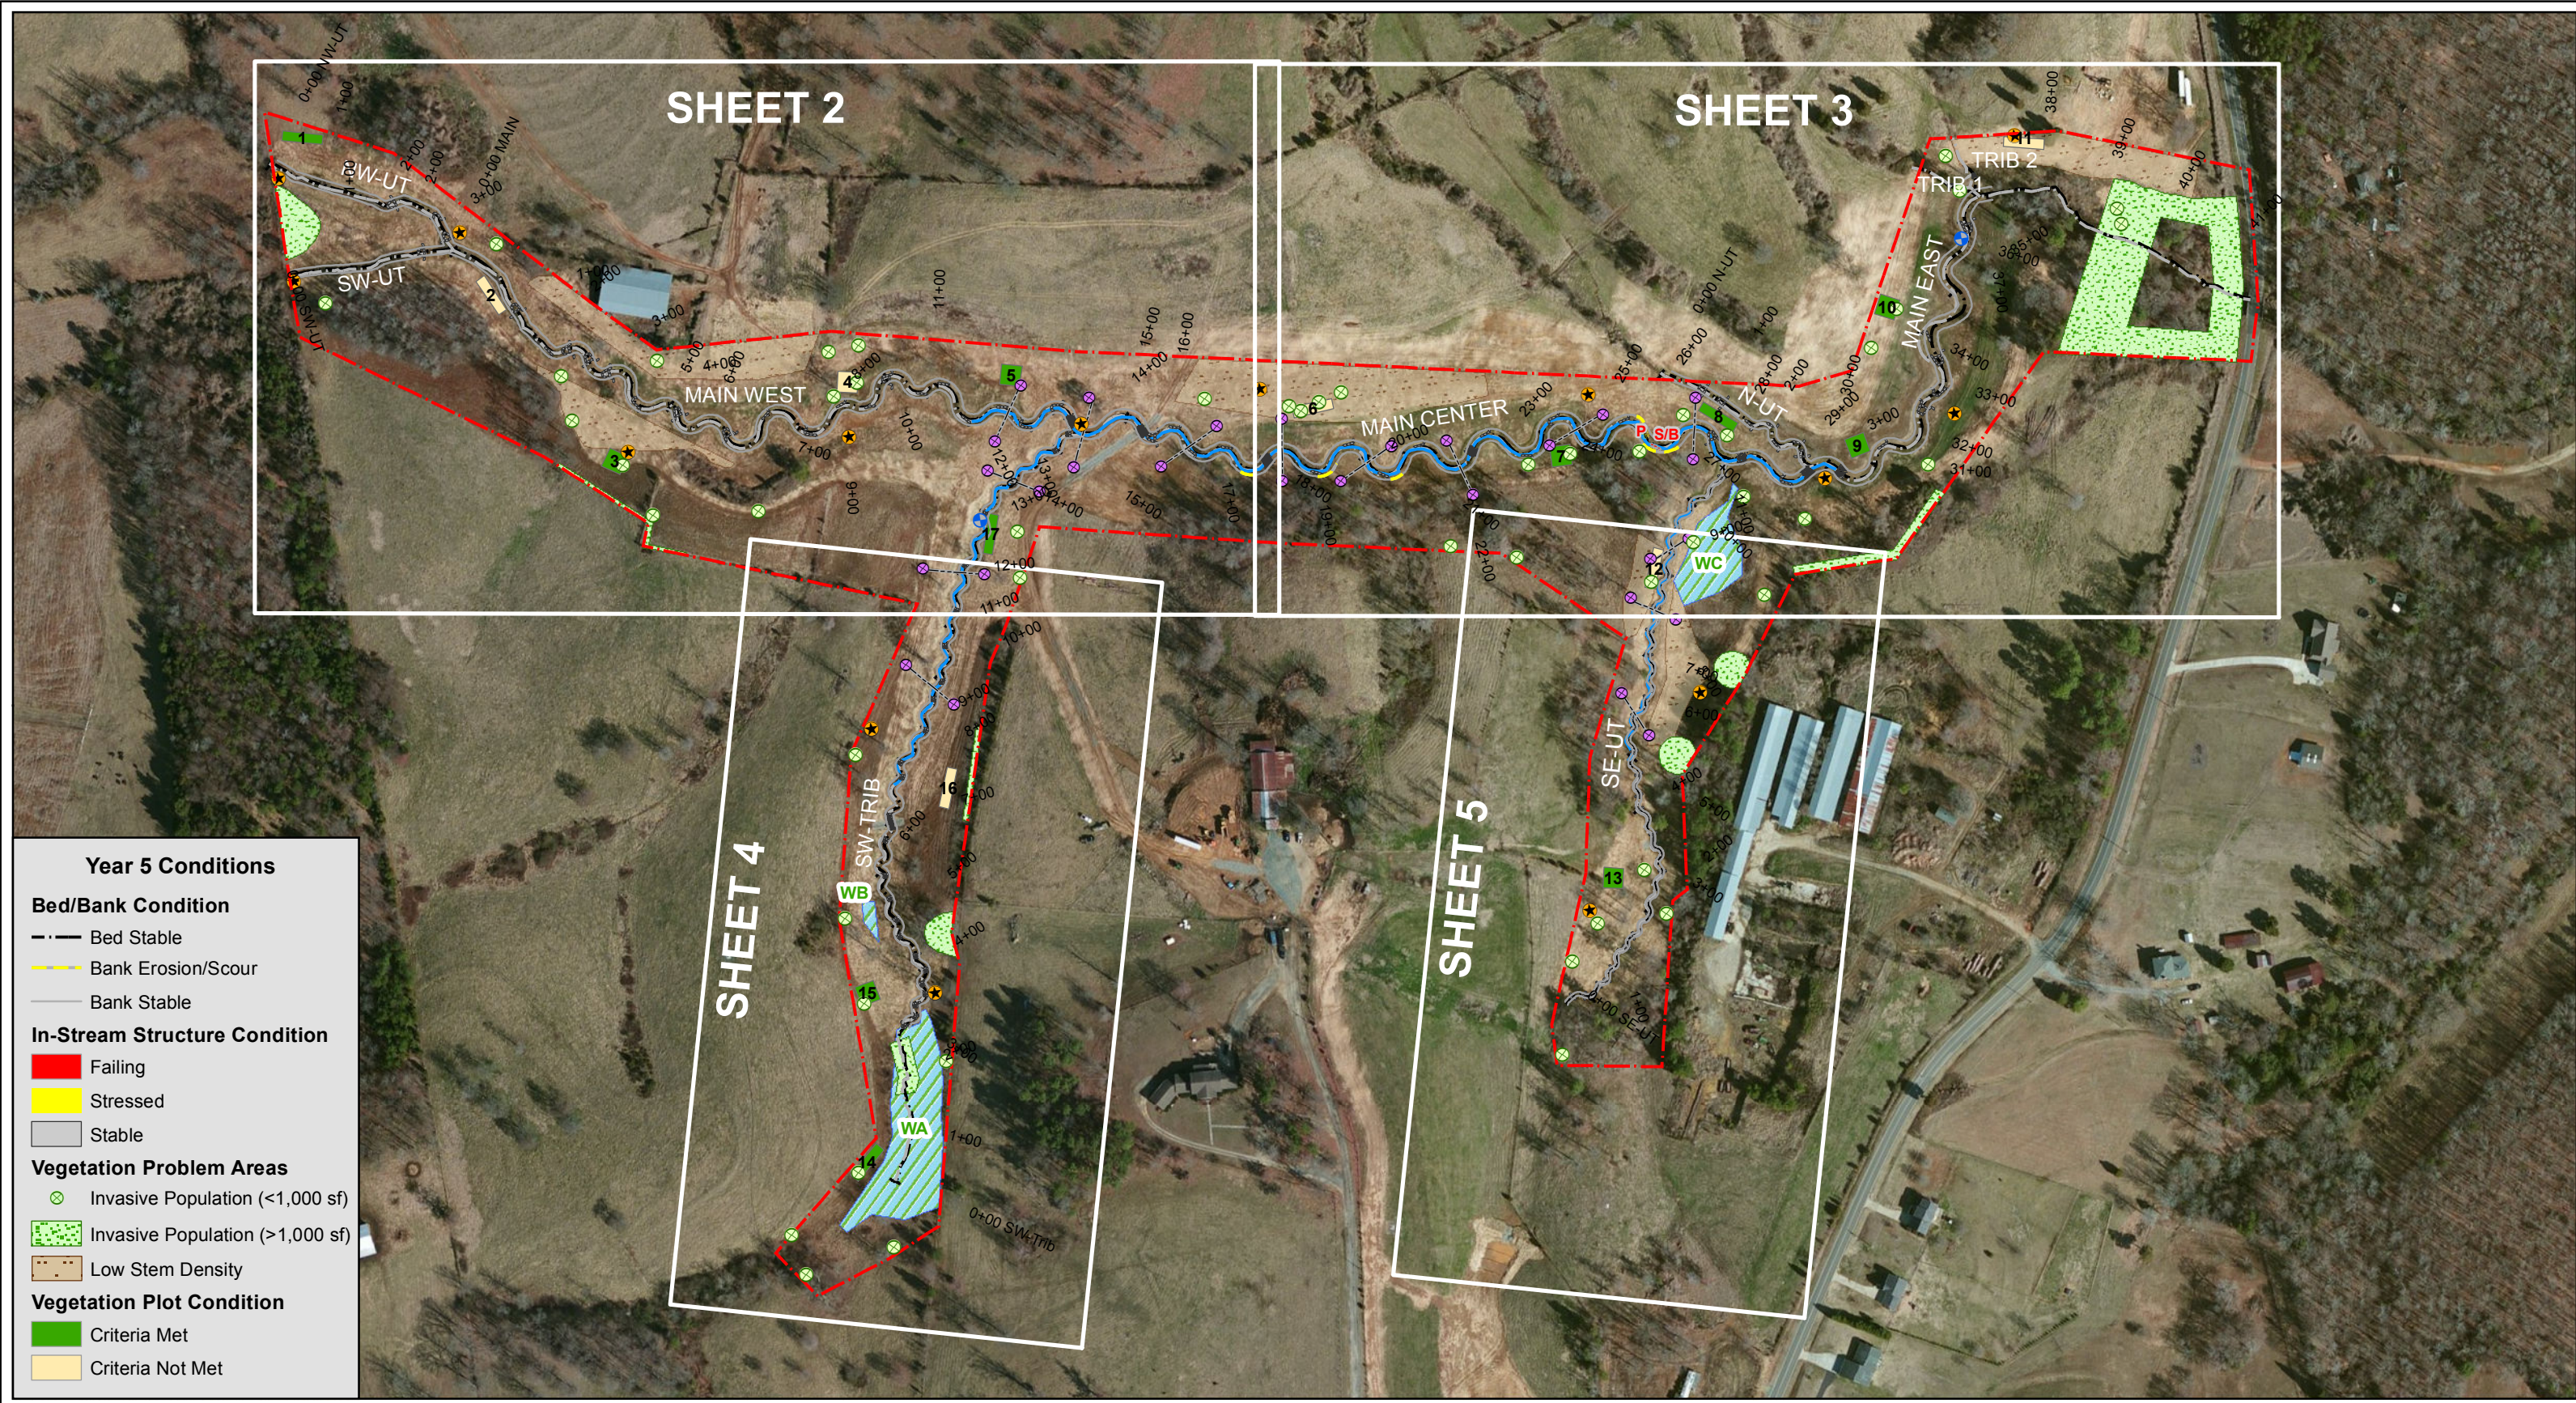
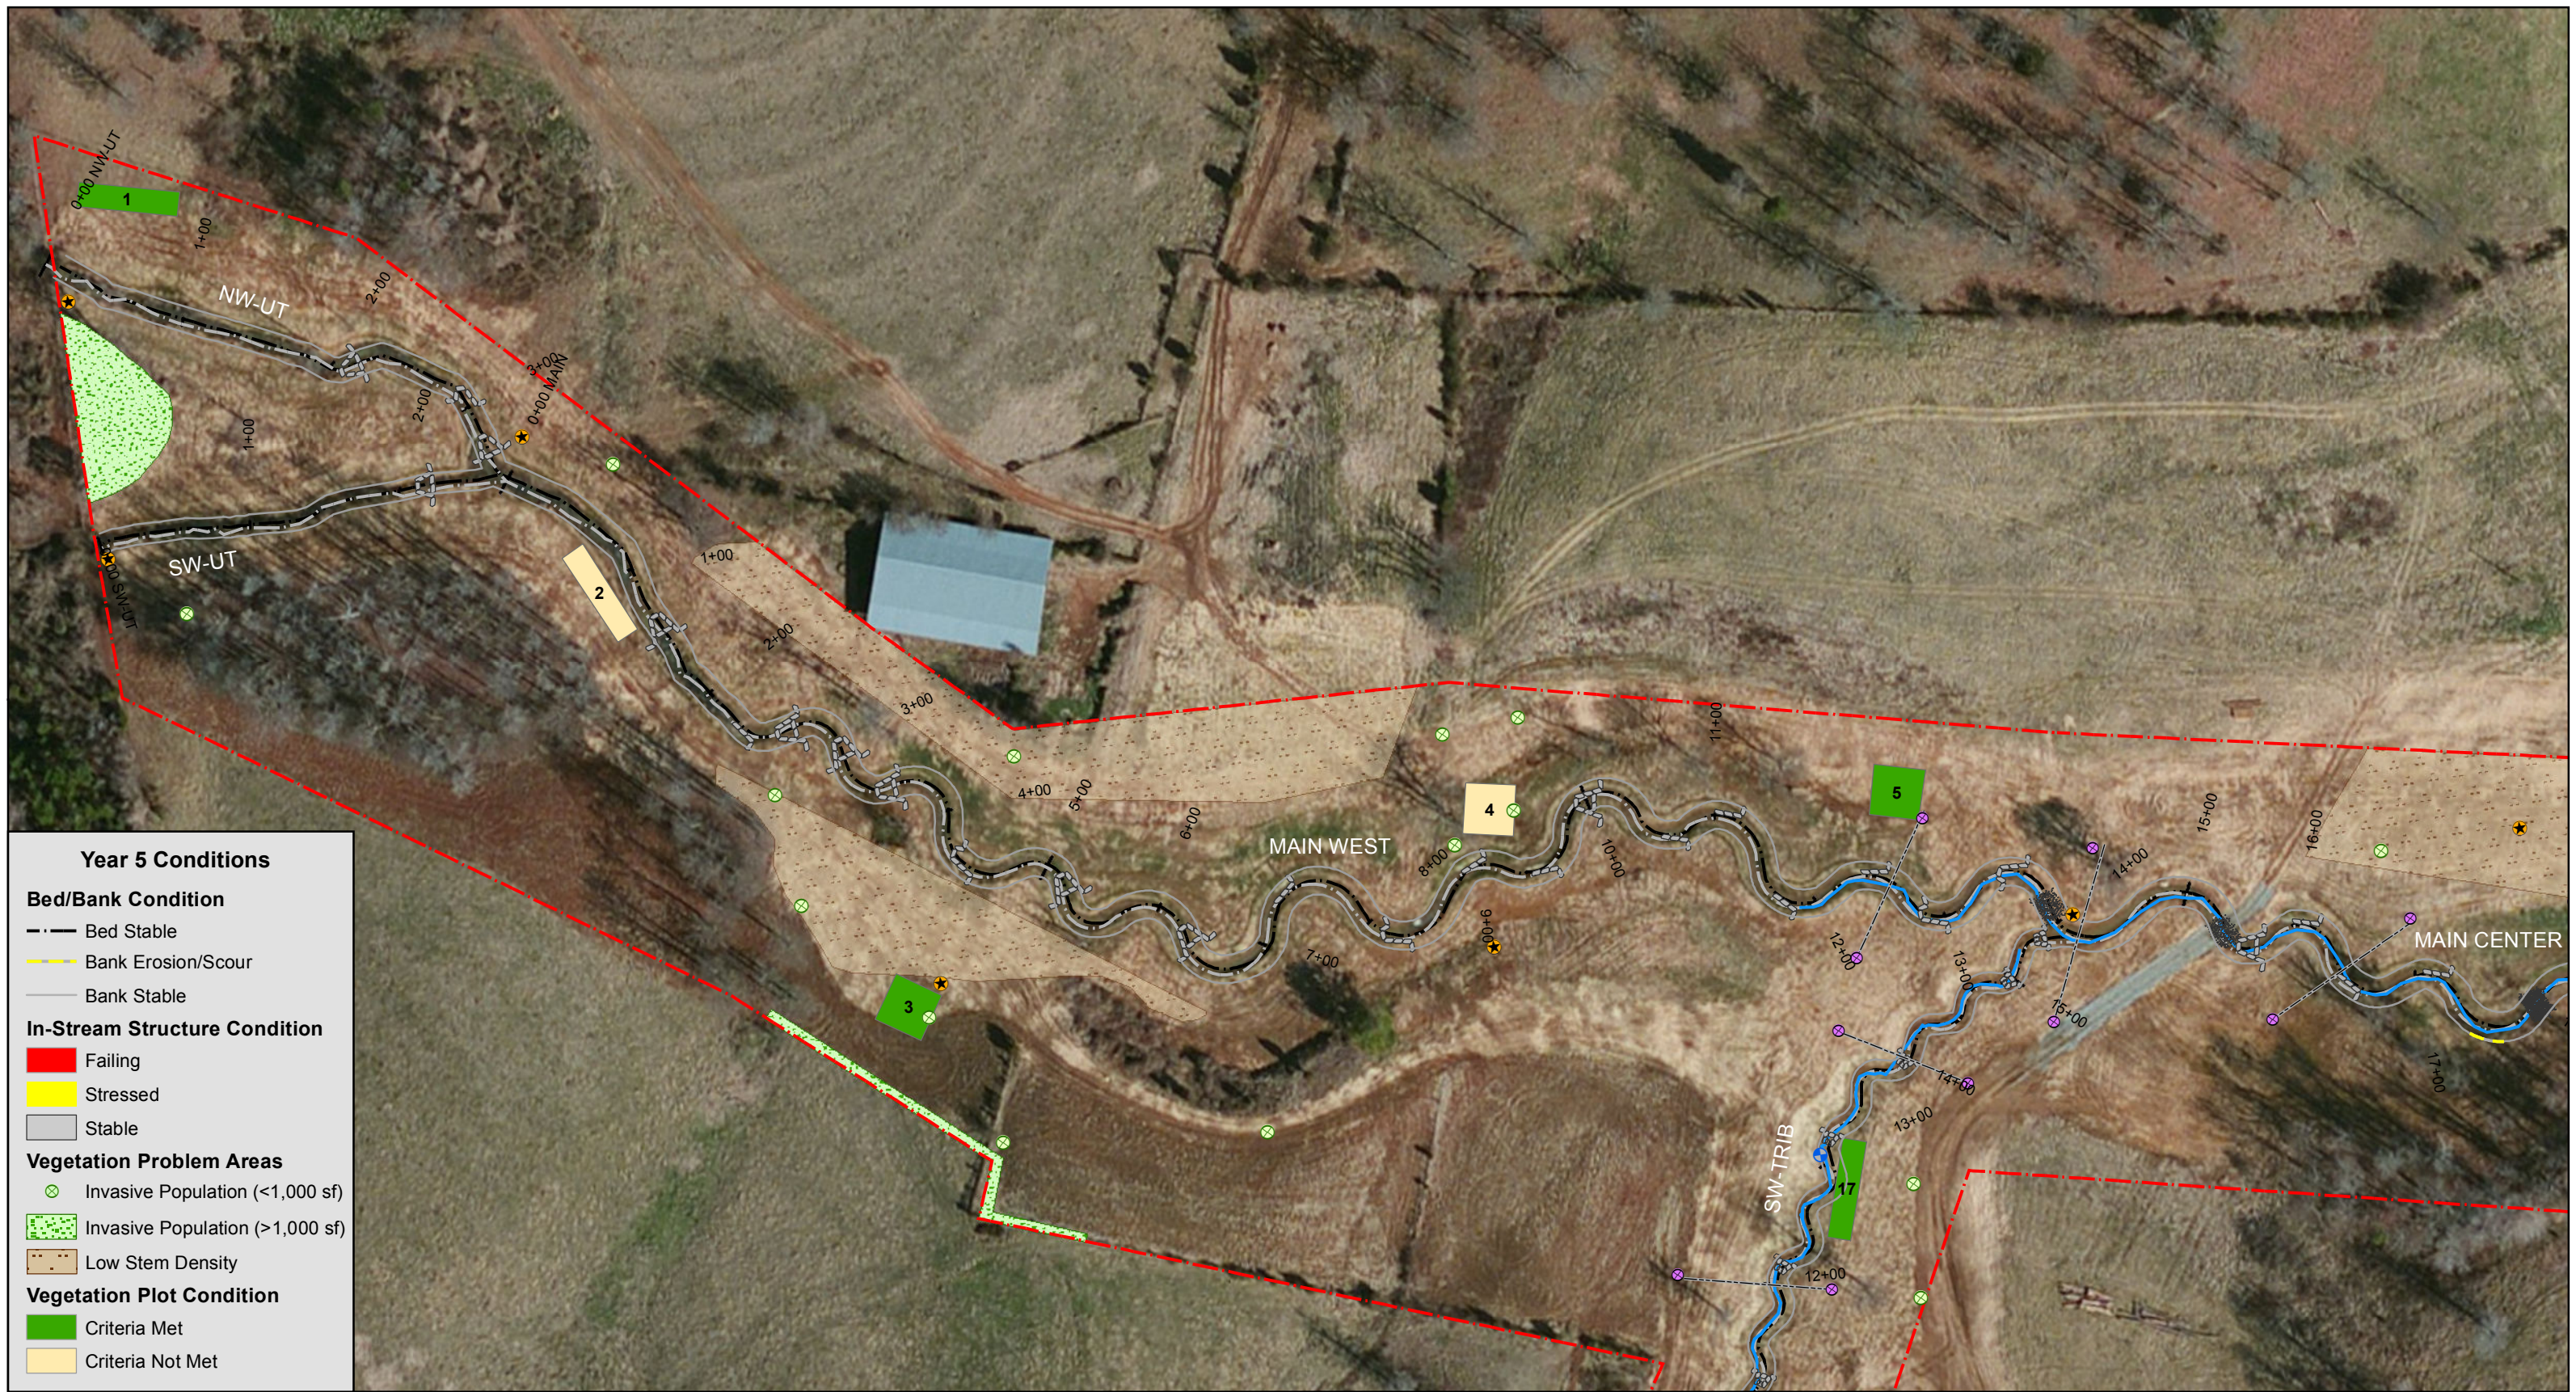
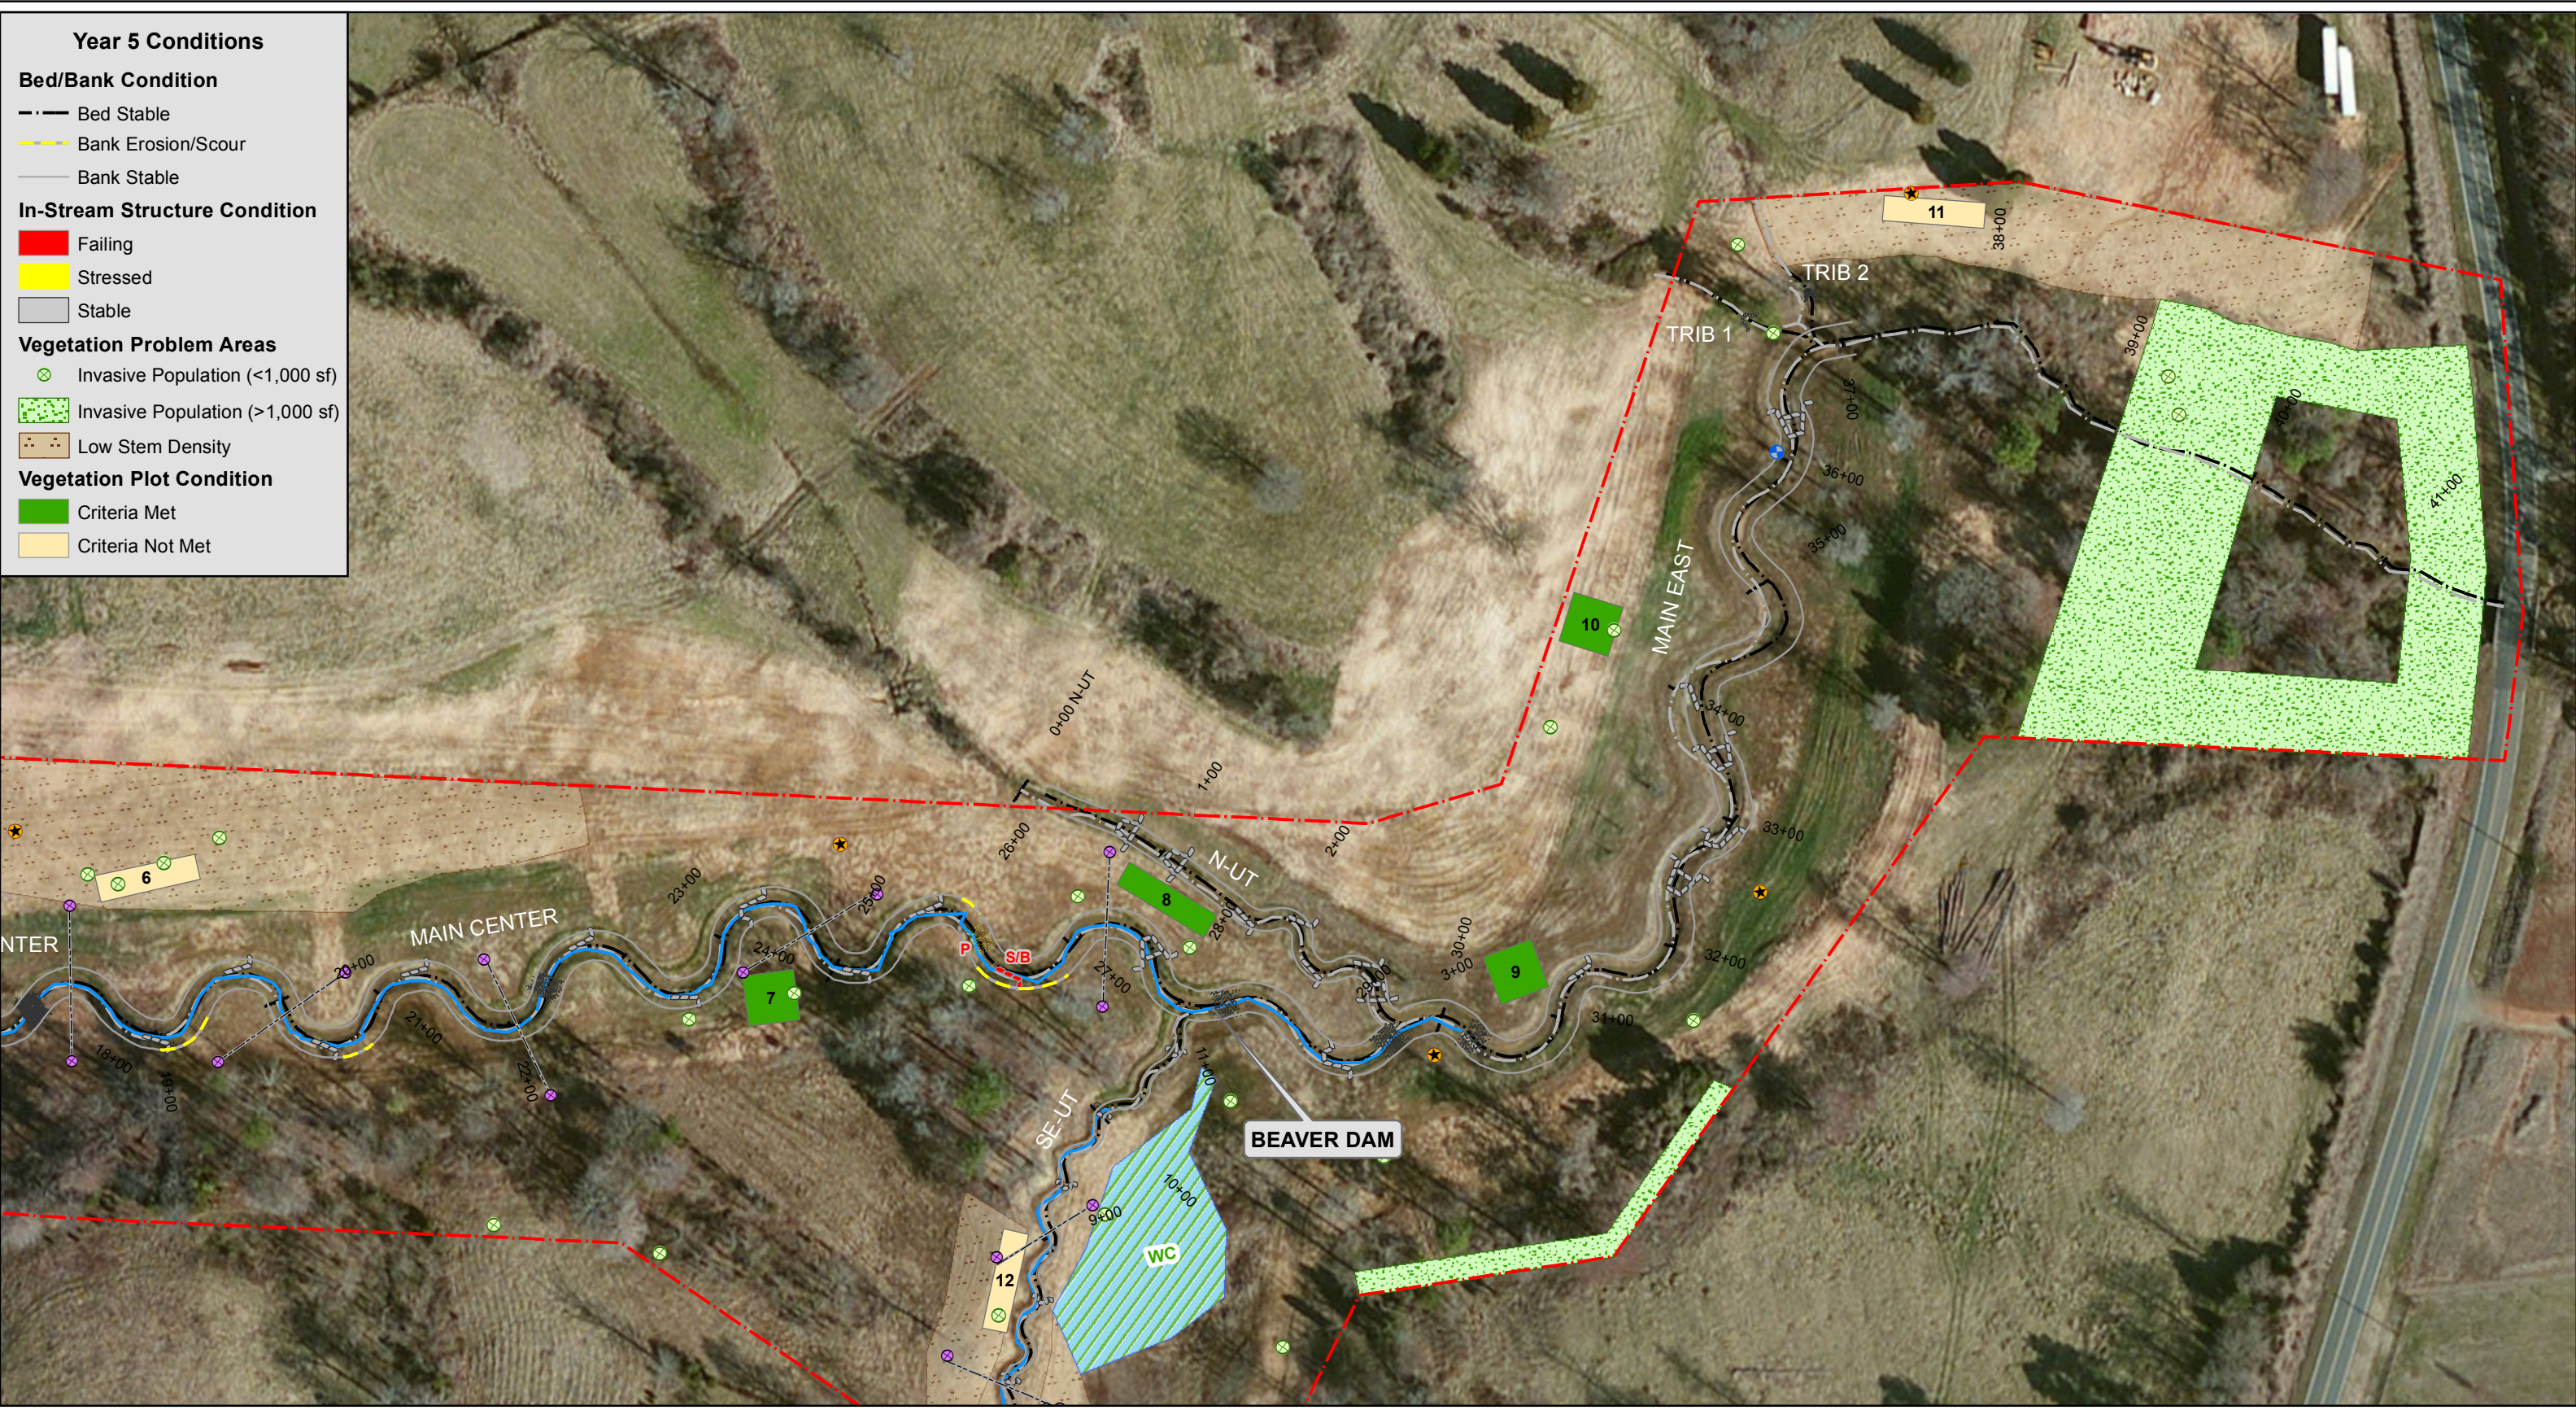
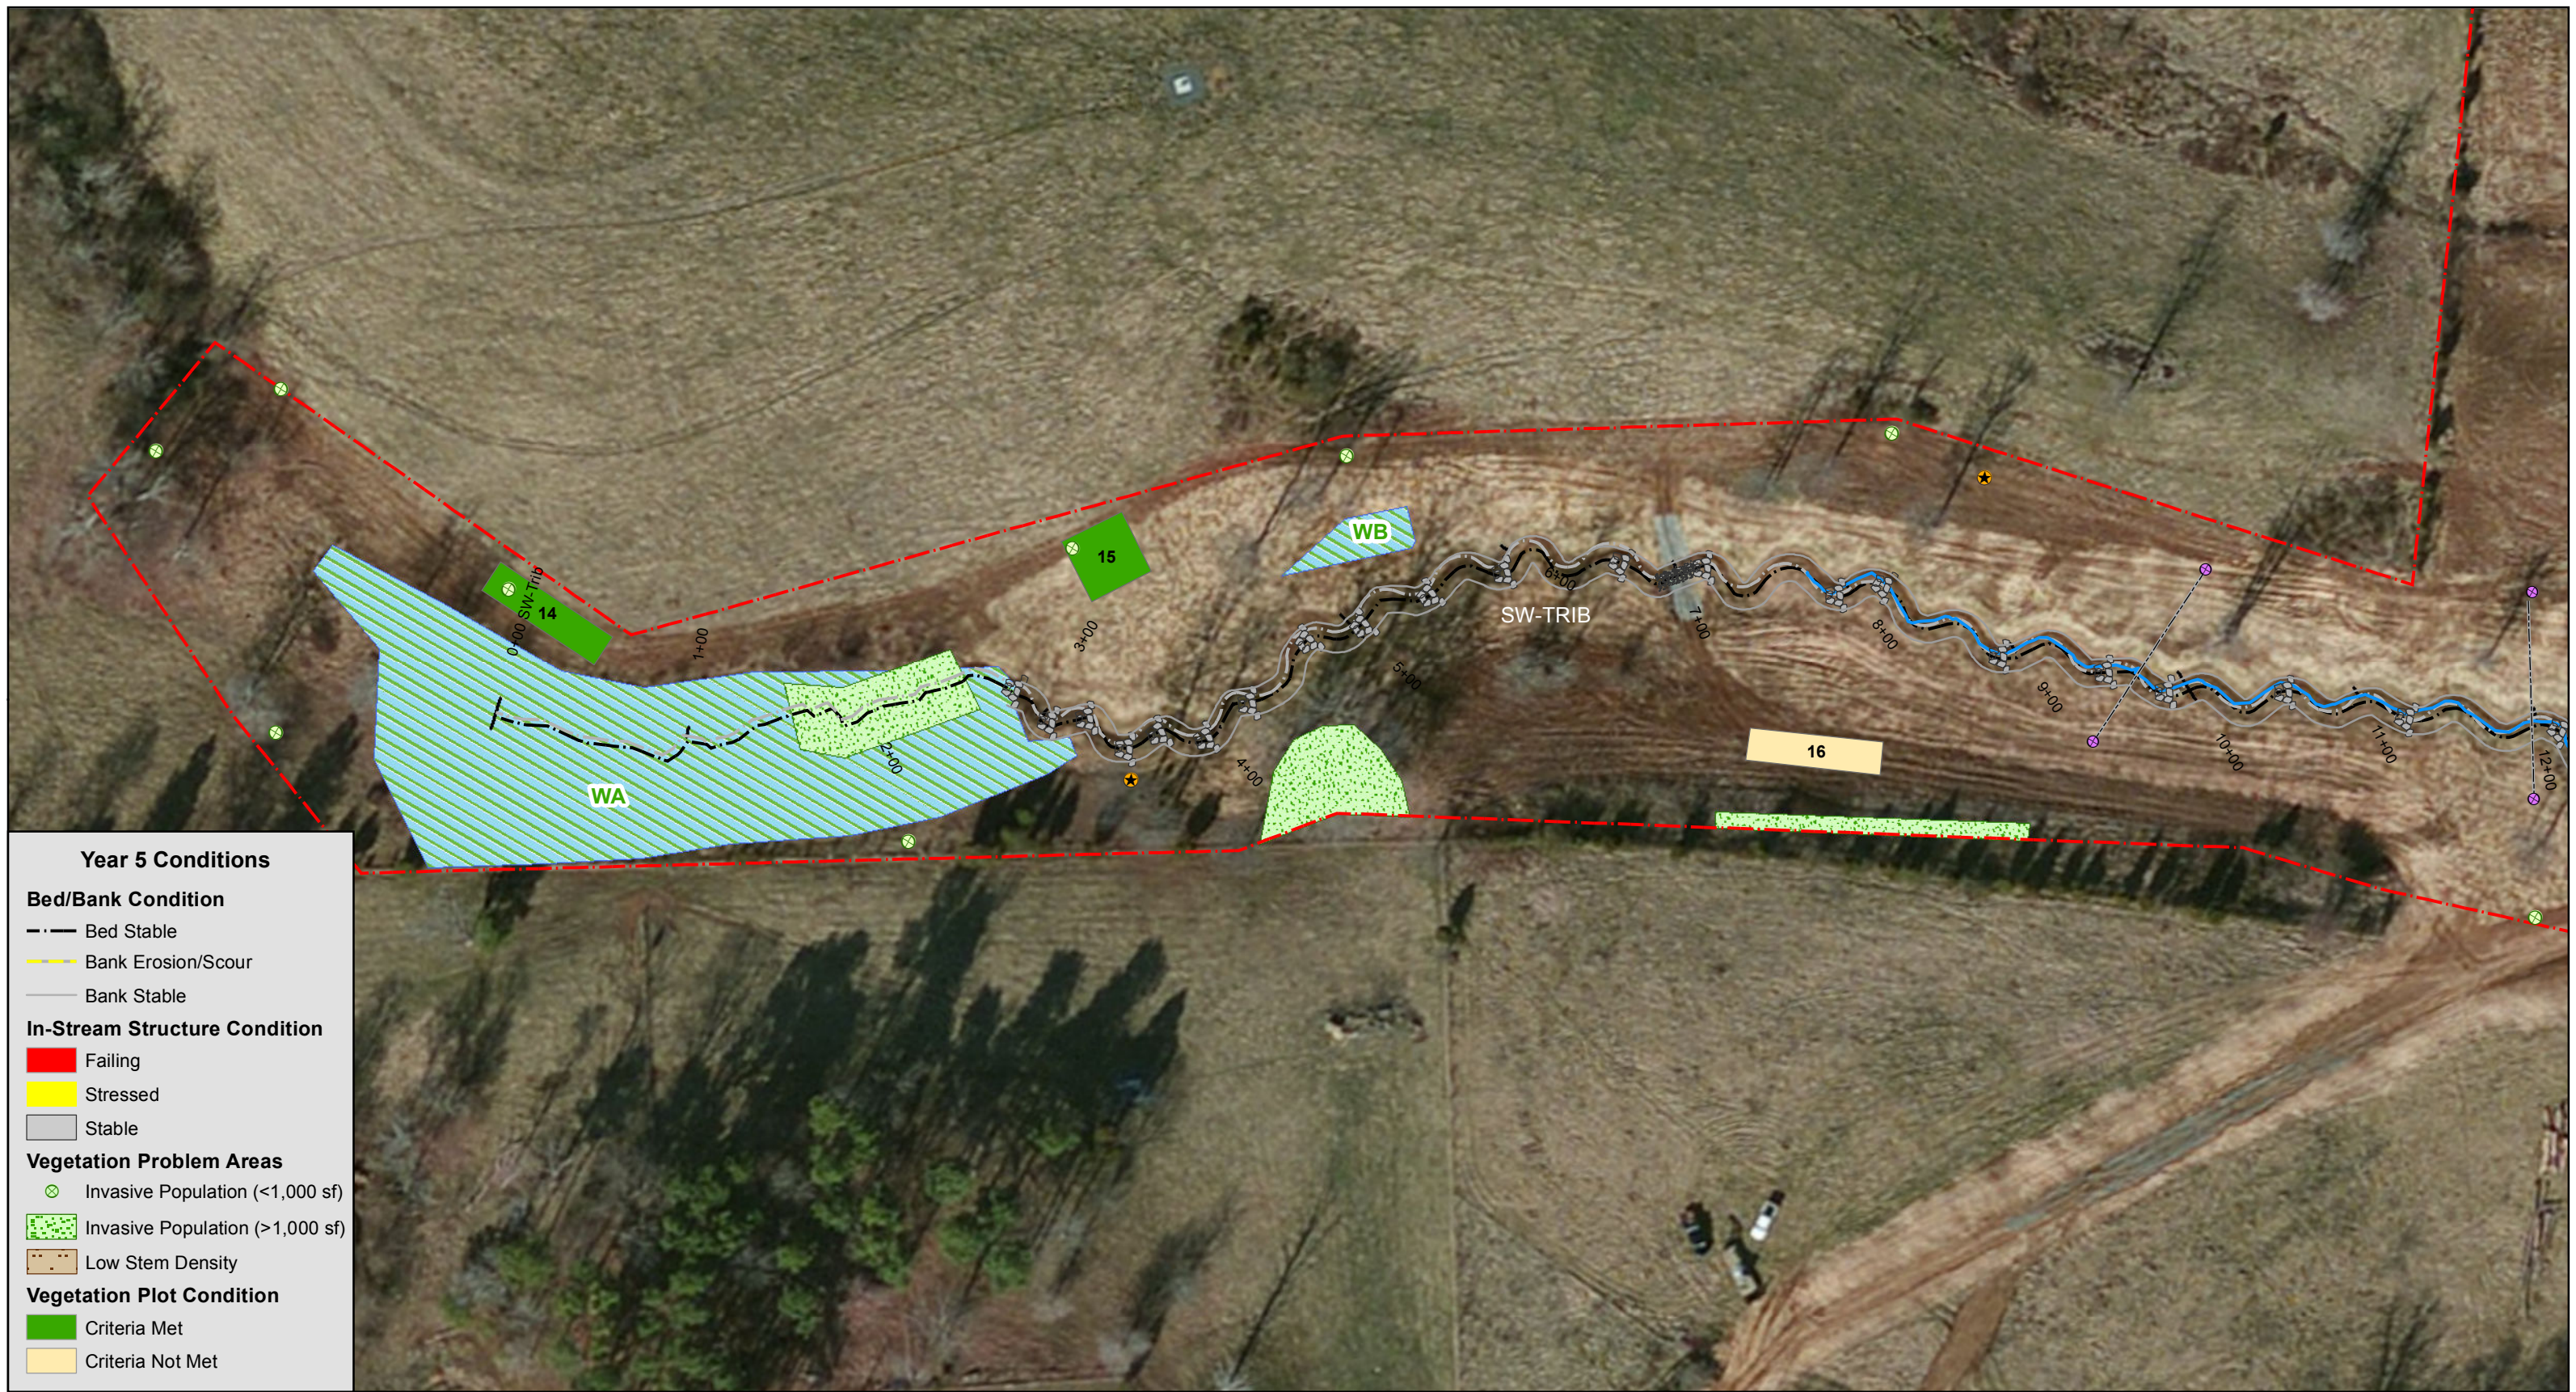
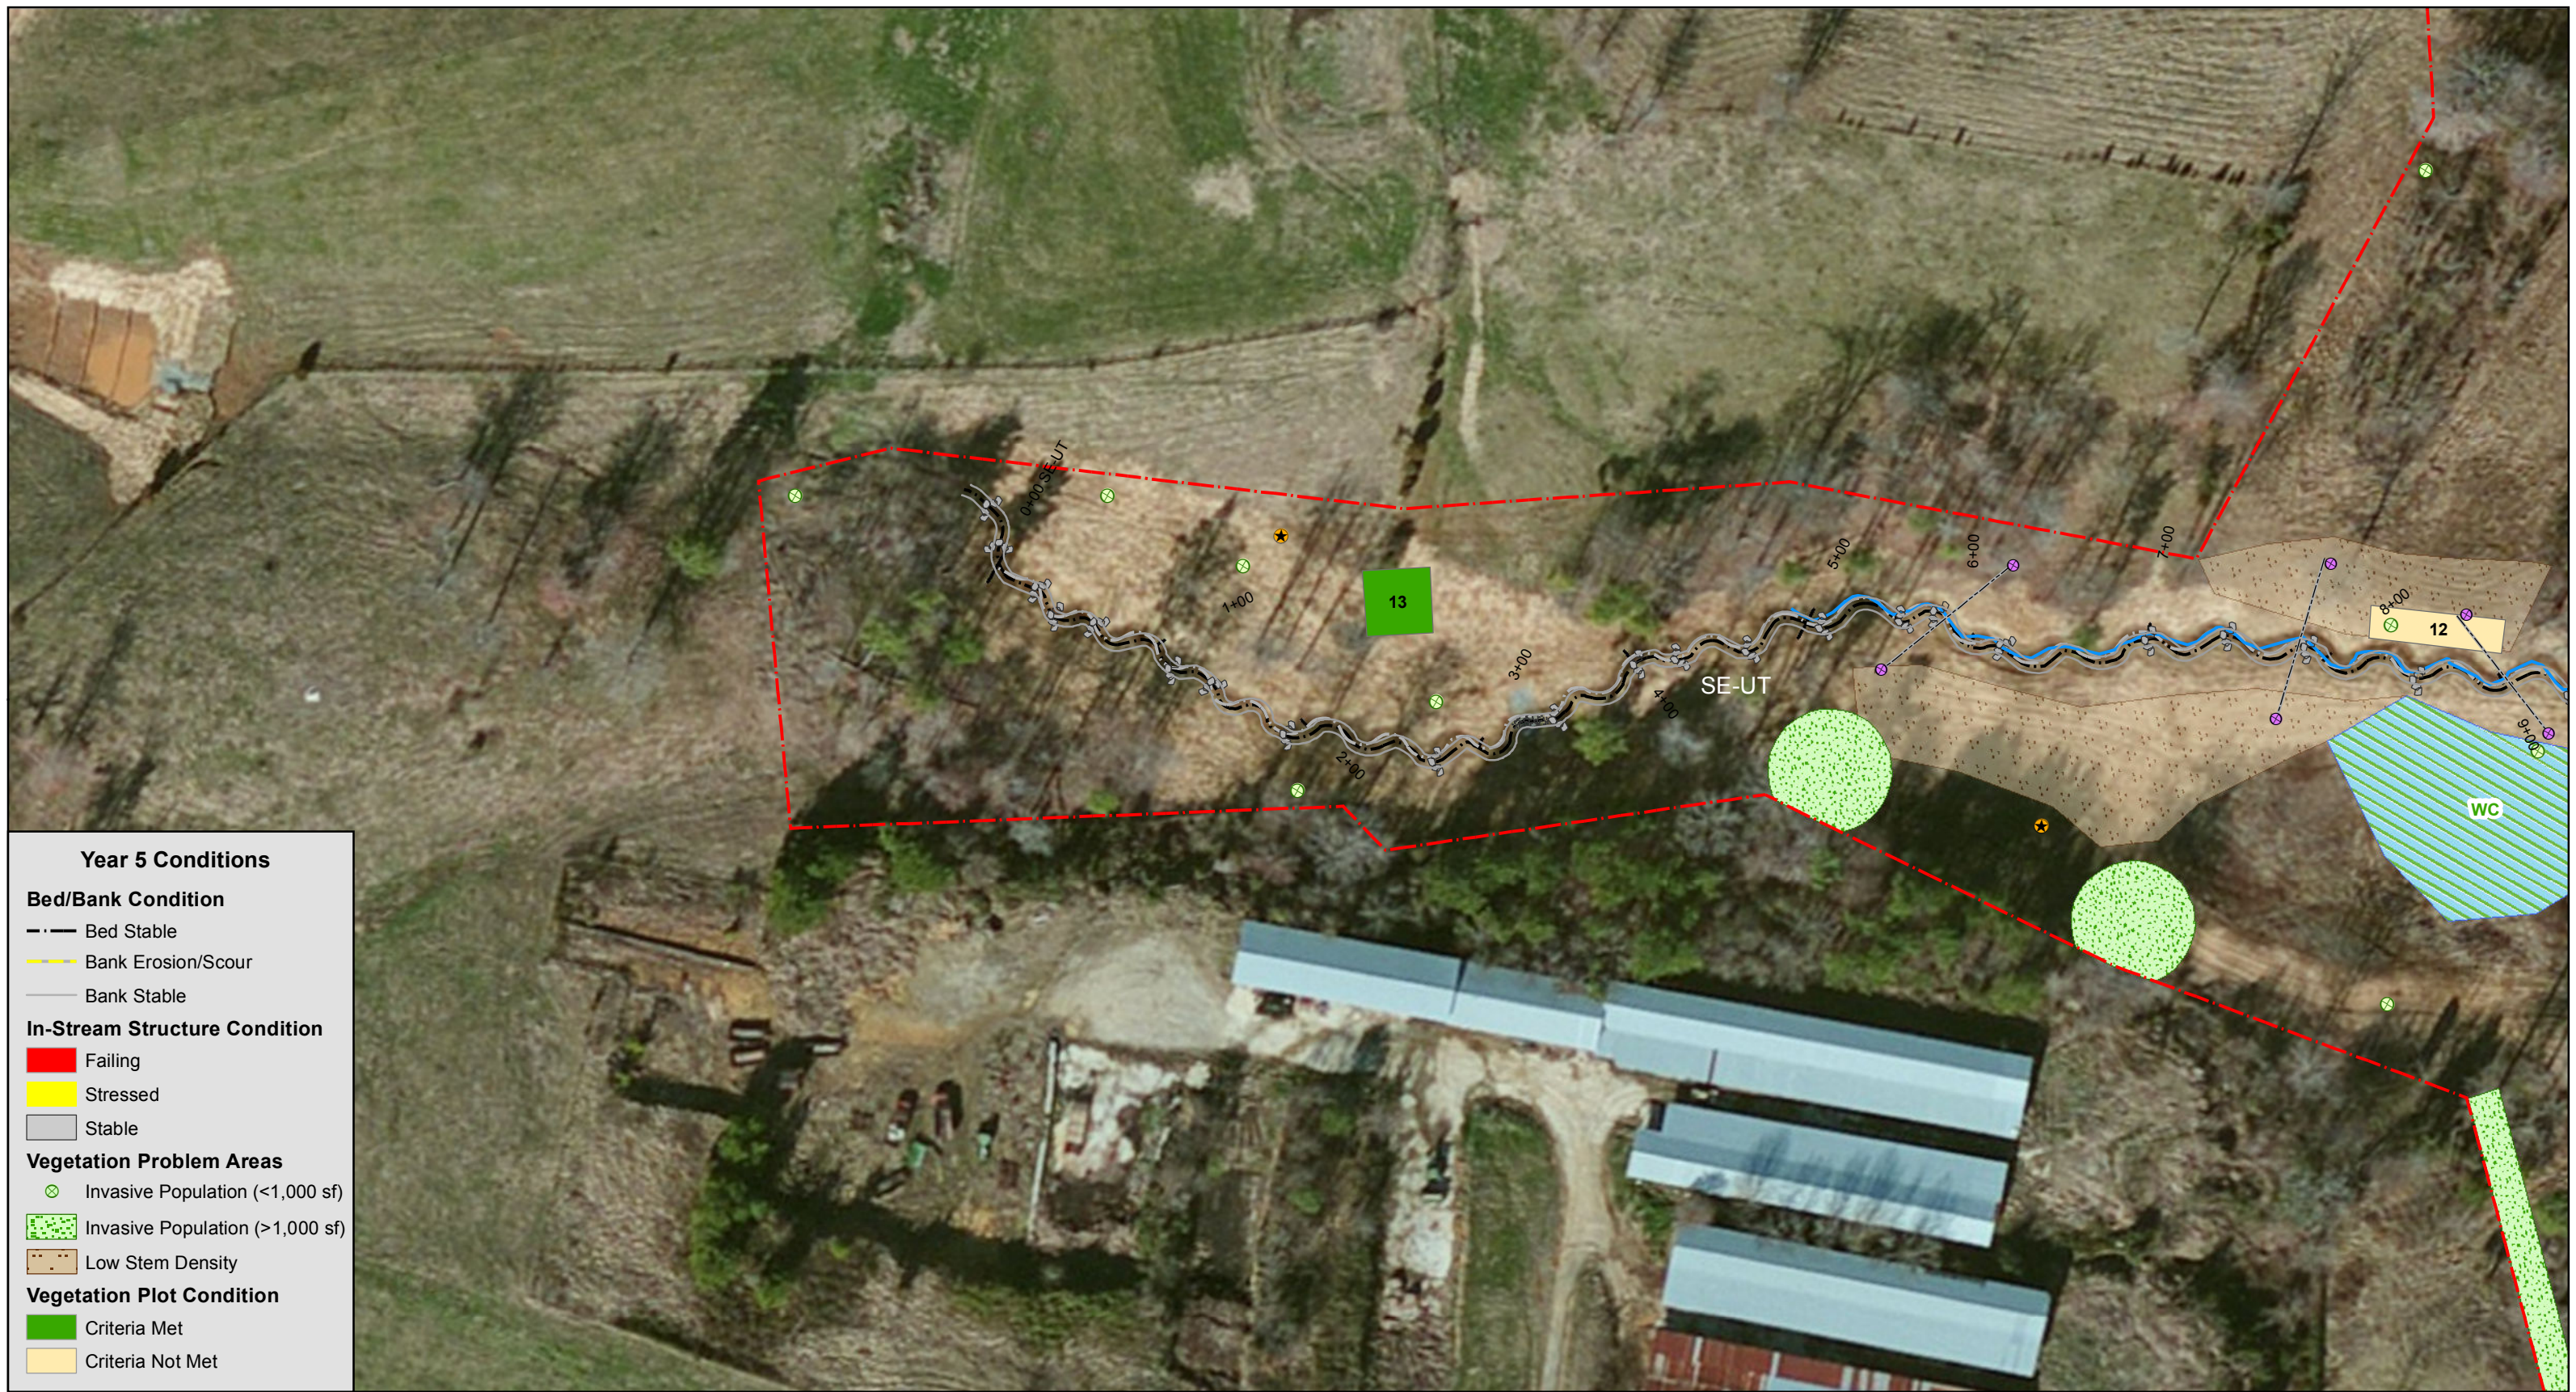
**FIGURE 2. CURRENT CONDITION PLAN VIEW
UT TO UWHARRIE RIVER STREAM RESTORATION PROJECT
RANDOLPH COUNTY, NORTH CAROLINA**

Year 5 monitoring surveys along UT to Uwharrie occurred in November 2016. Five areas of instability were noted during longitudinal surveys and are documented on the CCPV (Figure 2). These areas of bank erosion were observed along the Main Center reach at Stations 17+50, 19+00, 20+50, and between Stations 26+00 to 27+00. One rock vane has been compromised as a result of stream bank erosion around the vane arm. Additionally, one constructed riffle is stressed within this station range. Both of these structures were noted in previous years and do not appear to have worsened. No areas of instability were observed during longitudinal surveys of the SW-Trib, SE-UT or Main West.

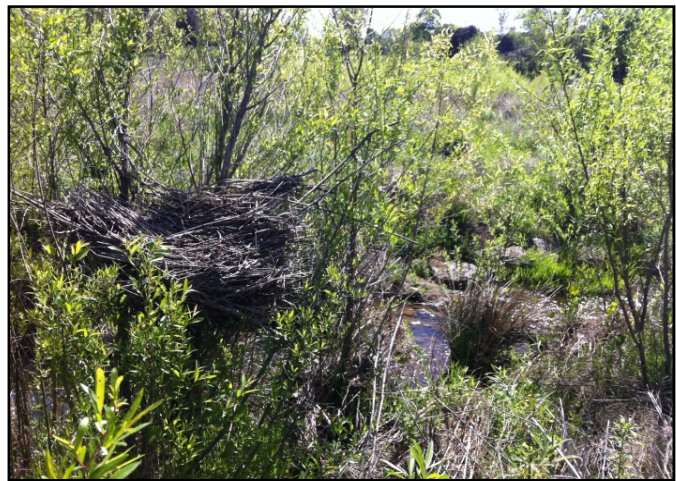
Photo 2: Wrack Lines on Main Center Following Bankfull Event - Spring 2013

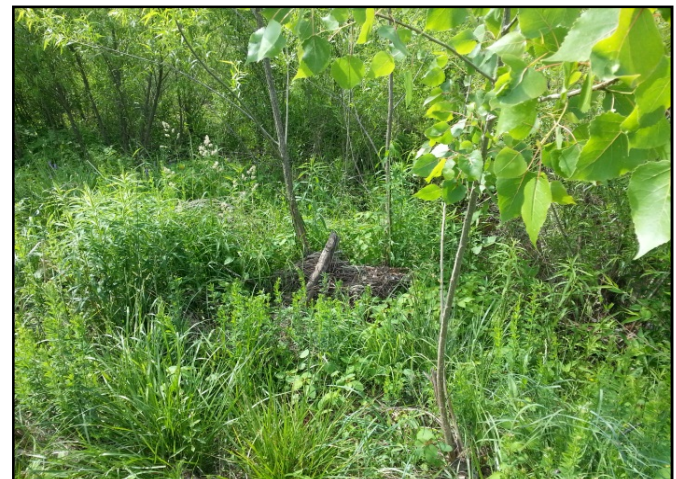
Photo 4: Wrack Lines on Main West Following Bankfull Event - Spring 2014
