Year 2 Monitoring Report

**UT WEST BRANCH ROCKY RIVER
RESTORATION SITE**

NCDMS Project #92684 (Contract # WBRR010521)
USACE Action ID: SAW-2017-00342 | NCDWR Project #18-1696

RE: UT West Branch Rocky River Project: Year 2 Monitoring Report

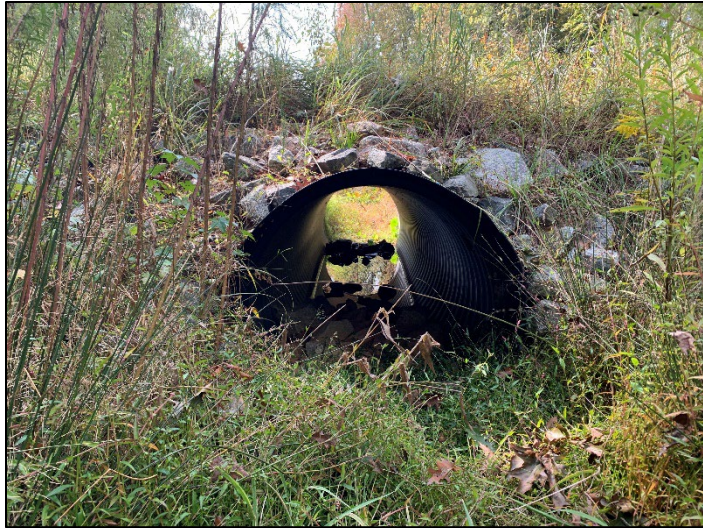
Crossing UTWB2 - Upstream

- DMS project culvert photos must be included in all monitoring reports; if possible, please include close up culvert photos for the installed culverts along UTWB2, UTWB3, and UT2-2, in order to show the status of any debris jamming, infilling, perching, etc.
[Appendix B has now been updated with culvert crossing photos and included in the final report, support files have also been updated.](#)

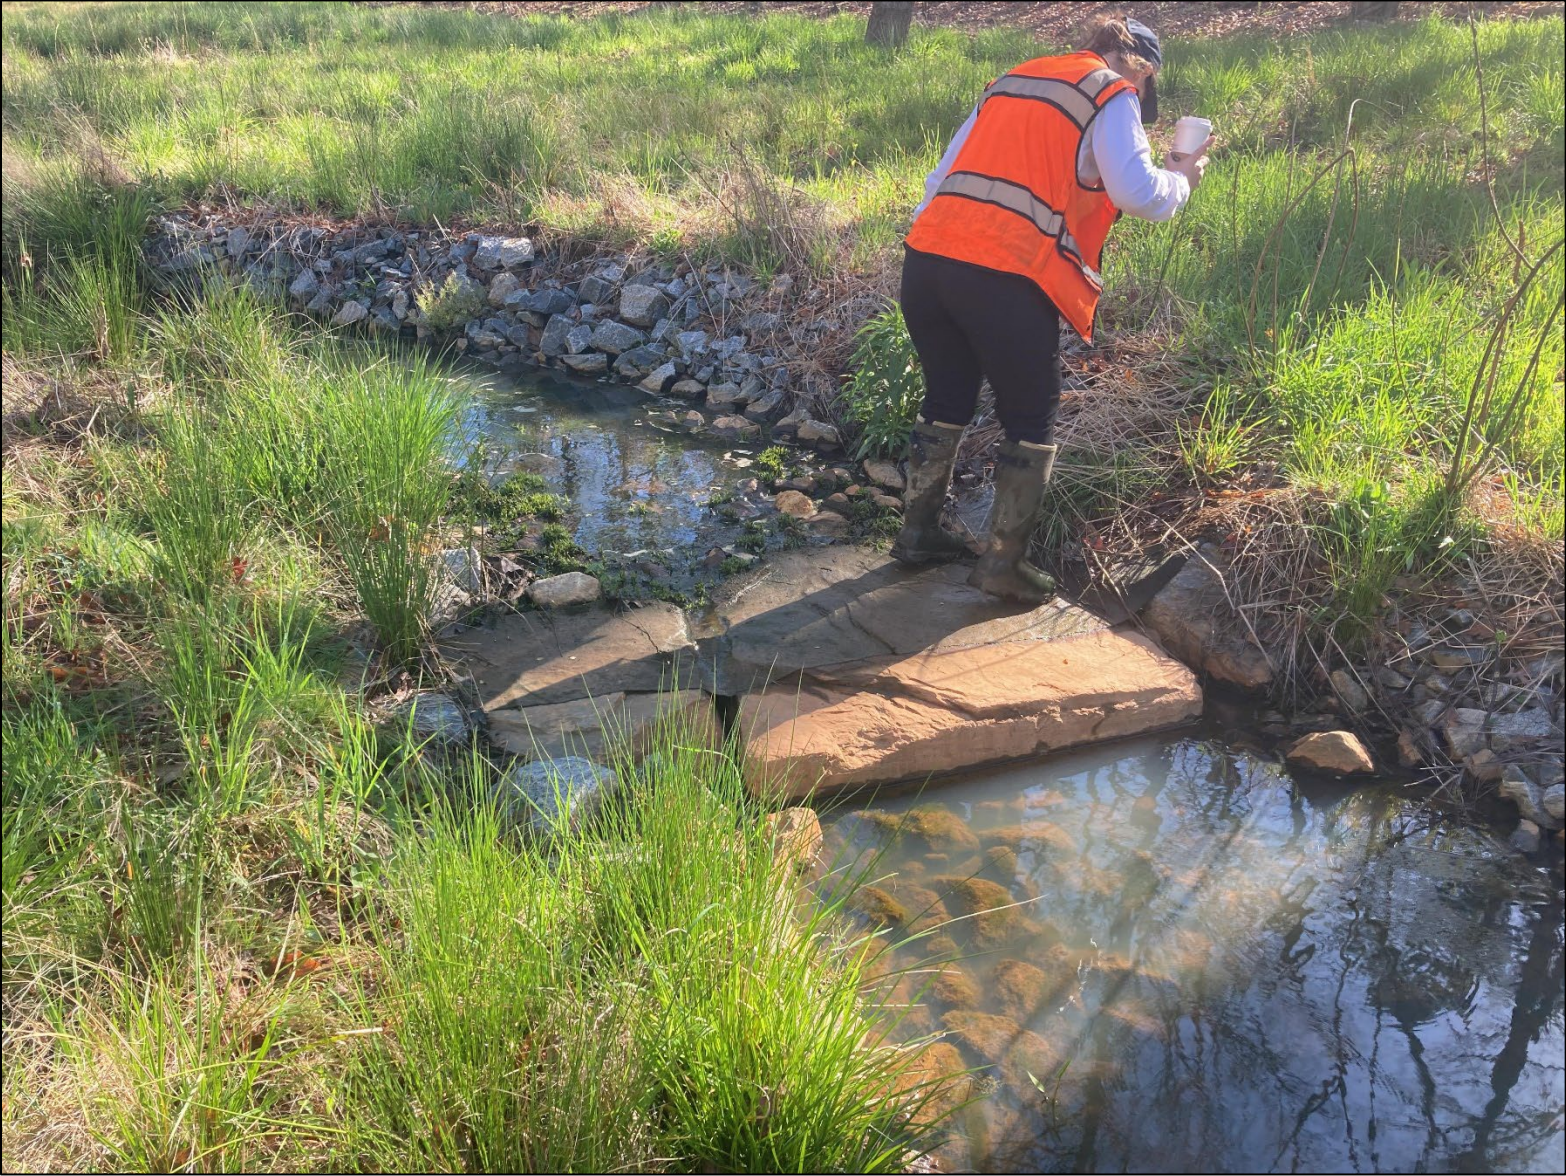
Visual assessment of the stream channel was performed to document signs of instability, such as eroding banks, structural instability, or excessive sedimentation. Overall, the channel is transporting sediment as designed and will continue to be monitored for aggradation and degradation. In-stream vegetation is established through much of the main channel and in the future may contribute to excessive aggradation. In MY2 all stream cross sections are stable and show no signs of any major alterations. Two structures were found to be piping on UTWB2 and will continue to be monitored to determine if remedial action is required, pictures can be found in Appendix B.

UTWB-2 Station 14+32 piping rock sill (4/4/2022)

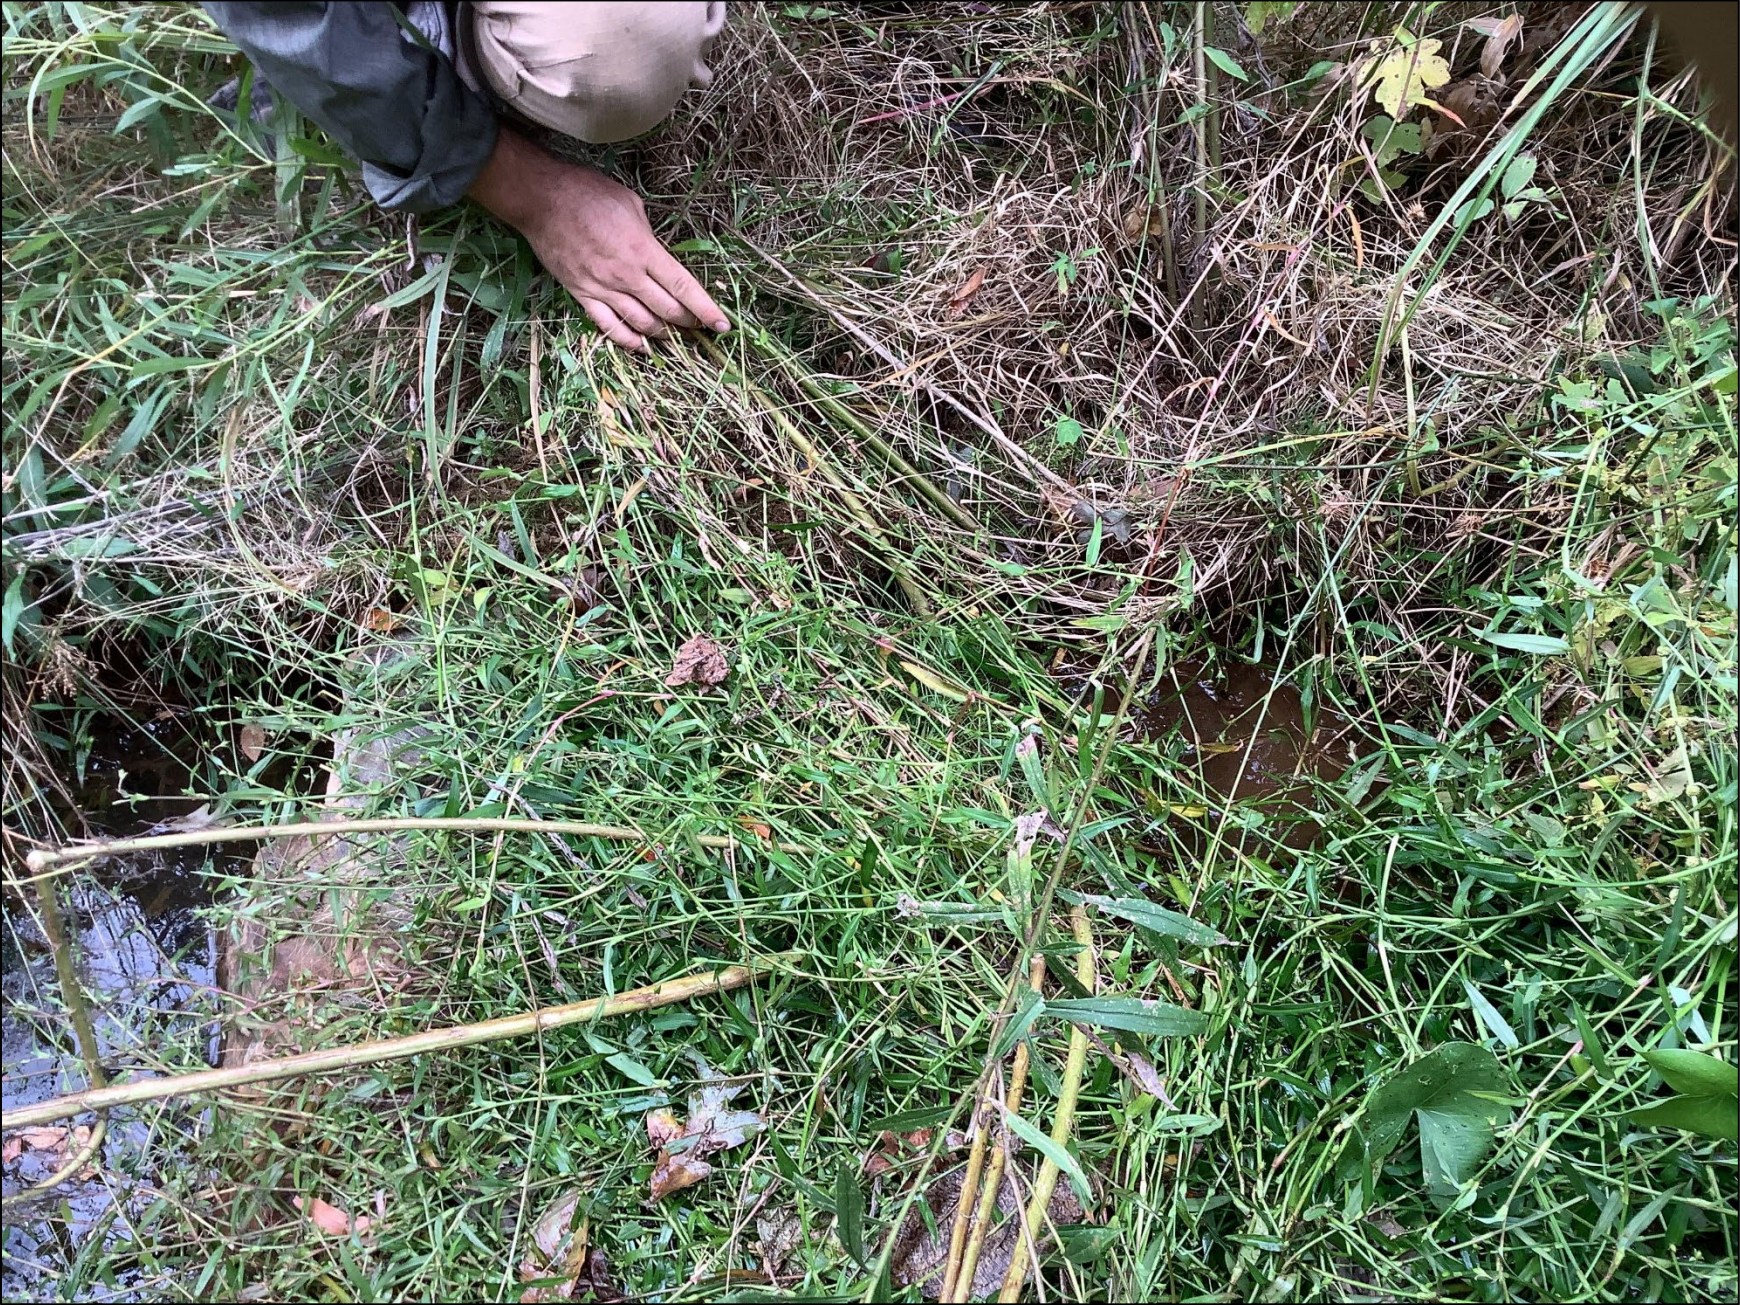
UTWB-2 Station 15+63 piping rock sill (10/10/2022)

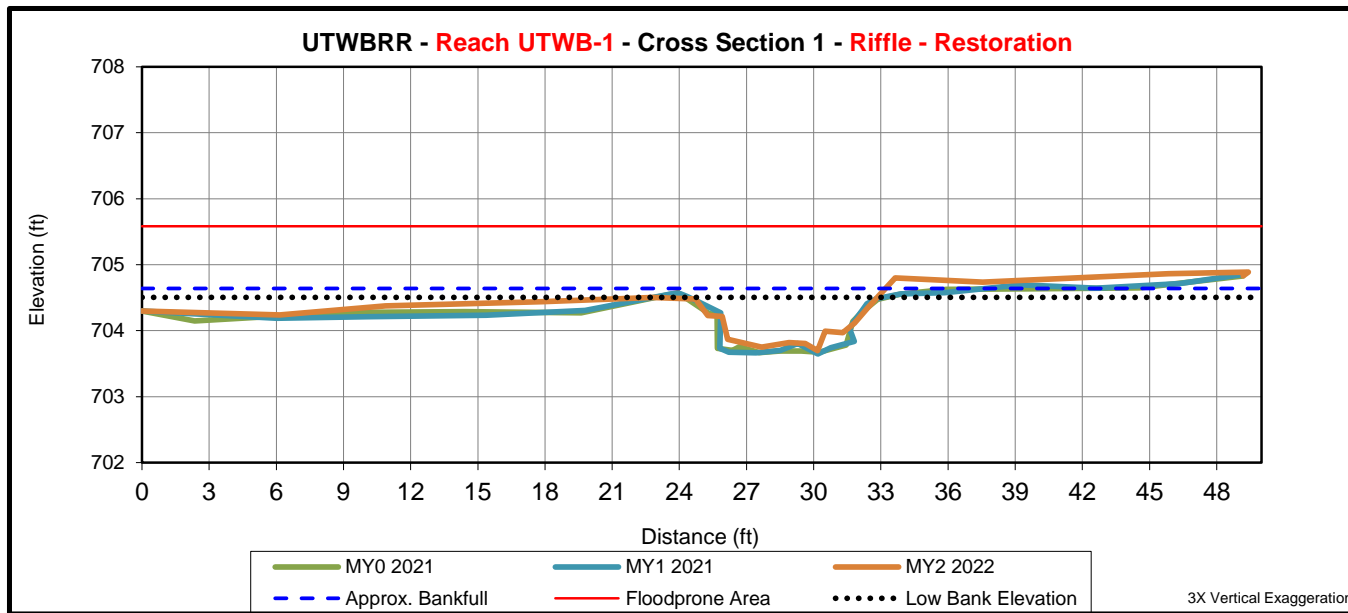
Cross Section 1 (Riffle)						
	MY0	MY1	MY2	MY3	MY5	MY7	MY+
Bankfull Elevation (ft) - Based on AB-XSA¹	704.56	704.6	704.6				
Bankfull Width (ft) ¹	9.8	9.9	10.4				
Floodprone Width (ft) ¹	>49.2	>49.1	>49.2				
Bankfull Max Depth (ft) ²	0.9	0.9	0.8				
Low Bank Elevation (ft)	704.56	704.6	704.5				
Bankfull Cross Sectional Area (ft ²) ²	5.7	5.5	4.3				
Bankfull Entrenchment Ratio ¹	>5	>5	>4.7				
Bankfull Bank Height Ratio ¹	1.0	1.0	0.9

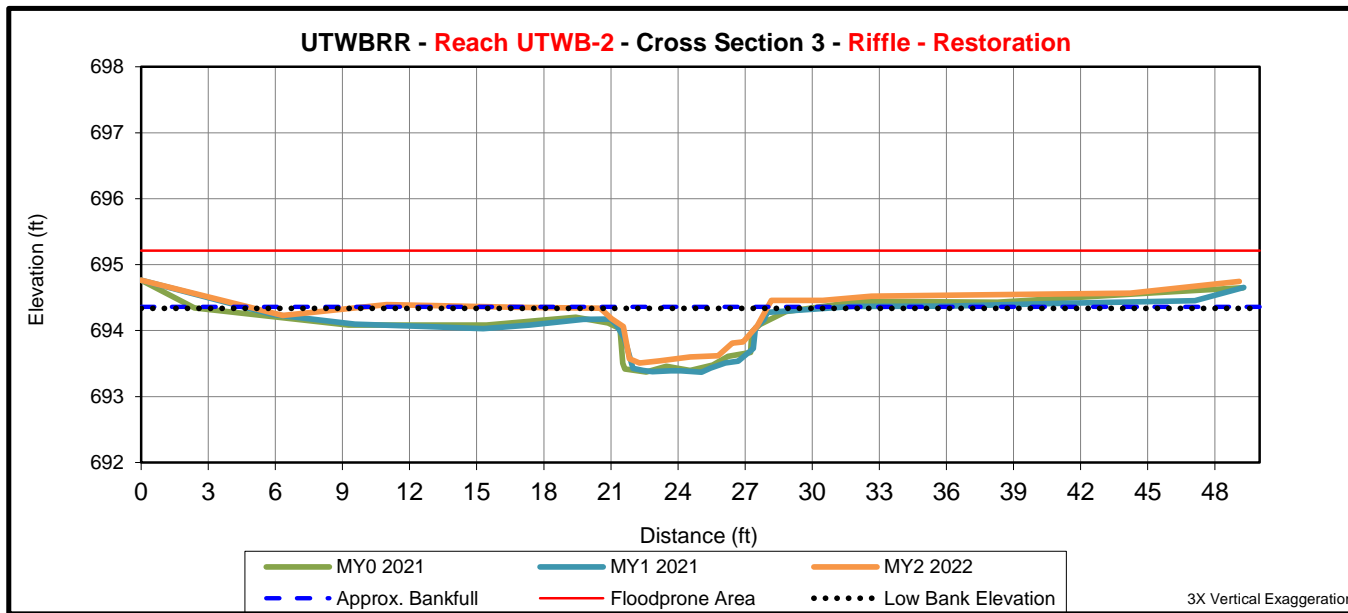
Cross Section 3 (Riffle)						
	MY0	MY1	MY2	MY3	MY5	MY7	MY+
Bankfull Elevation (ft) - Based on AB-XSA¹	694.20	694.2	694.4				
Bankfull Width (ft) ¹	8.9	6.9	7.5				
Floodprone Width (ft) ¹	>49.3	>49.3	>49.1				
Bankfull Max Depth (ft) ²	0.8	0.8	0.8				
Low Bank Elevation (ft)	694.20	694.2	694.3				
Bankfull Cross Sectional Area (ft ²) ²	4.5	4.2	4.3				
Bankfull Entrenchment Ratio ¹	>5.6	>7.1	>6.6				
Bankfull Bank Height Ratio ¹	1.0	1.0	1.0

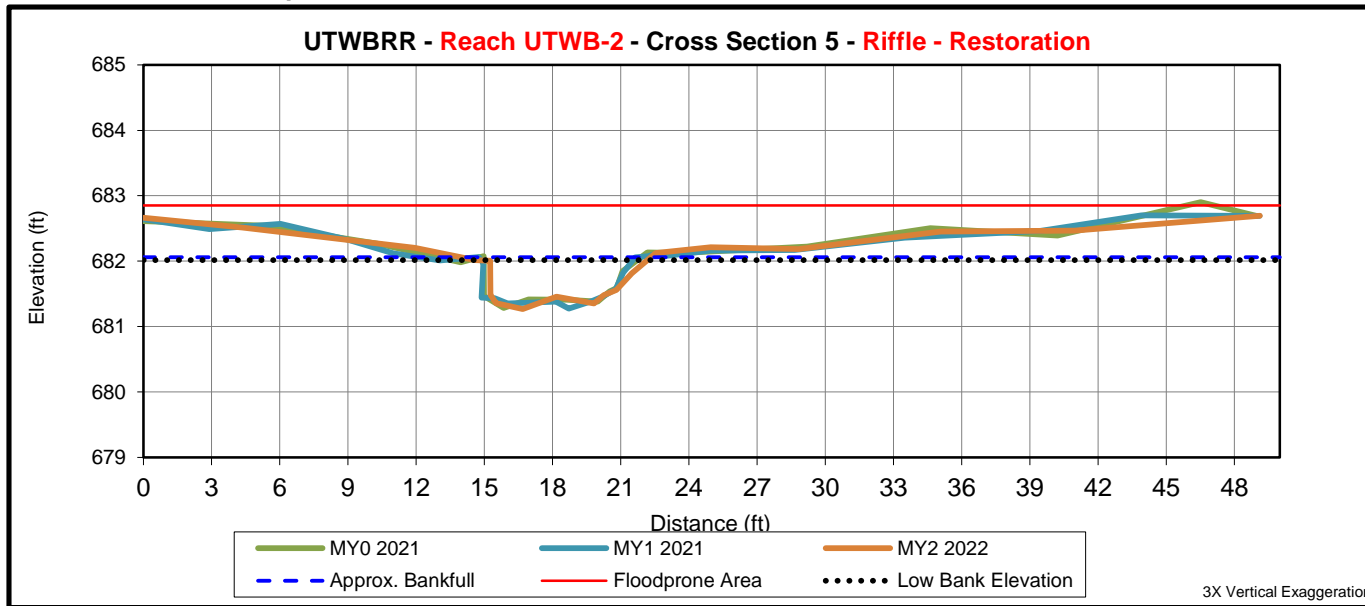
Cross Section 5 (Riffle)						
	MY0	MY1	MY2	MY3	MY5	MY7	MY+
Bankfull Elevation (ft) - Based on AB-XSA¹	682.08	682.1	682.1				
Bankfull Width (ft) ¹	7.0	7.0	7.7				
Floodprone Width (ft) ¹	>48.2	>49.1	>49.1				
Bankfull Max Depth (ft) ²	0.8	0.8	0.7				
Low Bank Elevation (ft)	682.08	682.1	682.0				
Bankfull Cross Sectional Area (ft ²) ²	4.1	4.1	3.8				
Bankfull Entrenchment Ratio ¹	>6.9	>7	>6.3				
Bankfull Bank Height Ratio ¹	1.0	1.0	0.9

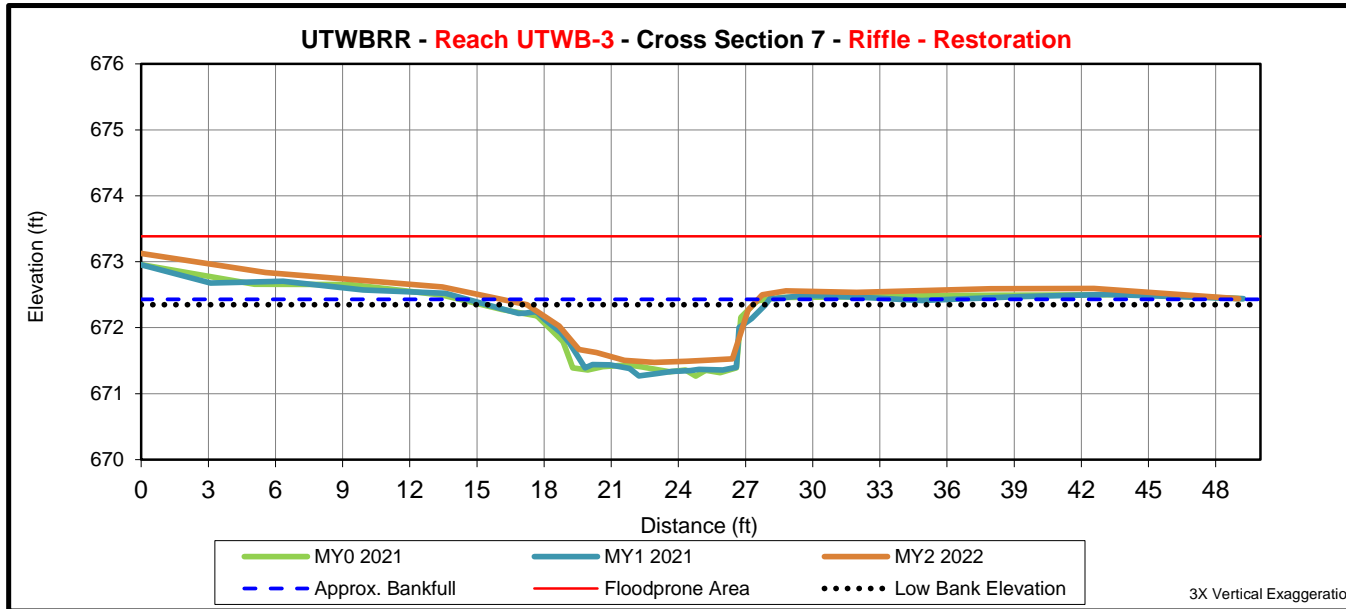
Cross Section 7 (Riffle)						
	MY0	MY1	MY2	MY3	MY5	MY7	MY+
Bankfull Elevation (ft) - Based on AB-XSA¹	672.28	672.3	672.4				
Bankfull Width (ft) ¹	11.0	10.1	10.3				
Floodprone Width (ft) ¹	>49.2	>49.2	>49				
Bankfull Max Depth (ft) ²	1.0	1.0	0.9				
Low Bank Elevation (ft)	672.28	672.2	672.3				
Bankfull Cross Sectional Area (ft ²) ²	7.5	6.9	6.6				
Bankfull Entrenchment Ratio ¹	>4.5	>4.9	>4.8				
Bankfull Bank Height Ratio ¹	1.0	0.9	0.9

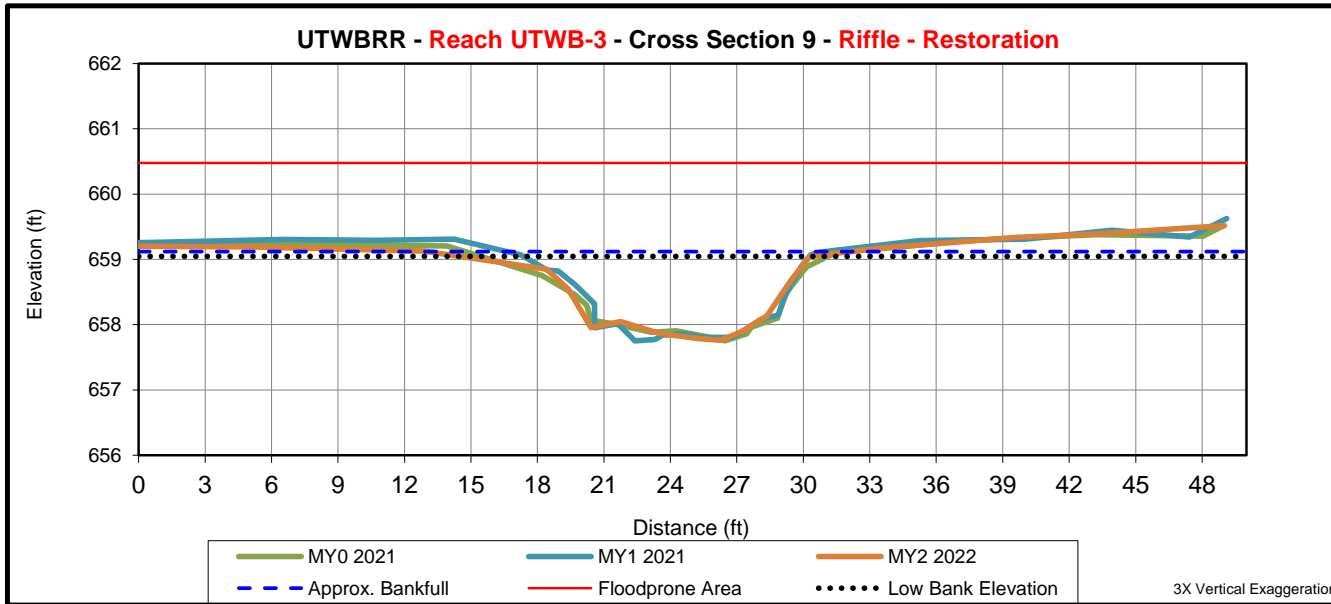
Cross Section 9 (Riffle)						
	MY0	MY1	MY2	MY3	MY5	MY7	MY+
Bankfull Elevation (ft) - Based on AB-XSA¹	659.10	659.2	659.1				
Bankfull Width (ft) ¹	16.5	15.4	17.3				
Floodprone Width (ft) ¹	>49	>49.1	>49				
Bankfull Max Depth (ft) ²	1.3	1.4	1.3				
Low Bank Elevation (ft)	659.10	659.1	659.0				
Bankfull Cross Sectional Area (ft ²) ²	12.7	12.5	11.5				
Bankfull Entrenchment Ratio ¹	>3.0	>3.2	>2.8				
Bankfull Bank Height Ratio ¹	1.0	1.0	0.9

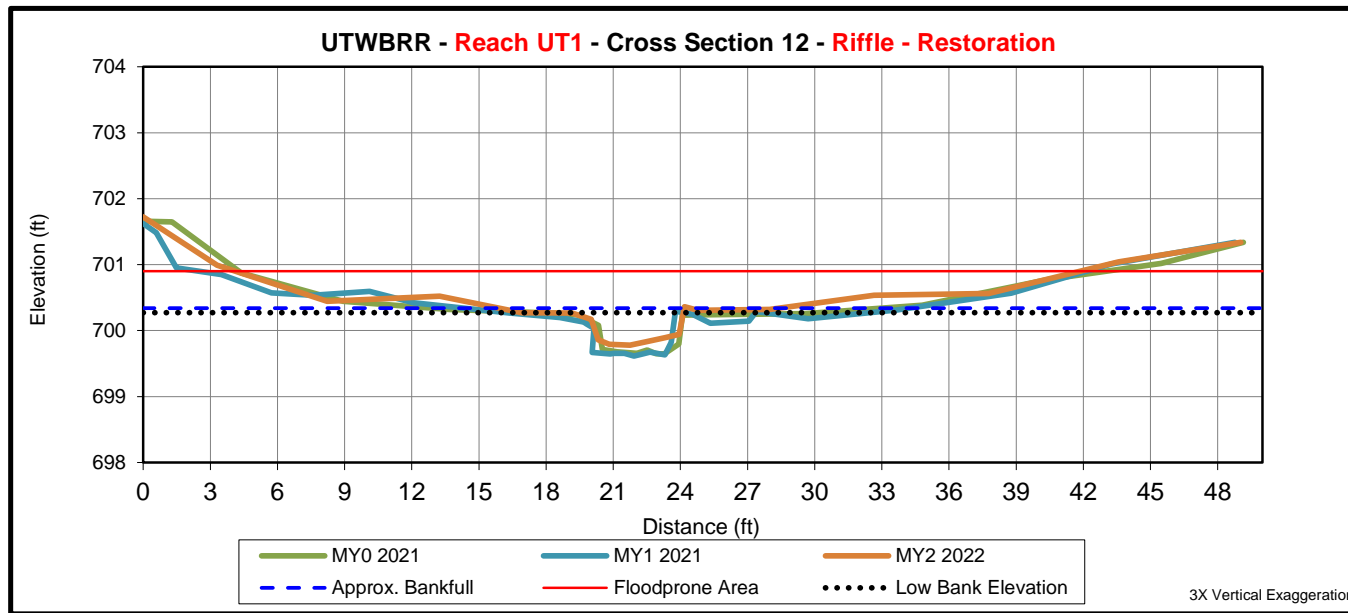
Cross Section 12 (Riffle)						
	MY0	MY1	MY2	MY3	MY5	MY7	MY+
Bankfull Elevation (ft) - Based on AB-XSA¹	700.24	700.2	700.3				
Bankfull Width (ft) ¹	5.3	5.1	5.4				
Floodprone Width (ft) ¹	36.7	37.7	37.7				
Bankfull Max Depth (ft) ²	0.6	0.6	0.5				
Low Bank Elevation (ft)	700.24	700.2	700.3				
Bankfull Cross Sectional Area (ft ²) ²	2.1	2.0	1.7				
Bankfull Entrenchment Ratio ¹	7.0	7.4	7.0				
Bankfull Bank Height Ratio ¹	1.0	1.0	0.9

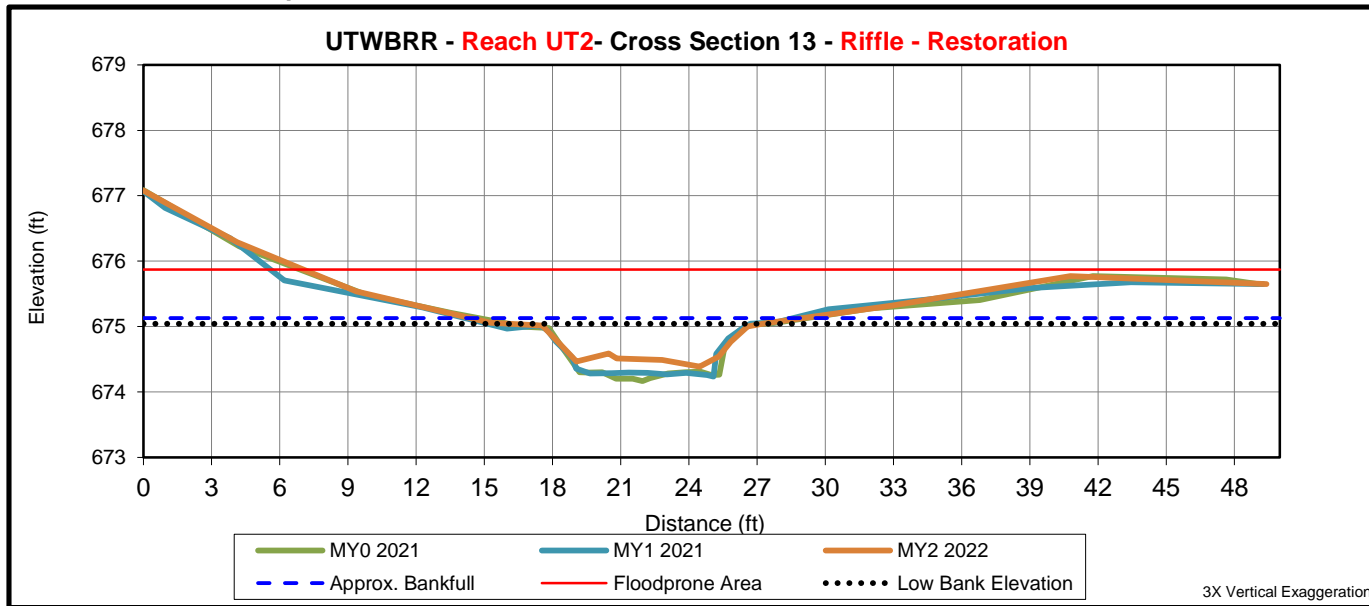
Cross Section 13 (Riffle)						
	MY0	MY1	MY2	MY3	MY5	MY7	MY+
Bankfull Elevation (ft) - Based on AB-XSA¹	675.00	675.0	675.1				
Bankfull Width (ft) ¹	9.8	9.0	12.0				
Floodprone Width (ft) ¹	>41.8	>43.5	>42.4				
Bankfull Max Depth (ft) ²	0.8	0.8	0.7				
Low Bank Elevation (ft)	675.00	675.0	675.0				
Bankfull Cross Sectional Area (ft ²) ²	5.3	5.0	4.3				
Bankfull Entrenchment Ratio ¹	>4.3	>4.8	>3.5				
Bankfull Bank Height Ratio ¹	1.0	1.0	0.9
