**Year 3 Monitoring Report**

**UT WEST BRANCH ROCKY RIVER  
RESTORATION SITE**

NCDMS Project #92684 (Contract # WBRR010521)  
USACE Action ID: SAW-2017-00342 | NCDWR Project #18-1696

Mecklenburg County, North Carolina  
Yadkin River Basin | HUC 03040105

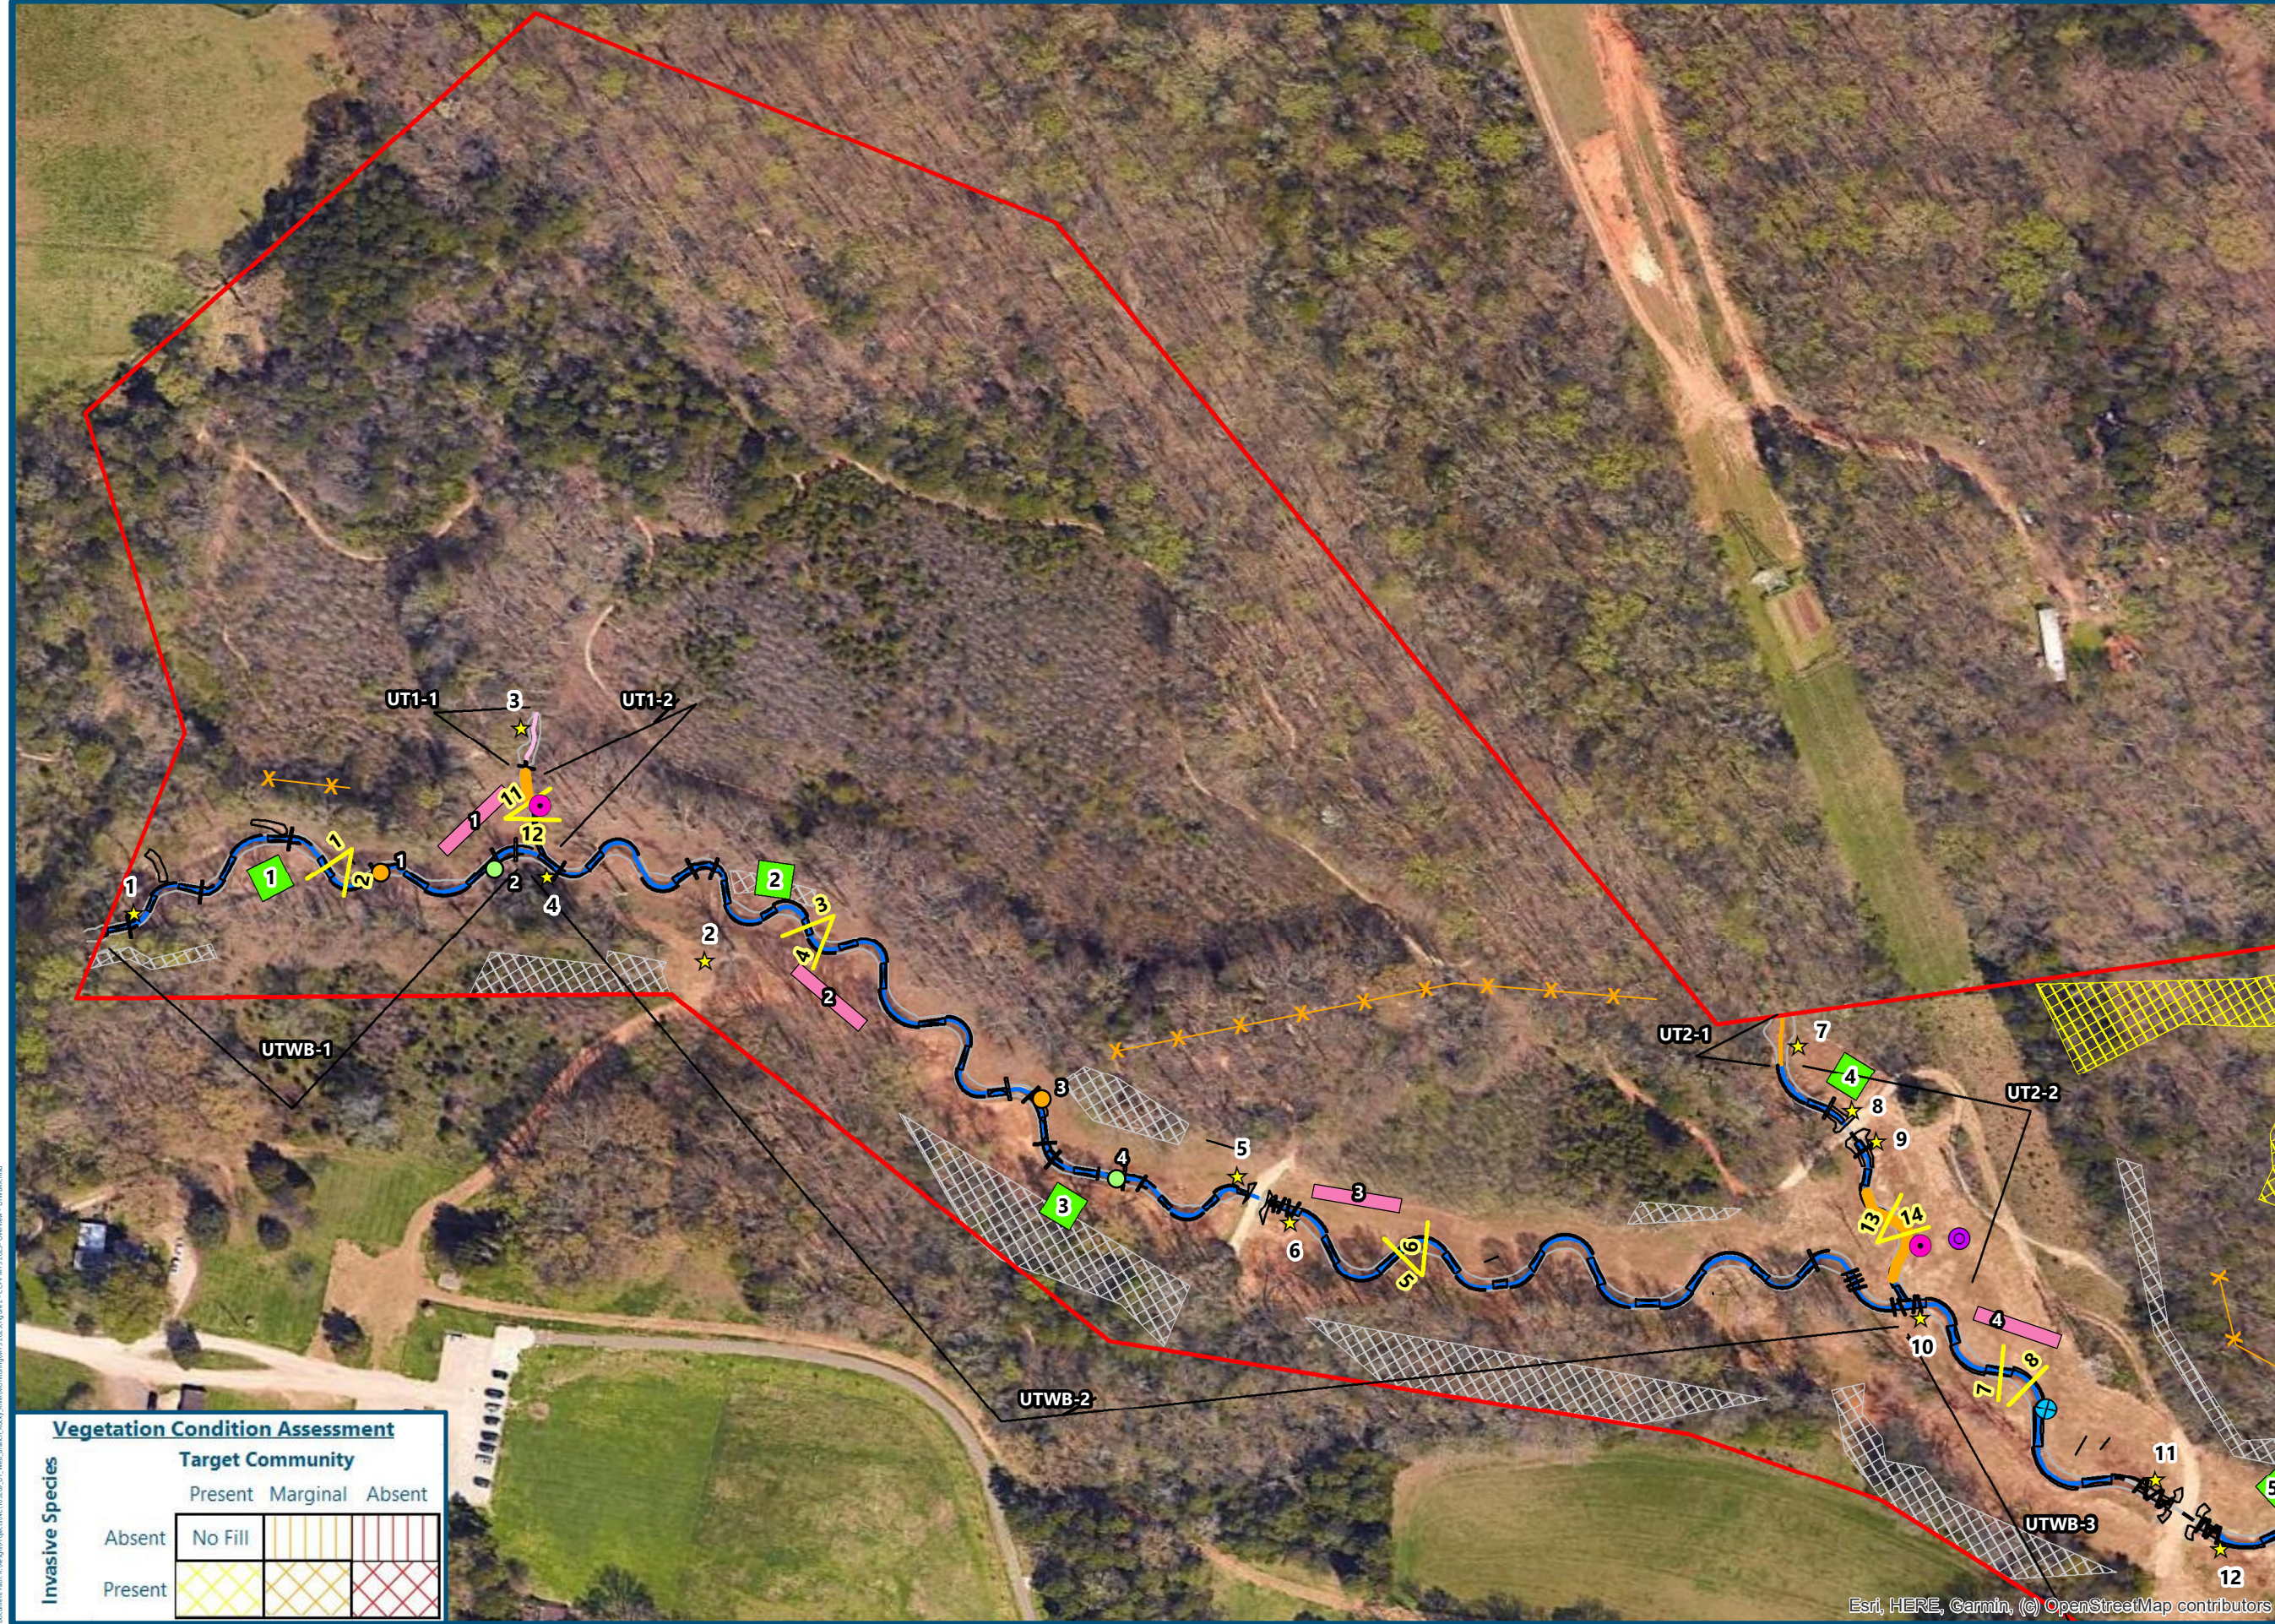
Figure 2 - CCPV MY3

Along UT1-2 there is approximately 20 feet of aggradation and on UT2-2 there is approximately 40 feet of aggradation that has been noted. In-stream vegetation throughout may contribute to this aggradation, removal of the excessive vegetation could help the aggradation in these channels. Four structures were found to be piping with two on UTWB-1 and two on UTWB-2. Structures #2 and #4 have been hand repaired and are now functioning properly. Structures #1 and #3 will be repaired in January 2024. The aggradation and structures will continue to be monitored in the future. Pictures of the aggradation area, piping structures can be found in **Appendix B** and locations of these areas can be found on **Figure 2**.

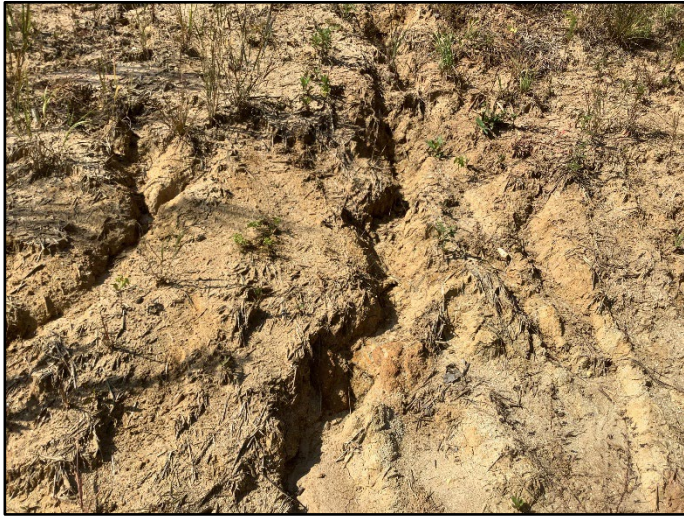
Side Slope Repair Area (10/10/2022)

Includes repairing approximately 1,000 square feet of surface erosion along the right bank, roughly 75 feet above the southeastern boundary of the easement. Repairs will involve raking and smoothing the area, reseeding with a temporary seed mix and a permanent native seed mix, and stabilized using natural fiber straw jute matting, anchored with wooden stakes. A total of 15 bareroots will be replanted in the disturbed area utilizing River birch (*Betula nigra*), Tulip poplar (*Liriodendron tulipifera*), and Water oak (*Quercus nigra*). Approximate location is depicted in Figures 1-1B.

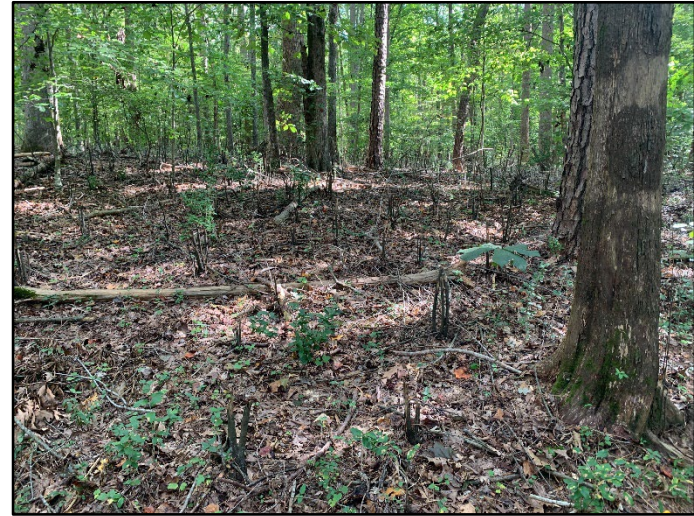
Invasives Treated (10/4/1023)

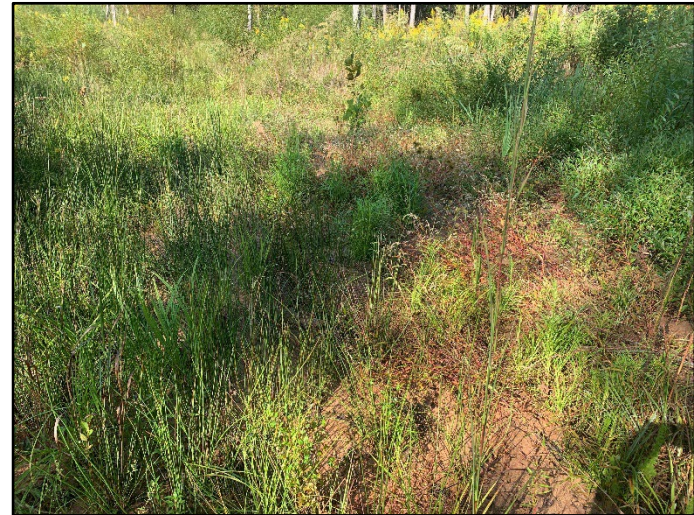
Aggradation on UT2-2 (12/3/2023)

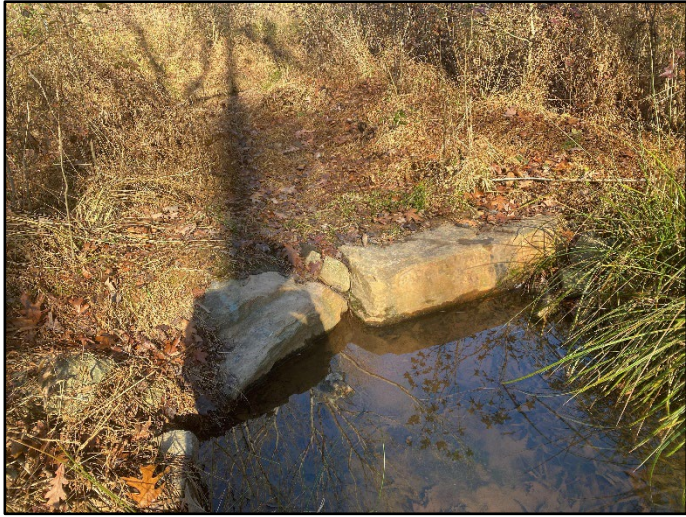
Piping Structure #1 - Unrepaired (12/3/2023)

Note – Of the four piping riffles discussed at the 8/30/2023 IRT site meeting, two have been hand-repaired (photos are provided in the MY3/2023 monitoring report) and two have similar repairs planned for December 2023-January 2024.

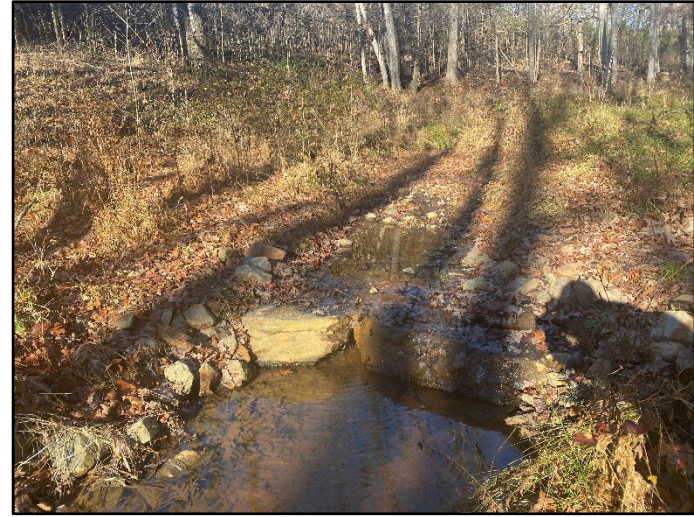
Piping Structure #2 - Repaired (12/3/2023)

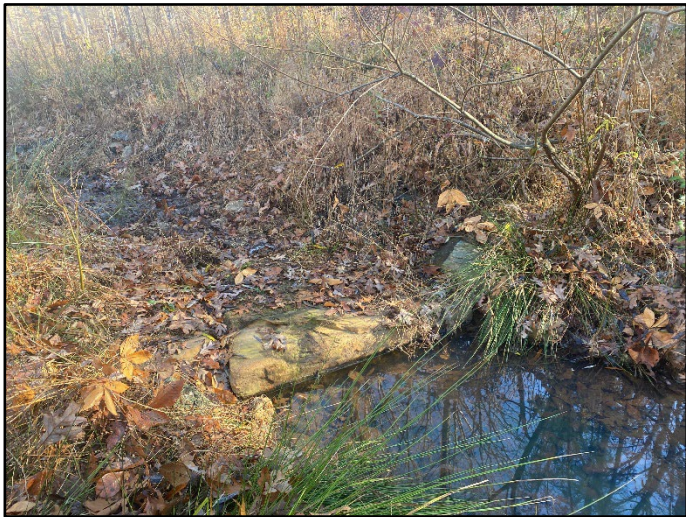
Piping Structure #3 - Unrepaired (12/3/2023)

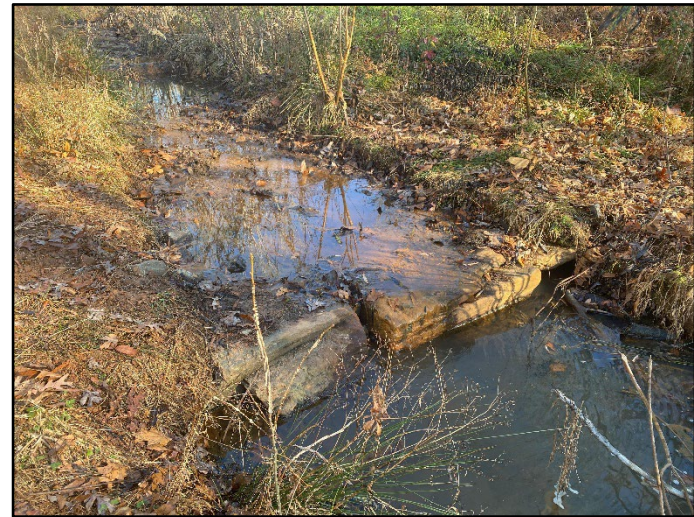
Piping Structure #4 - Repaired (12/3/2023)
