Valley Fields Farm Monitoring Report Year 1 (2010)

Davidson County, North Carolina

EEP Project ID #407

Submitted December 2010
Revised March 2011

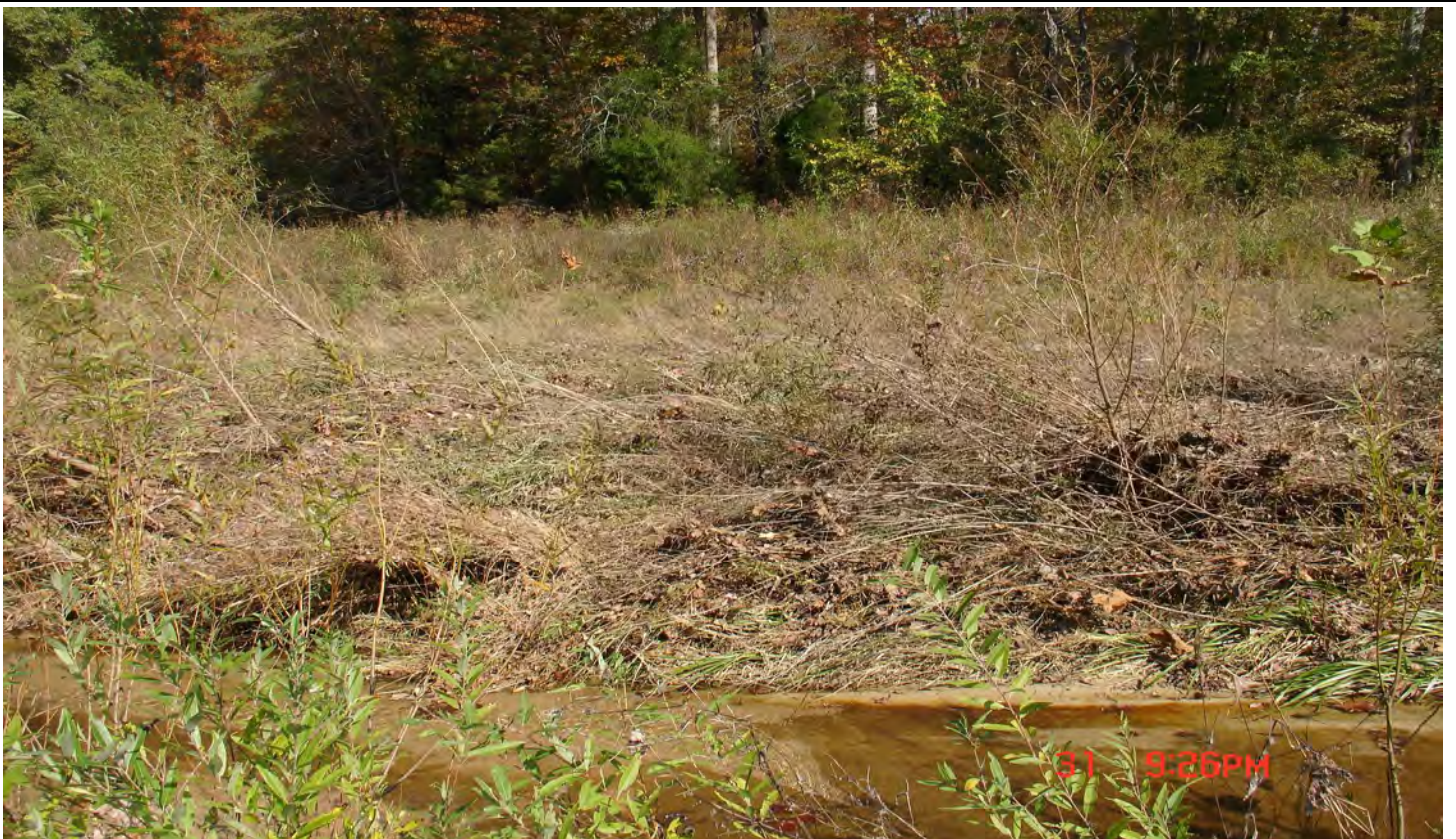
PB05 (2010)

Date of Data Collection	Date of Occurrence	Method	Photo # (if available)
7/8/2010	N/A	Rackline observed in floodplain	SP1
11/4/2010	N/A	Rackline observed at bankfull	PB05
