Valley Fields Farm Monitoring Report FINAL Year 2 (2011)

Davidson County, North Carolina

EEP Project ID #407

Submitted December 2011

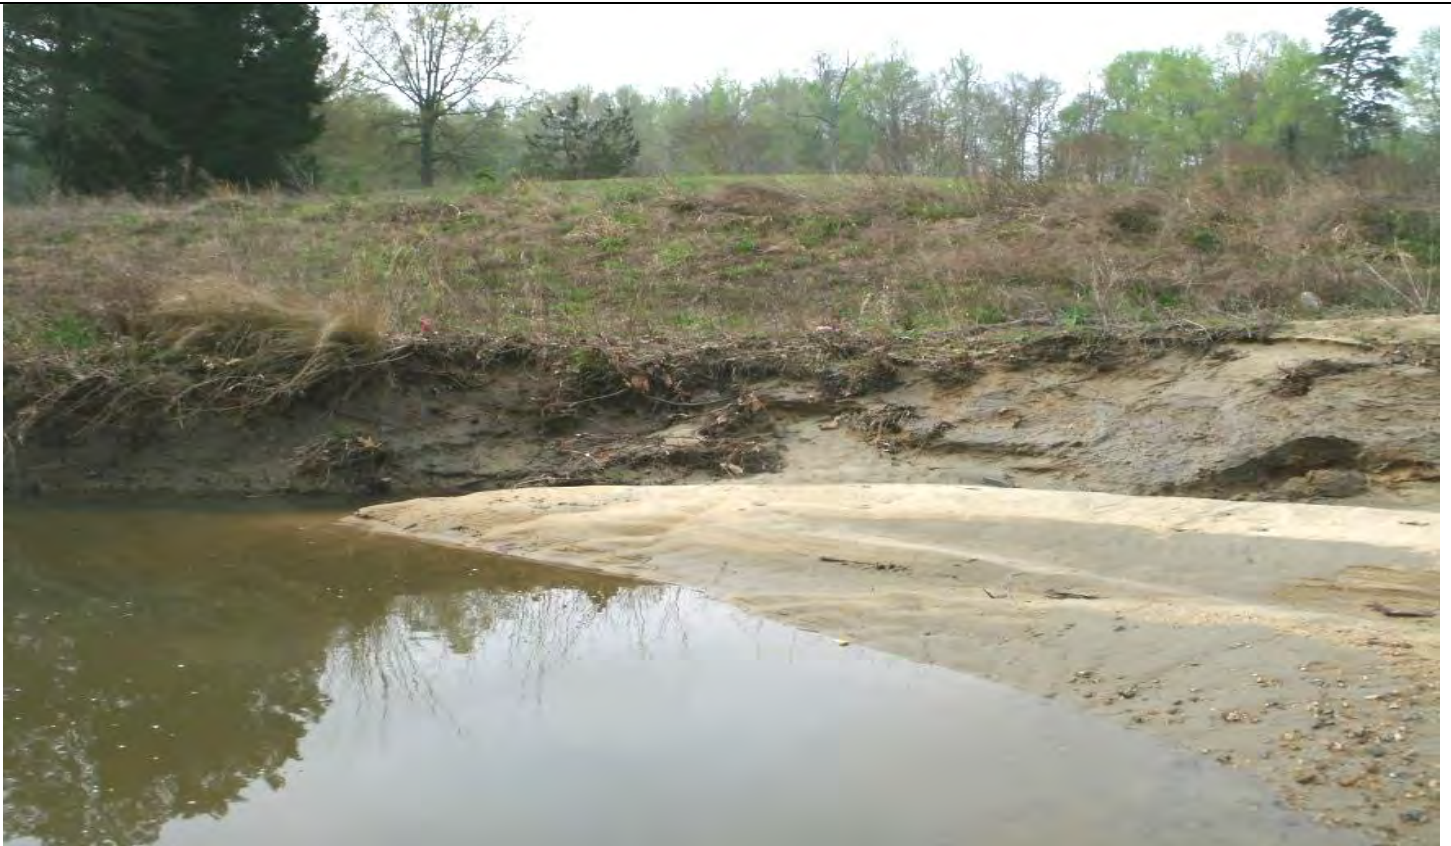
outsides of the meander bends. This bank erosion was not considered consistent throughout the reach, and may have been a result of the backwater condition previously created by the beaver dam on Reach Lower A. Reach B also had a 200 foot section of bank erosion occurring on both banks. A repair plan for Reach B was designed by KHA in 2010; however the planned repairs have been postponed due to adjacent property owner negotiations.

SP02 (2011) - Bank Slump on left bank of Reach B (STA 150+350)

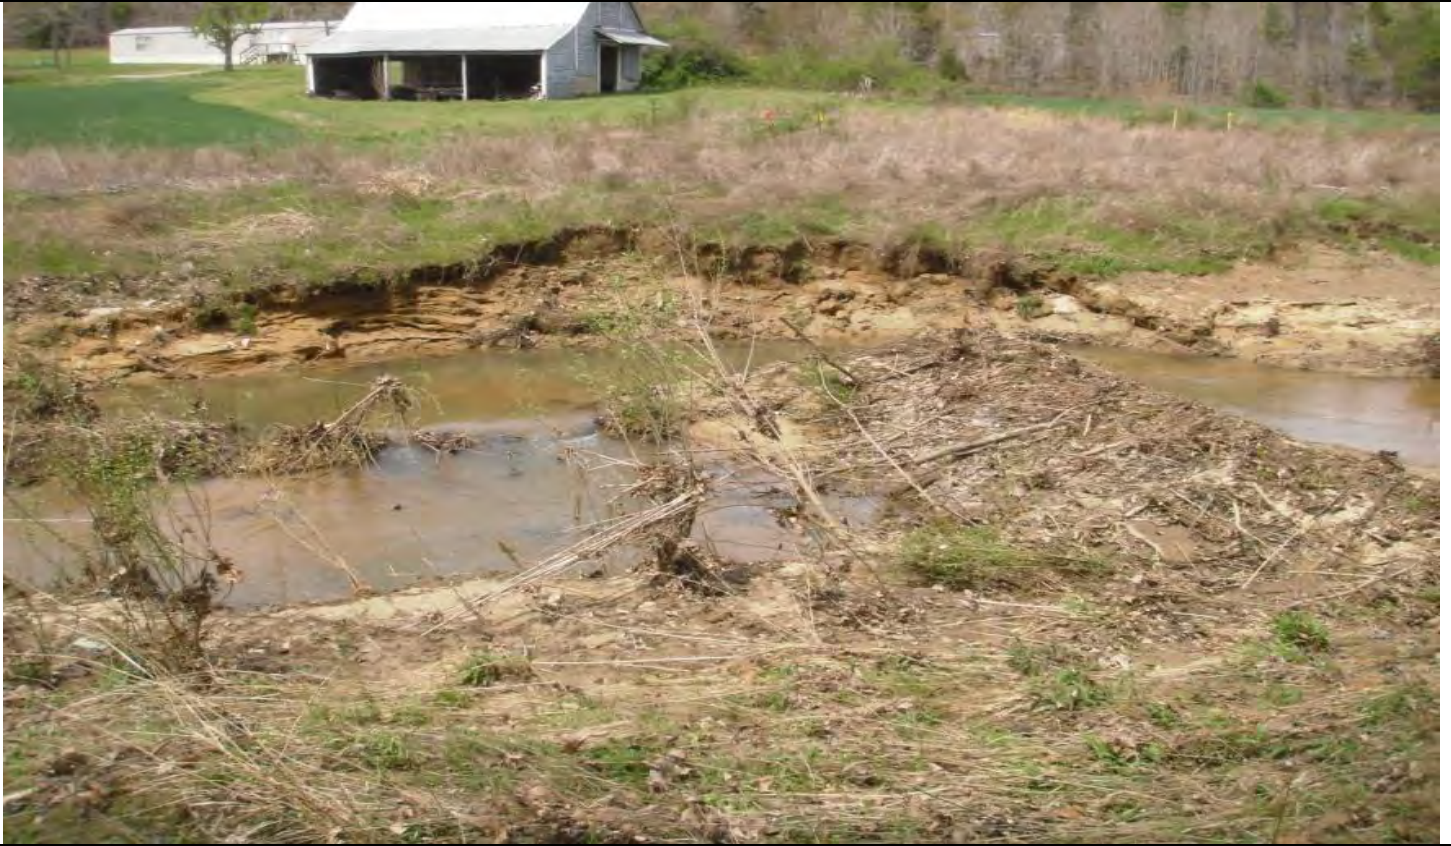
- Three beaver dams have been documented throughout the monitoring period to date, however, only one of these dams is still actively impounding water. The large beaver dam on Reach Lower A near station 95+50 is no longer impounding water, as the right bank of the stream has eroded. Erosion from the beaver dam at this location has re-routed the stream centerline, as evident in Figure 3, and has created a near vertical bank (Photos SP04-SP06, Appendix B). The initial assessment site visit conducted in April 2011 documented a small beaver dam at station 70+00. This beaver dam was not present during the monitoring site visit. Finally, a large two to three foot tall beaver dam is still actively present near station 59+50 on Reach Upper A. This beaver dam is causing backwater to extend to the upstream project extents of Reach Upper A.

SP05 (2011) - 2-foot tall beaver dam on Reach A (STA 95+50)

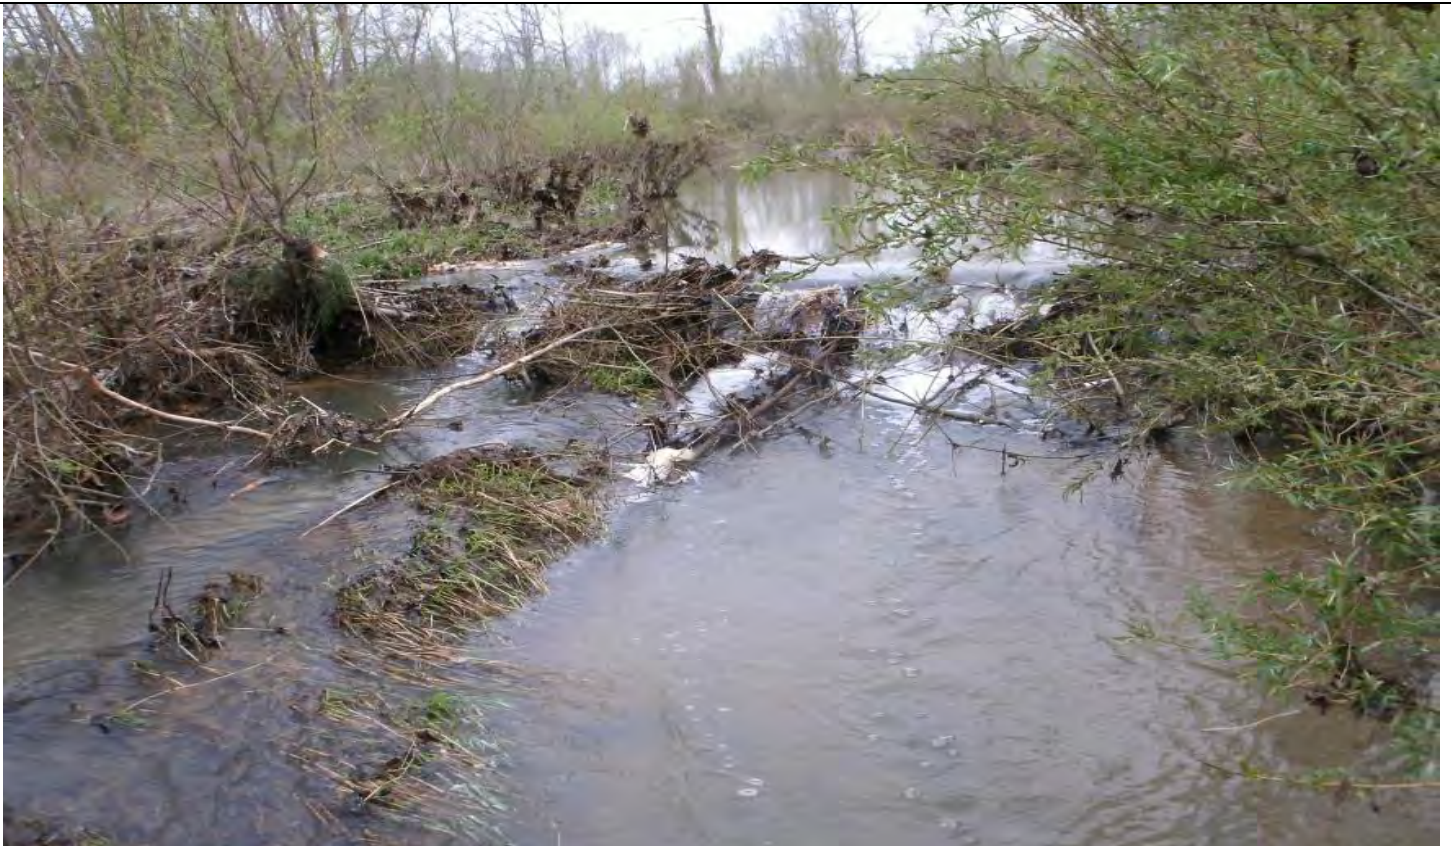
SP06 (2011) - 2-foot tall beaver dam on Reach A (STA 95+50)

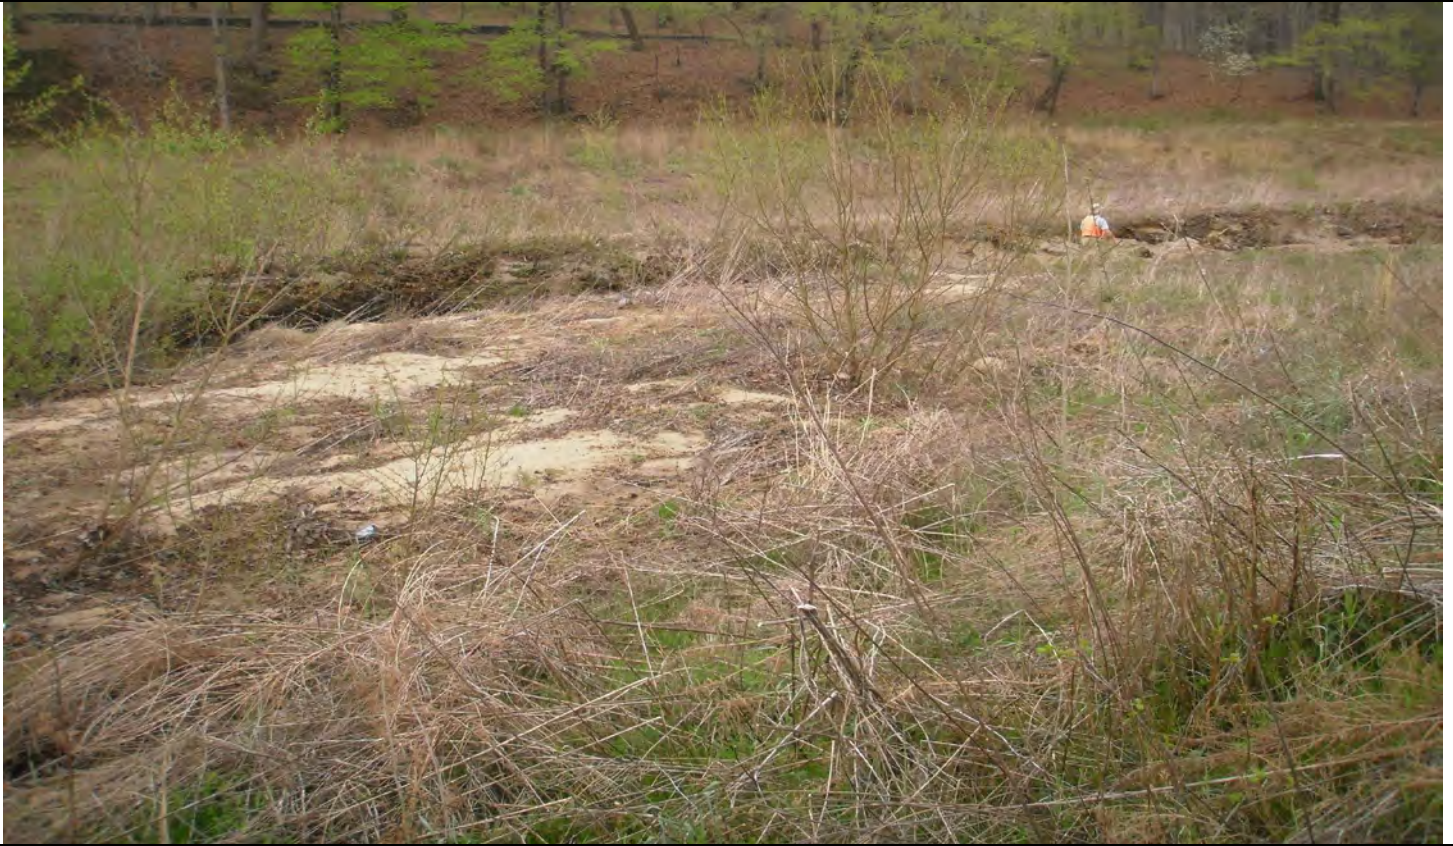
SP07 (2011) - 2 to 3 foot tall beaver dam on Reach Upper A (STA 59+75)

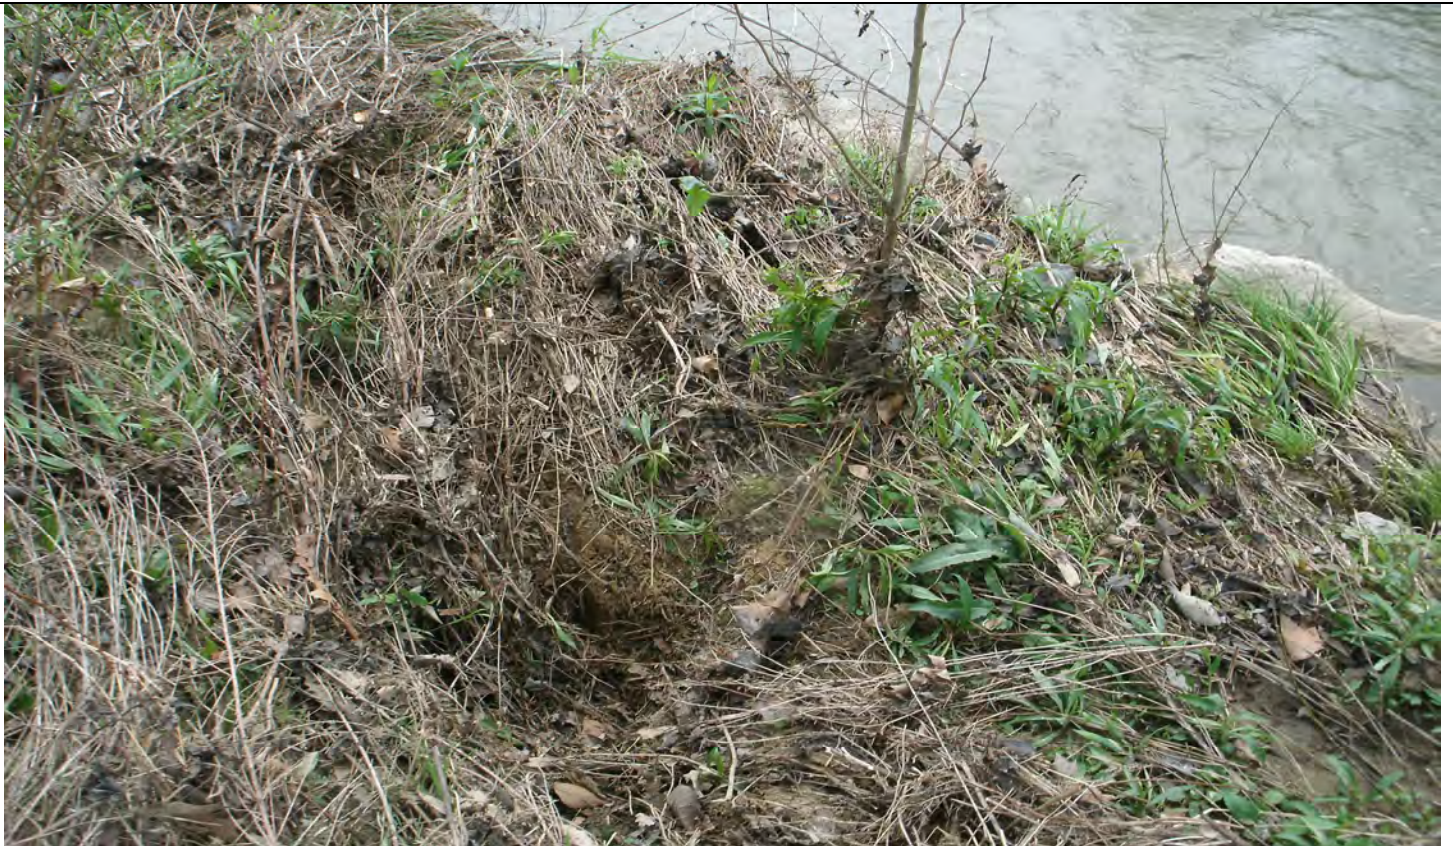
- Bankfull wracklines were present in the floodplain on Reach A, Reach B, and Reach C, which indicated that a bankfull event occurred during this monitoring period. Refer to Appendix E for Table 12: Verification of Bankfull.

SP08 (2011) - Bankfull indicator (deposition) on Reach B

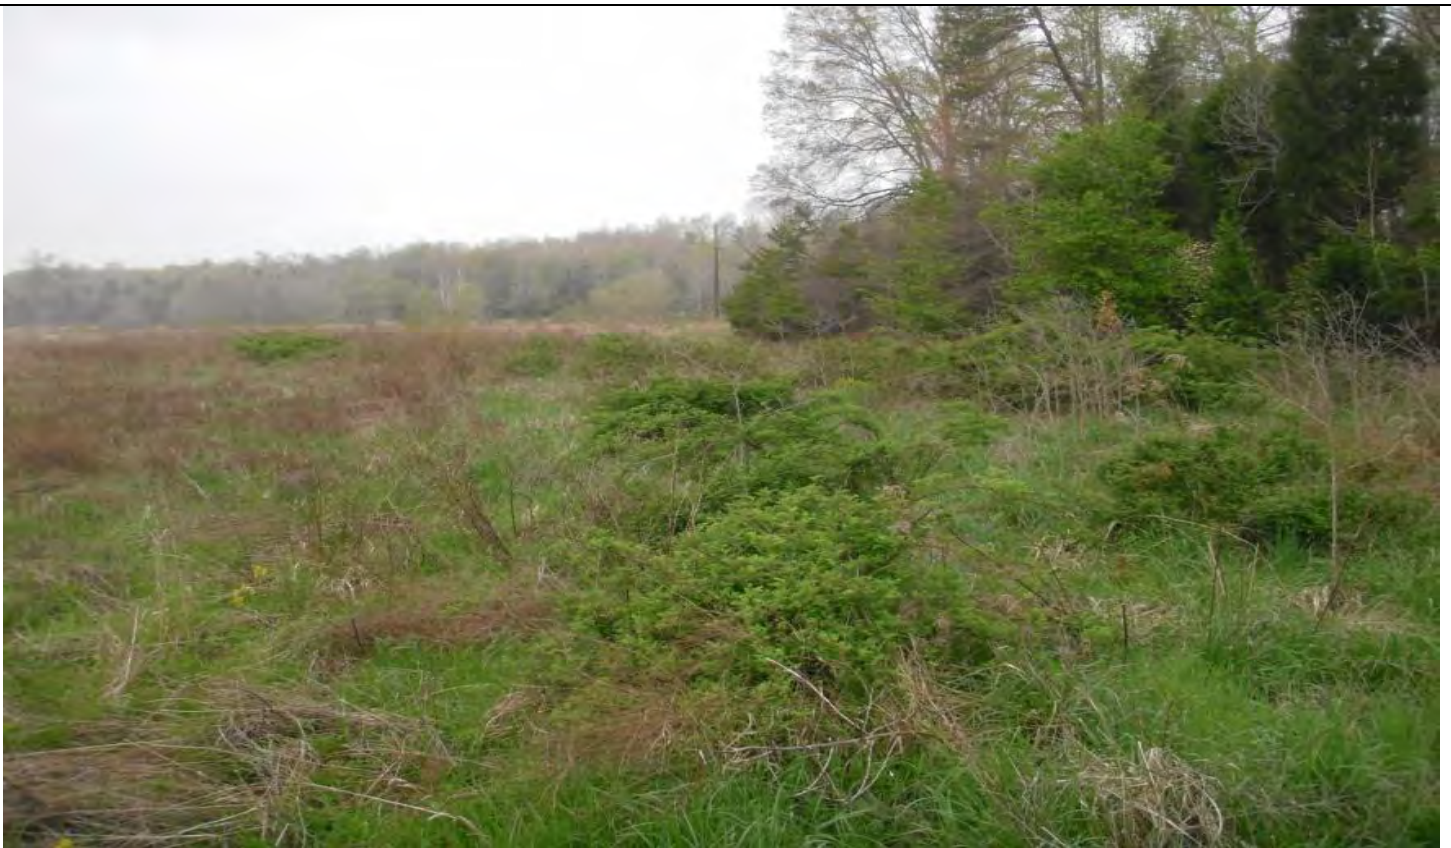
- Two significant sized areas of unvegetated floodplain bench are located along Reach Lower A (approximately 175 feet total), and Reach Lower B (approximately 350 feet total). These locations are showing signs of erosion as a result of the bare, unvegetated soil (Photos VP03-VP07, Appendix A; SP02-SP03, Appendix B).

VP07 (2011) - Bare bench on left bank of Reach Lower A (STA 94+00)

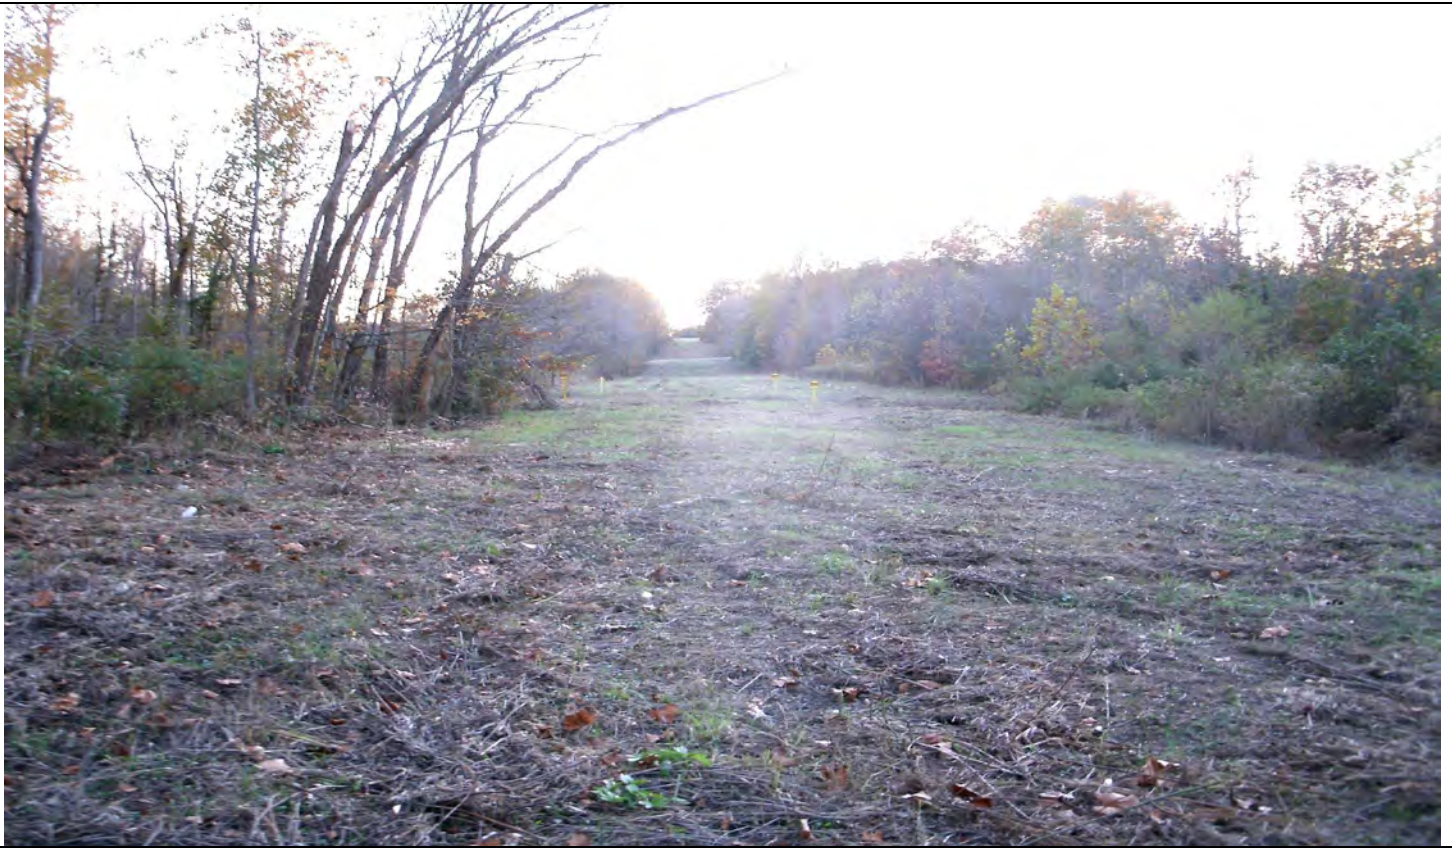
VP10 (2011) - Multiflora Rose along tree line north of Wetland A-5

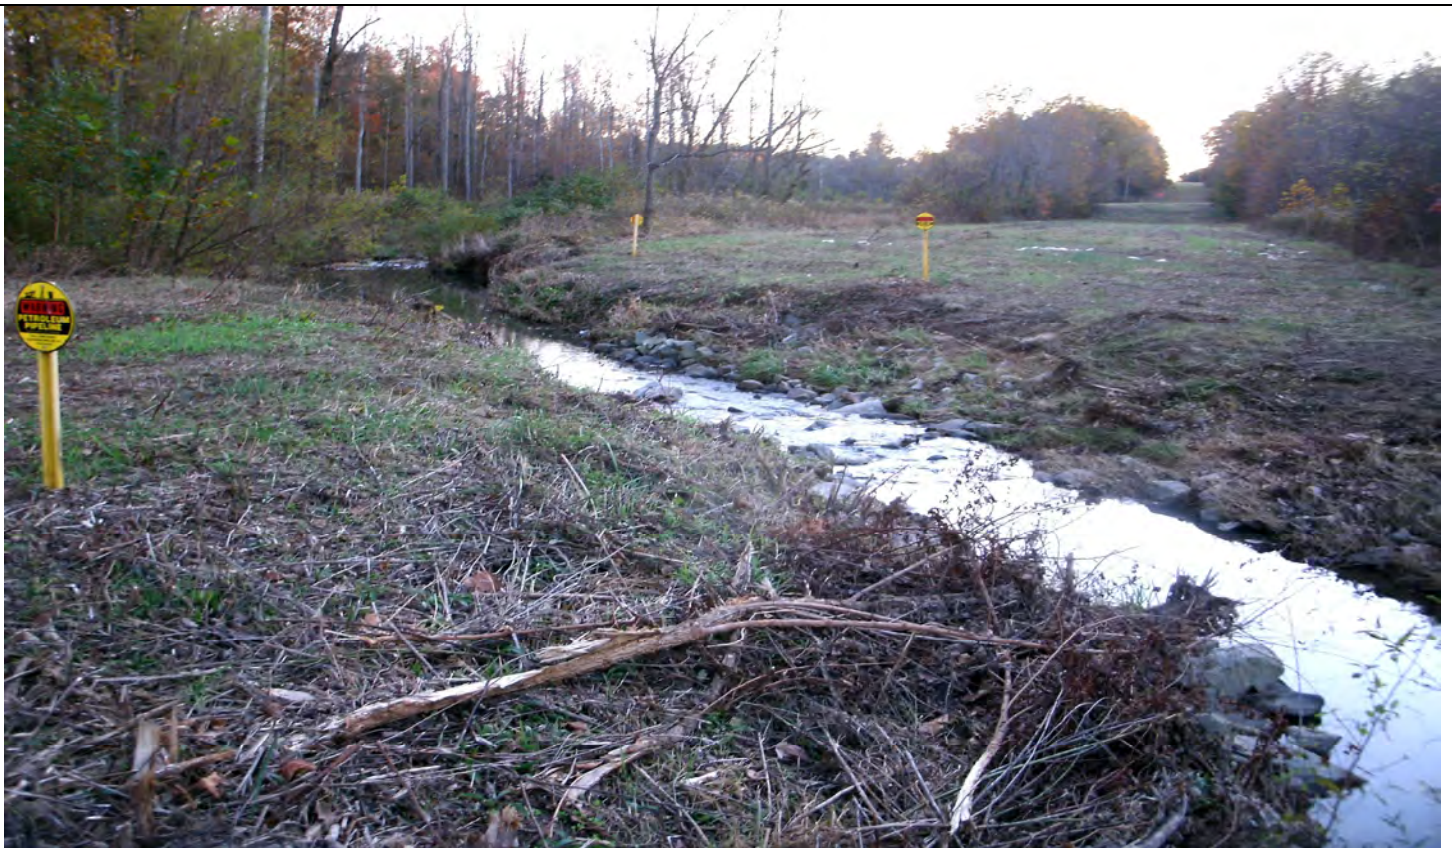
- The utility easement located parallel to Reach C and which crosses Reach Upper A just above the confluence with Reach C was cleared sometime between the 2011 initial site assessment and the monitoring survey field visits (Photos VP11-13).

VP11 (2011) – Cleared utility easement running parallel to Reach Upper A2 (STA 63+00)

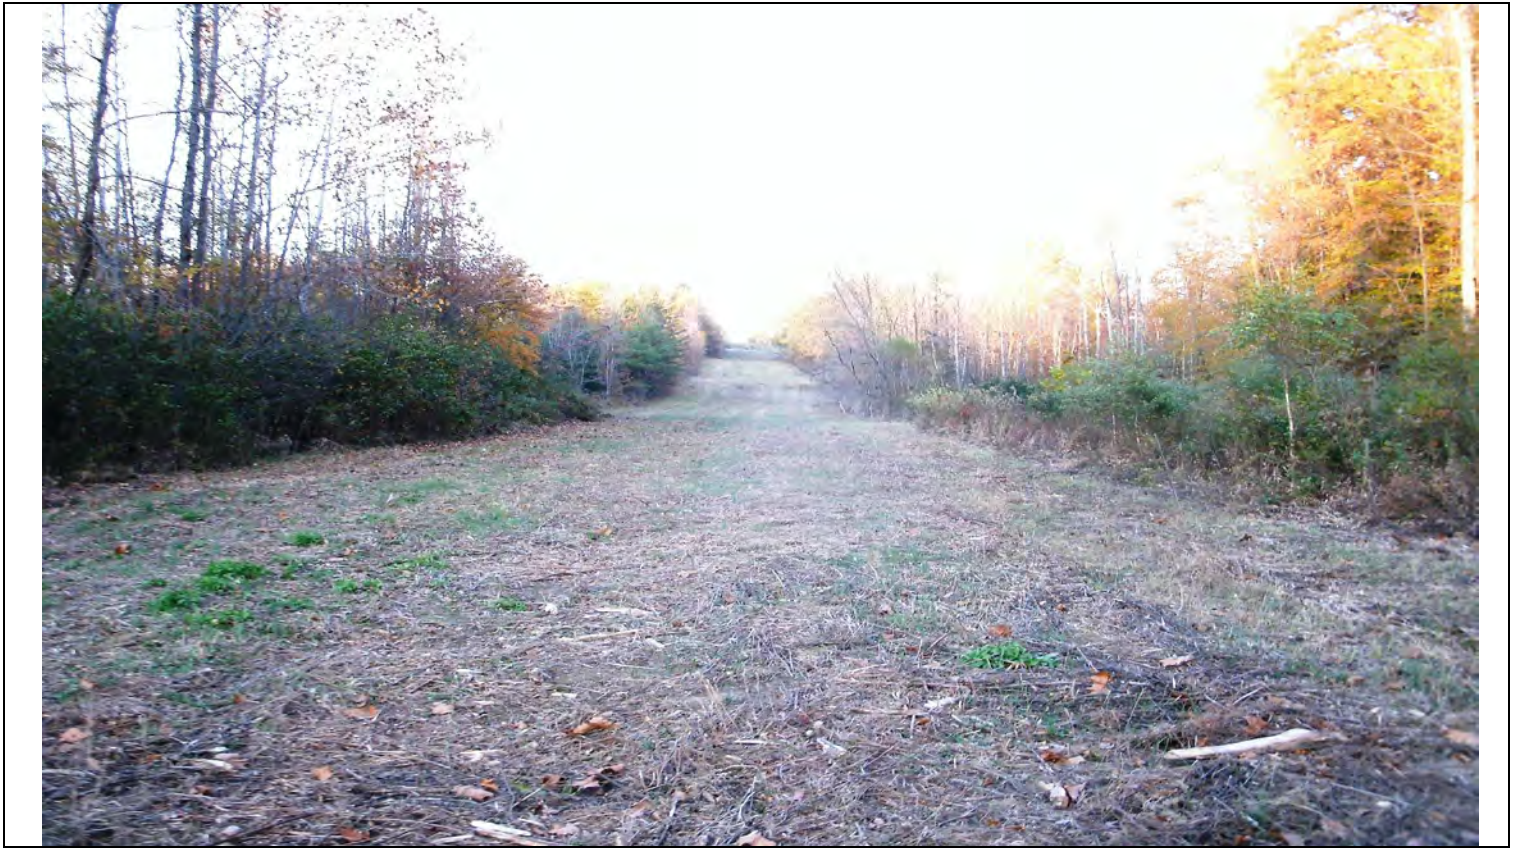
- The rip rap at the Reach Upper A utility crossing also appeared to be maintained during the easement clearing process (Photos VP11-13).

VP12 (2011) - Cleared utility easement at Reach Upper A (STA 61+50)

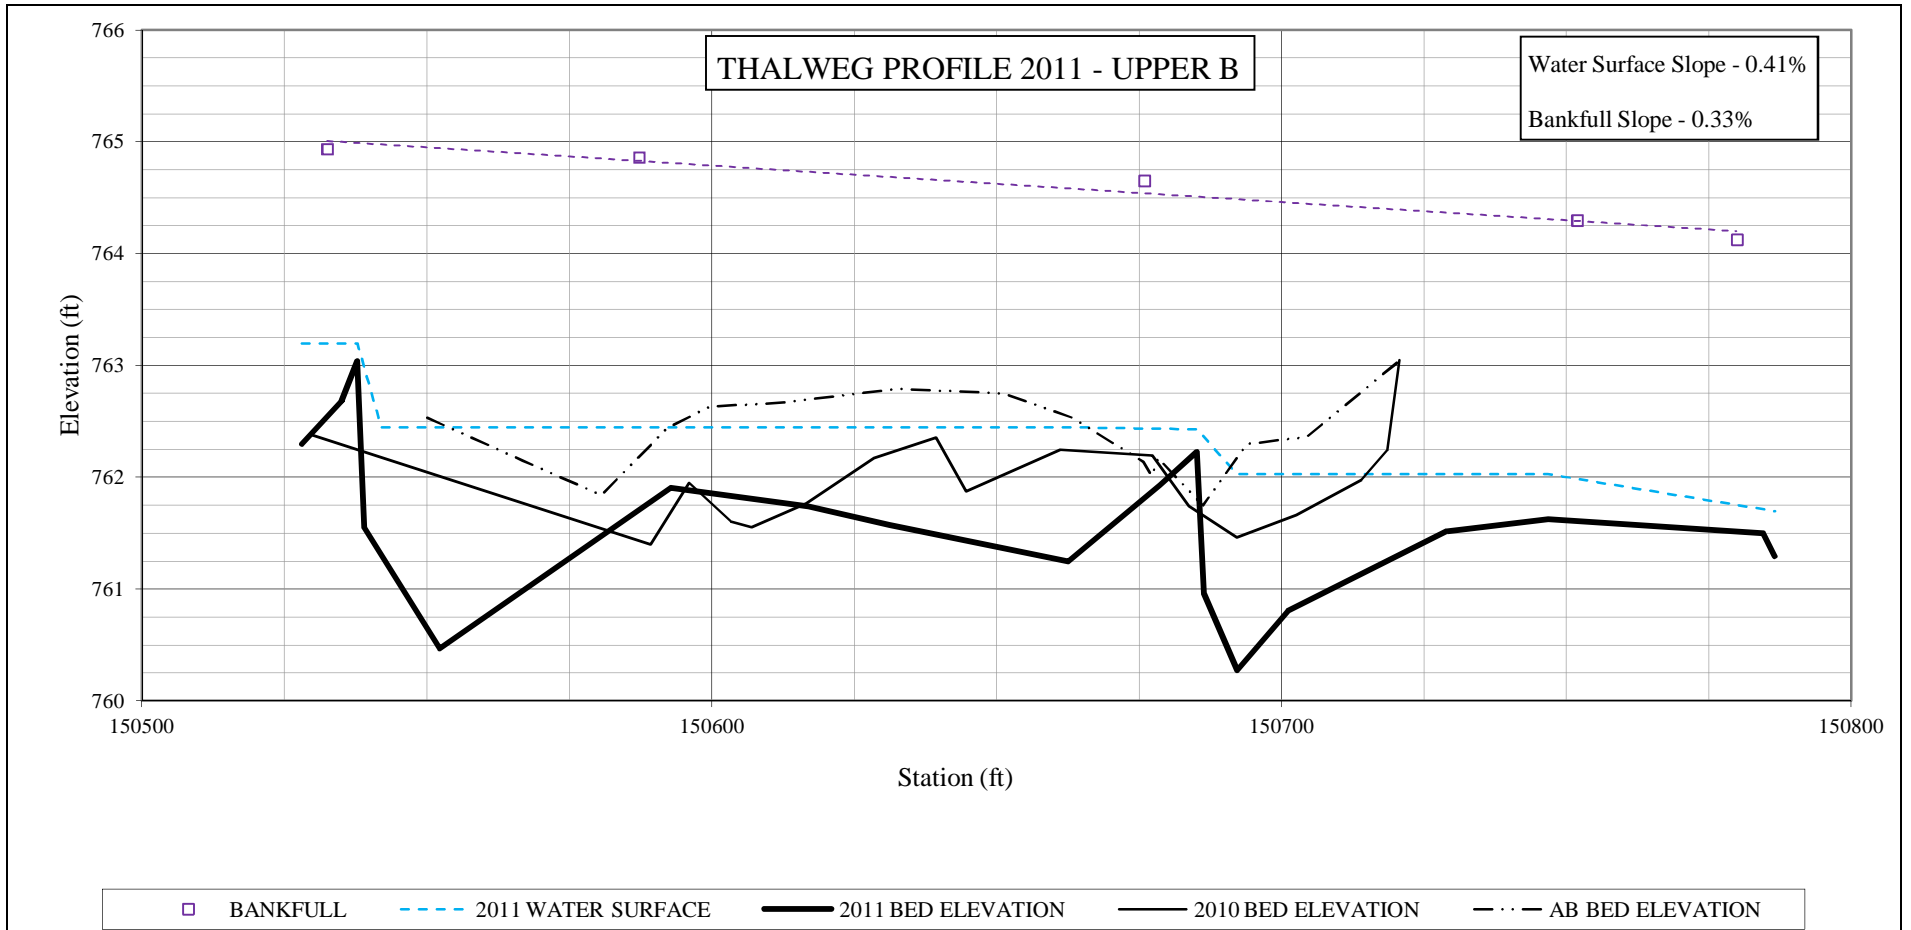
NOTES: Impacted by beaver dam on downstream end of profile. Beaver dam also appears to be preventing the transport of bed material out of the pools.
