# Valley Fields Farm Stream Restoration Project

## Monitoring Report: Year 03

Davidson County, North Carolina  
Upper Yadkin River Basin  
Cataloging Unit 030401030  
EEP Project ID #407

January 2014

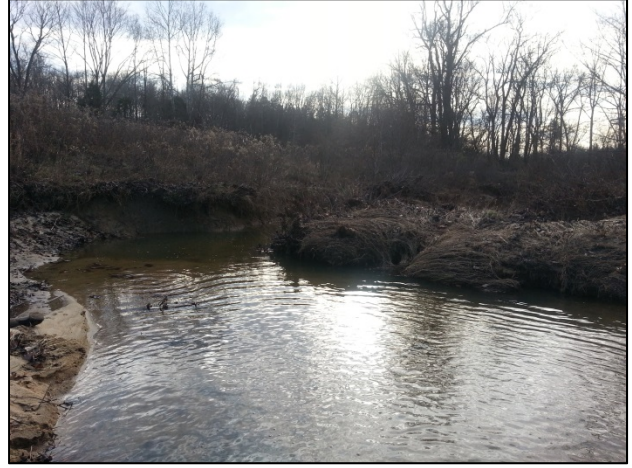
Bank erosion (Station 79+00) – 12/18/2013

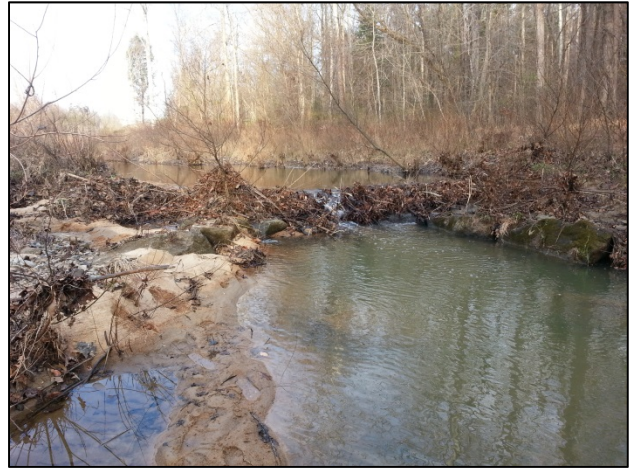
Beaver dam (Station 95+75) – 12/18/2013

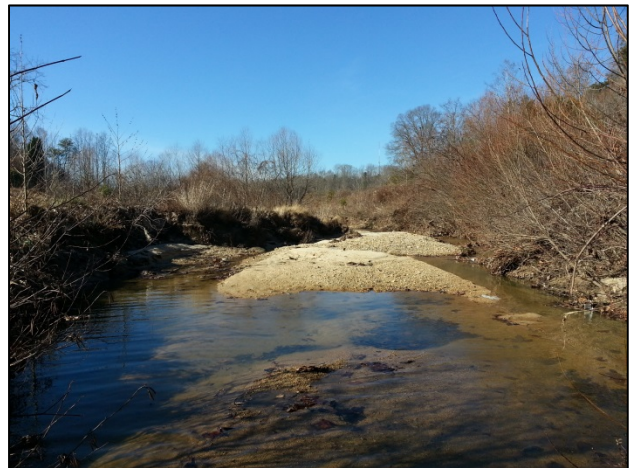
Bank erosion (Station 50+00) – 12/18/2013
