Valley Fields Farm Stream Restoration Project

Monitoring Report: Year 05

Davidson County, North Carolina
Upper Yadkin River Basin
Cataloging Unit 030401030
DMS Project ID #407

December 2015

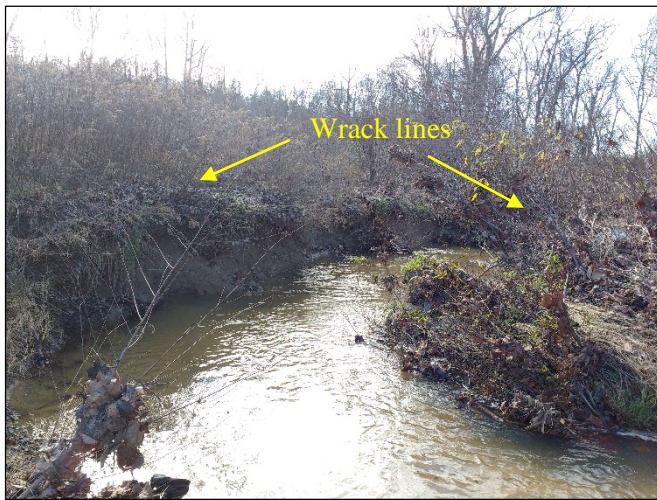
Photo 1. Wracklines along Reach A

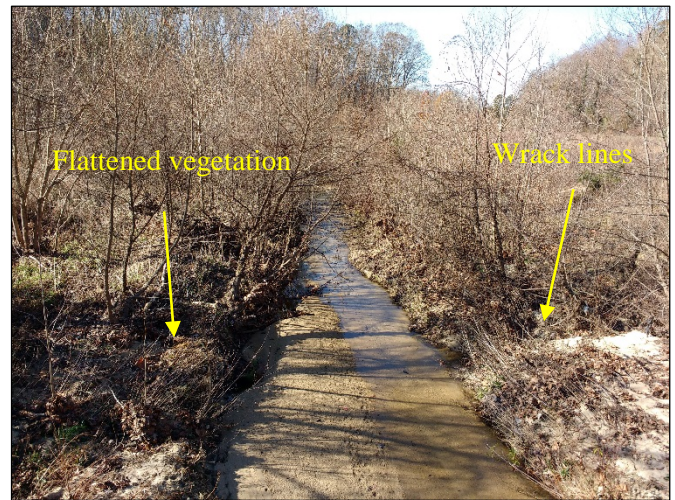
Photo 2. Wracklines and flattened vegetation along Reach B

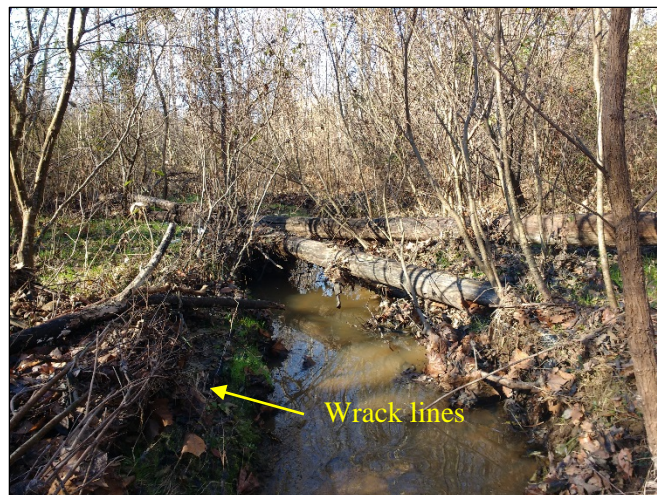
Photo 3. Wracklines along Reach C
