MONITORING YEAR 6 ANNUAL REPORT

VILE CREEK MITIGATION SITE

Alleghany County, NC
DEQ Contract No. 5999
DMS Project No. 96582

Data Collection Period: April – October 2022
Submission Date: February 3, 2023

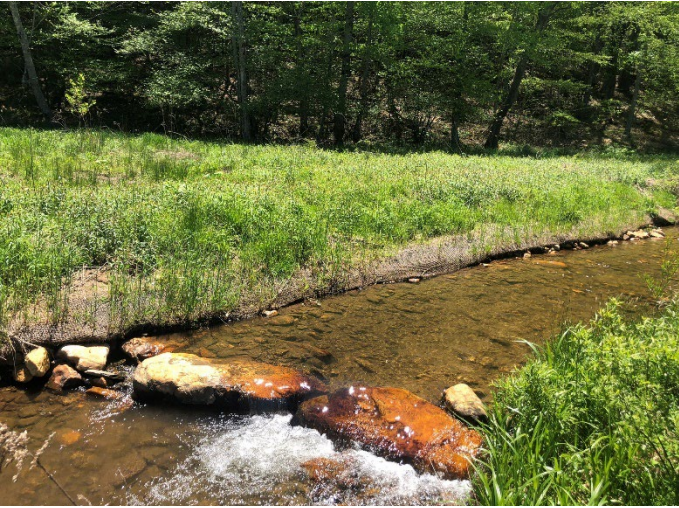
Vile Creek R2: STA 118+50 - 118+80 - Right Bank Repair 05-11-2022

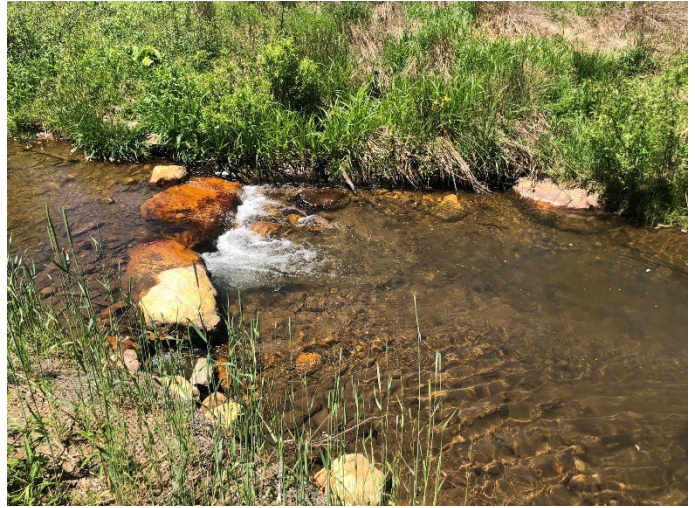
Vile Creek R2: STA 118+80 – J-Hook Repair 05-11-2022

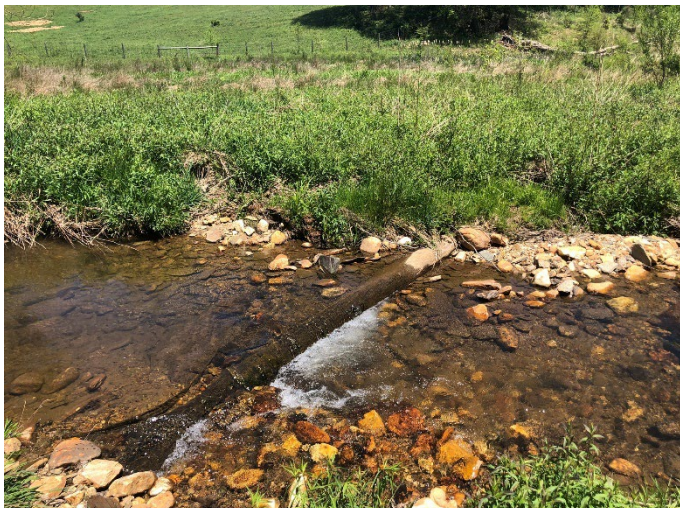
Vile Creek R2: STA 119+50 - 119+70 - Bank Repair 05-11-2022

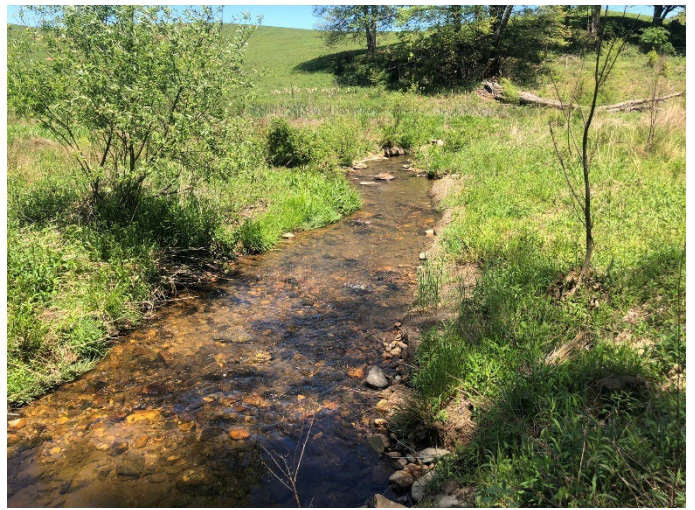
Vile Creek R2: STA 121+00 - 121+25 - Right Bank Repair 05-11-2022

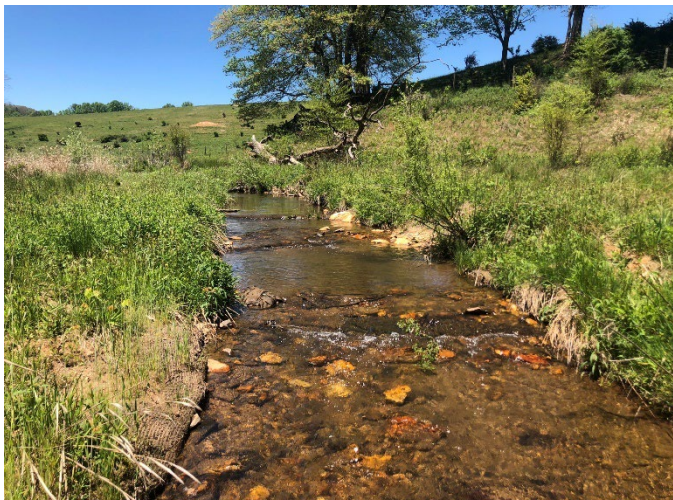
Vile Creek R2: STA 122+20 - 123+00 – Stream Repair
05-11-2022

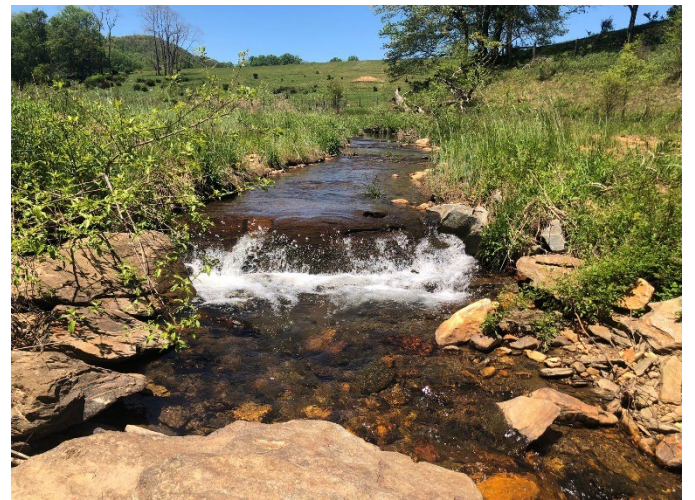
Vile Creek R2: STA 123+00 – Rock Sill Repair 05-11-2022

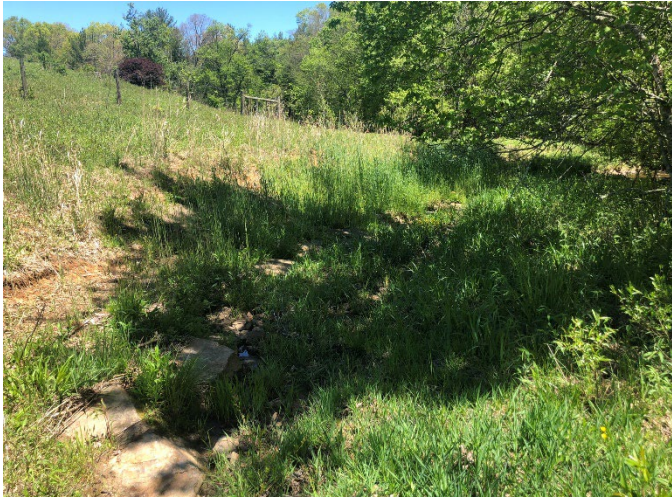
Vile Creek R3: STA 125+00 - 125+60 - Secondary Channel Repair
05-11-2022

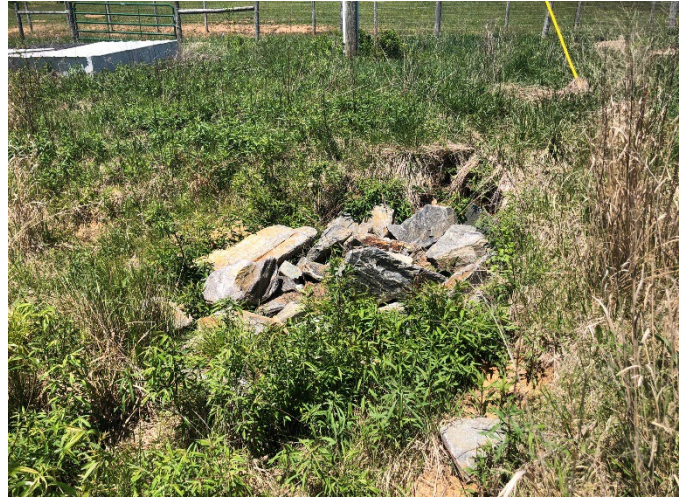
UT2 BMP – Headcut Repair 05-11-2022

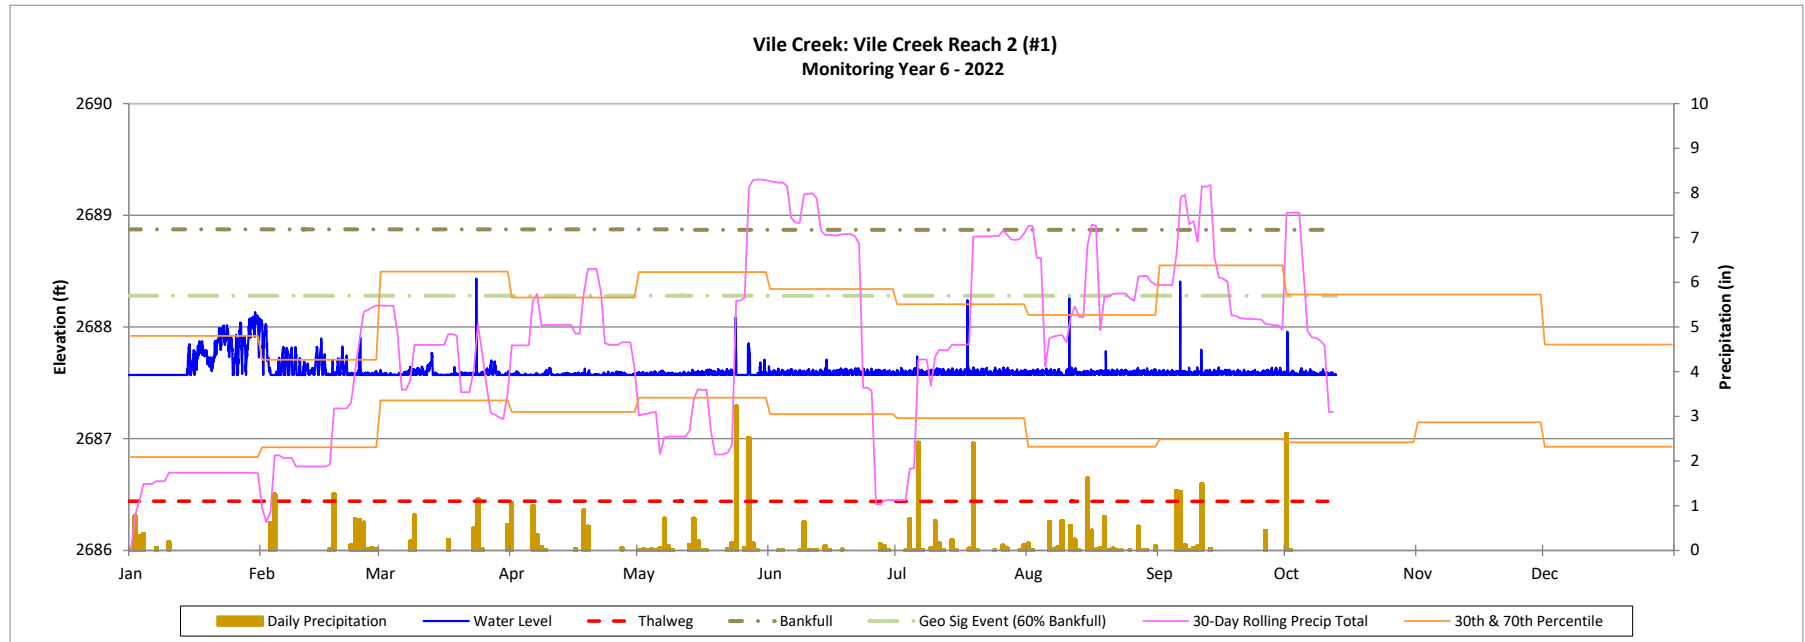
Crest Gage Plot

*Crest Gage probe experienced intermittent freezing temperatures Jan - Mar 2022 resulting in incorrect water level readings

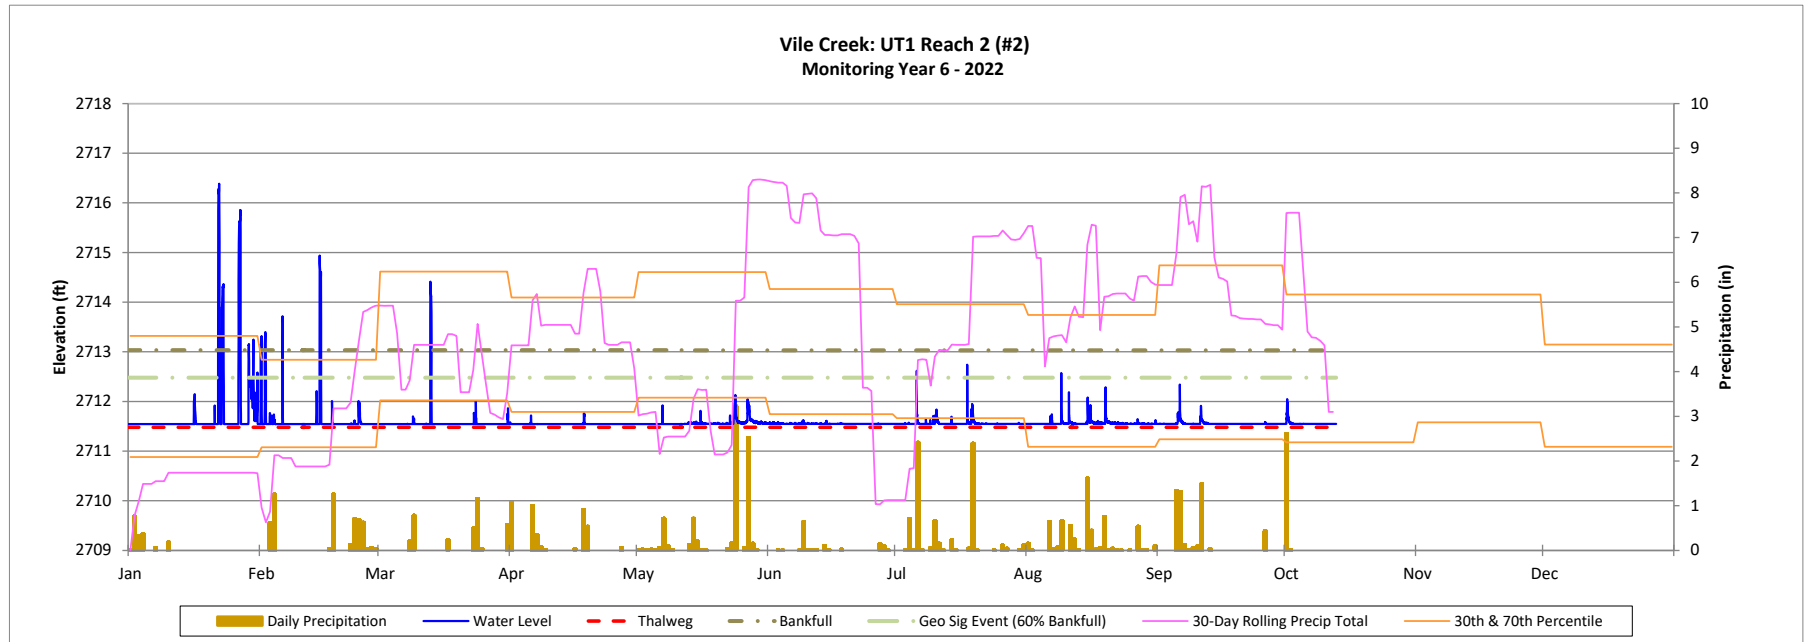
Crest Gage Plot

*Crest Gage probe experienced intermittent freezing temperatures Jan-Mar 2022 resulting in incorrect water level readings
