AS-BUILT BASELINE MONITORING REPORT

VILE CREEK MITIGATION SITE

Alleghany County, NC
DEQ Contract No. 5999
DMS Project No. 96582
DWR No. 14-0869
USACE Action ID 2014-01585

Data Collection Period: February - May 2017
Final Submission Date: June 14, 2017

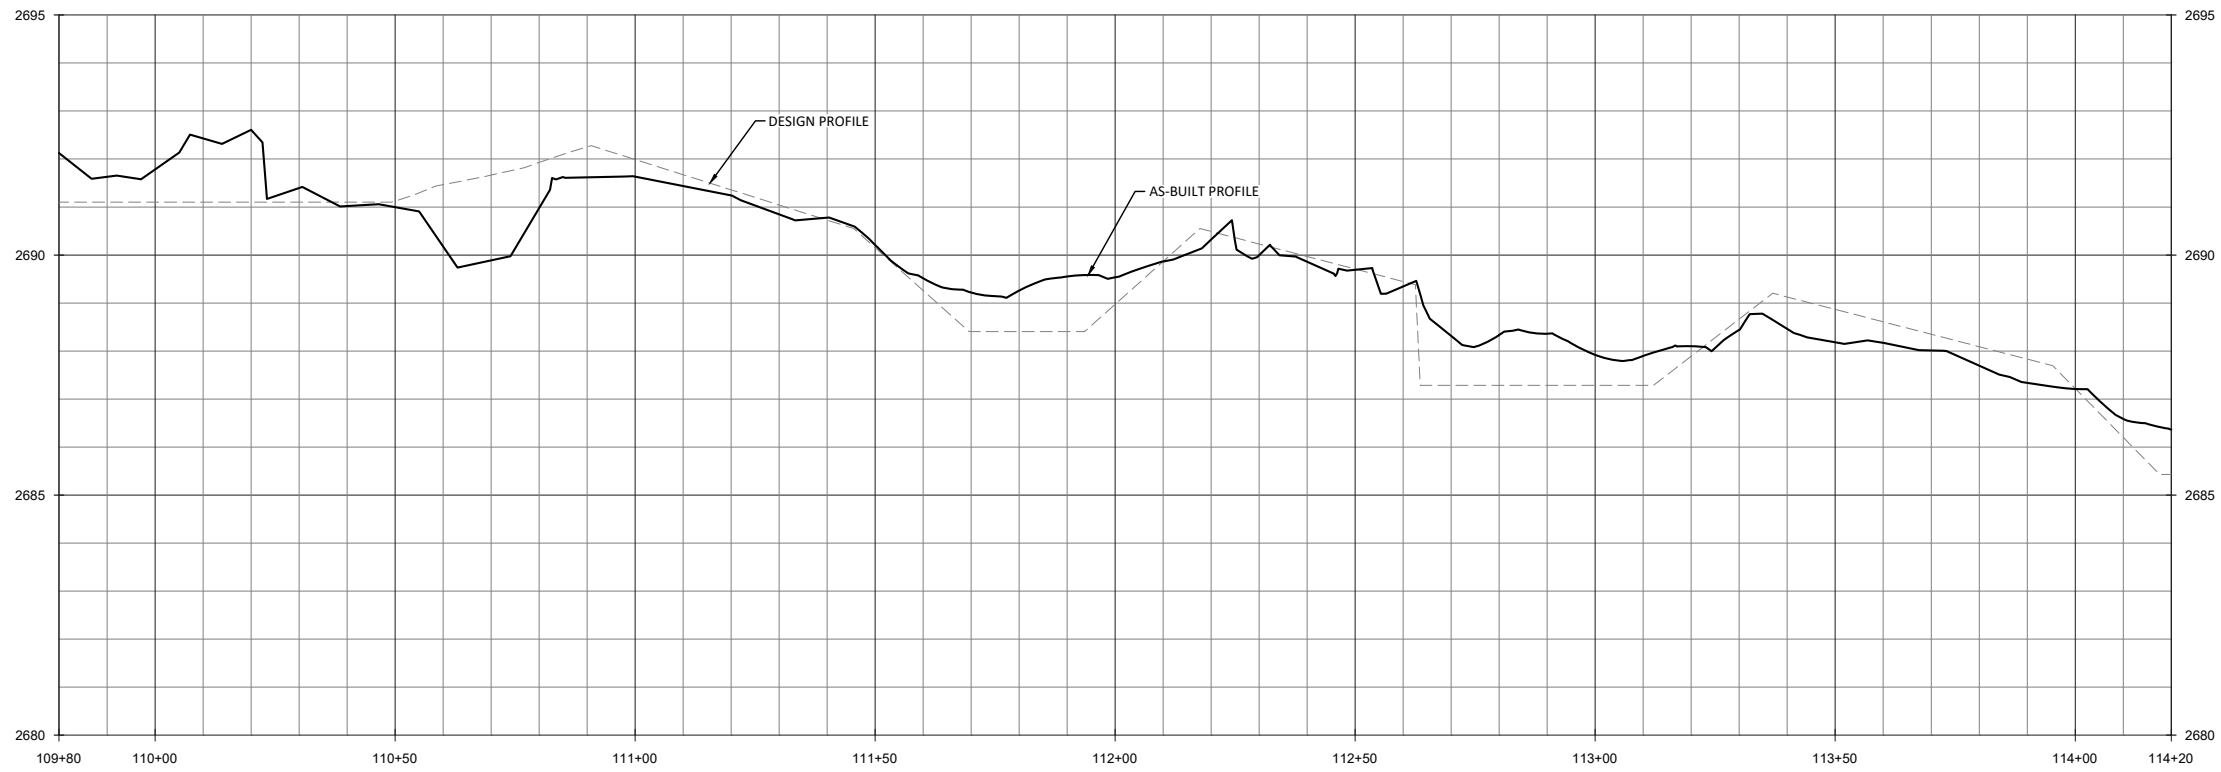
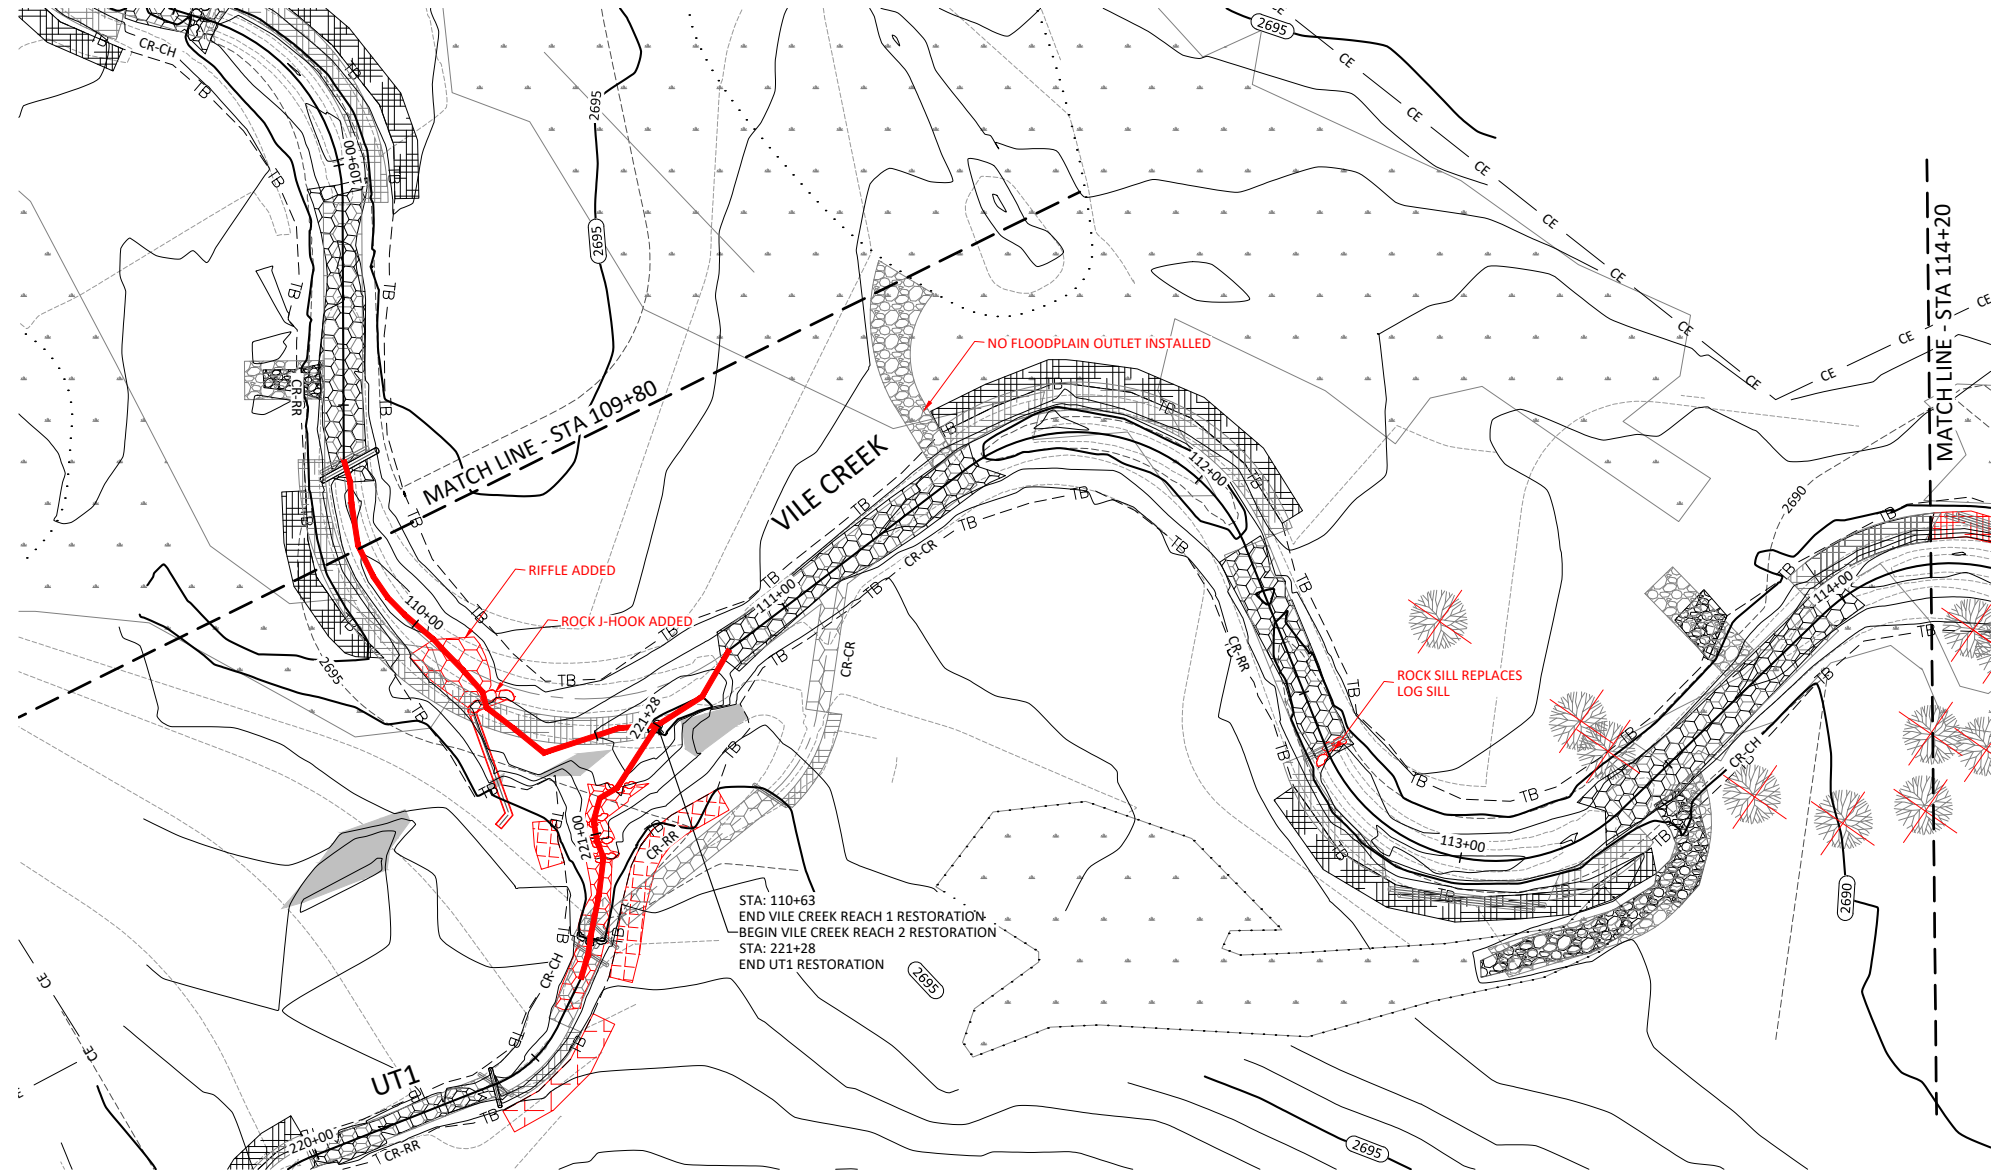
NOTE:
 SOD MATS ADDED ON MOST BANKS WHERE NO BANK REVETMENTS EXIST.
 ALIGNMENT REVISION IN FIELD TO UTILIZE AND MAINTAIN BEDROCK.
 STA: 109+64 - 110+83

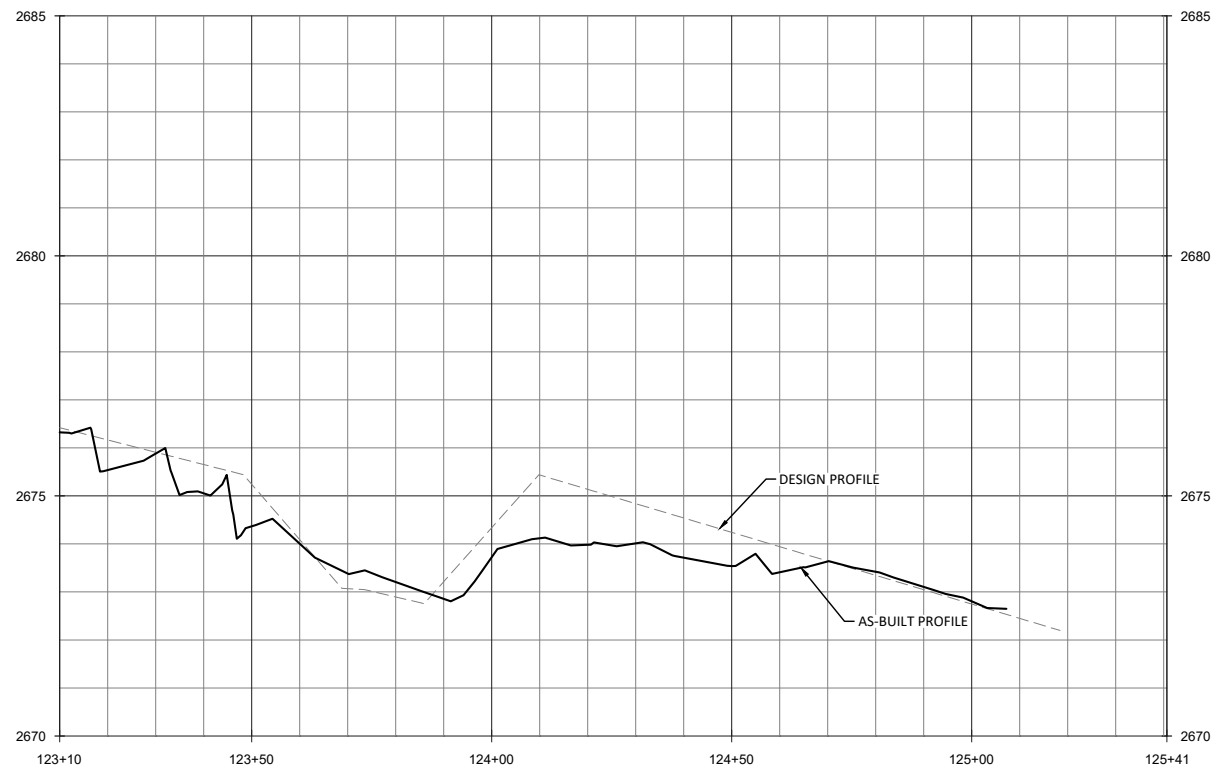
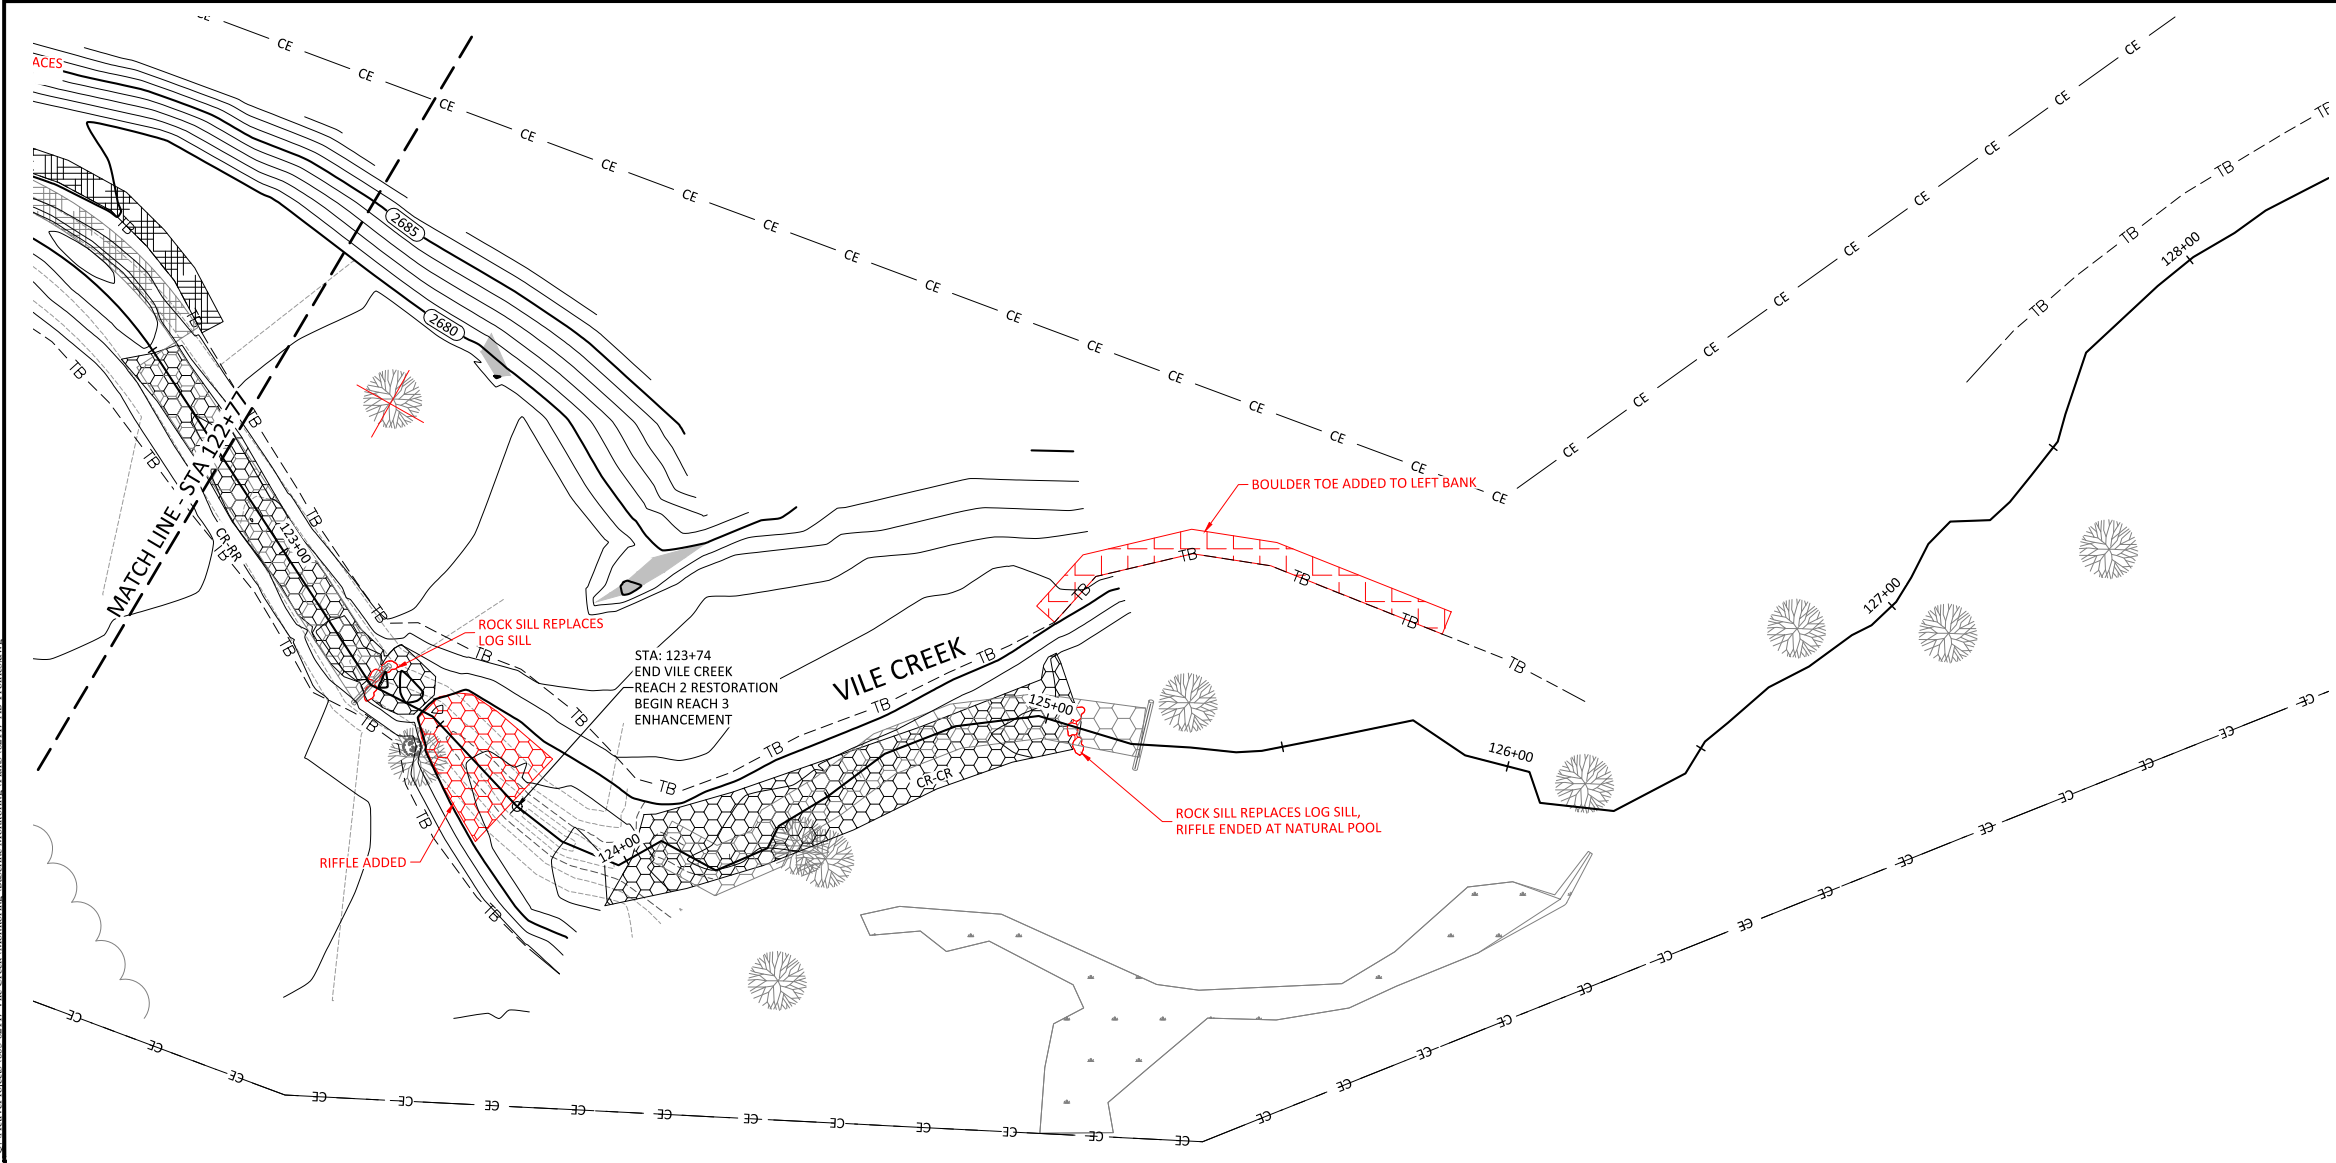
NOTE:
 STA: 126+00 - 127+50 - ADDITIONAL BANK GRADING PERFORMED AND BOULDER TOE ADDED ON LEFT BANK
 Sheet Index

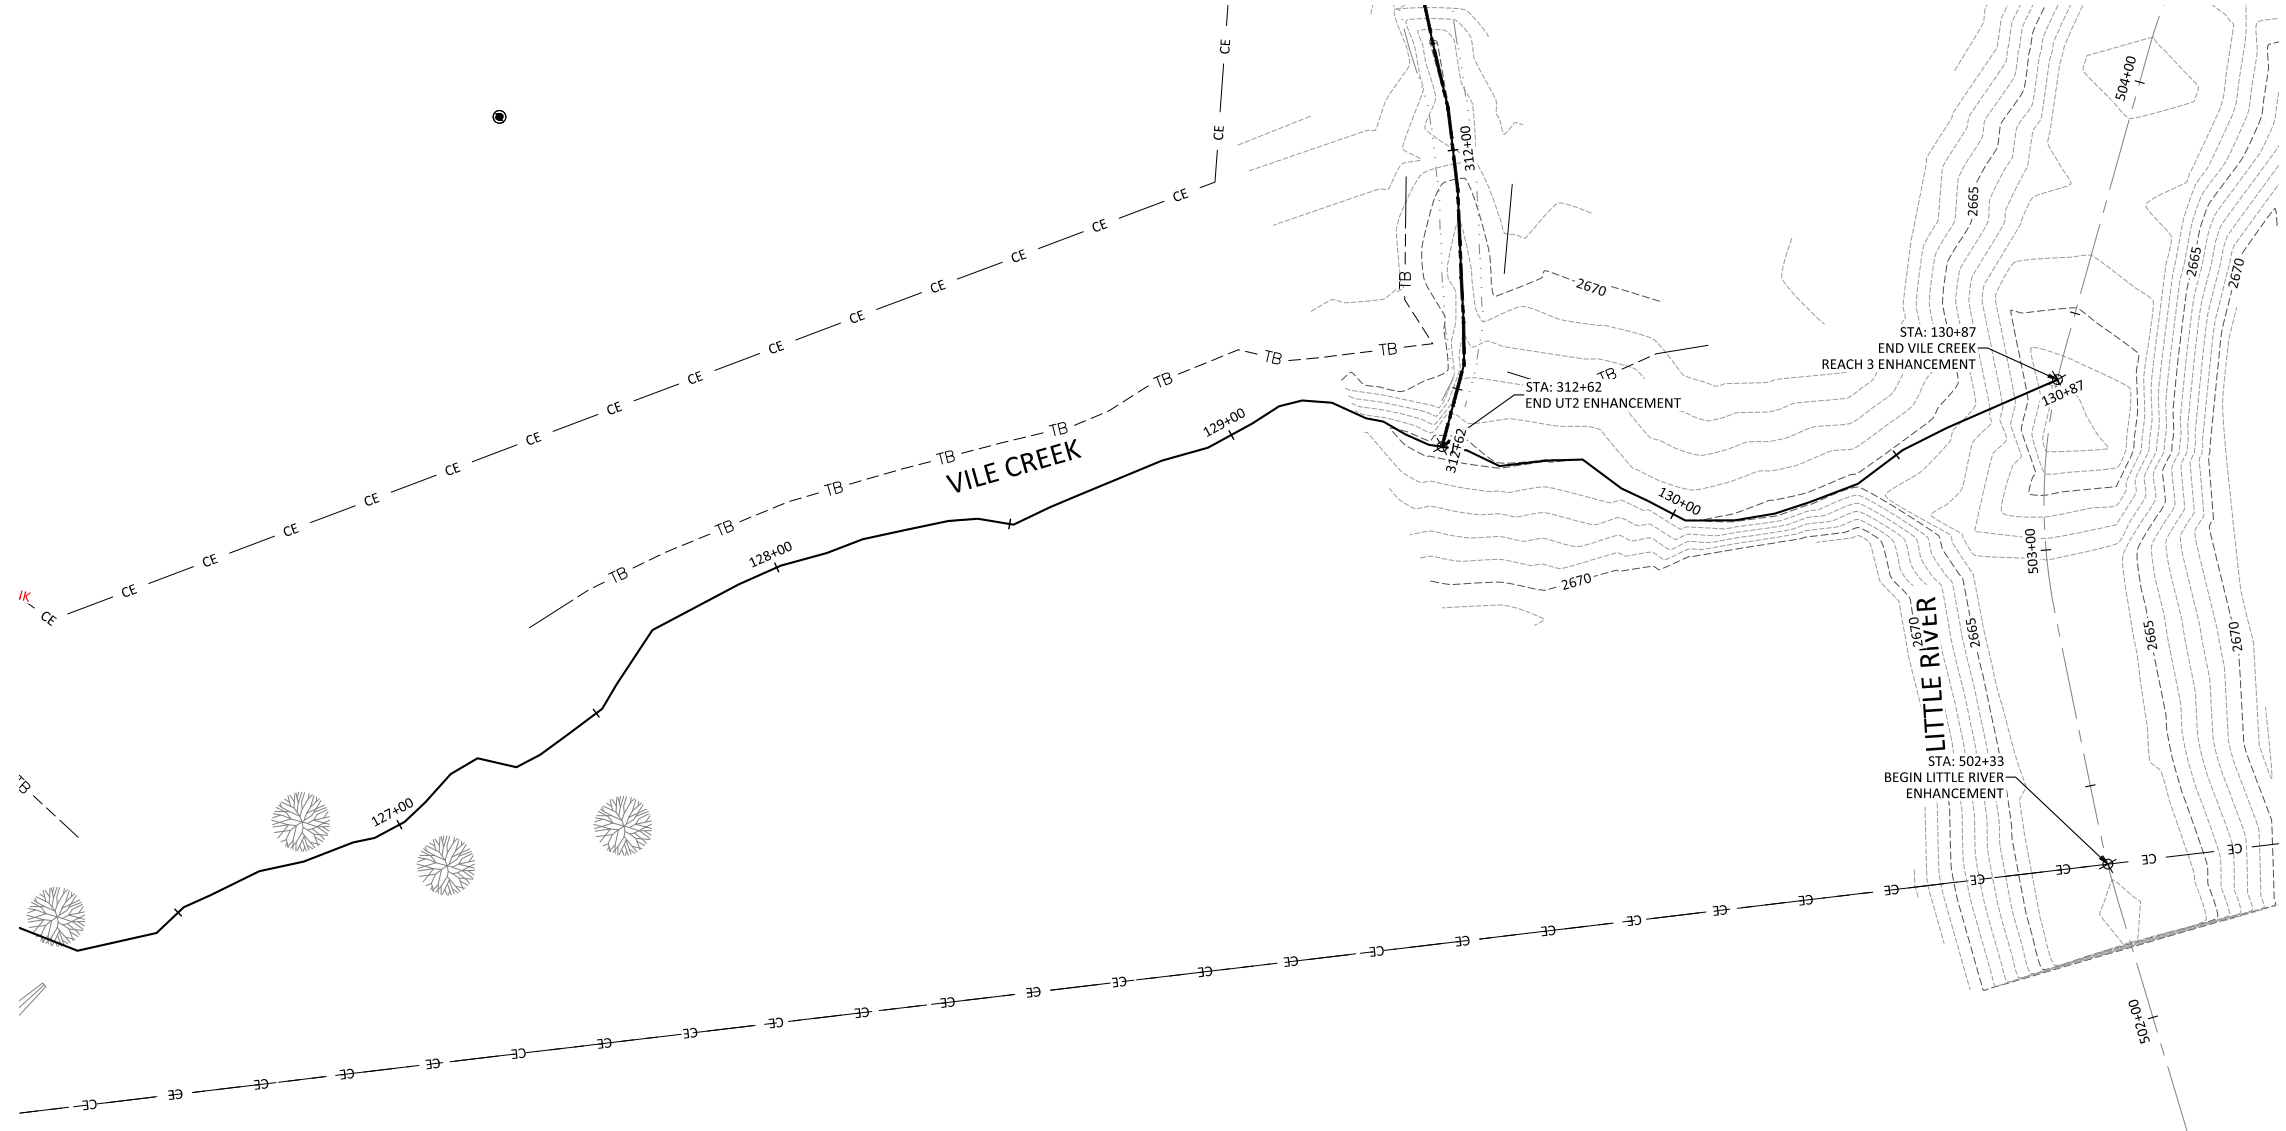
NOTE:
 STA: 126+00 - 127+50 - BANK GRADING ON LEFT BANK

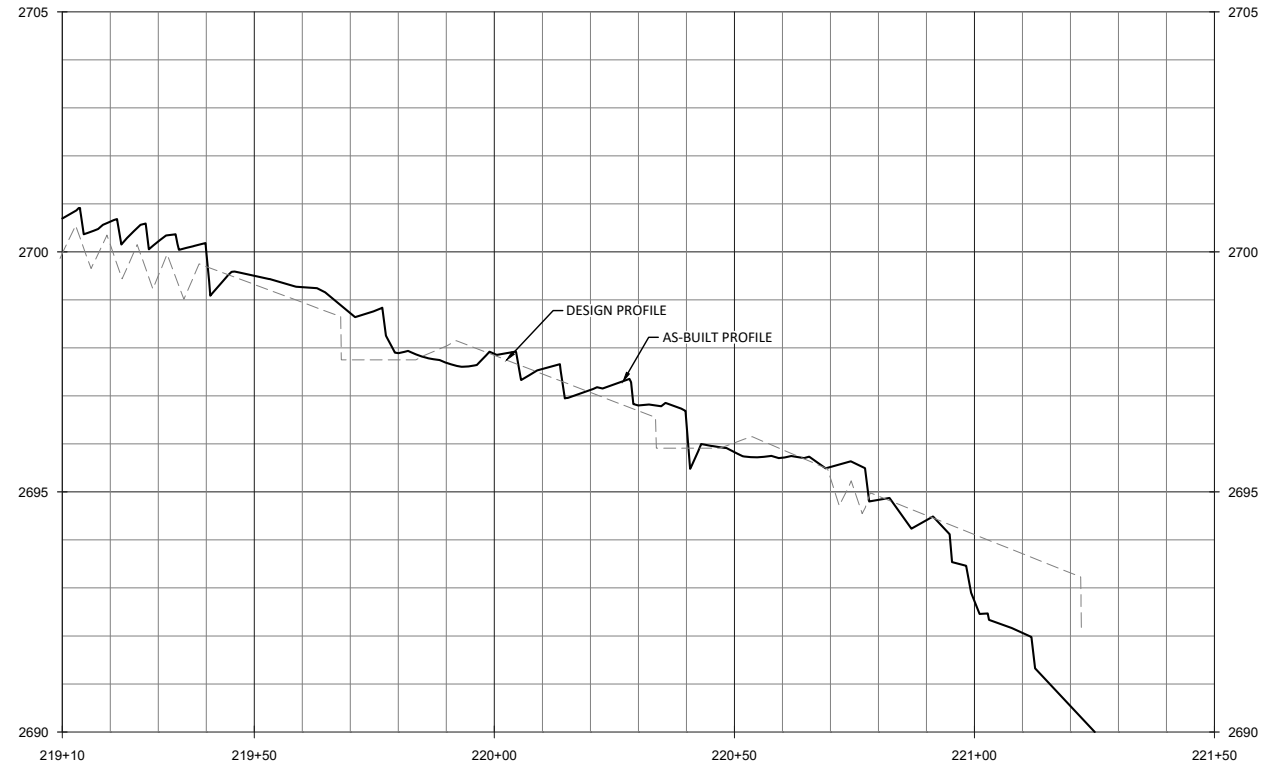
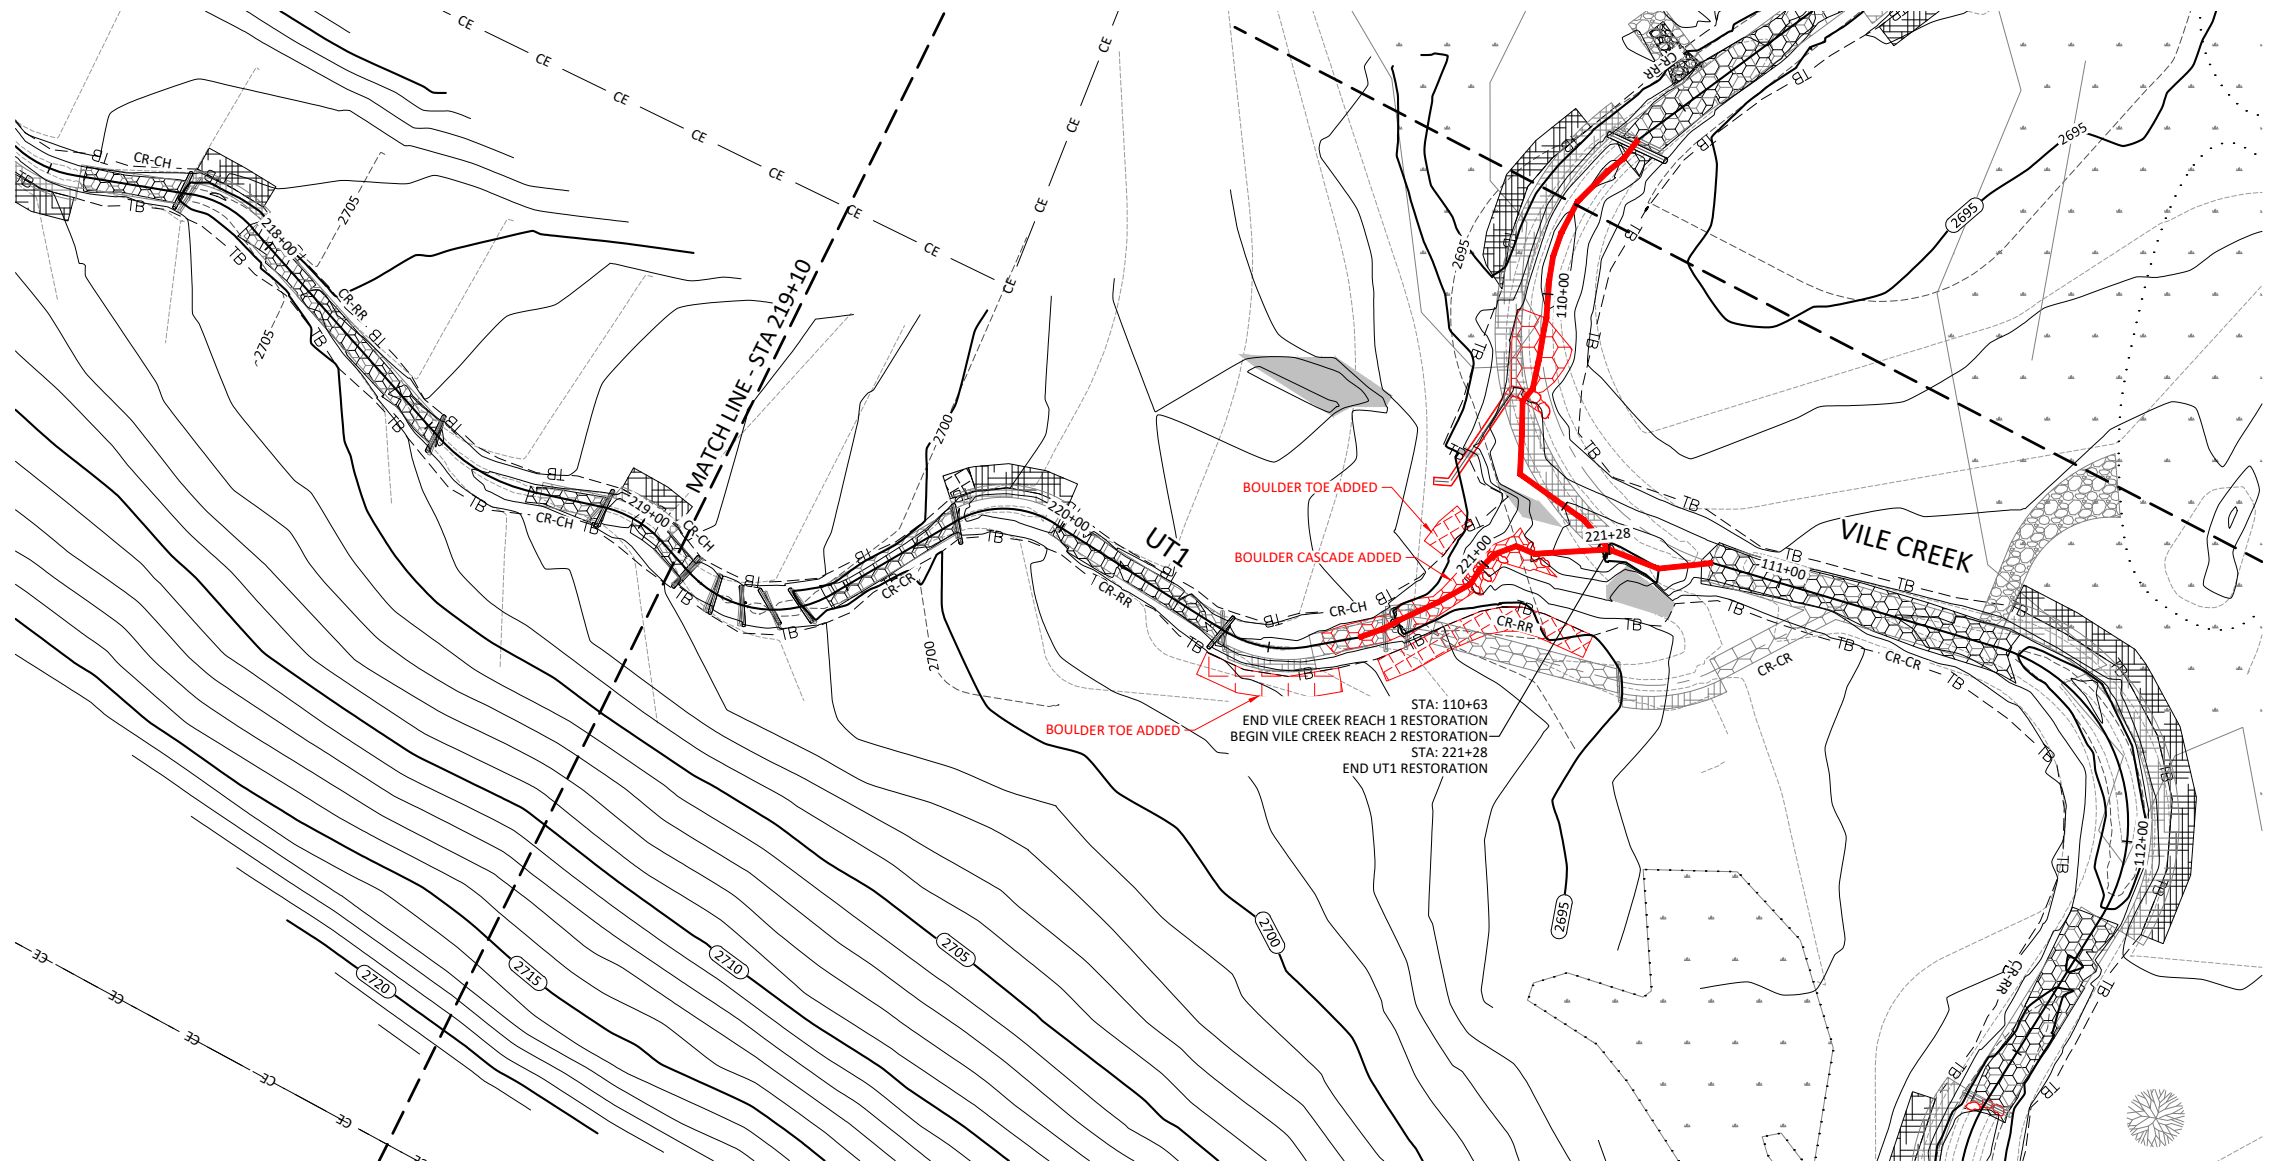
NOTE:
SOD MATS ADDED ON MOST BANKS WHERE NO BANK REVETMENTS EXIST.
STA: 220+69 - 221+28 - ALIGNMENT REVISION IN FIELD IN ORDER TO UTILIZE AND MAINTAIN BEDROCK

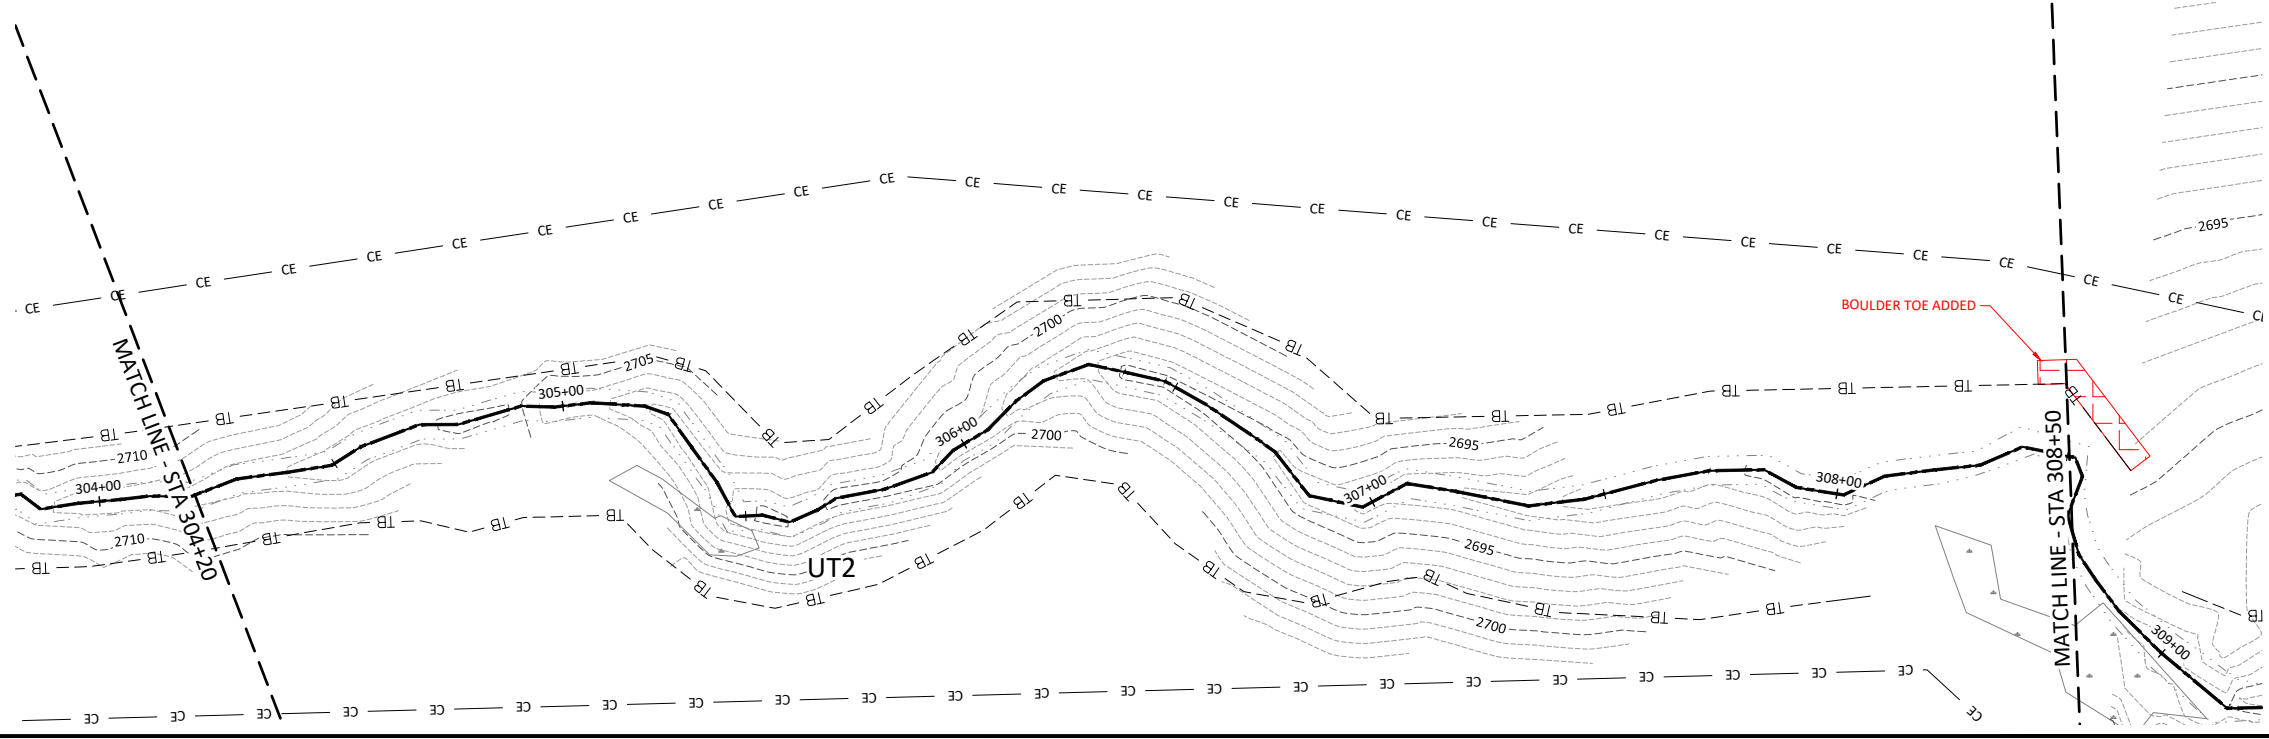
NOTE:
STA: 305+25 - 306+75 - BANK GRADING AND LIGHT MATTING ON RIGHT BANK
STA: 306+50 - BOULDER TOE ADDED TO LEFT BANK
STA: 307+00 - 307+50 - BANK GRADING AND LIGHT MATTING ON BOTH BANKS
