# MONITORING YEAR 2 ANNUAL REPORT

## VILE CREEK MITIGATION SITE

Alleghany County, NC  
DEQ Contract No. 5999  
DMS Project No. 96582

Data Collection Period: April – November 2018  
Submission Date: December 13, 2018

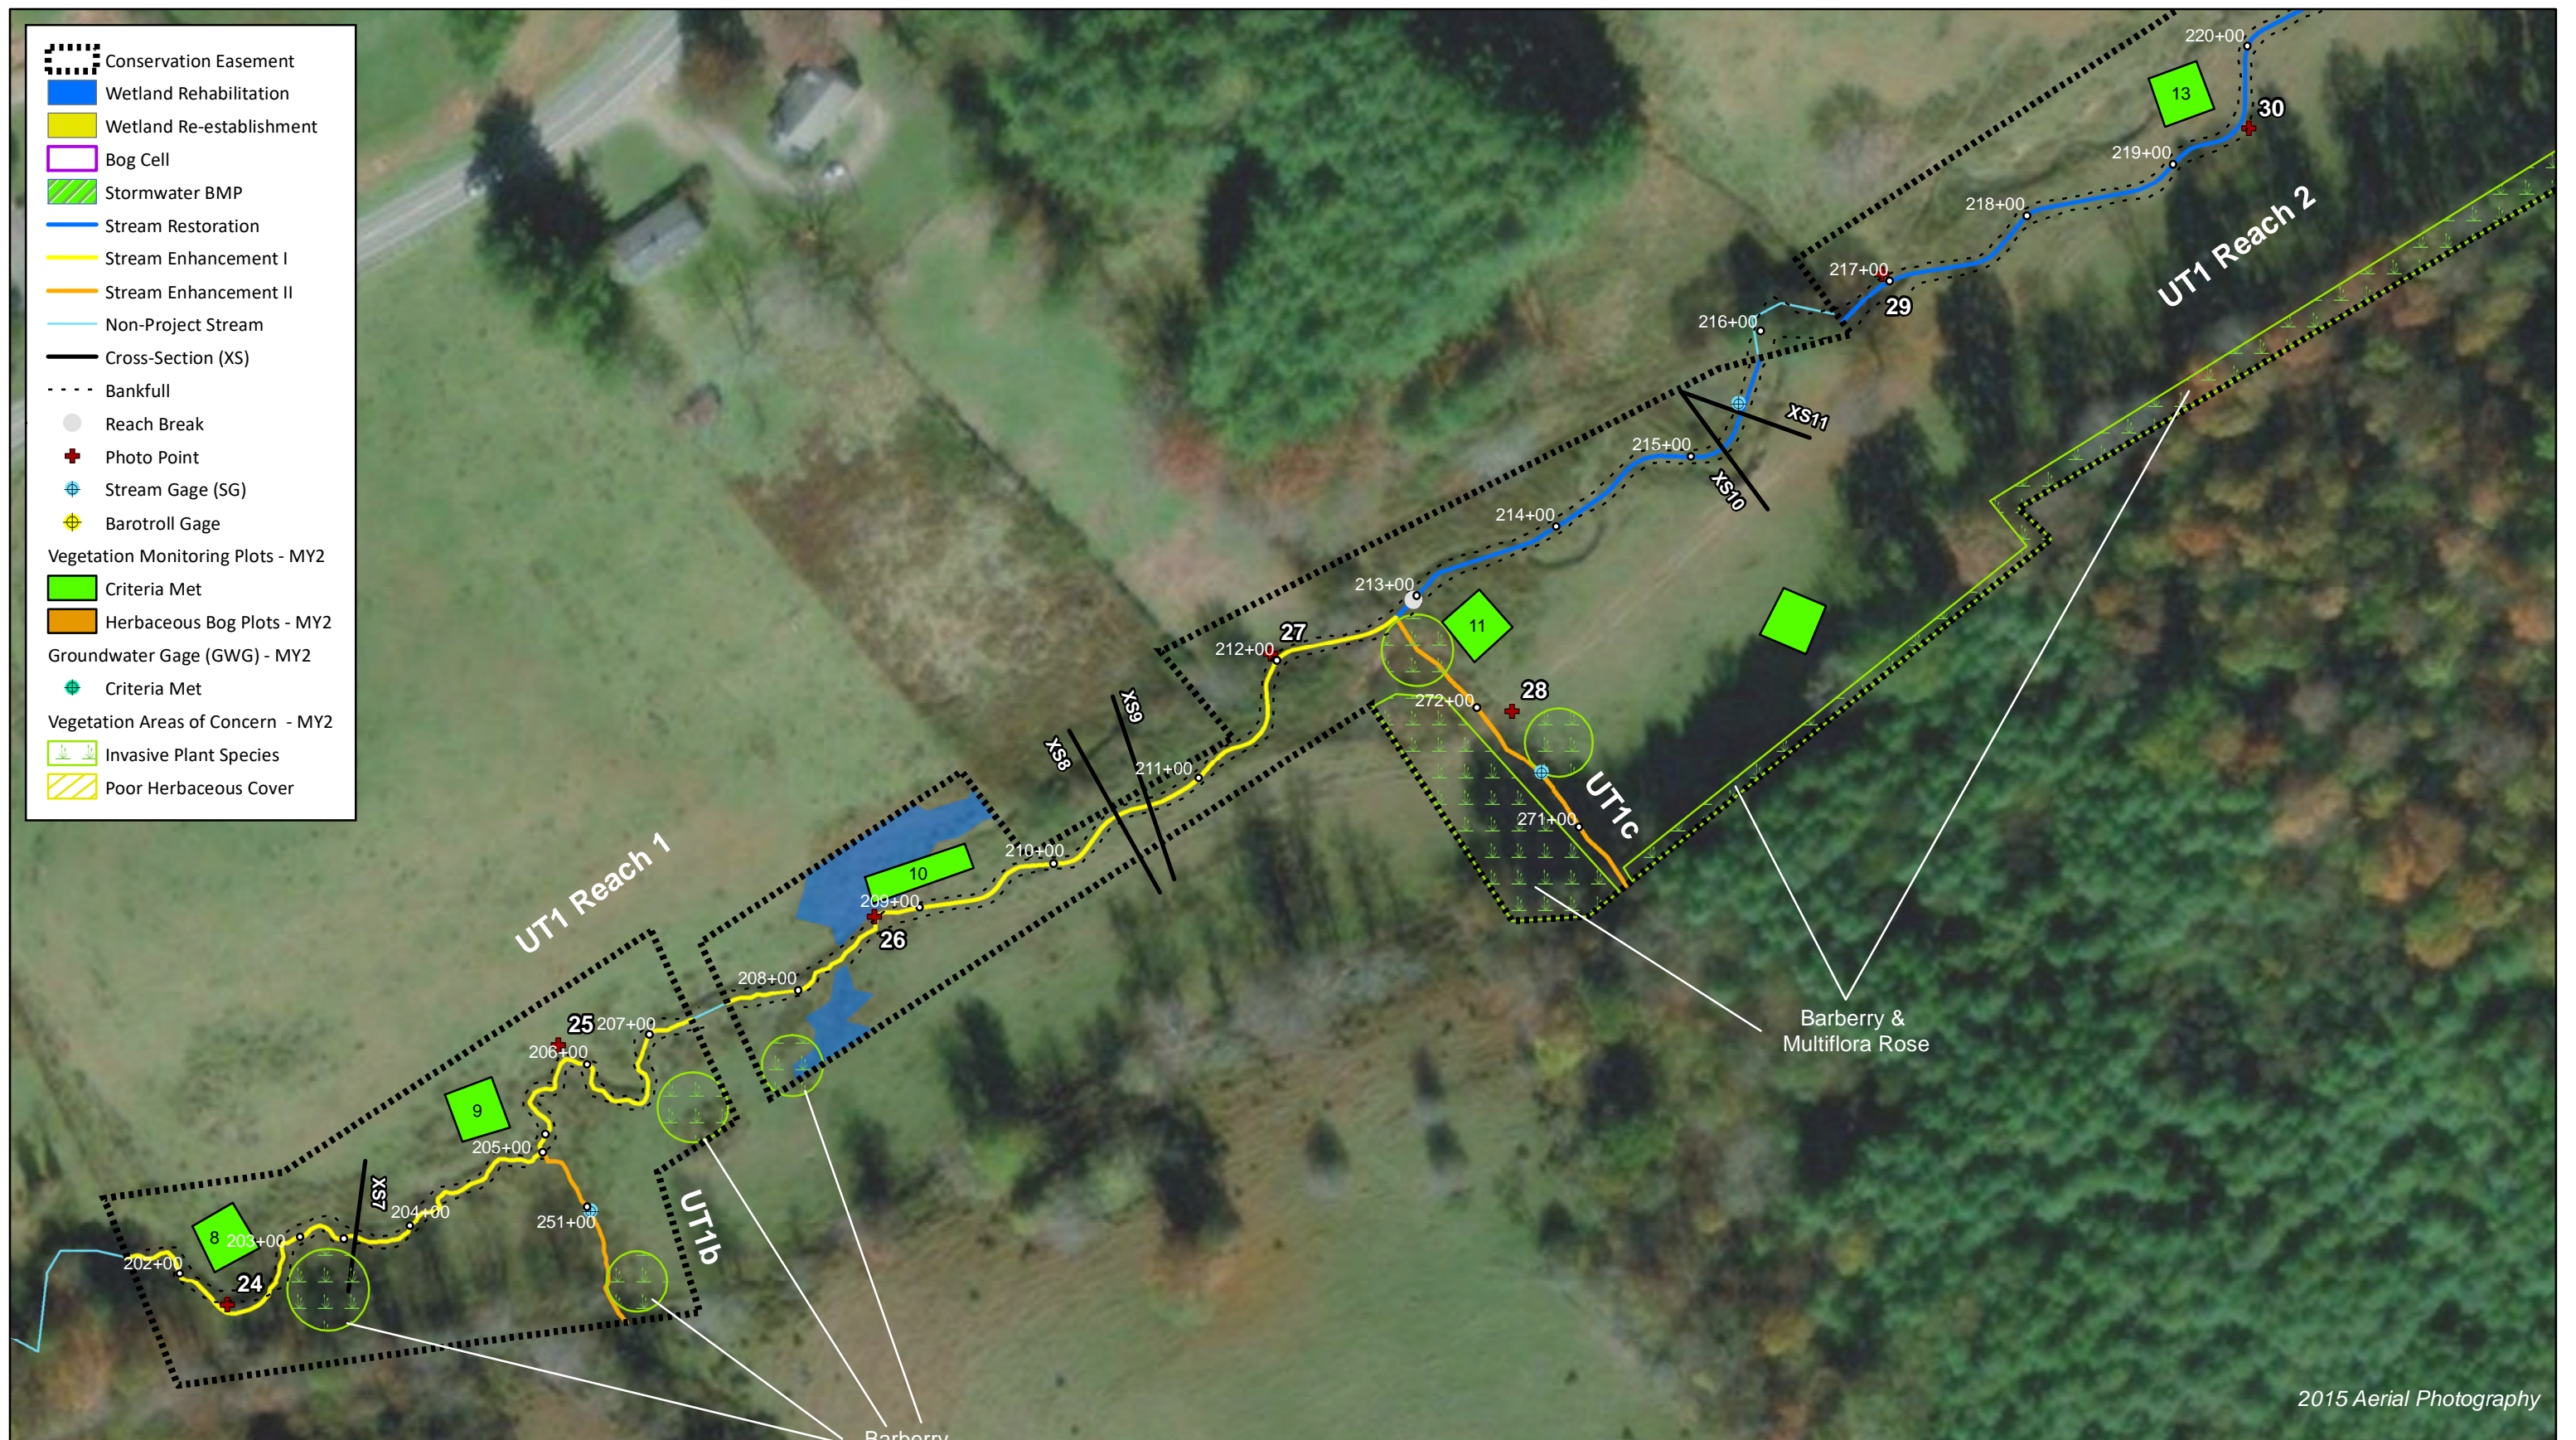
Figure 3.1 Integrated Current Condition Plan View (Sheet 1)  
 Vile Creek Mitigation Site  
 DMS Project No. 96582  
 Monitoring Year 2 - 2018

Following Hurricane Florene and Tropical Storm Michael in Fall 2018, areas of minor scour and erosion were observed along several meander bends including, but not limited to Vile Creek Reach 3 station 124+00, Vile Creek Reach 1 and UT1 confluence, UT1 Reach 1 station 211+50, and UT2 station 306+50. The bank erosion areas were mostly associated with Enhancement I and Enhancement II streams. The UT2 stream, which is an Enhancement II, was observed with bed aggradation at stations 308+75, 310+00, and station 311+25. Aggradation has resulted in sheet flow onto the flood plain rather than a single channel at station 311+25. While these areas are under the mapping threshold, Wildlands will continue to monitor the areas of concern during future site visits.

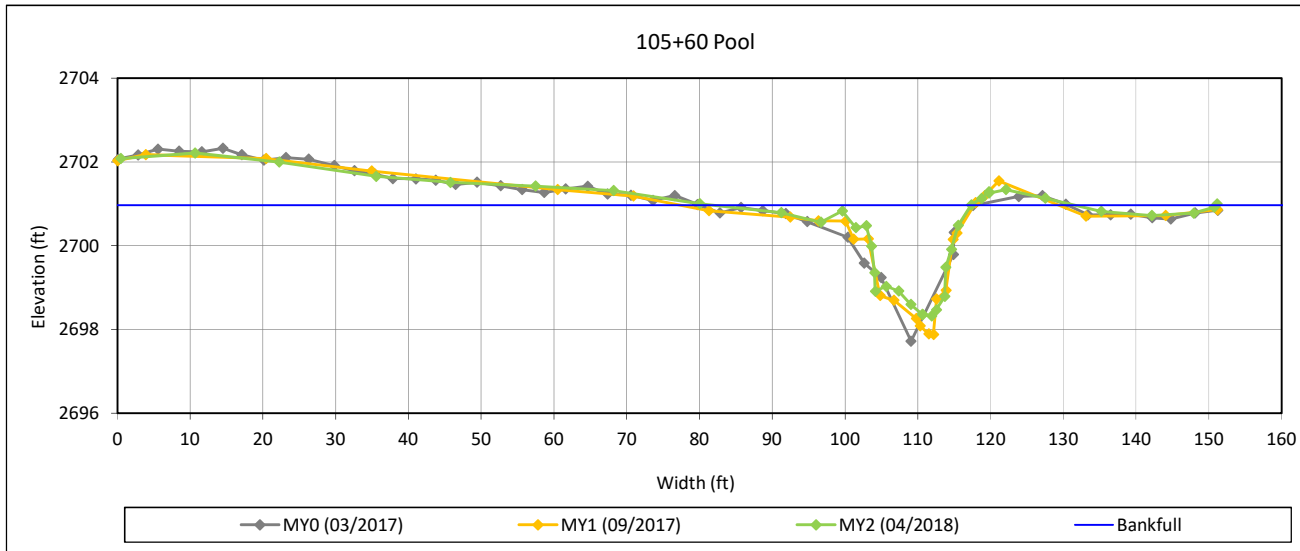
#### Cross-section 1 - Vile Creek Reach 1

29.2	x-section area (ft.sq.)
26.1	width (ft)
1.1	mean depth (ft)
2.7	max depth (ft)
28.0	wetted perimeter (ft)
1.0	hydraulic radius (ft)
23.3	width-depth ratio

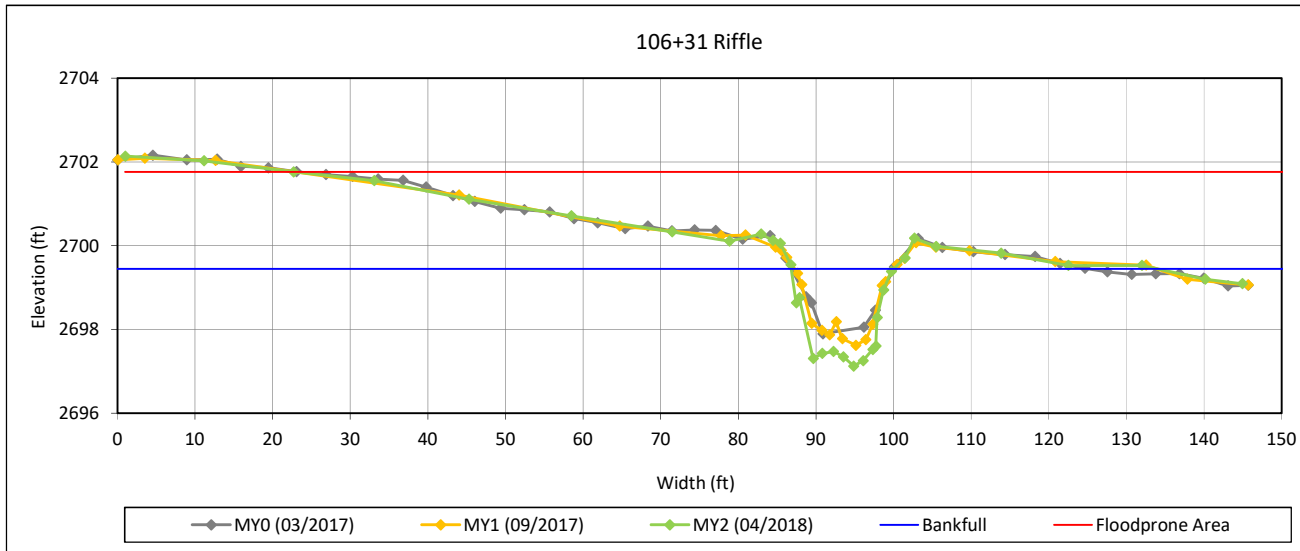
#### Cross-section 2 - Vile Creek Reach 1

21.2	x-section area (ft.sq.)
13.2	width (ft)
1.6	mean depth (ft)
2.3	max depth (ft)
15.1	wetted perimeter (ft)
1.4	hydraulic radius (ft)
8.2	width-depth ratio
143.9	W flood prone area (ft)
10.9	entrenchment ratio
1.3	low bank height ratio

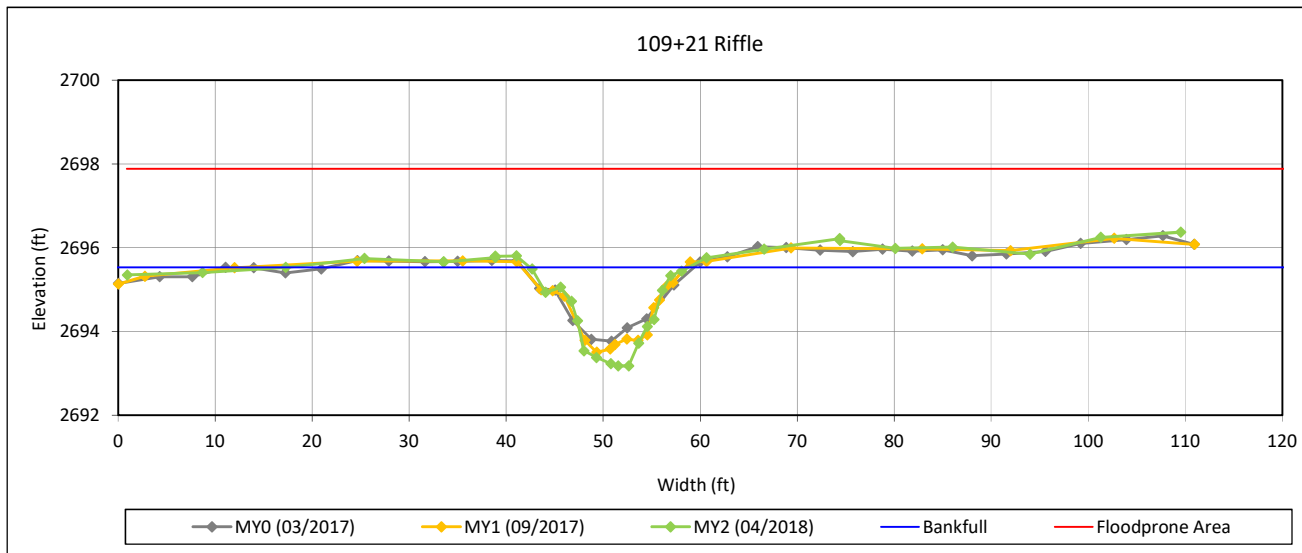
#### Cross-section 3 - Vile Creek Reach 1

19.8	x-section area (ft.sq.)
16.3	width (ft)
1.2	mean depth (ft)
2.4	max depth (ft)
17.6	wetted perimeter (ft)
1.1	hydraulic radius (ft)
13.5	width-depth ratio
108.6	W flood prone area (ft)
6.6	entrenchment ratio
1.1	low bank height ratio

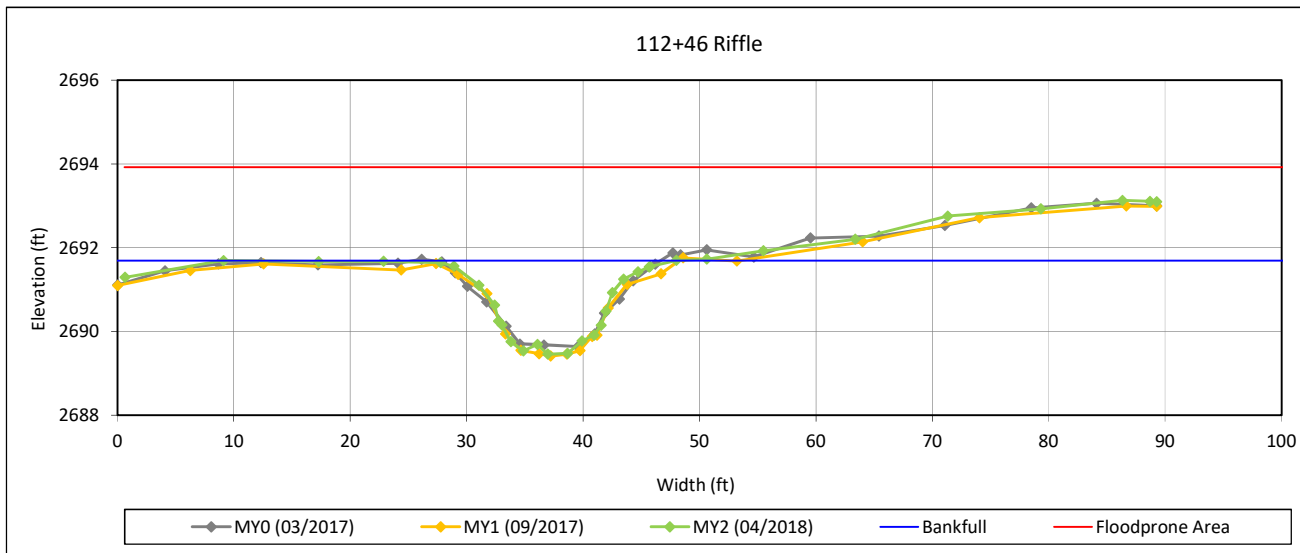
#### Cross-section 4 - Vile Creek Reach 2

22.5	x-section area (ft.sq.)
20.1	width (ft)
1.1	mean depth (ft)
2.2	max depth (ft)
21.0	wetted perimeter (ft)
1.1	hydraulic radius (ft)
18.0	width-depth ratio
88.6	W flood prone area (ft)
4.4	entrenchment ratio
1.0	low bank height ratio

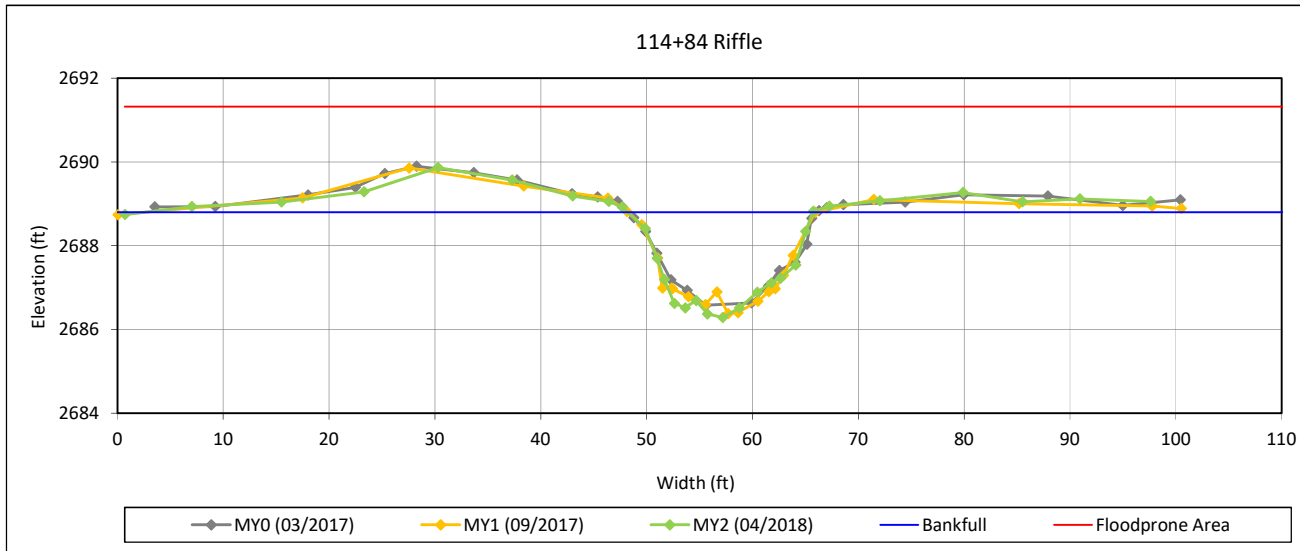
#### Cross-section 5 - Vile Creek Reach 2

28.6	x-section area (ft.sq.)
17.5	width (ft)
1.6	mean depth (ft)
2.5	max depth (ft)
18.7	wetted perimeter (ft)
1.5	hydraulic radius (ft)
10.7	width-depth ratio
96.9	W flood prone area (ft)
5.5	entrenchment ratio
1.1	low bank height ratio

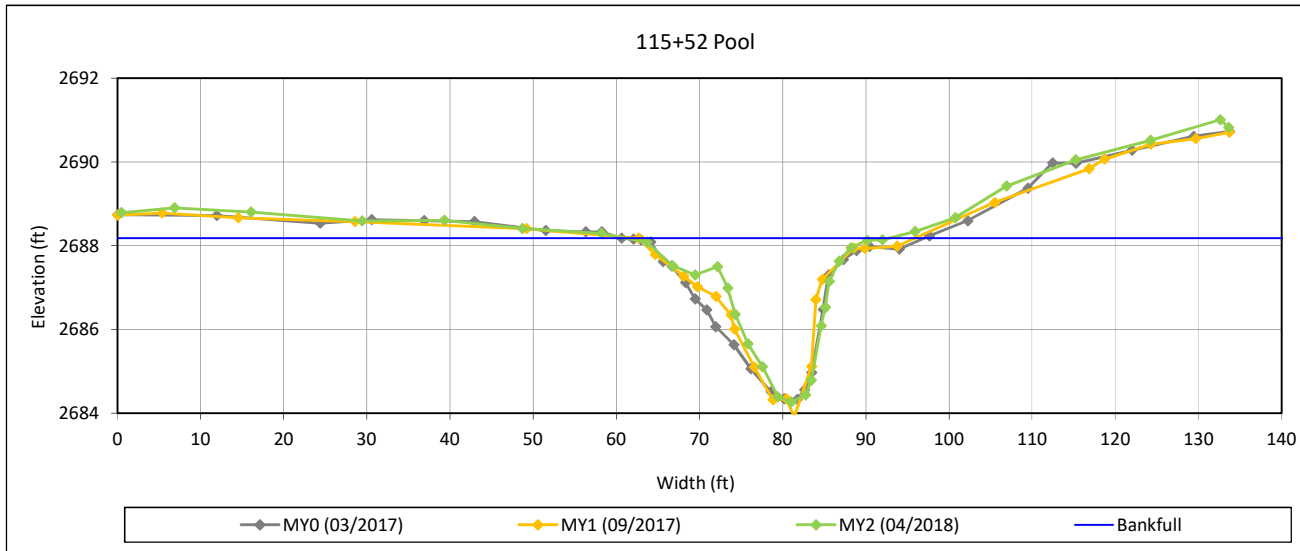
#### Cross-section 6 - Vile Creek Reach 2

44.3	x-section area (ft.sq.)
26.5	width (ft)
1.7	mean depth (ft)
3.9	max depth (ft)
28.5	wetted perimeter (ft)
1.6	hydraulic radius (ft)
15.9	width-depth ratio

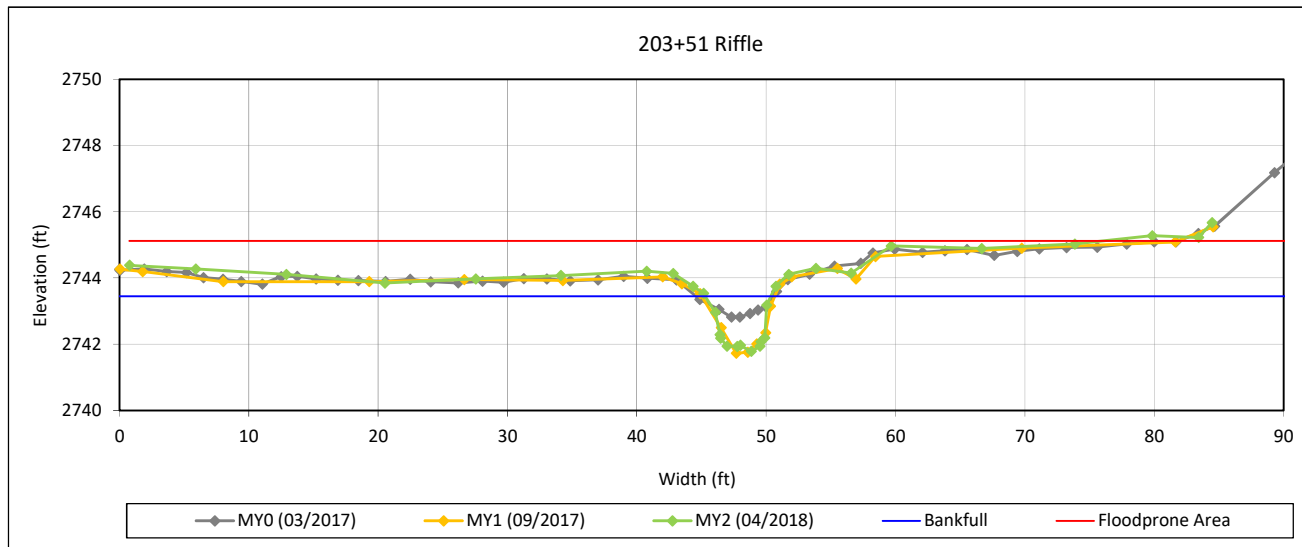
#### Cross-section 7 - UT1 Reach 1

5.9	x-section area (ft.sq.)
5.1	width (ft)
1.2	mean depth (ft)
1.7	max depth (ft)
6.9	wetted perimeter (ft)
0.9	hydraulic radius (ft)
4.4	width-depth ratio
83.7	W flood prone area (ft)
16.4	entrenchment ratio
1.3	low bank height ratio

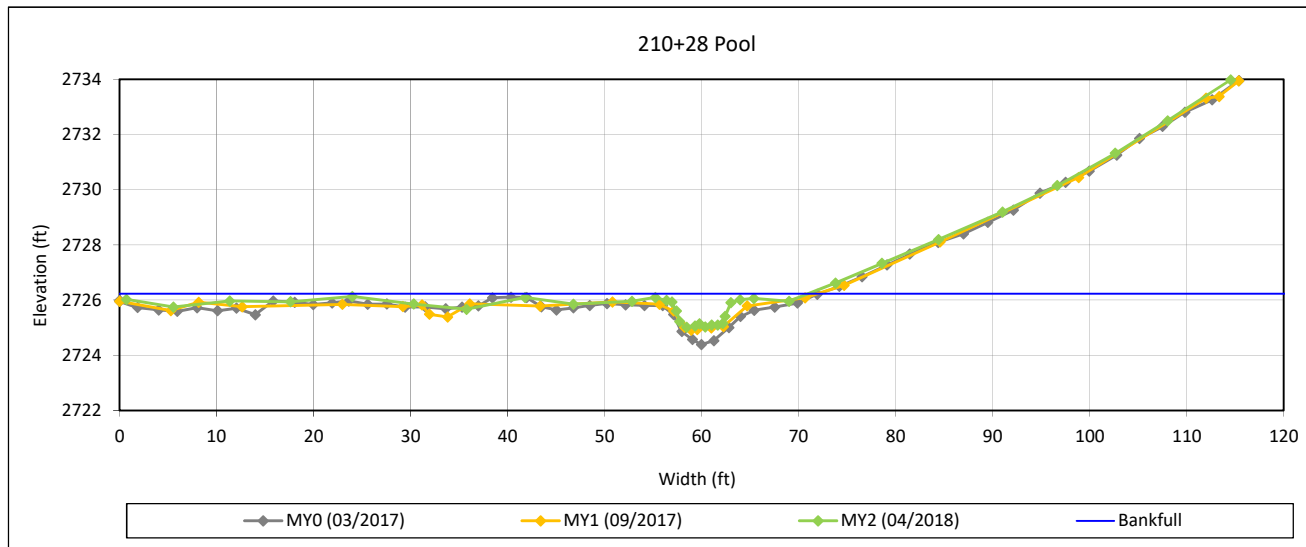
#### Cross-section 8 - UT1 Reach 1

7.1	x-section area (ft.sq.)
10.2	width (ft)
0.7	mean depth (ft)
1.2	max depth (ft)
10.8	wetted perimeter (ft)
0.7	hydraulic radius (ft)
14.6	width-depth ratio

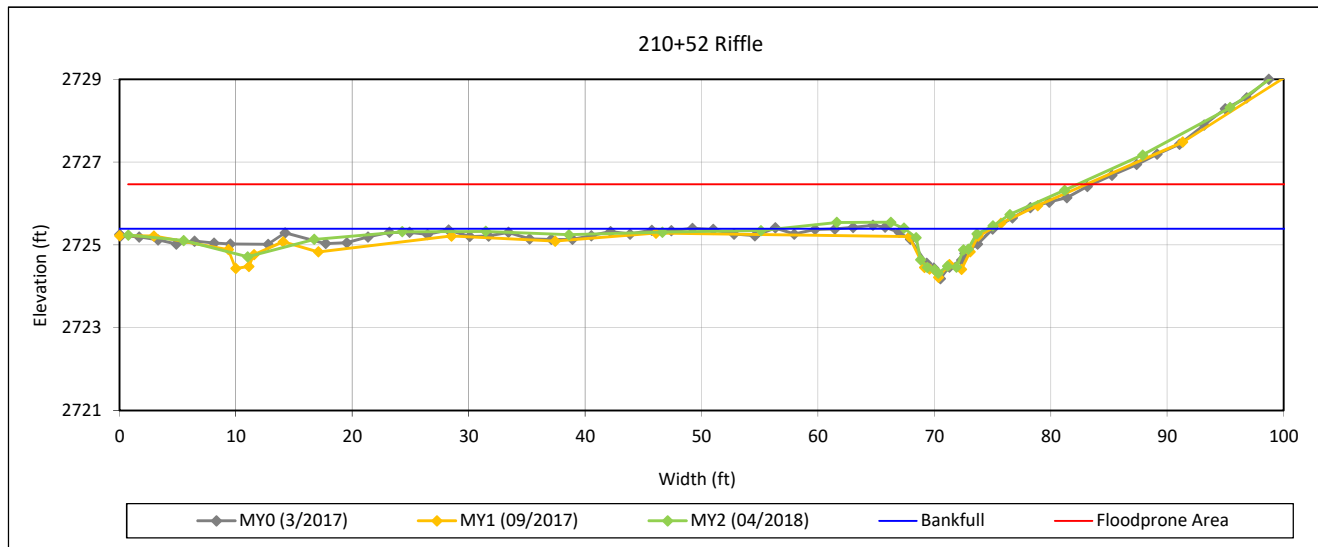
#### Cross-section 9 - UT1 Reach 1

4.1	x-section area (ft.sq.)
7.1	width (ft)
0.6	mean depth (ft)
1.1	max depth (ft)
7.7	wetted perimeter (ft)
0.5	hydraulic radius (ft)
12.2	width-depth ratio
80.2	W flood prone area (ft)
11.3	entrenchment ratio
0.9	low bank height ratio

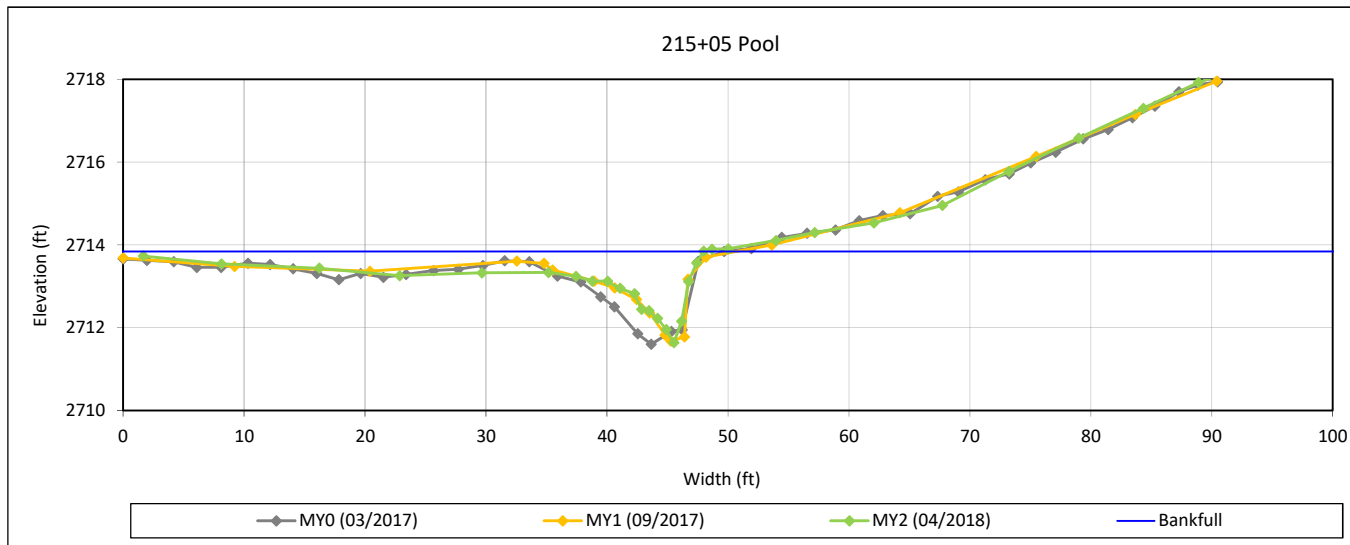
#### Cross-section 10 - UT1 Reach 2

12.6	x-section area (ft.sq.)
12.8	width (ft)
1.0	mean depth (ft)
2.2	max depth (ft)
14.0	wetted perimeter (ft)
0.9	hydraulic radius (ft)
13.0	width-depth ratio

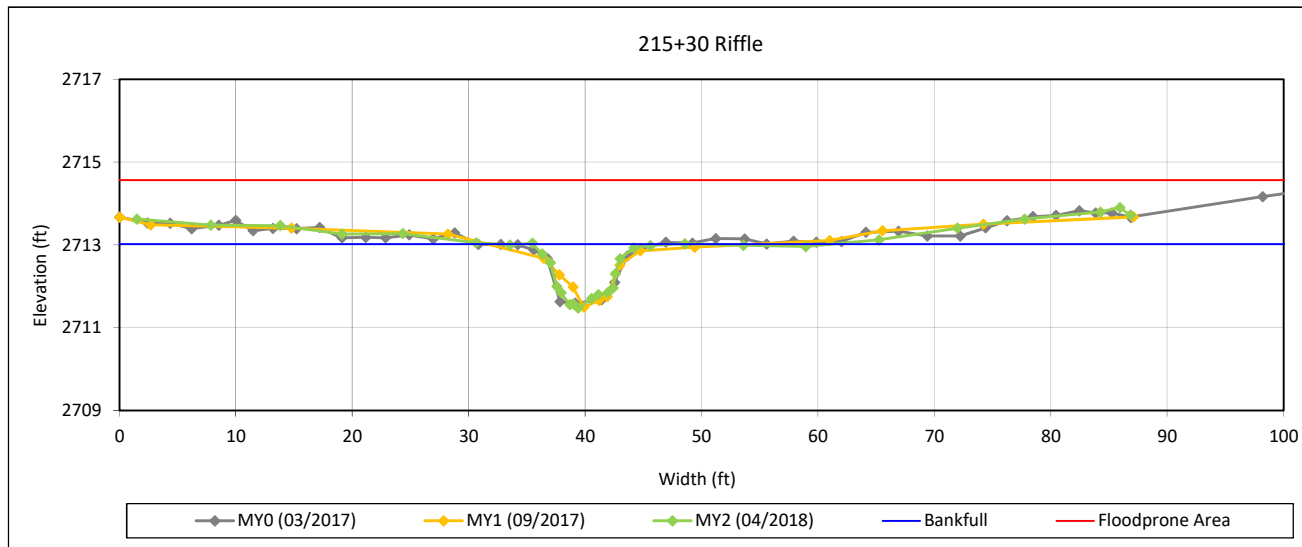
#### Cross-section 11 - UT1 Reach 2

7.8	x-section area (ft.sq.)
10.1	width (ft)
0.8	mean depth (ft)
1.5	max depth (ft)
10.9	wetted perimeter (ft)
0.7	hydraulic radius (ft)
13.0	width-depth ratio
85.3	W flood prone area (ft)
8.5	entrenchment ratio
0.9	low bank height ratio
