MONITORING YEAR 4 ANNUAL REPORT

VILE CREEK MITIGATION SITE

Alleghany County, NC
DEQ Contract No. 5999
DMS Project No. 96582

Data Collection Period: April – November 2020
Submission Date: January 19, 2021

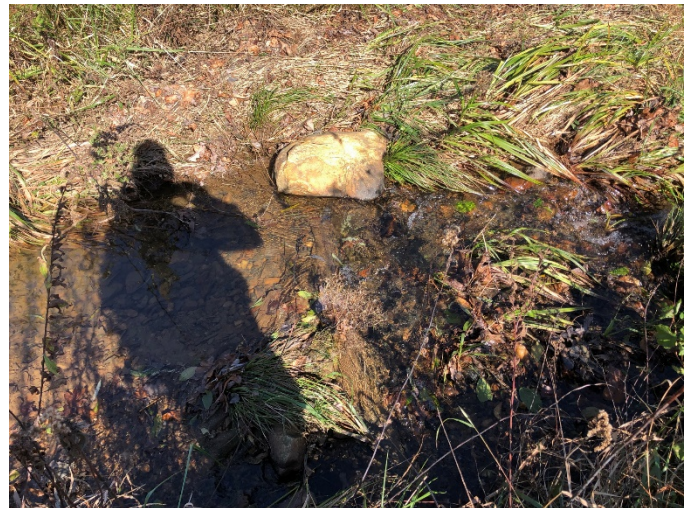
Photo 5 – Vile Creek R2: Station 122+80-123+00 – Bank scour. 11-6-2020

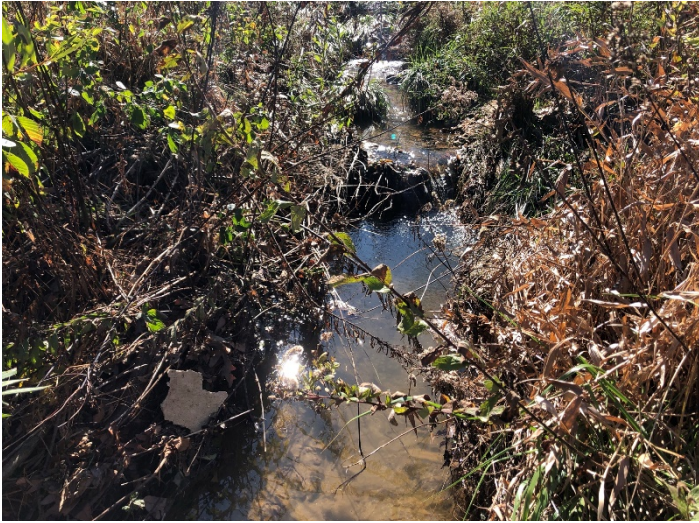
Photo 6 – UT1 R1: Station 204+90 – Structure missing. 11-6-2020

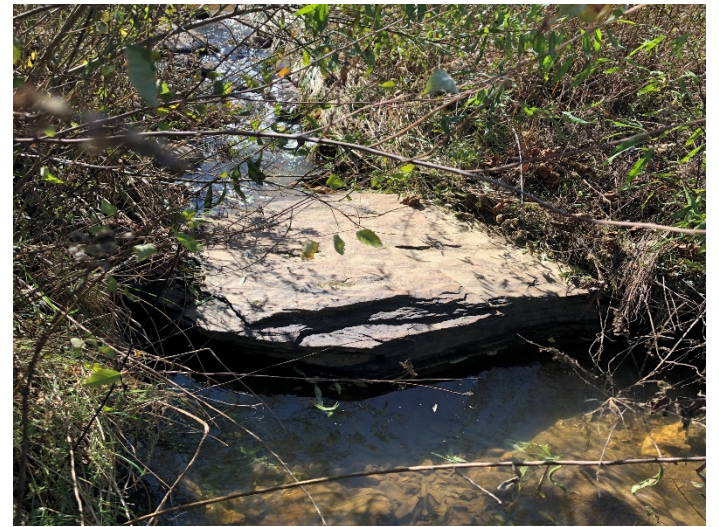
Photo 9 – UT1 R1: Station 206+40 – 206+60 – Bank Scour 11-6-2020

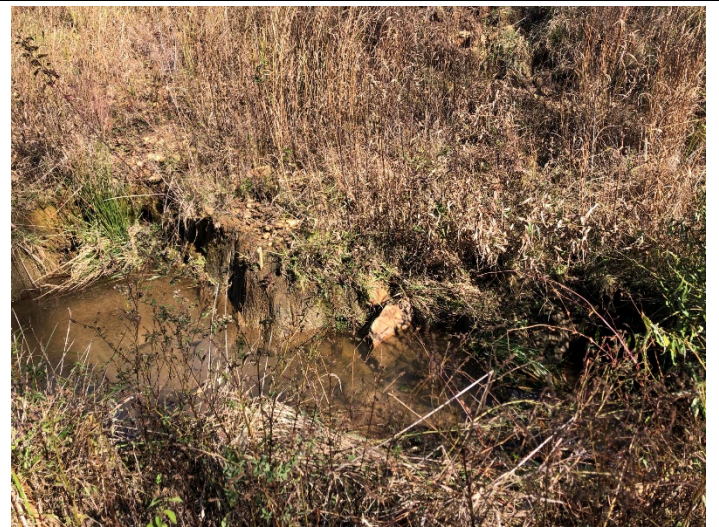
Photo 11 – UT2: Station 305+00 – 305+50 – Bank scour. 11-6-2020

The headcut at the intake of the BMP located at the top of UT2 was repaired with hand tools and live stakes in March of 2020. The live stakes have started taking root; however, further repairs will be needed to fix the headcut. In addition, a large undercut bank was repaired with live brush on UT2 at station 306+30. These repairs will be further evaluated during MY5 site walks.

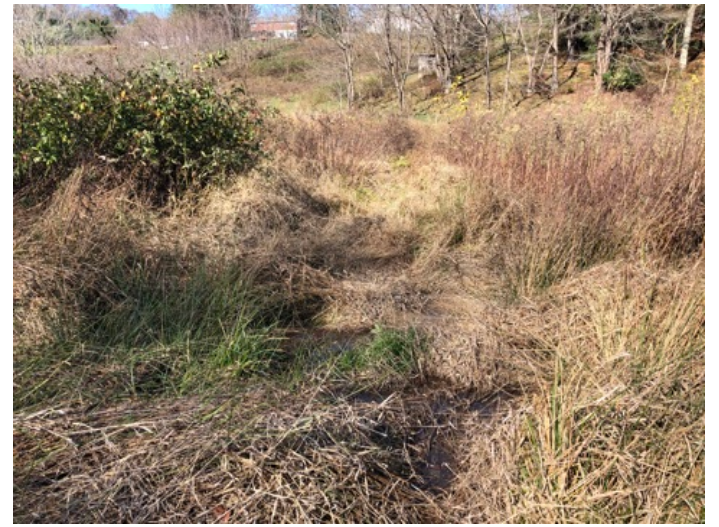
Photo 15 – UT1B: Stream aggradation. 11-6-2020
