**Horse Creek Stream Restoration
Mitigation Plan (Baseline Monitoring)
Wake County, North Carolina**

**North Carolina Department of Environment and Natural Resources
Ecosystem Enhancement Program**

August 14, 2006

**NCEEP Project # 182
Dewberry Project # 02050**

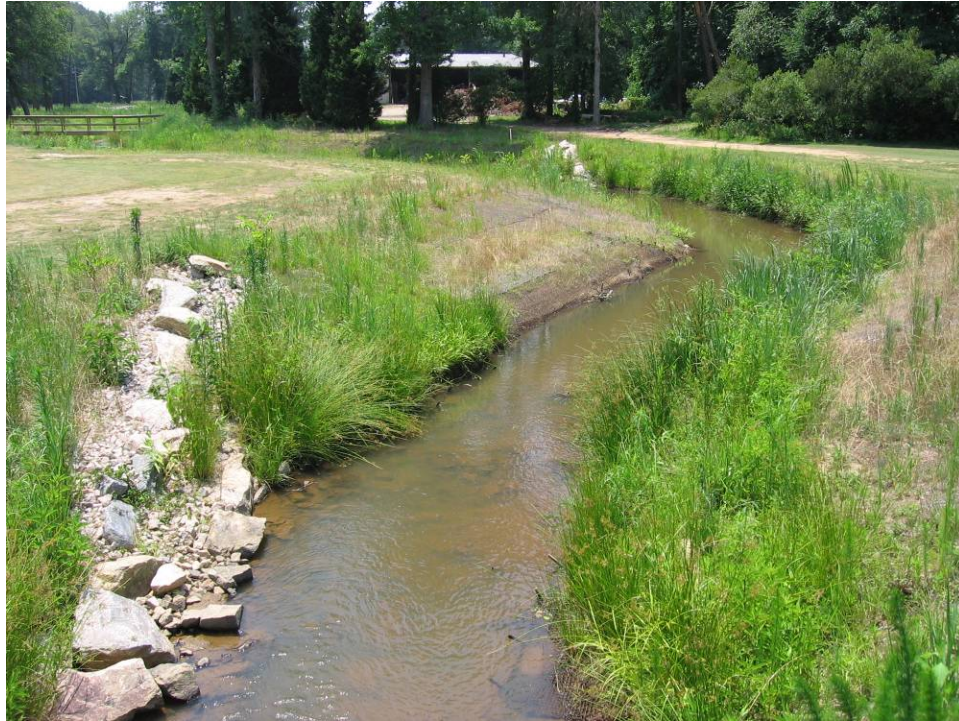
Photo 5: Vegetative Problem Area c, 4+00 – 4+50 (0788 – Left Bank) 06/22/05

Problem: Bare Bank

Probable Cause: Cause undetermined

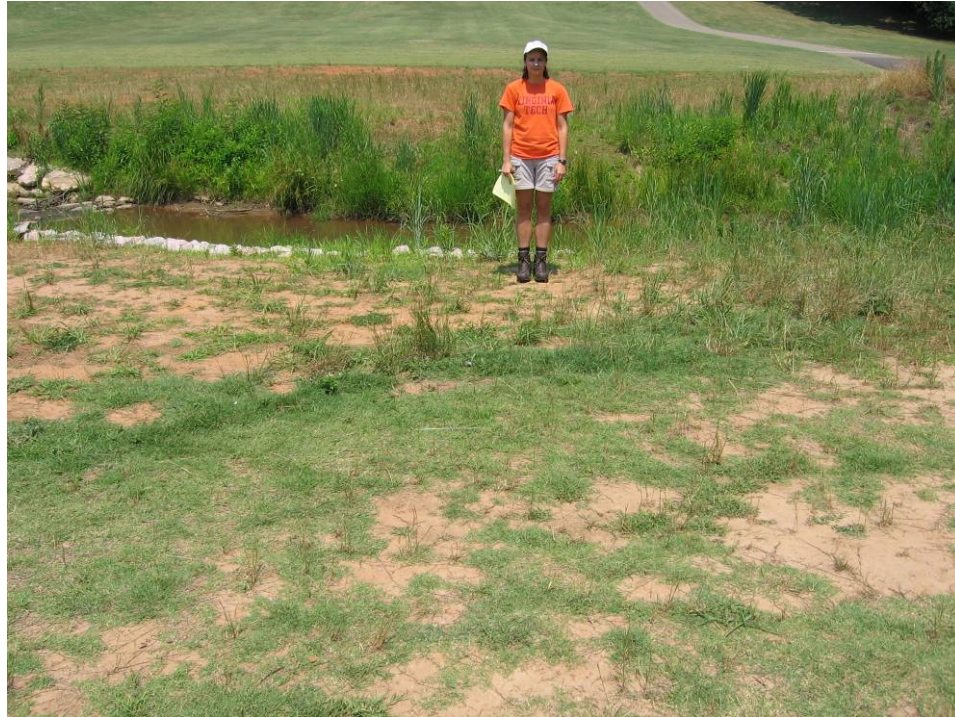
Photo 6: Vegetative Problem Area a, 0+80 – 1+40 (0780 – Left Bank) 06/22/05

Problem: Bare Floodplain
Probable Cause: Possible land owner maintenance.

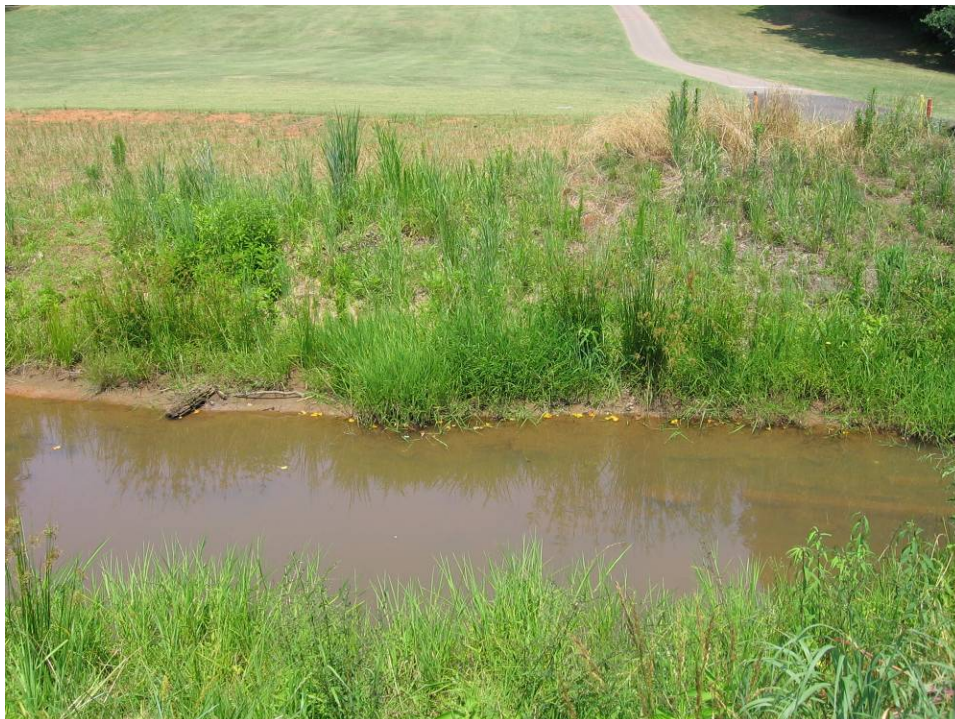
Photo 7: Vegetative Problem Area b, 0+80 – 1+40 (0783 – Right Bank) 06/22/05

Problem: Bare Floodplain
Probable Cause: Possible land owner maintenance.

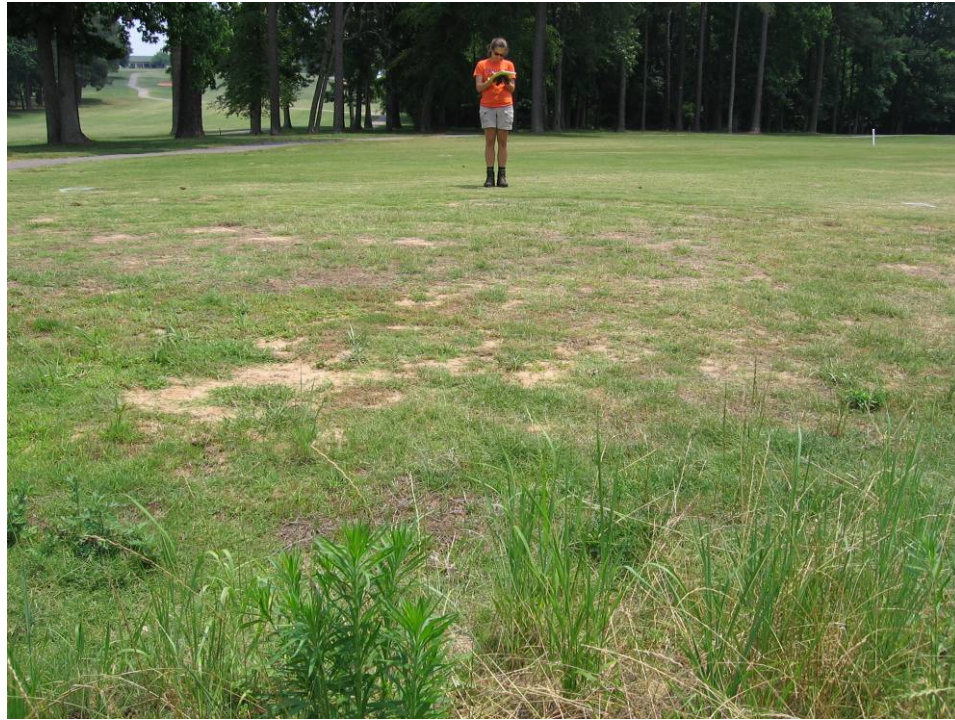
Photo 8: Vegetative Problem Area d, 5+80 – 8+00 (0791 – Left Bank) 06/22/05

Problem: Bare Floodplain
Probable Cause: Possible land owner maintenance.

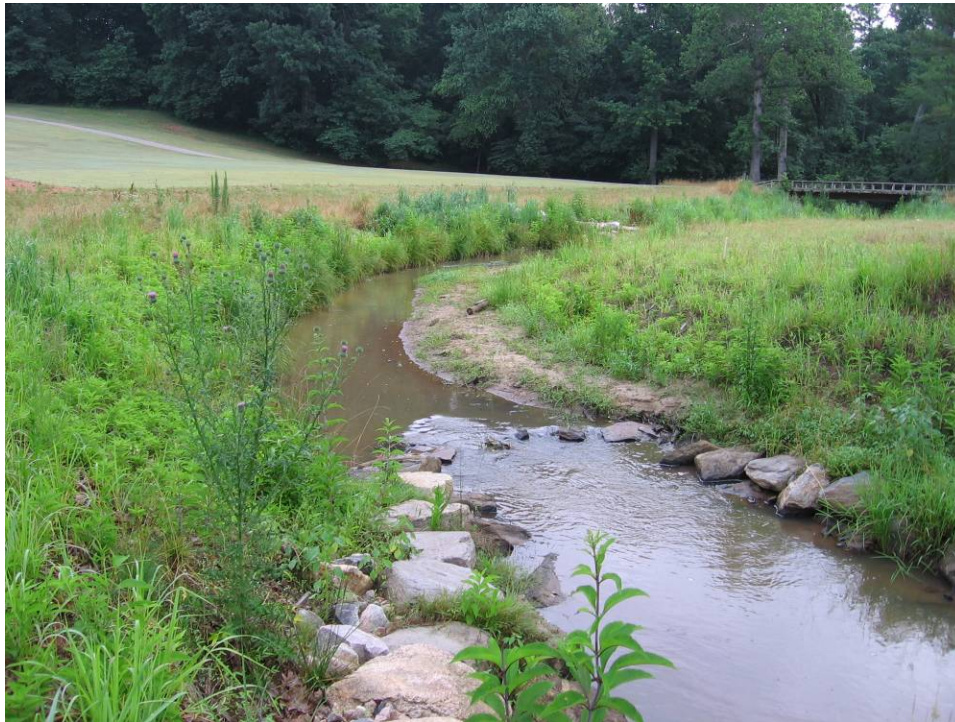
Photo 9: Vegetative Problem Area e: 5+00 – 6+00 (0875 – Right Bank) 06/22/05

Problem: Bare Floodplain
Probable Cause: Possible land owner maintenance.
Comment: Approximately 15 ft is unmowed.

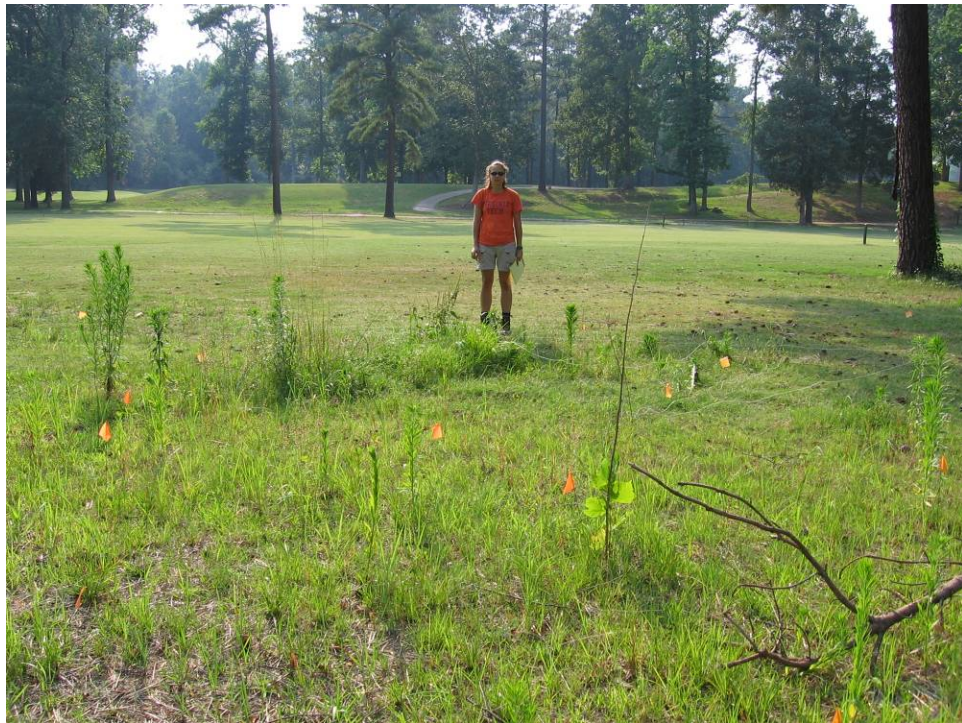
Photo 10: Vegetative Problem Area f, 14+00 – 17+00 (0813 – Right Bank) 06/22/05

Problem: Bare Floodplain
Probable Cause: Possible land owner maintenance.
Comment: Vegetation Planted on 2 ft spacing and mowed around.

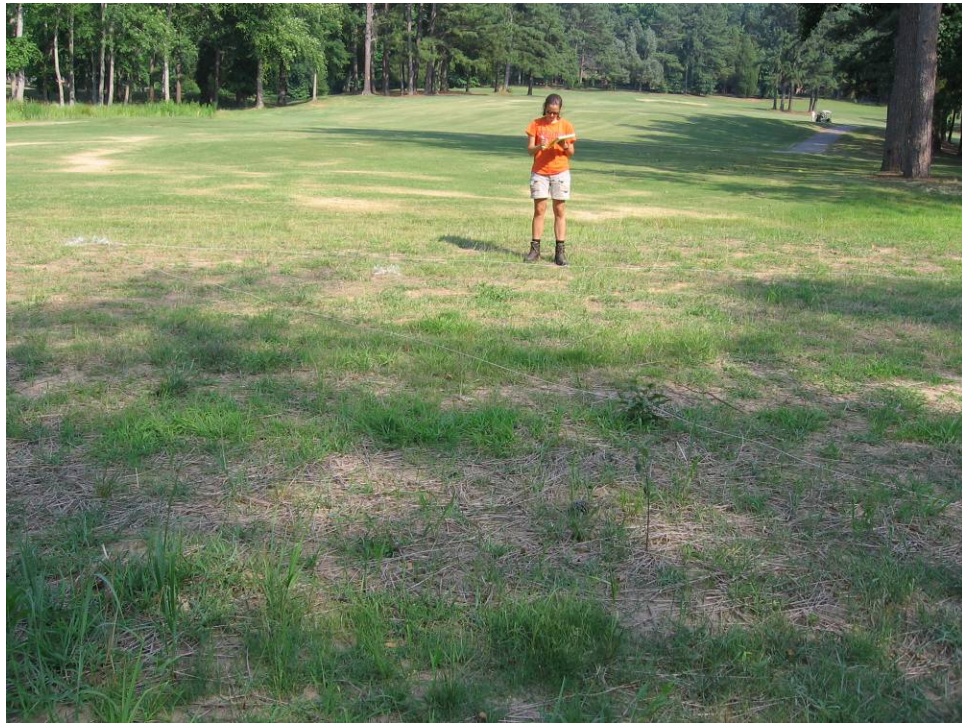
Photo 11: Vegetative Problem Area g, 14+00 – 15+00 (0811 – Left Bank) 06/22/05

Problem: Bare Floodplain
Probable Cause: Possible land owner maintenance.

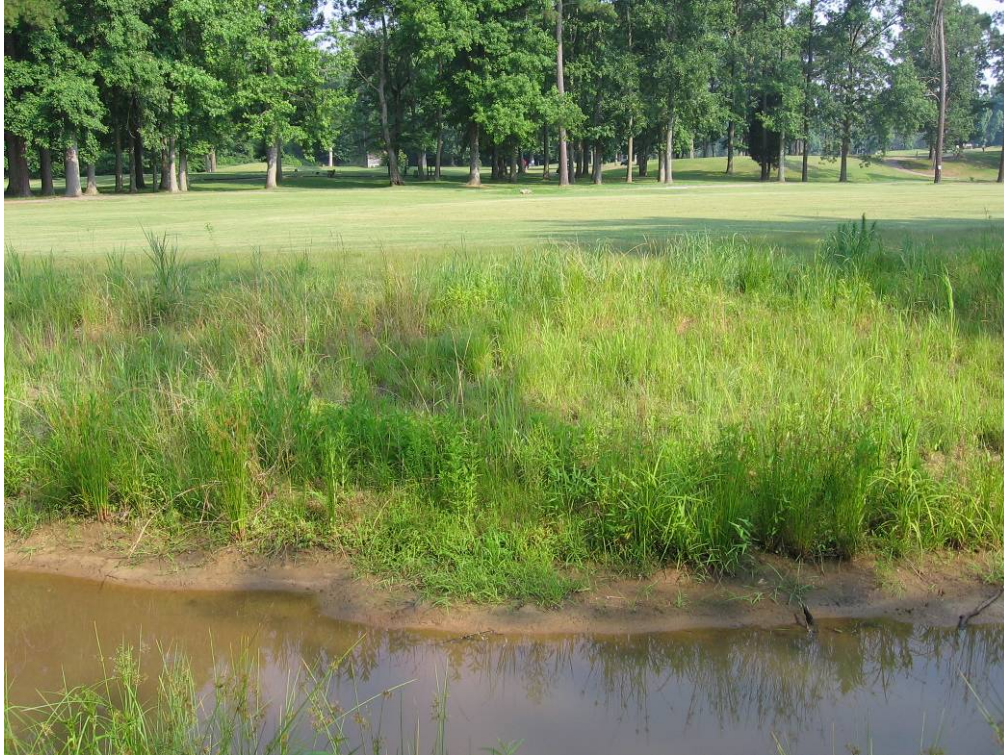
Photo 12: Vegetative Problem Area h, 17+00 – 20+50 (0832 – Right Bank) 06/22/05

Problem: Bare Floodplain
Probable Cause: Possible land owner maintenance.

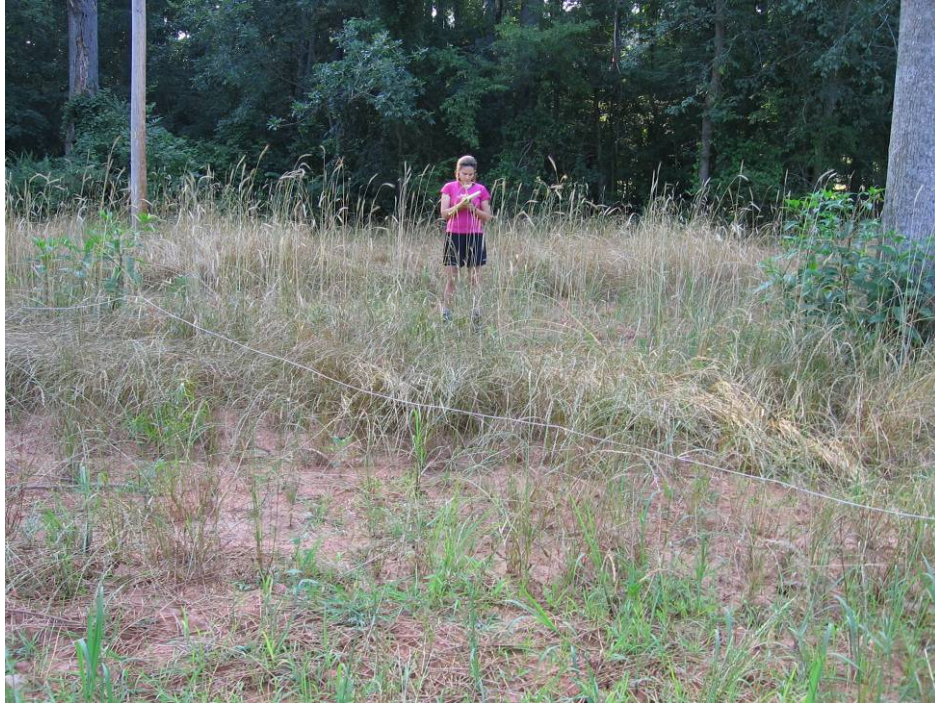
Photo 13: Vegetative Problem Area i, 22+50 – 23+80 (0819 – Left Bank) 06/22/05

Problem: Bare Floodplain

Probable Cause: Does not appear to be maintained or suffer from predation. Lack of sun and water not deemed to be issues. Possible soil deficiencies.

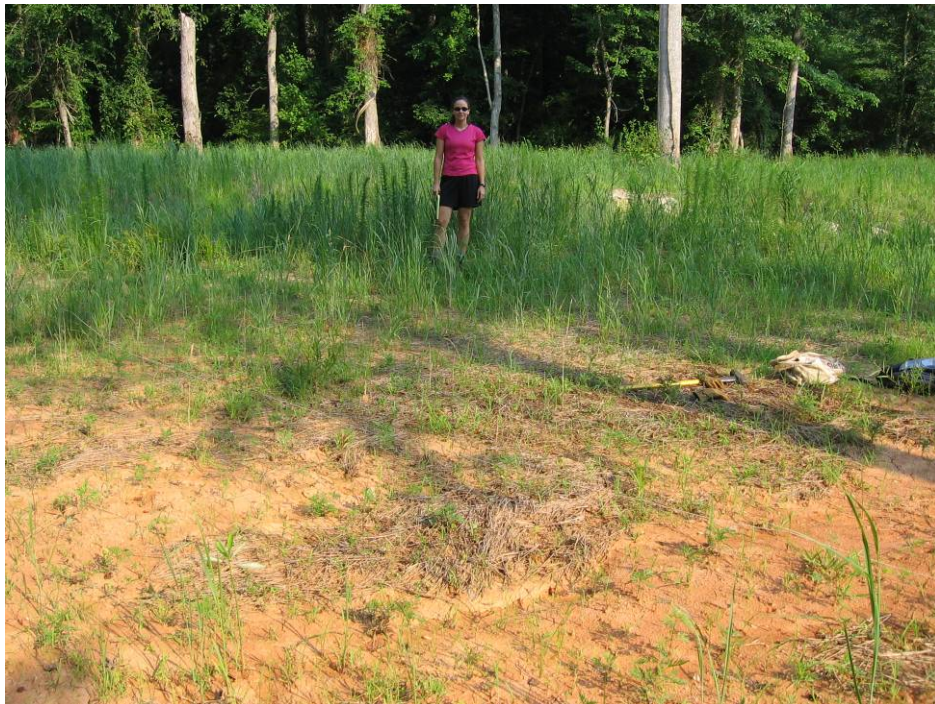
Photo 14: Vegetative Problem Area j, 25+50 – 26+50 (0822 – Left Bank) 06/22/05

Problem: Bare Floodplain

Probable Cause: Does not appear to be maintained or suffer from predation. Lack of sun and water not deemed to be issues. Possible soil deficiencies.

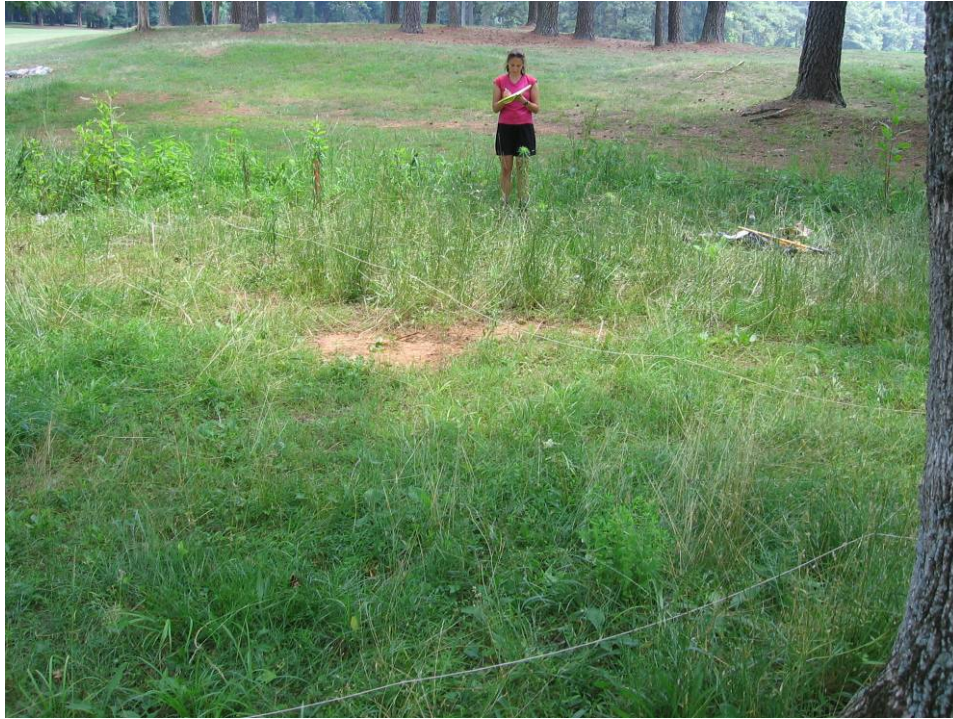
Photo 15: Vegetative Problem Area k, 0+80 – 2+00 UT (0848–Right Bank) 06/22/05

Problem: Bare Floodplain

Probable Cause: Lack of planted species, abundance of volunteer species.

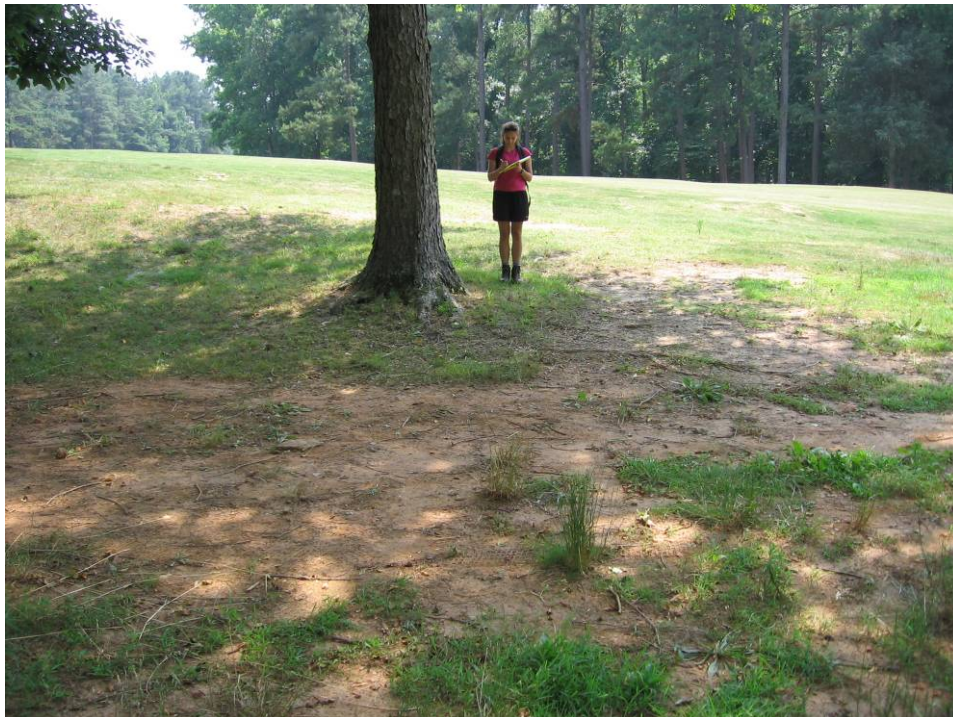
Photo 16: Vegetative Problem Area l, 1+50 – 2+50 UT (Left Bank) 06/22/05

Problem: Bare Floodplain

Probable Cause: Possible lack of sunlight. Possible land owner maintenance.

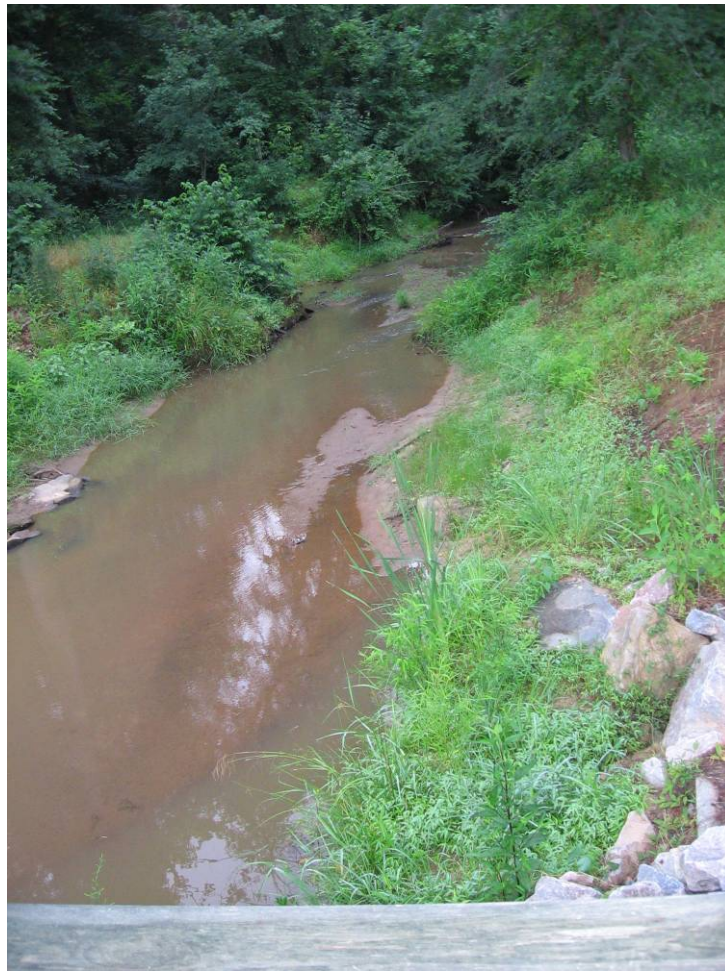
Photo 53: Problem Area I, 0+20 (0868 - Looking upstream) 06/22/05

Category: Problem Area.

Problem: Sedimentation.

Probable Cause: Upstream sub-development construction has increased the sediment supply of the stream temporarily.

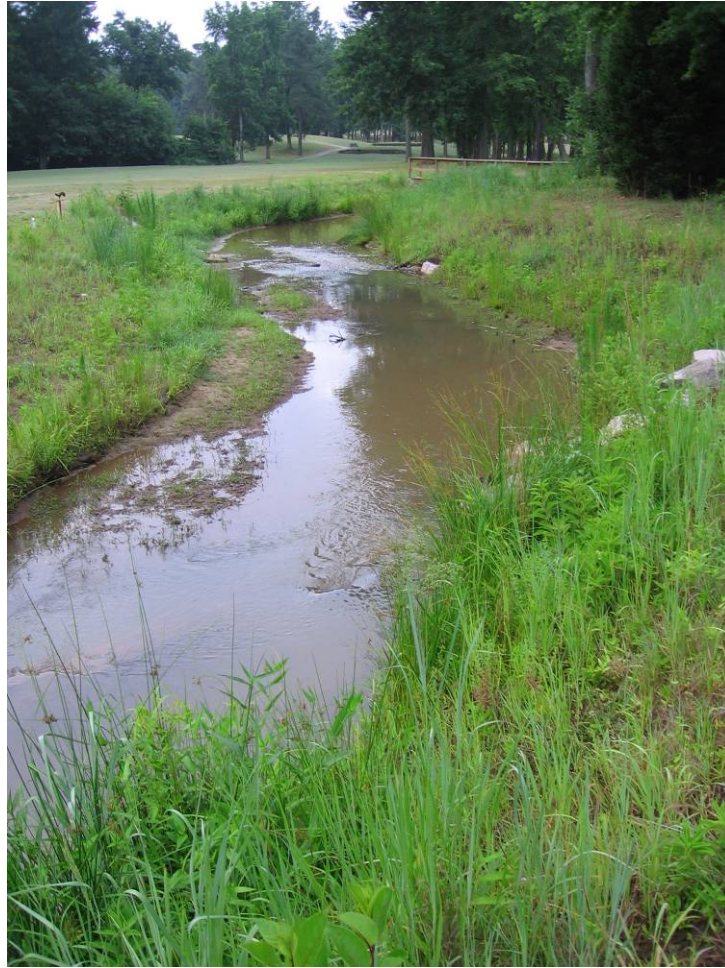
Photo 54: Problem Area II, 7+50 (0873 - Looking downstream) 06/22/05

Category: Problem Area.

Problem: Flow directed too close to the right bank (in the foreground) and as a result, bouncing off the bank, and being directed too close to the left bank (in the background of the photo). The shift in the thalweg is creating the formation of a mid-channel bar that is quickly gathering vegetation.

Probable Cause: The upstream rock-vane is not turning the flow enough to keep it off of the outside of the meander bend. The additional rock, placed as toe protection is helping to bounce the flow to the opposite bank, duplicating the problem of flow direction immediately downstream as well.

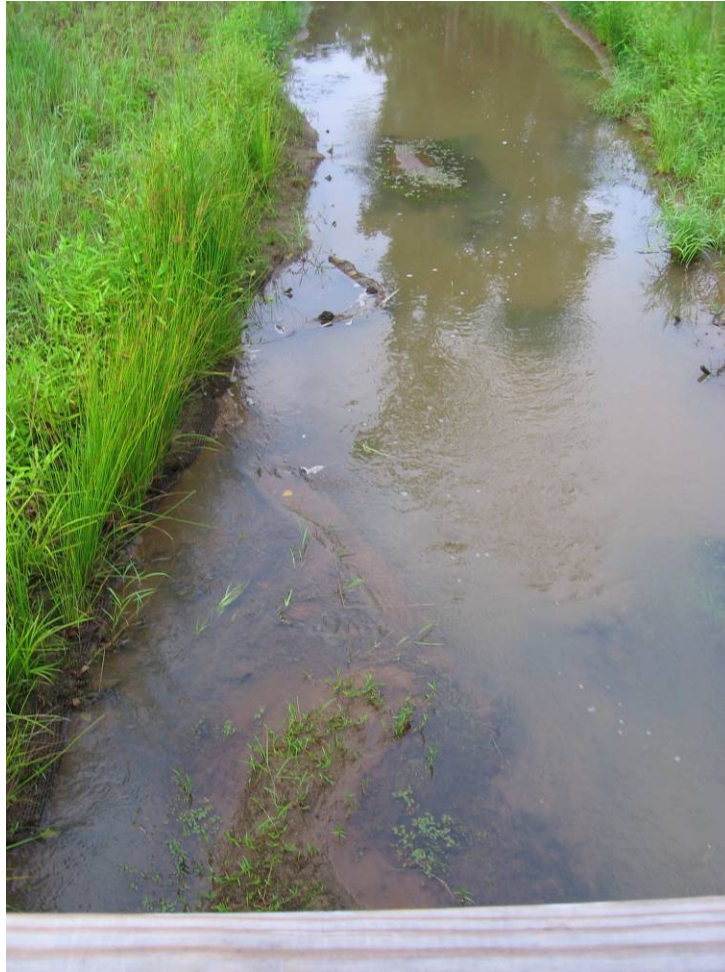
Photo 55: Problem Area III, 8+50 (0882 - Looking downstream) 06/22/05

Category: Area of Concern.

Problem: Beginning formation of vegetated mid-channel bars.

Probable Cause: The structure above the walking bridge is poorly formed and adversely affects flow vectors. Additionally, the woody debris downstream of the bridge and structure is also negatively influencing flow and aiding in the formation of the mid-channel bars. The vegetation appears to be maintaining an appropriate width at this point. Future monitoring visits should determine if the bars are able to gain enough mass to cause diversion of the flow.

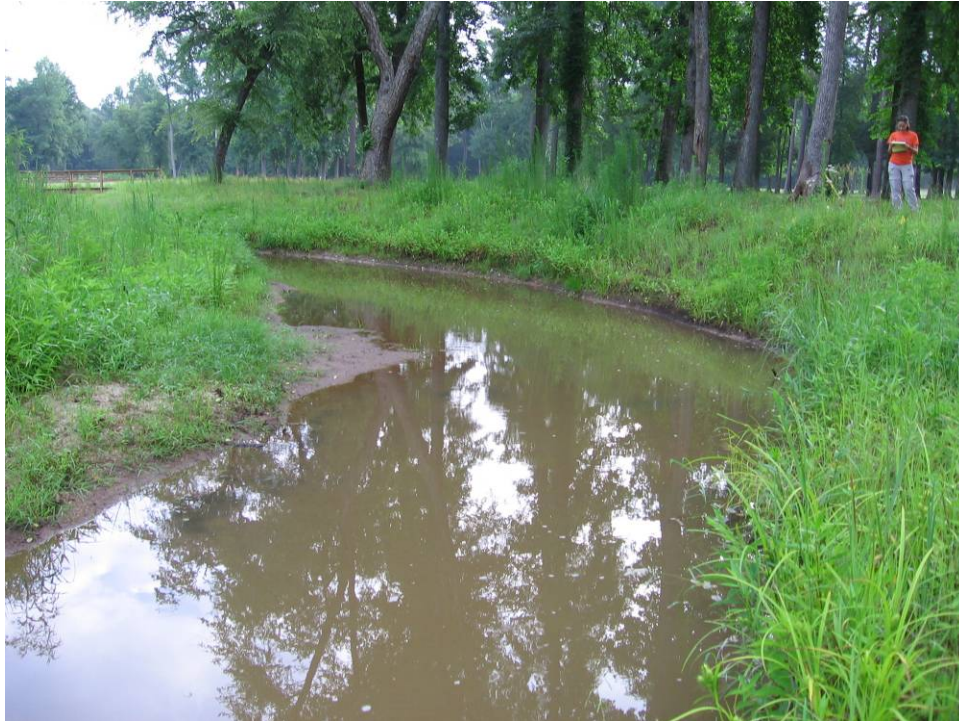
Photo 56: Problem Area IV, 10+00 (0885 - Looking upstream) 06/22/05

Category: Area of Concern.

Problem: Elongation of point-bar and mild undercutting of outside of bend signaling possible lateral migration of meander bend.

Probable Cause: The flow is not being turned enough (there is nothing artificial in place to force the turn) therefore it is creating undue stress on the outside of the bend. If the bend migrates significantly, causing bank erosion on the outside of the bend this will become a problem area. Conversely, if the migration is minimal and the vegetation protects the outside of the bend than this area will no longer be of a concern.

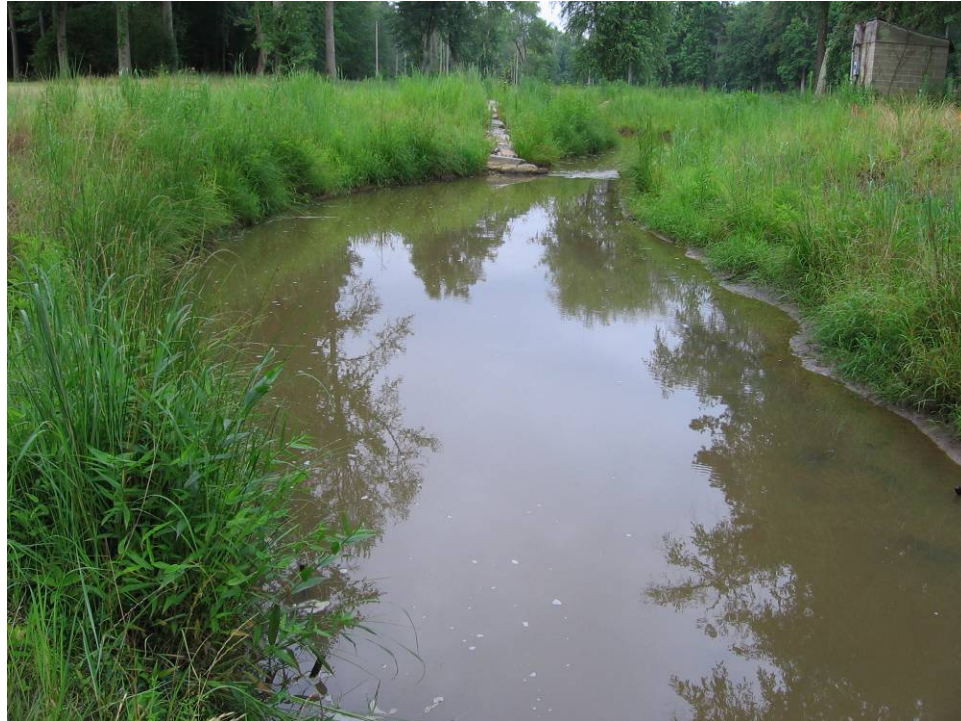
Photo 57: Problem Area V, 13+80 (0893 - Looking downstream) 06/22/05

Category: Area of Difference.

Problem: Channel has developed a pool that is much wider than the design pool.

Probable Cause: Bank failure, possibly due to slow establishment of vegetation, on the outside of the meander bend. Point-bar has not migrated and vegetation appears to have stabilized banks, so at this point in time there does not seem to be any lateral migration. Currently, the vegetation appears to have stabilized the pool; therefore, this pool is being treated as a feature experiencing natural variation and has not generated any cause for concern. This feature is denoted only because it differs from the design and will not be photographed in the future unless it shows signs of moving towards instability.

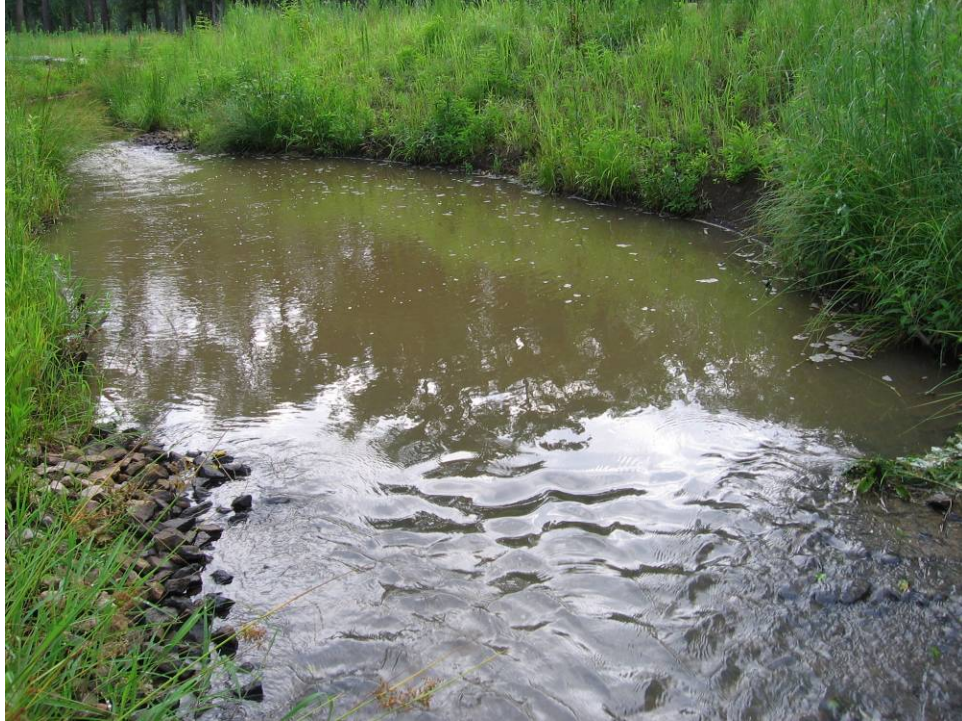
Photo 58: Problem Area VI, 15+40 (0898 - Looking upstream) 06/22/05

Category: Area of Difference.

Problem: Channel has developed a pool that is much wider than the design pool.

Probable Cause: Bank failure, possibly due to slow establishment of vegetation, on the right bank.

Vegetation appears to have stabilized banks, so at this point in time there does not seem to be any lateral migration occurring. Currently, the vegetation appears to have stabilized the pool; therefore, this pool is being treated as a feature experiencing natural variation and has not generated any cause for concern. This feature is denoted only because it differs from the design and will not be photographed in the future unless it shows signs of moving towards instability.

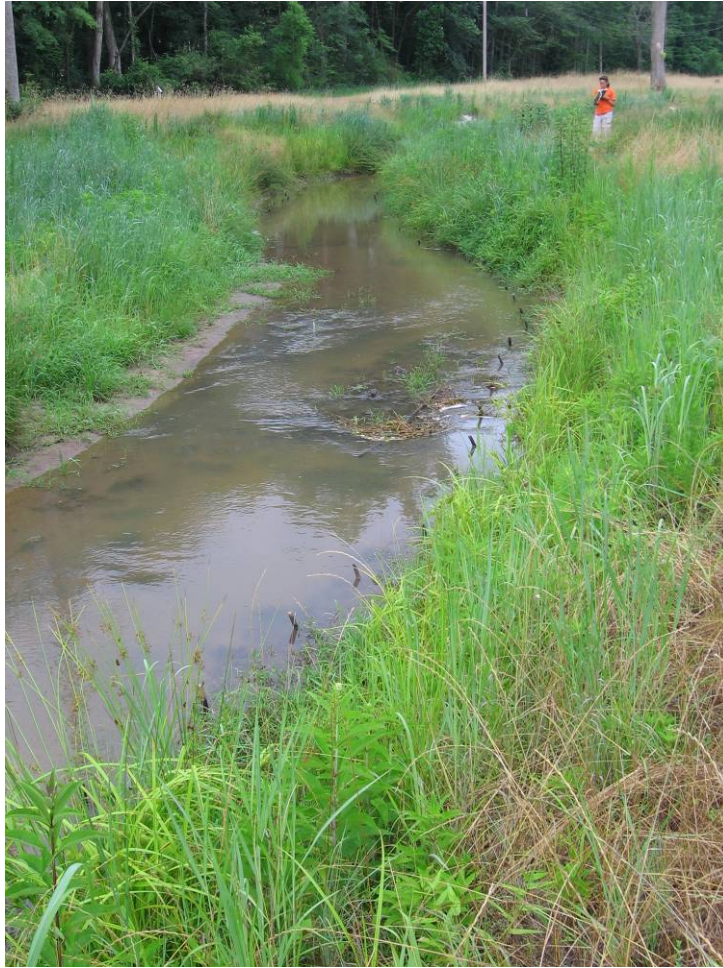
Photo 59: Problem Area VII, 21+20 (0908 - Looking downstream) 06/22/05

Category: Area of Concern.

Problem: Formation of vegetated mid-channel bars and consequently flow vector modification.

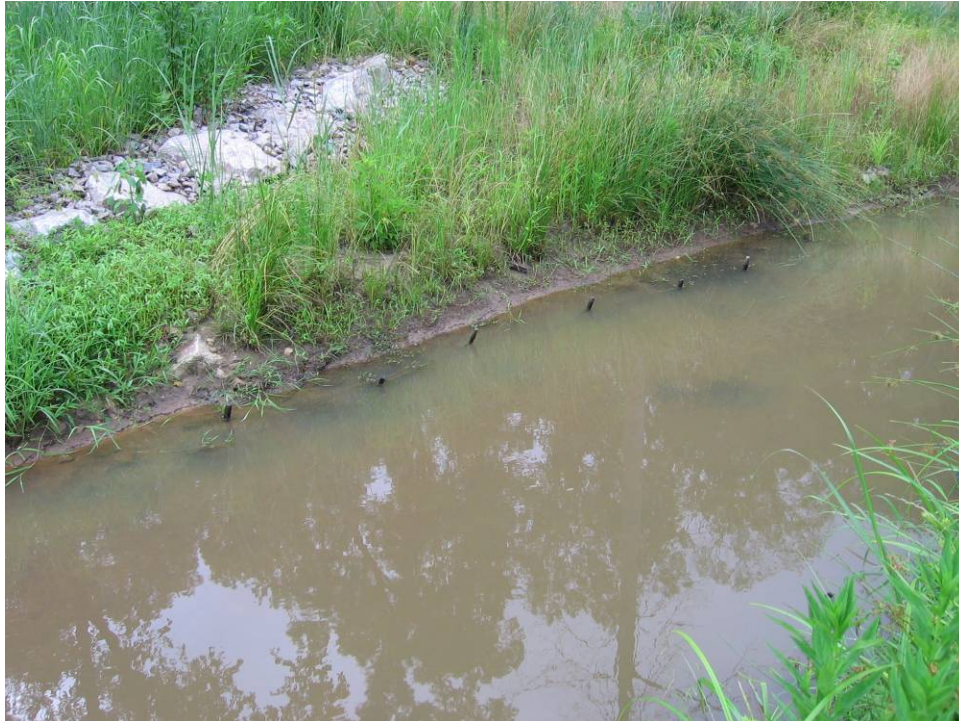
Photo 60: Problem Area VIII, 22+00 (0909 – From Right Bank) 06/22/05

Category: Area of Concern.

Problem: Undercutting of left bank immediately downstream of Rock-Vane.
