**HORSE CREEK STREAM RESTORATION
MONITORING REPORT
EEP Project No. 71082
Monitoring Year – 01
2006**

September 2006

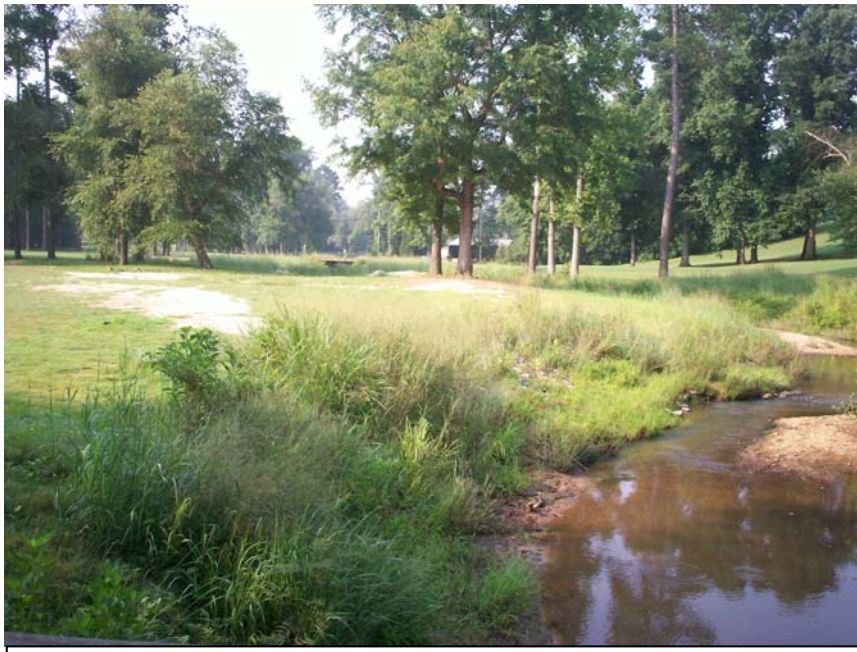
VPA 2: Vegetative Problem Area "i" 22+00 – 22+50

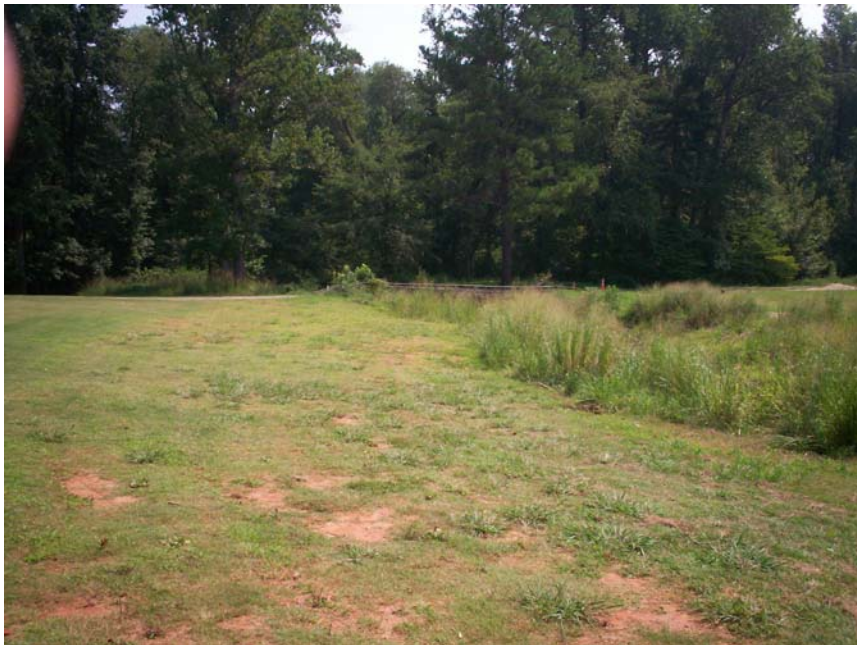
VPA 3: Vegetative Problem Area "a" 0+80 – 3+50

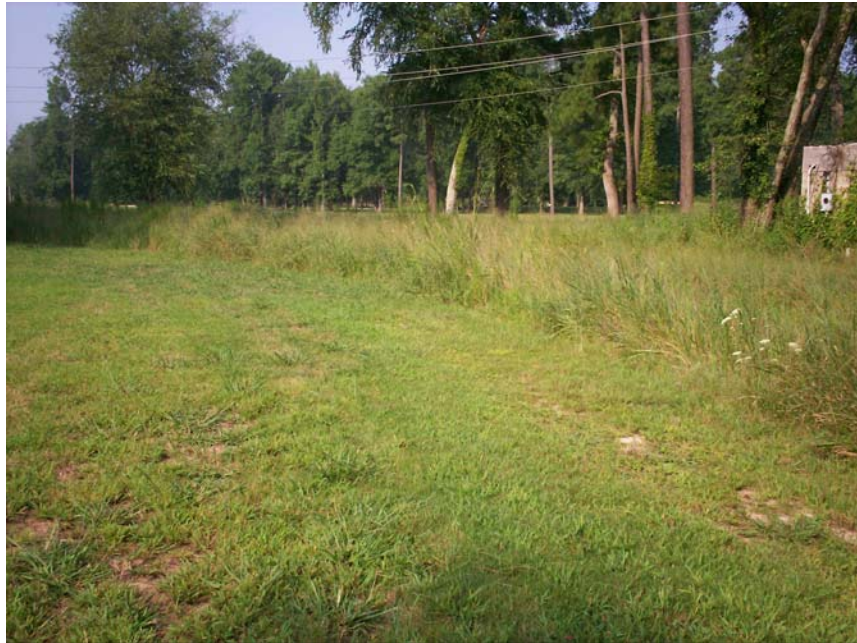
VPA 8: Vegetative Problem Area "f" 12+50 – 16+50

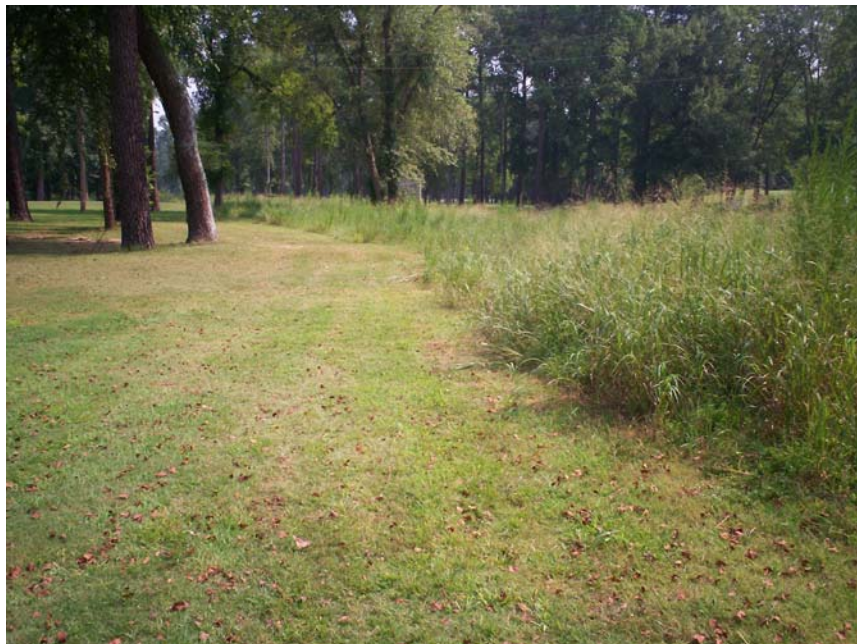
VPA 9: Vegetative Problem Area "g" 13+50 – 15+30

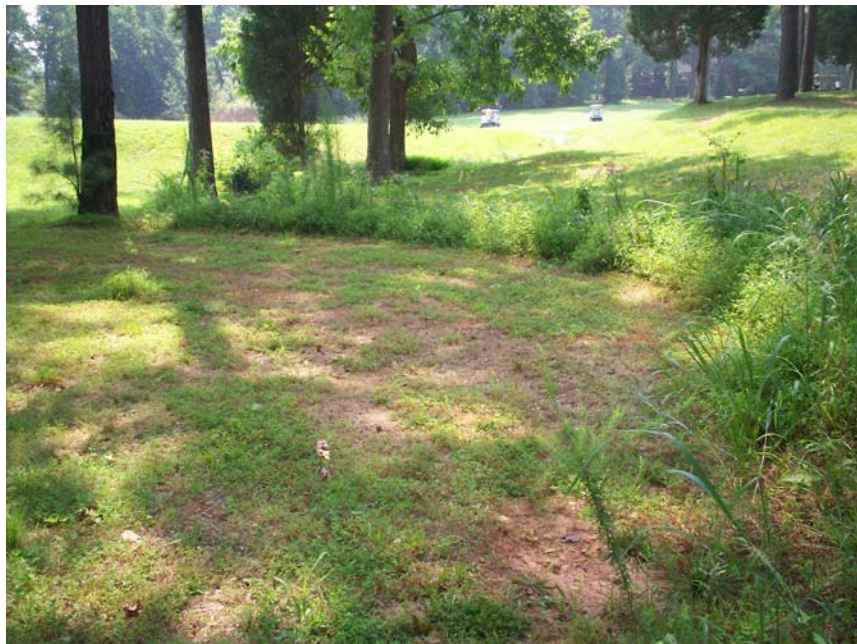
VPA 13: Vegetative Problem Area "k" throughout UT

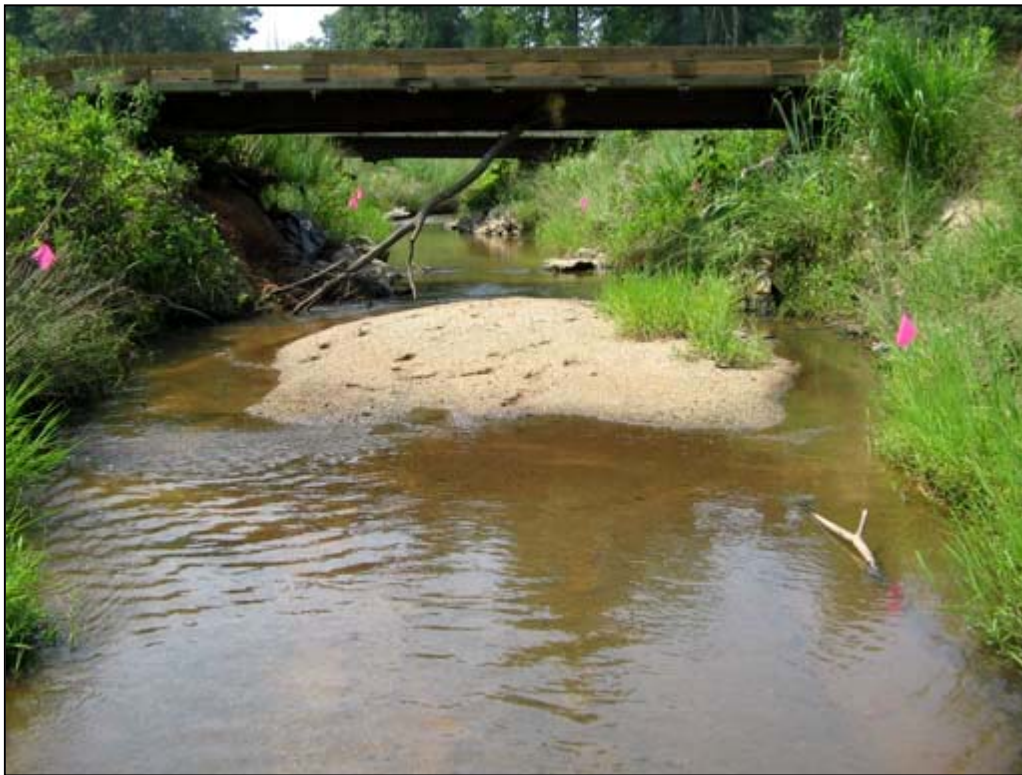
Photograph SPA-1: Aggradation/Bar Formation, 4+90, 8.01.06

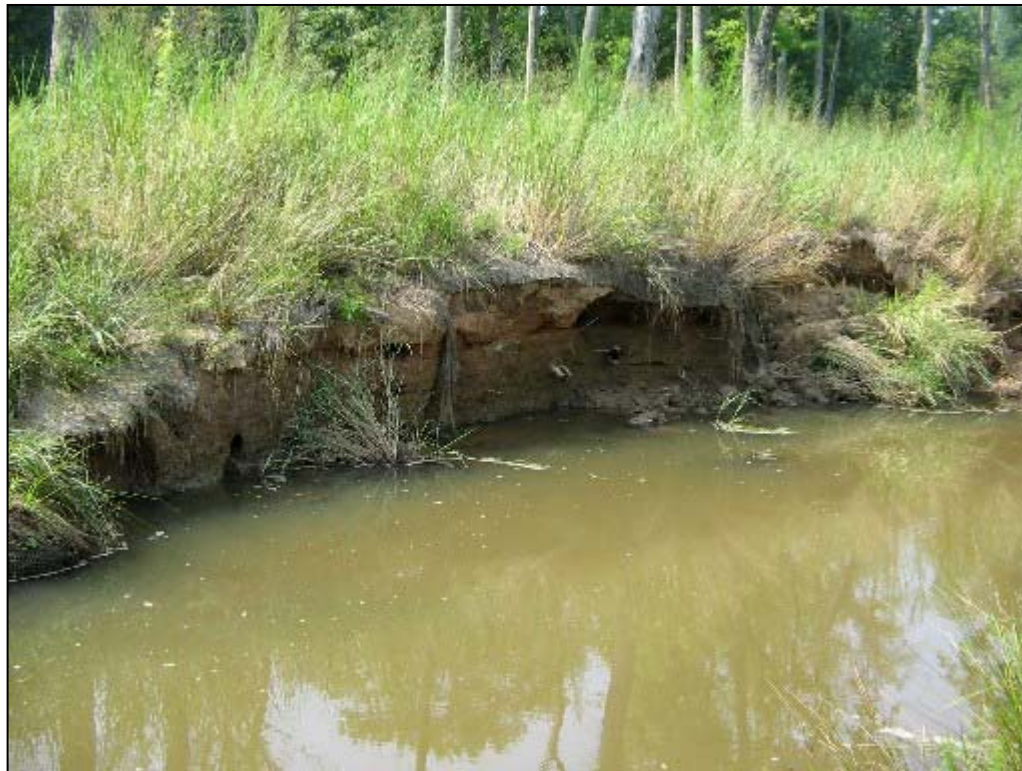
Photograph SPA-2: Bank Scour, 25+10, 8.01.06

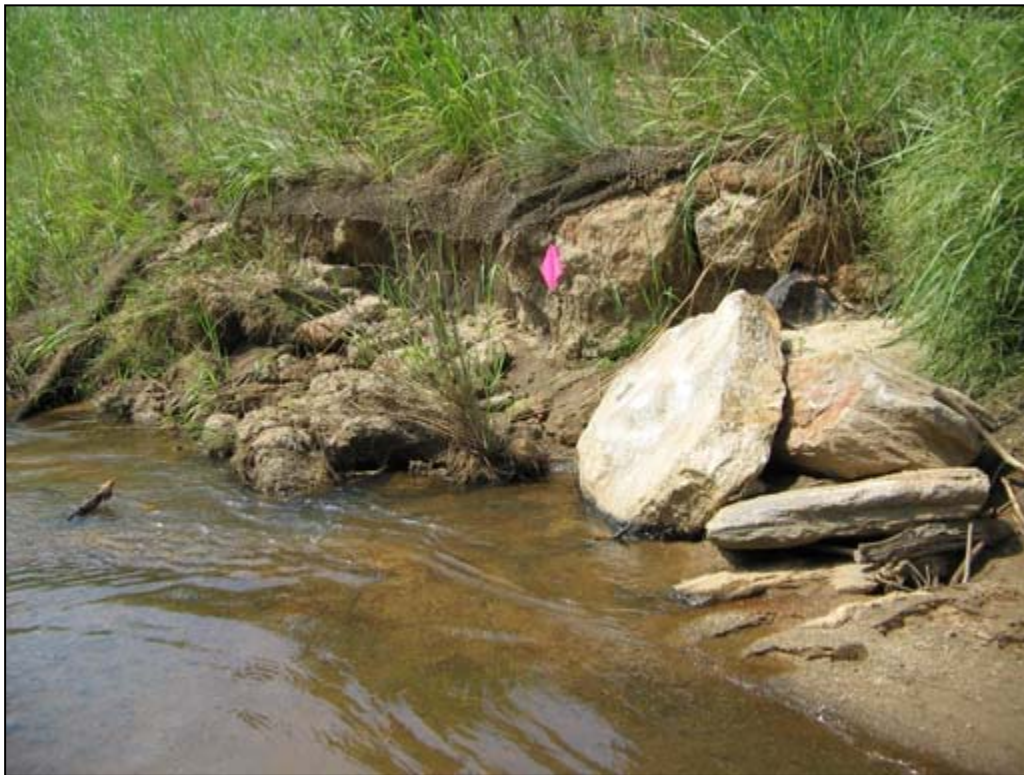
Problem Area XIV	27+10	Bank slumping before establishment of vegetation.	
Engineered structures-back or arm scour			
Problem Area II	2+85	Bank failure around right arm of structure and exposed footer rocks.	SPA-3
Problem Area VI	14+20	Construction deviated from Design - structure arms too high.	
Problem Area IX	22+00	Downstream vegetated mid-channel bar (Problem Area VIII) is causing restricted flow and backwater areas upstream.	
Problem Area X	23+50	Construction deviated from Design - structure too high.	
Problem Area XII	25+60	Construction deviated from Design - structure too high.

Photograph SPA-3: Engineered Structure - Back or Arm Scour, 2+85, 8.01.06

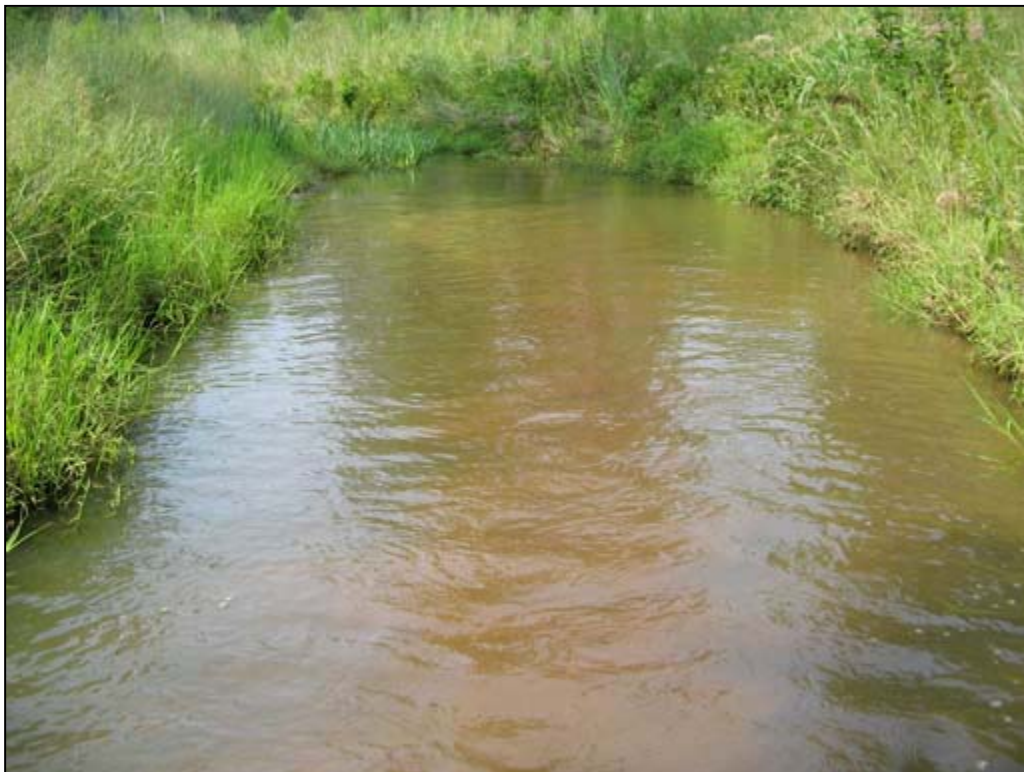
Channel over widening			
Problem Area III	4+90	See aggradation/bar formation	SPA-4
Problem Area V	13+80	Suspected bank failure before vegetation established; angle discharge from UT.	
Problem Area VII	15+30	Suspected bank failure before vegetation established.	
Problem Area X	23+50	See engineered structures - back or arm scour.

Photograph SPA-4: Channel Over-widening, 22+00, 8.01.06
